Profile/Photo Observation Report

Date:	11/13/2021	Weather:		Coding:	PACP 7.0
Pipe Length (ft):	282.3	Owner:	City of Hobart	Pre Clean:	Heavy Cleaning
P.O.#:	YES502259	Surveyor:	Steven Bucklin	PSR:	P-604-008-007
Customer:	City of Hobart, IN (Red	Clean Date:	11/13/2021	Shape:	C

Street:	Beverly Boulevard	Flow Control:	Not Controlled
City:	City of Hobart	Year Renewed:	
Location:	Local rural streets with light traffic, t	Tape/Media #:	
Purpose:	Routine Assessment	Dia/Height:	10"
Use:	Sanitary Sewage Pipe	Material:	CP
Drain Area:		Lining:	None
Category:	NA		
Comment:			
Location Details:		Direction of Survey:	Downstream
US MH:	M-604-007	DS MH:	M-604-008
		Total Length Surveyed (ft):	282.3

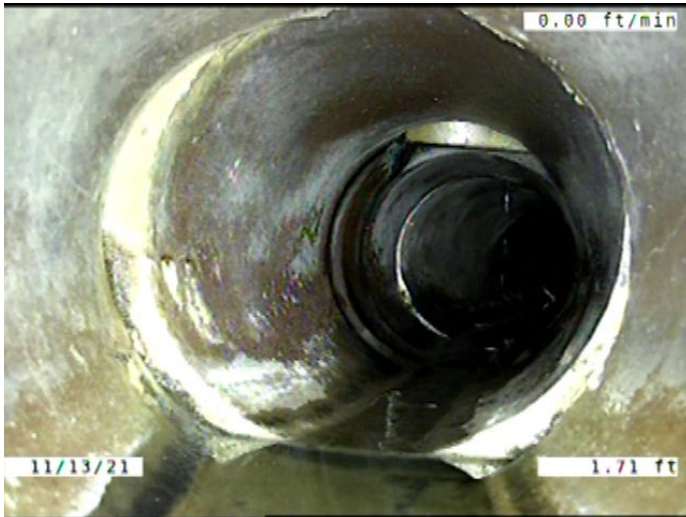
Code: **LR**
 Description: **Line Right**

Distance (ft): **1.7**
 Structural Grade: **0**
 O&M Grade: **2**
 Clock Start/From:
 Clock To:
 1st Value:
 2nd Value:
 Value Percent: **15.000**
 Continuous Index:
 Within 8" of Joint: **NO**
 Remarks:

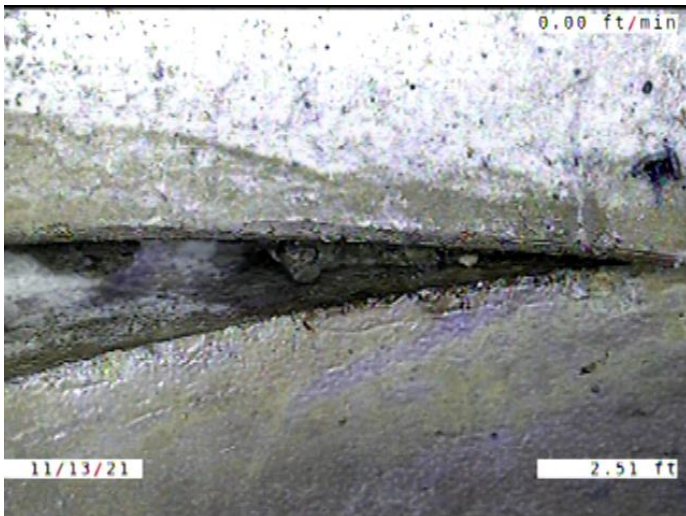
Code: **ISJ**
 Description: **Infiltration Stain Joint**

Distance (ft): **2.5**
 Structural Grade: **0**
 O&M Grade: **1**
 Clock Start/From: **7**
 Clock To: **5**
 1st Value:
 2nd Value:
 Value Percent:
 Continuous Index:
 Within 8" of Joint: **YES**
 Remarks:

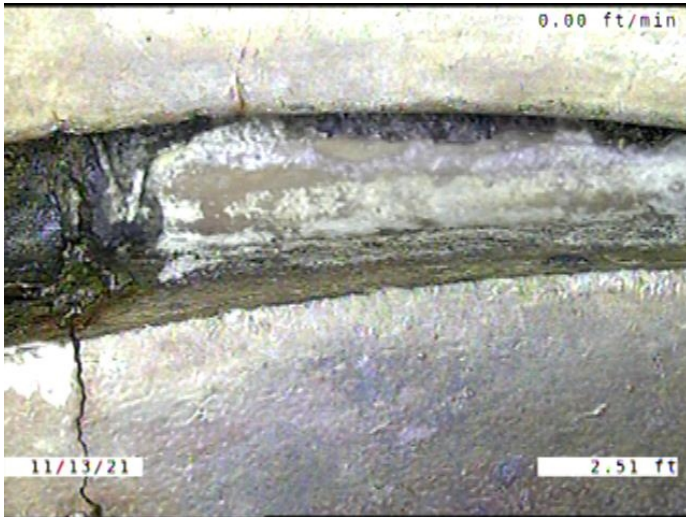
Code: **JAM**
 Description: **Joint Angular Medium**

Distance (ft): **2.5**
 Structural Grade: **3**
 O&M Grade: **0**
 Clock Start/From:
 Clock To:
 1st Value:
 2nd Value:
 Value Percent:
 Continuous Index:
 Within 8" of Joint: **NO**
 Remarks:

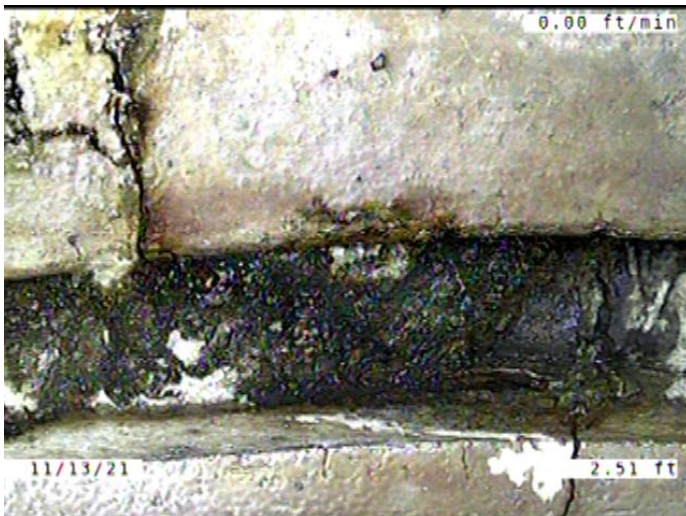
Code: **CM**
 Description: **Crack Multiple**

Distance (ft): **2.5**
 Structural Grade: **3**
 O&M Grade: **0**
 Clock Start/From: **8**
 Clock To: **10**
 1st Value:
 2nd Value:
 Value Percent:
 Continuous Index:
 Within 8" of Joint: **YES**
 Remarks:

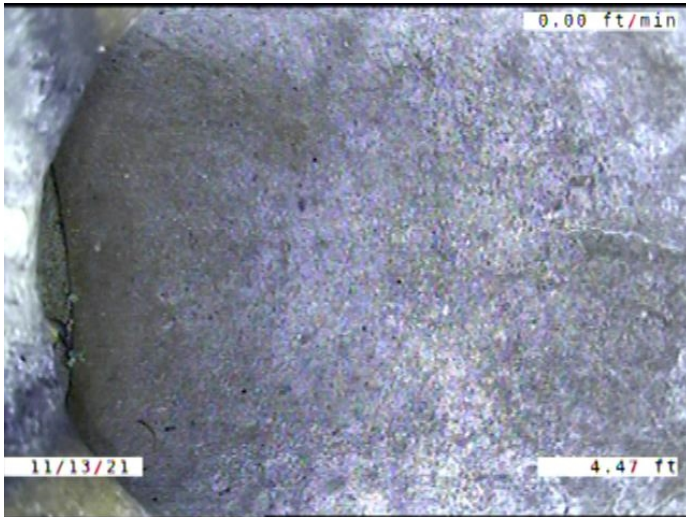
Code: **TBI**
 Description: **Tap Break-in Intruding**

Distance (ft): **4.5**
 Structural Grade: **0**
 O&M Grade: **2**
 Clock Start/From: **12**
 Clock To:
 1st Value: **4.000**
 2nd Value: **1.000**
 Value Percent:
 Continuous Index:
 Within 8" of Joint: **YES**
 Remarks: **ACTIVE**

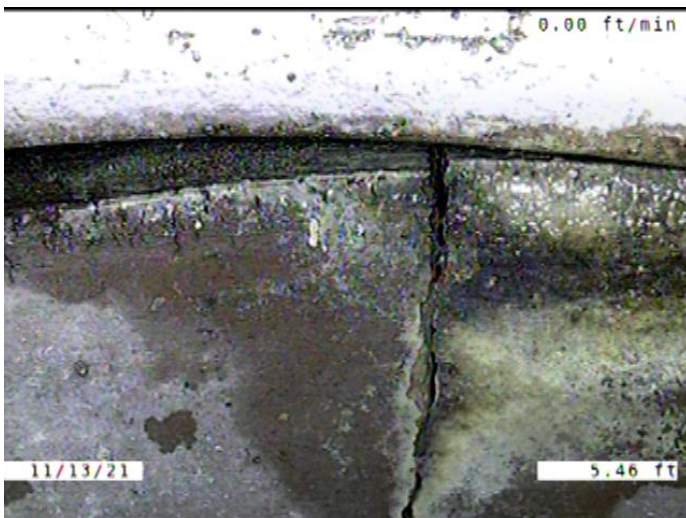
Code: **IRB**
 Description: **Infiltration Runner Barrel**

Distance (ft): **5.5**
 Structural Grade: **0**
 O&M Grade: **4**
 Clock Start/From: **12**
 Clock To:
 1st Value:
 2nd Value:
 Value Percent:
 Continuous Index:
 Within 8" of Joint: **YES**
 Remarks: **WAS NOT LEAKING UNTIL THE
BREAK IN SERVIE BEHIND THE CAME**

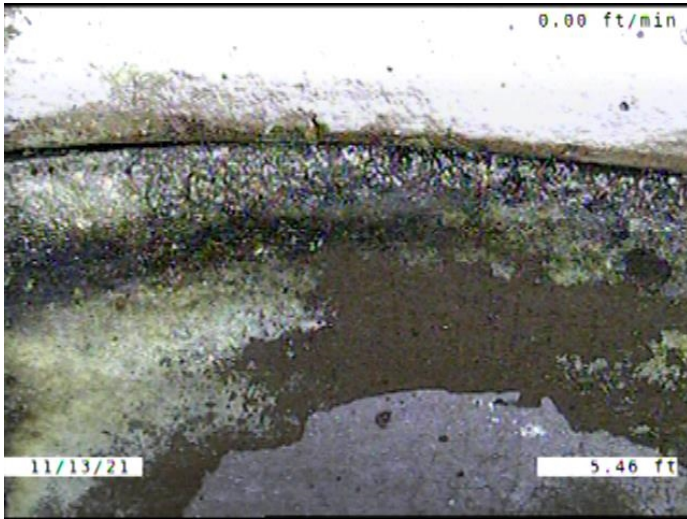
Code: **DAE**
Description: **Deposits Attached Encrustation**

Distance (ft): **5.5**
Structural Grade: **0**
O&M Grade: **2**
Clock Start/From: **11**
Clock To: **5**
1st Value:
2nd Value:
Value Percent: **5.000**
Continuous Index:
Within 8" of Joint: **YES**
Remarks:

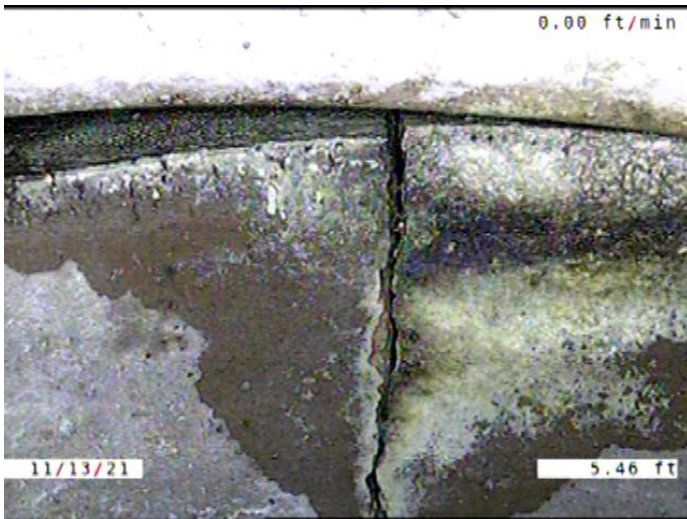
Code: **B**
Description: **Broken**

Distance (ft): **5.5**
Structural Grade: **4**
O&M Grade: **0**
Clock Start/From: **10**
Clock To: **4**
1st Value:
2nd Value:
Value Percent:
Continuous Index:
Within 8" of Joint: **YES**
Remarks:

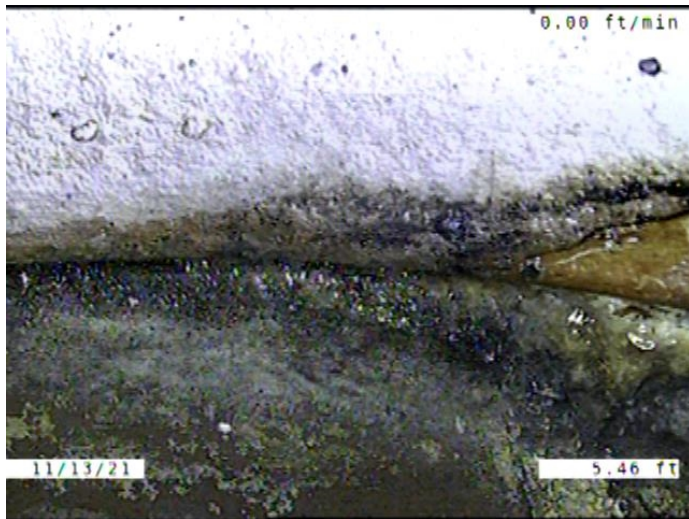
Code: **IRJ**
 Description: **Infiltration Runner Joint**

Distance (ft): **5.5**
 Structural Grade: **0**
 O&M Grade: **4**
 Clock Start/From: **2**
 Clock To:
 1st Value:
 2nd Value:
 Value Percent:
 Continuous Index:
 Within 8" of Joint: **YES**
 Remarks:

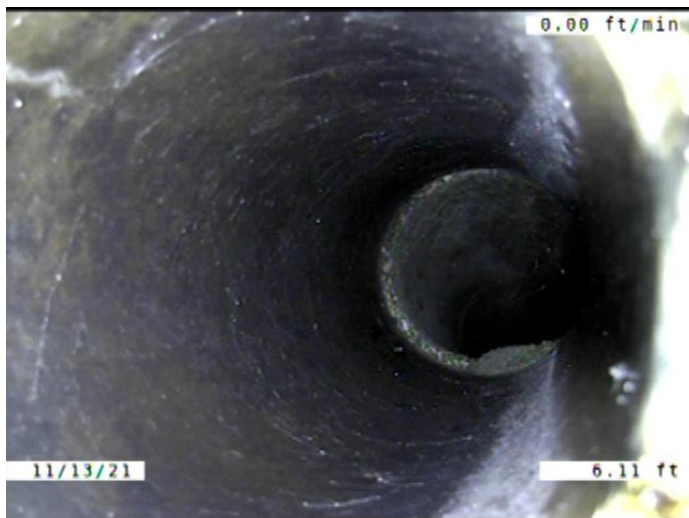
Code: **TBD**
 Description: **Tap Break-in/Hammer Defective**

Distance (ft): **6.1**
 Structural Grade: **0**
 O&M Grade: **3**
 Clock Start/From: **2**
 Clock To:
 1st Value: **4.000**
 2nd Value:
 Value Percent:
 Continuous Index:
 Within 8" of Joint: **YES**
 Remarks: **Defective**

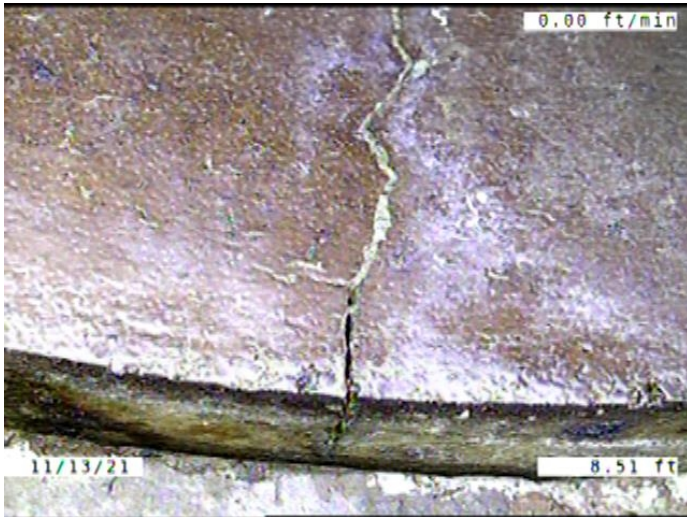
Code: **CM**
 Description: **Crack Multiple**

Distance (ft): **8.5**
 Structural Grade: **3**
 O&M Grade: **0**
 Clock Start/From: **3**
 Clock To: **4**
 1st Value:
 2nd Value:
 Value Percent:
 Continuous Index:
 Within 8" of Joint: **YES**
 Remarks:

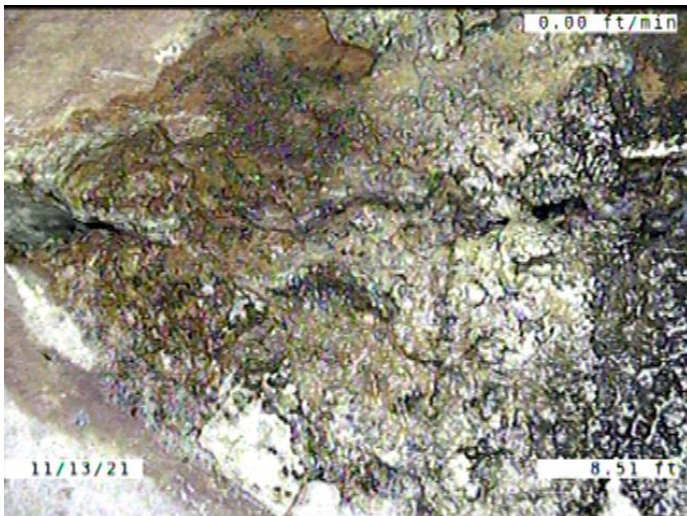
Code: **DAE**
 Description: **Deposits Attached Encrustation**

Distance (ft): **8.5**
 Structural Grade: **0**
 O&M Grade: **2**
 Clock Start/From: **7**
 Clock To: **5**
 1st Value:
 2nd Value:
 Value Percent: **5.000**
 Continuous Index: **S01**
 Within 8" of Joint: **YES**
 Remarks:

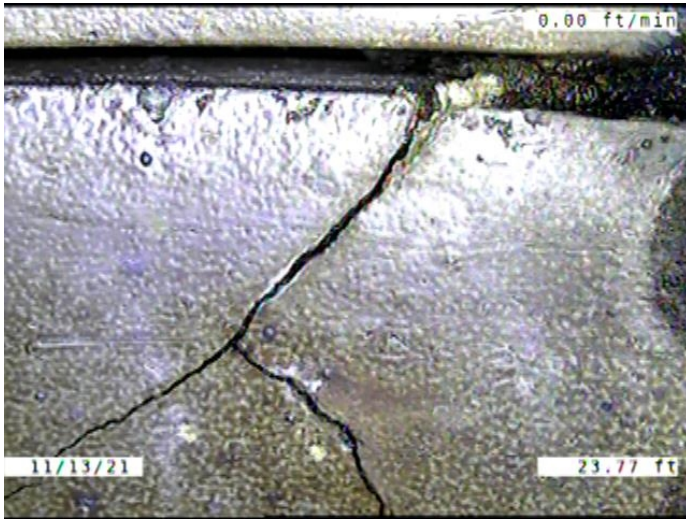
Code: **FM**
 Description: **Fracture Multiple**

Distance (ft): **23.8**
 Structural Grade: **4**
 O&M Grade: **0**
 Clock Start/From: **8**
 Clock To: **5**
 1st Value:
 2nd Value:
 Value Percent:
 Continuous Index:
 Within 8" of Joint: **YES**
 Remarks:

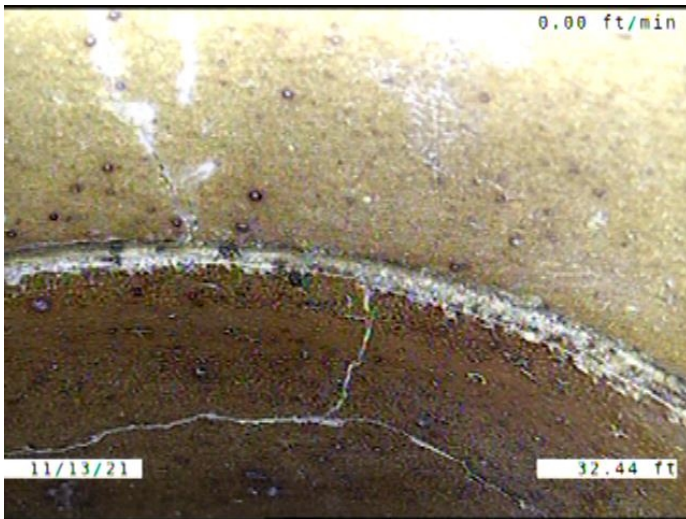
Code: **CM**
 Description: **Crack Multiple**

Distance (ft): **32.4**
 Structural Grade: **3**
 O&M Grade: **0**
 Clock Start/From: **12**
 Clock To: **12**
 1st Value:
 2nd Value:
 Value Percent:
 Continuous Index:
 Within 8" of Joint: **YES**
 Remarks:

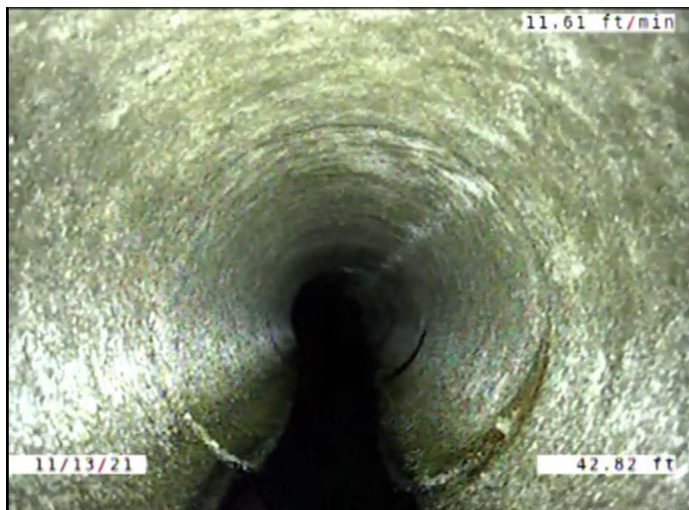
Code: **ISJ**
 Description: **Infiltration Stain Joint**

Distance (ft): **42.8**
 Structural Grade: **0**
 O&M Grade: **1**
 Clock Start/From: **3**
 Clock To: **5**
 1st Value:
 2nd Value:
 Value Percent:
 Continuous Index: **S09**
 Within 8" of Joint: **YES**
 Remarks:

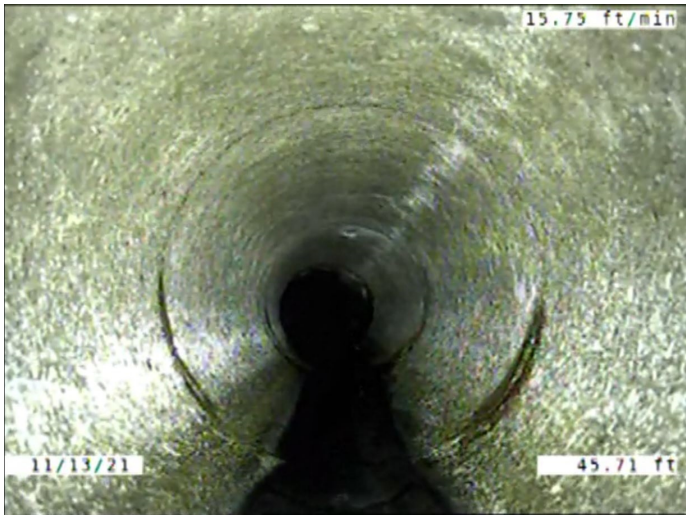
Code: **ISJ**
 Description: **Infiltration Stain Joint**

Distance (ft): **45.7**
 Structural Grade: **0**
 O&M Grade: **1**
 Clock Start/From: **7**
 Clock To: **9**
 1st Value:
 2nd Value:
 Value Percent:
 Continuous Index: **S10**
 Within 8" of Joint: **YES**
 Remarks:

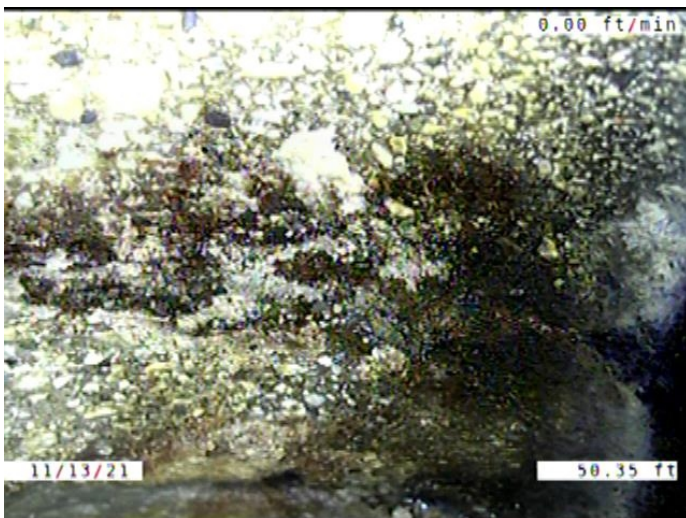
Code: **FM**
 Description: **Fracture Multiple**

Distance (ft): **50.4**
 Structural Grade: **4**
 O&M Grade: **0**
 Clock Start/From: **12**
 Clock To: **12**
 1st Value:
 2nd Value:
 Value Percent:
 Continuous Index:
 Within 8" of Joint: **YES**
 Remarks:

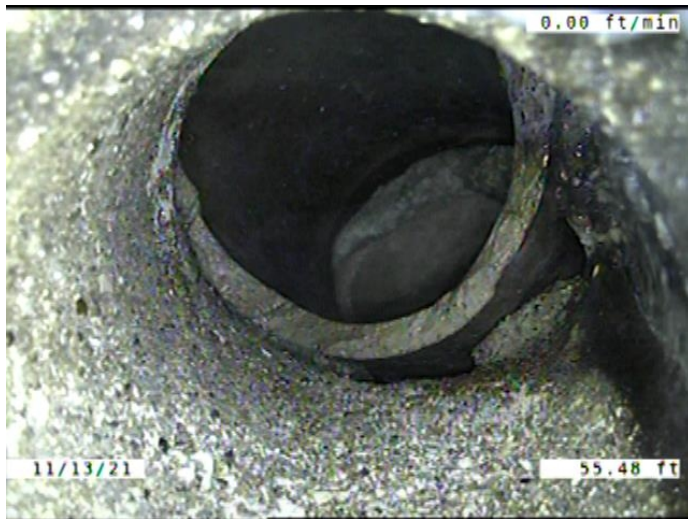
Code: **TF**
Description: **Tap Factory**

Distance (ft): **55.5**
Structural Grade: **0**
O&M Grade: **0**
Clock Start/From: **2**
Clock To:
1st Value: **6.000**
2nd Value:
Value Percent:
Continuous Index:
Within 8" of Joint: **YES**
Remarks: **CONSTANTLY RUNNING WATER.**

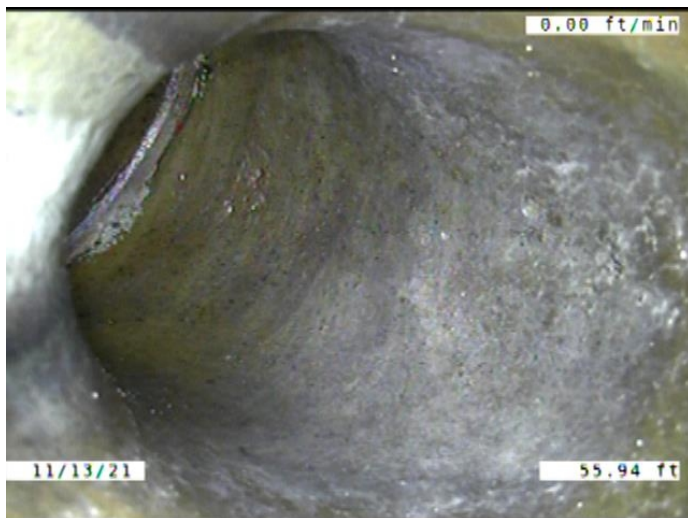
Code: **TBI**
Description: **Tap Break-in Intruding**

Distance (ft): **55.9**
Structural Grade: **0**
O&M Grade: **2**
Clock Start/From: **12**
Clock To:
1st Value: **4.000**
2nd Value: **1.000**
Value Percent:
Continuous Index:
Within 8" of Joint: **YES**
Remarks:

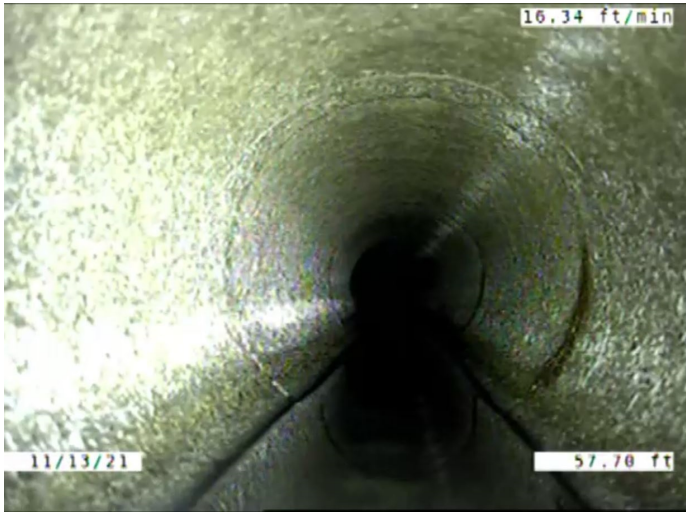
Code: **ISJ**
Description: **Infiltration Stain Joint**

Distance (ft): **57.7**
Structural Grade: **0**
O&M Grade: **1**
Clock Start/From: **7**
Clock To: **9**
1st Value:
2nd Value:
Value Percent:
Continuous Index: **F10**
Within 8" of Joint: **YES**
Remarks:

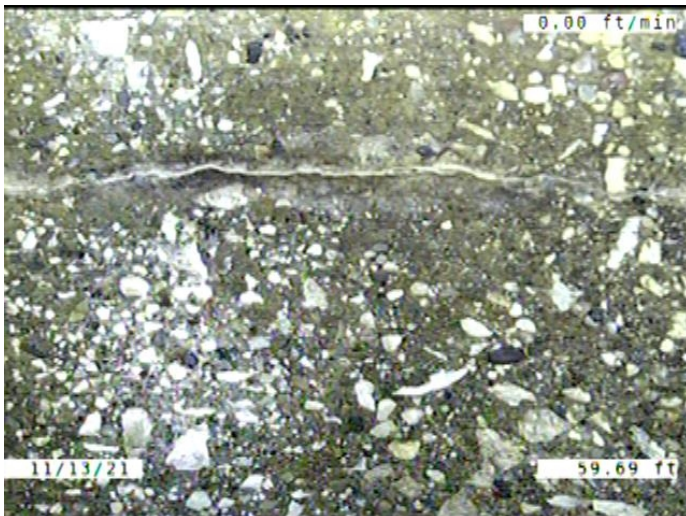
Code: **CM**
Description: **Crack Multiple**

Distance (ft): **59.7**
Structural Grade: **3**
O&M Grade: **0**
Clock Start/From: **8**
Clock To: **3**
1st Value:
2nd Value:
Value Percent:
Continuous Index:
Within 8" of Joint: **YES**
Remarks:

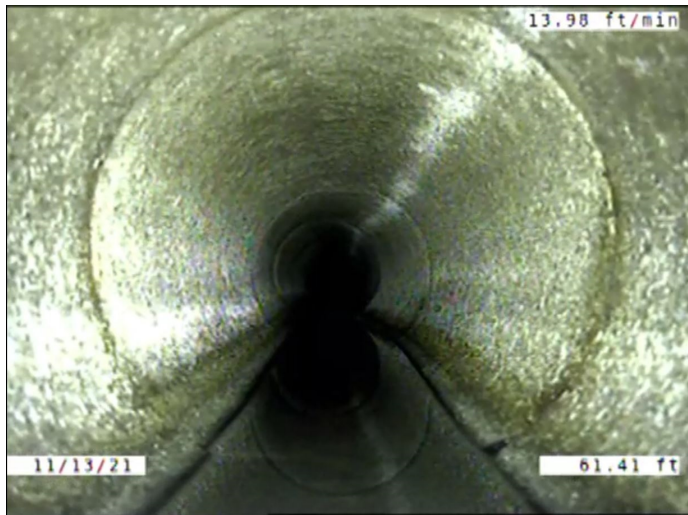
Code: **ISJ**
 Description: **Infiltration Stain Joint**

Distance (ft): **61.4**
 Structural Grade: **0**
 O&M Grade: **1**
 Clock Start/From: **3**
 Clock To: **5**
 1st Value:
 2nd Value:
 Value Percent:
 Continuous Index: **F09**
 Within 8" of Joint: **YES**
 Remarks:

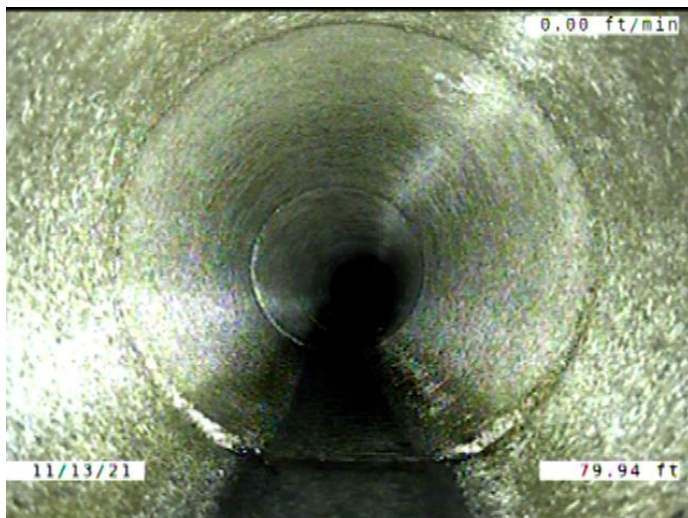
Code: **DAE**
 Description: **Deposits Attached Encrustation**

Distance (ft): **79.9**
 Structural Grade: **0**
 O&M Grade: **2**
 Clock Start/From: **7**
 Clock To: **5**
 1st Value:
 2nd Value:
 Value Percent: **5.000**
 Continuous Index: **F01**
 Within 8" of Joint: **YES**
 Remarks:

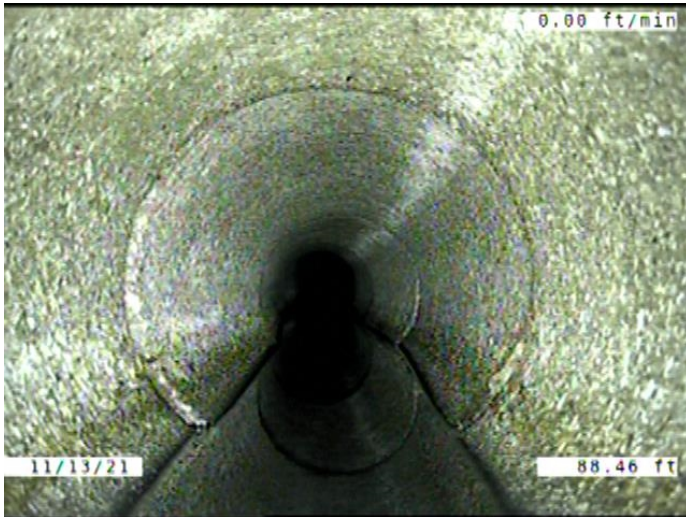
Code: **MWLS**
Description: **Miscellaneous Water Level Sag**

Distance (ft): **88.5**
Structural Grade: **2**
O&M Grade: **0**
Clock Start/From:
Clock To:
1st Value:
2nd Value:
Value Percent: **5.000**
Continuous Index: **S02**
Within 8" of Joint: **NO**
Remarks:

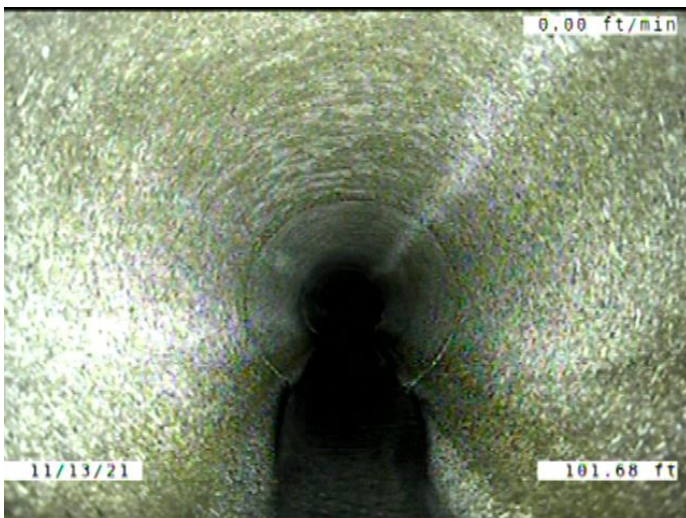
Code: **MWLS**
Description: **Miscellaneous Water Level Sag**

Distance (ft): **101.7**
Structural Grade: **2**
O&M Grade: **0**
Clock Start/From:
Clock To:
1st Value:
2nd Value:
Value Percent: **5.000**
Continuous Index: **F02**
Within 8" of Joint: **NO**
Remarks:

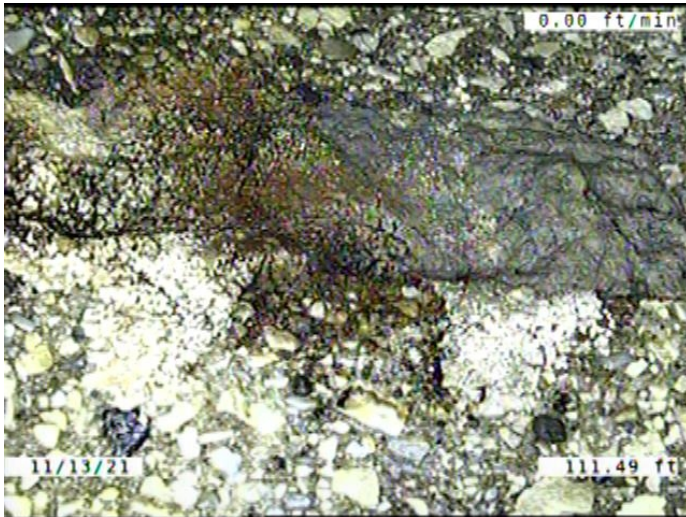
Code: **DAE**
Description: **Deposits Attached Encrustation**

Distance (ft): **111.5**
Structural Grade: **0**
O&M Grade: **2**
Clock Start/From: **3**
Clock To: **4**
1st Value:
2nd Value:
Value Percent: **5.000**
Continuous Index:
Within 8" of Joint: **YES**
Remarks:

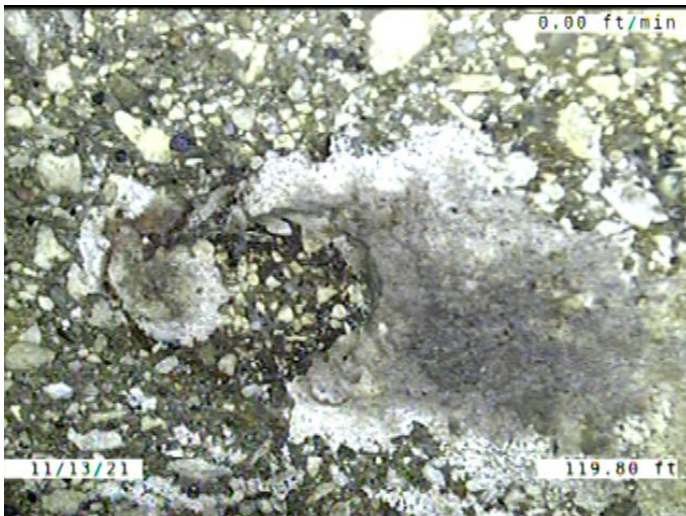
Code: **DAE**
Description: **Deposits Attached Encrustation**

Distance (ft): **119.8**
Structural Grade: **0**
O&M Grade: **2**
Clock Start/From: **2**
Clock To: **3**
1st Value:
2nd Value:
Value Percent: **5.000**
Continuous Index:
Within 8" of Joint: **NO**
Remarks:

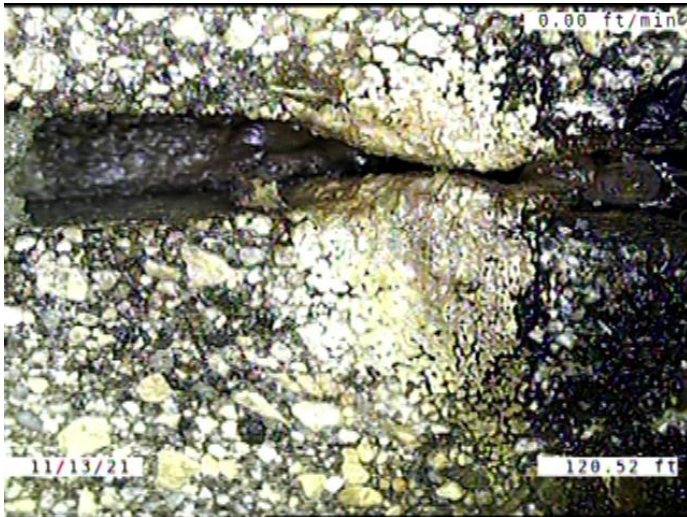
Code: **DAE**
 Description: **Deposits Attached Encrustation**

Distance (ft): **120.5**
 Structural Grade: **0**
 O&M Grade: **2**
 Clock Start/From: **7**
 Clock To: **5**
 1st Value:
 2nd Value:
 Value Percent: **5.000**
 Continuous Index: **S03**
 Within 8" of Joint: **YES**
 Remarks:

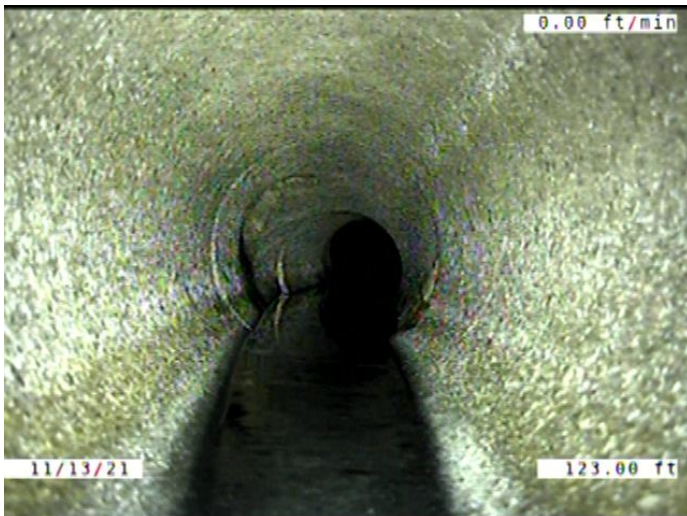
Code: **MWLS**
 Description: **Miscellaneous Water Level Sag**

Distance (ft): **123.0**
 Structural Grade: **2**
 O&M Grade: **0**
 Clock Start/From:
 Clock To:
 1st Value:
 2nd Value:
 Value Percent: **10.000**
 Continuous Index: **S04**
 Within 8" of Joint: **NO**
 Remarks:

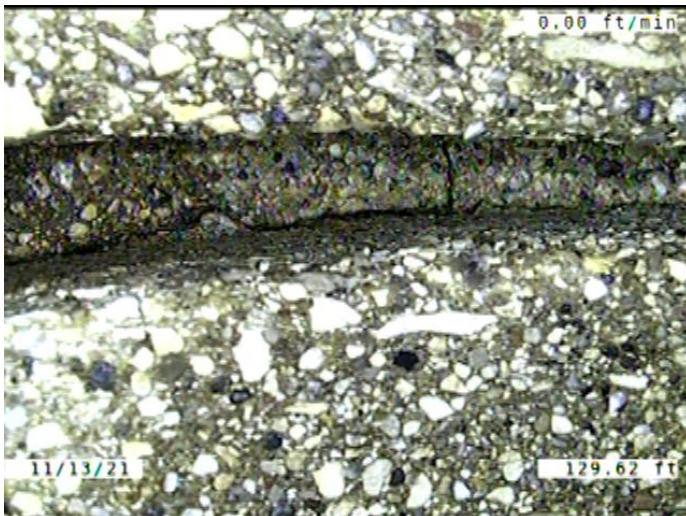
Code: **FL**
 Description: **Fracture Longitudinal**

Distance (ft): **129.6**
 Structural Grade: **3**
 O&M Grade: **0**
 Clock Start/From: **11**
 Clock To:
 1st Value:
 2nd Value:
 Value Percent:
 Continuous Index:
 Within 8" of Joint: **YES**
 Remarks:

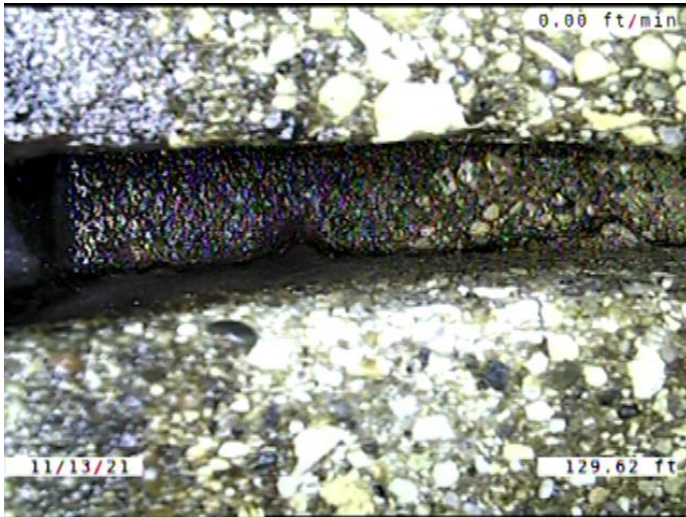
Code: **JAM**
Description: **Joint Angular Medium**

Distance (ft): **129.6**
Structural Grade: **3**
O&M Grade: **0**
Clock Start/From:
Clock To:
1st Value:
2nd Value:
Value Percent:
Continuous Index:
Within 8" of Joint: **NO**
Remarks:

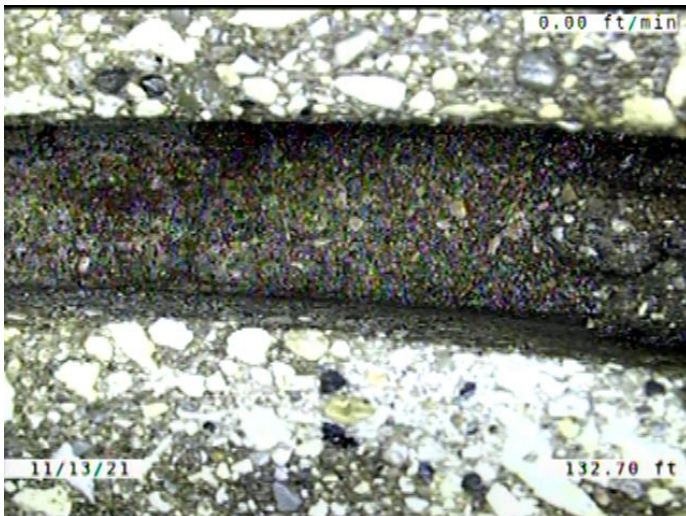
Code: **JAM**
Description: **Joint Angular Medium**

Distance (ft): **132.7**
Structural Grade: **3**
O&M Grade: **0**
Clock Start/From:
Clock To:
1st Value:
2nd Value:
Value Percent:
Continuous Index:
Within 8" of Joint: **NO**
Remarks:

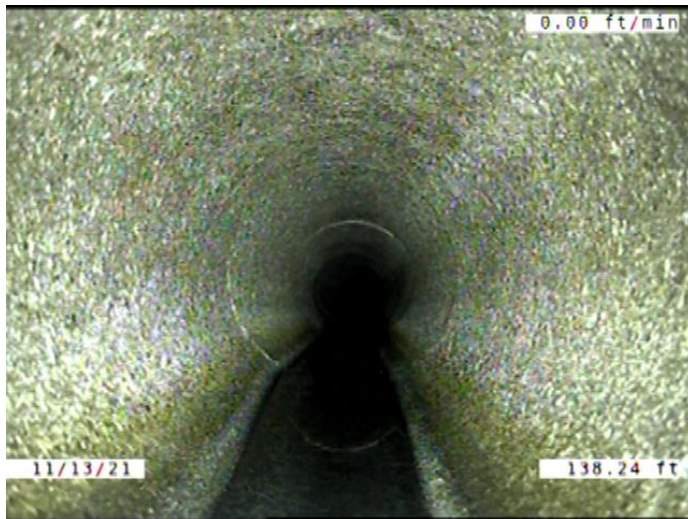
Code: **MWLS**
 Description: **Miscellaneous Water Level Sag**

Distance (ft): **138.2**
 Structural Grade: **2**
 O&M Grade: **0**
 Clock Start/From:
 Clock To:
 1st Value:
 2nd Value:
 Value Percent: **10.000**
 Continuous Index: **F04**
 Within 8" of Joint: **NO**
 Remarks:

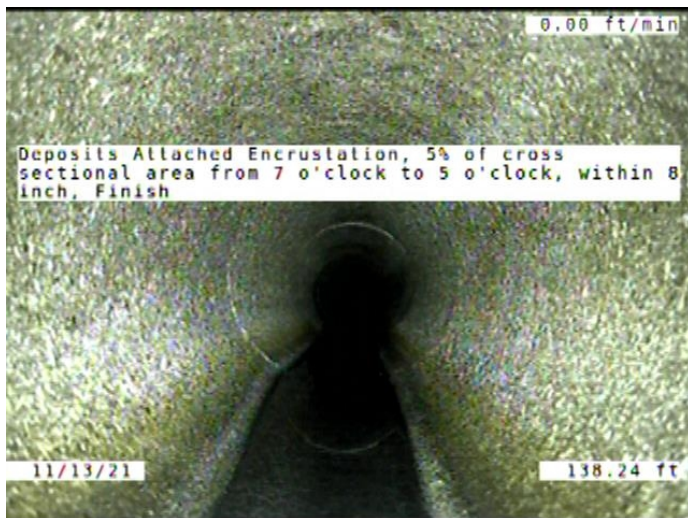
Code: **DAE**
 Description: **Deposits Attached Encrustation**

Distance (ft): **138.2**
 Structural Grade: **0**
 O&M Grade: **2**
 Clock Start/From: **7**
 Clock To: **5**
 1st Value:
 2nd Value:
 Value Percent: **5.000**
 Continuous Index: **F03**
 Within 8" of Joint: **YES**
 Remarks:

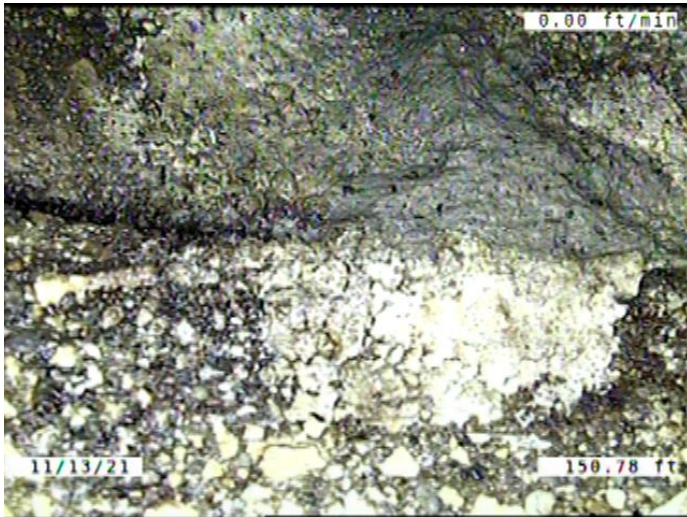
Code: **DAE**
 Description: **Deposits Attached Encrustation**

Distance (ft): **150.8**
 Structural Grade: **0**
 O&M Grade: **2**
 Clock Start/From: **2**
 Clock To: **4**
 1st Value:
 2nd Value:
 Value Percent: **5.000**
 Continuous Index:
 Within 8" of Joint: **YES**
 Remarks:

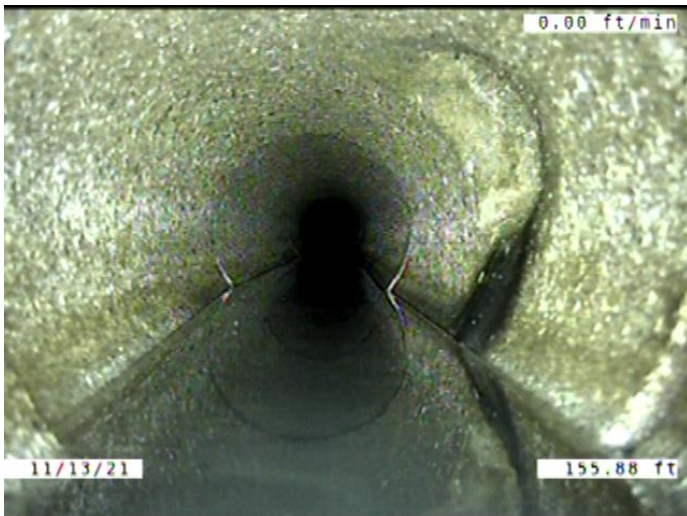
Code: **MWLS**
 Description: **Miscellaneous Water Level Sag**

Distance (ft): **155.9**
 Structural Grade: **2**
 O&M Grade: **0**
 Clock Start/From:
 Clock To:
 1st Value:
 2nd Value:
 Value Percent: **10.000**
 Continuous Index: **S05**
 Within 8" of Joint: **NO**
 Remarks:

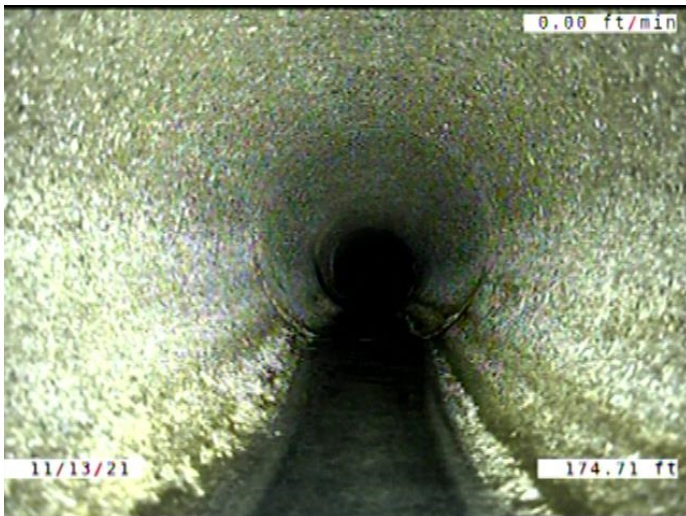
Code: **MWLS**
 Description: **Miscellaneous Water Level Sag**

Distance (ft): **174.7**
 Structural Grade: **2**
 O&M Grade: **0**
 Clock Start/From:
 Clock To:
 1st Value:
 2nd Value:
 Value Percent: **10.000**
 Continuous Index: **F05**
 Within 8" of Joint: **NO**
 Remarks:

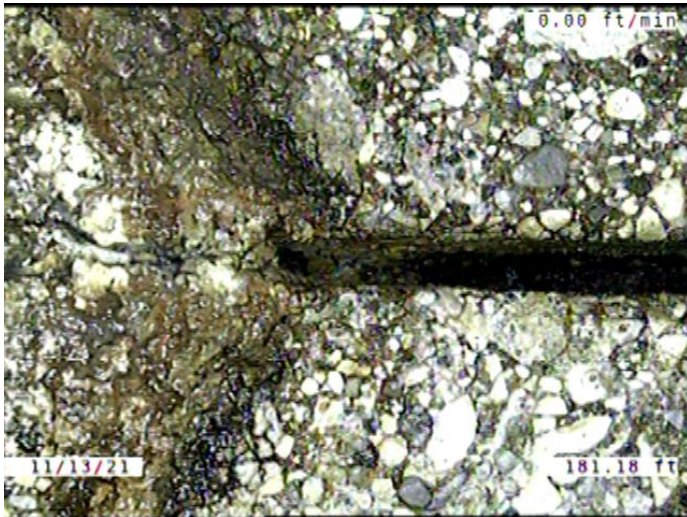
Code: **DAE**
 Description: **Deposits Attached Encrustation**

Distance (ft): **181.2**
 Structural Grade: **0**
 O&M Grade: **2**
 Clock Start/From: **4**
 Clock To:
 1st Value:
 2nd Value:
 Value Percent: **5.000**
 Continuous Index:
 Within 8" of Joint: **YES**
 Remarks:

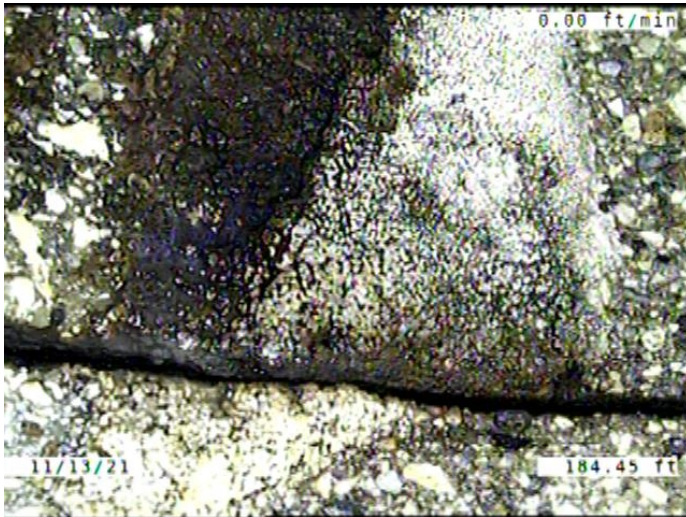
Code: **DAE**
 Description: **Deposits Attached Encrustation**

Distance (ft): **184.5**
 Structural Grade: **0**
 O&M Grade: **2**
 Clock Start/From: **2**
 Clock To: **3**
 1st Value:
 2nd Value:
 Value Percent: **5.000**
 Continuous Index:
 Within 8" of Joint: **YES**
 Remarks:

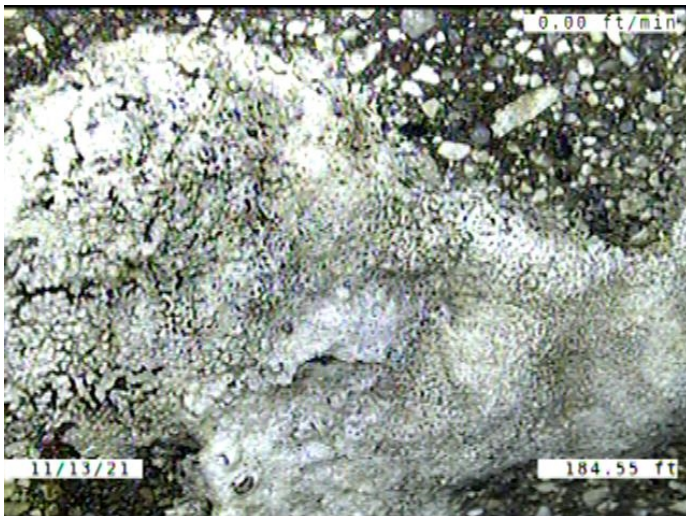
Code: **DAE**
 Description: **Deposits Attached Encrustation**

Distance (ft): **184.5**
 Structural Grade: **0**
 O&M Grade: **2**
 Clock Start/From: **9**
 Clock To: **11**
 1st Value:
 2nd Value:
 Value Percent: **5.000**
 Continuous Index:
 Within 8" of Joint: **YES**
 Remarks:

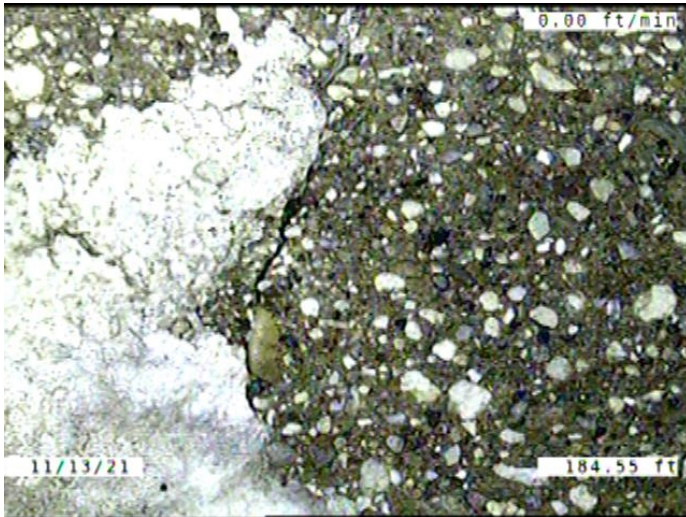
Code: **FM**
 Description: **Fracture Multiple**

Distance (ft): **184.6**
 Structural Grade: **4**
 O&M Grade: **0**
 Clock Start/From: **4**
 Clock To: **11**
 1st Value:
 2nd Value:
 Value Percent:
 Continuous Index:
 Within 8" of Joint: **YES**
 Remarks:

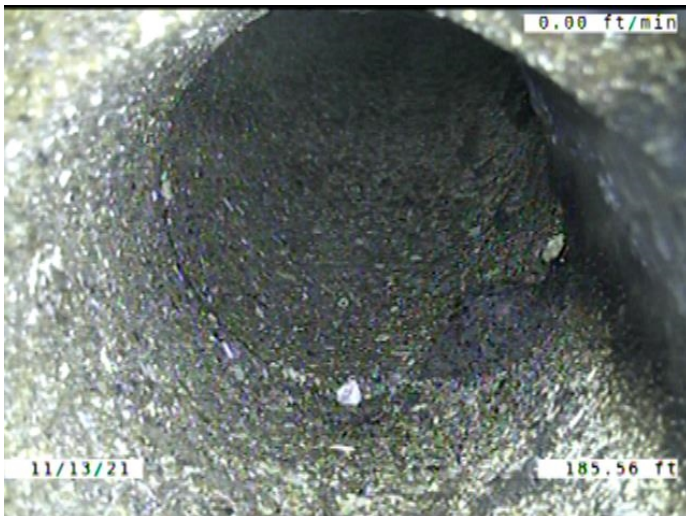
Code: **TF**
 Description: **Tap Factory**

Distance (ft): **185.6**
 Structural Grade: **0**
 O&M Grade: **0**
 Clock Start/From: **2**
 Clock To:
 1st Value: **6.000**
 2nd Value:
 Value Percent:
 Continuous Index:
 Within 8" of Joint: **YES**
 Remarks: **CONSTANTLY RUNNING WATER.**

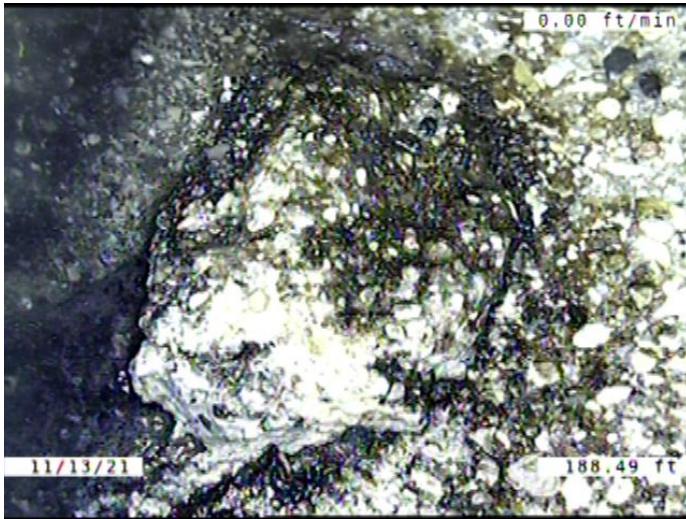
Code: **DAE**
 Description: **Deposits Attached Encrustation**

Distance (ft): **188.5**
 Structural Grade: **0**
 O&M Grade: **2**
 Clock Start/From: **4**
 Clock To: **7**
 1st Value:
 2nd Value:
 Value Percent: **5.000**
 Continuous Index:
 Within 8" of Joint: **NO**
 Remarks:

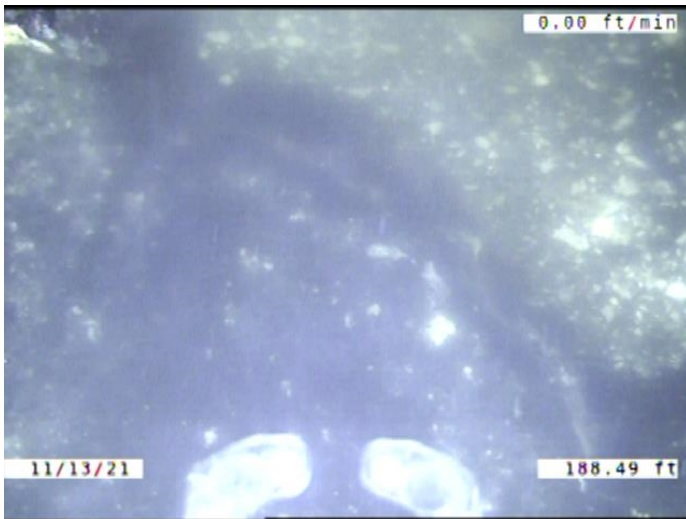
Code: **CS**
 Description: **Crack Spiral**

Distance (ft): **188.5**
 Structural Grade: **2**
 O&M Grade: **0**
 Clock Start/From: **4**
 Clock To: **7**
 1st Value:
 2nd Value:
 Value Percent:
 Continuous Index:
 Within 8" of Joint: **NO**
 Remarks:

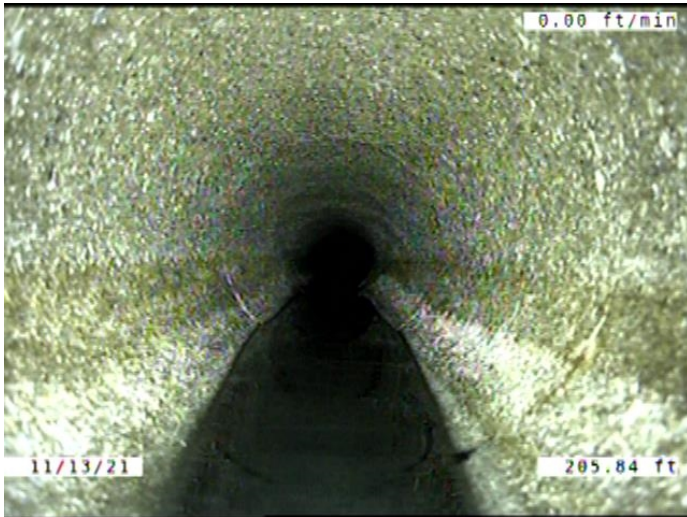
Code: **MWLS**
 Description: **Miscellaneous Water Level Sag**

Distance (ft): **205.8**
 Structural Grade: **2**
 O&M Grade: **0**
 Clock Start/From:
 Clock To:
 1st Value:
 2nd Value:
 Value Percent: **5.000**
 Continuous Index: **S06**
 Within 8" of Joint: **NO**
 Remarks:

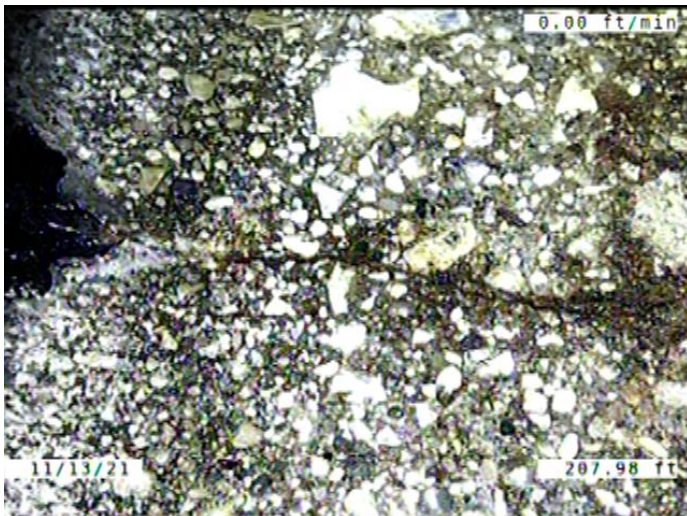
Code: **CS**
 Description: **Crack Spiral**

Distance (ft): **208.0**
 Structural Grade: **2**
 O&M Grade: **0**
 Clock Start/From: **2**
 Clock To: **6**
 1st Value:
 2nd Value:
 Value Percent:
 Continuous Index:
 Within 8" of Joint: **NO**
 Remarks:

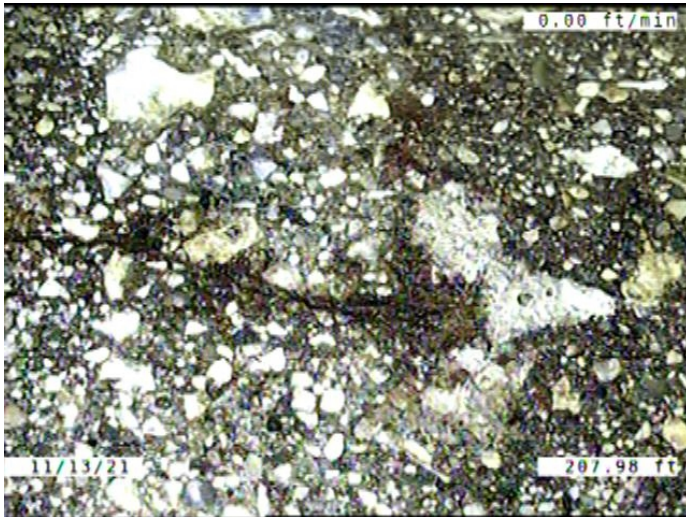
Code: **ISB**
 Description: **Infiltration Stain Barrel**

Distance (ft): **208.0**
 Structural Grade: **0**
 O&M Grade: **1**
 Clock Start/From: **3**
 Clock To: **4**
 1st Value:
 2nd Value:
 Value Percent:
 Continuous Index:
 Within 8" of Joint: **NO**
 Remarks:

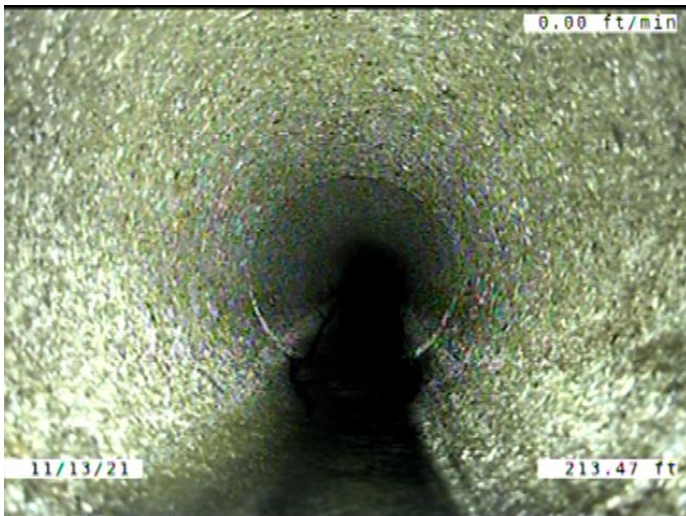
Code: **MWLS**
 Description: **Miscellaneous Water Level Sag**

Distance (ft): **213.5**
 Structural Grade: **2**
 O&M Grade: **0**
 Clock Start/From:
 Clock To:
 1st Value:
 2nd Value:
 Value Percent: **5.000**
 Continuous Index: **F06**
 Within 8" of Joint: **NO**
 Remarks:

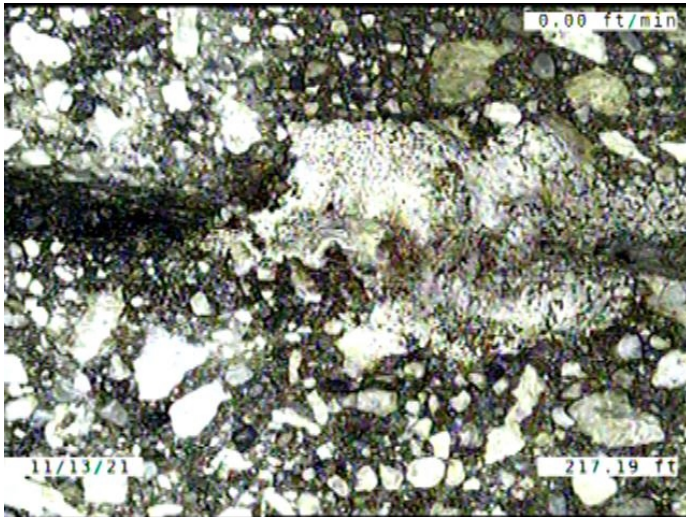
Code: **DAE**
 Description: **Deposits Attached Encrustation**

Distance (ft): **217.2**
 Structural Grade: **0**
 O&M Grade: **2**
 Clock Start/From: **3**
 Clock To: **4**
 1st Value:
 2nd Value:
 Value Percent: **5.000**
 Continuous Index:
 Within 8" of Joint: **YES**
 Remarks:

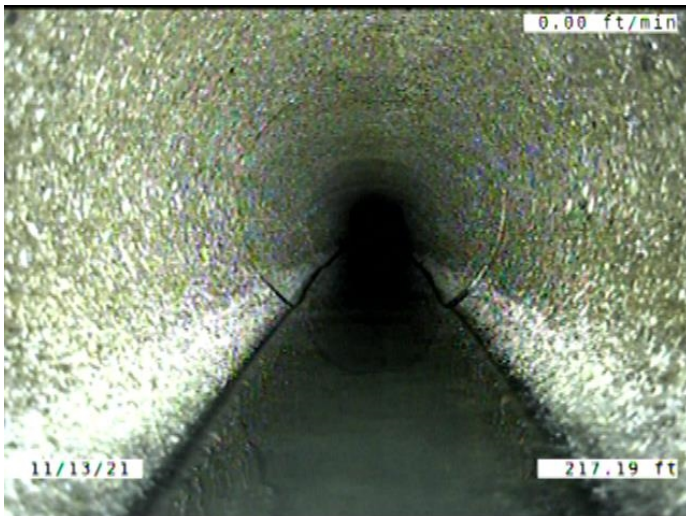
Code: **MWLS**
 Description: **Miscellaneous Water Level Sag**

Distance (ft): **217.2**
 Structural Grade: **2**
 O&M Grade: **0**
 Clock Start/From:
 Clock To:
 1st Value:
 2nd Value:
 Value Percent: **10.000**
 Continuous Index: **S07**
 Within 8" of Joint: **NO**
 Remarks:

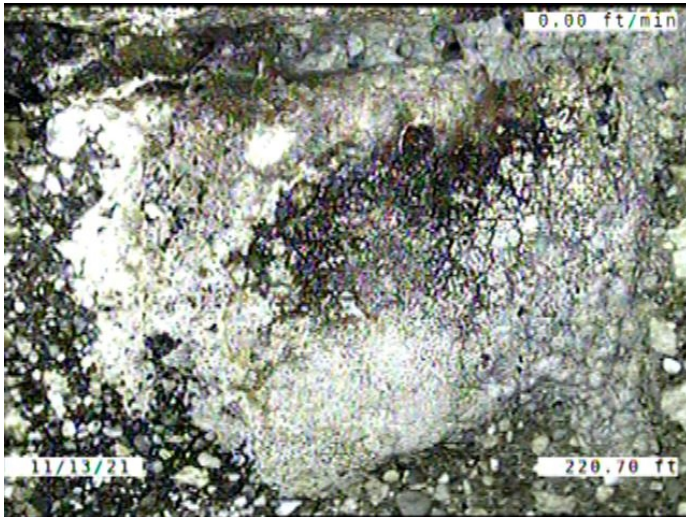
Code: **DAE**
 Description: **Deposits Attached Encrustation**

Distance (ft): **220.7**
 Structural Grade: **0**
 O&M Grade: **2**
 Clock Start/From: **8**
 Clock To: **9**
 1st Value:
 2nd Value:
 Value Percent: **5.000**
 Continuous Index:
 Within 8" of Joint: **YES**
 Remarks:

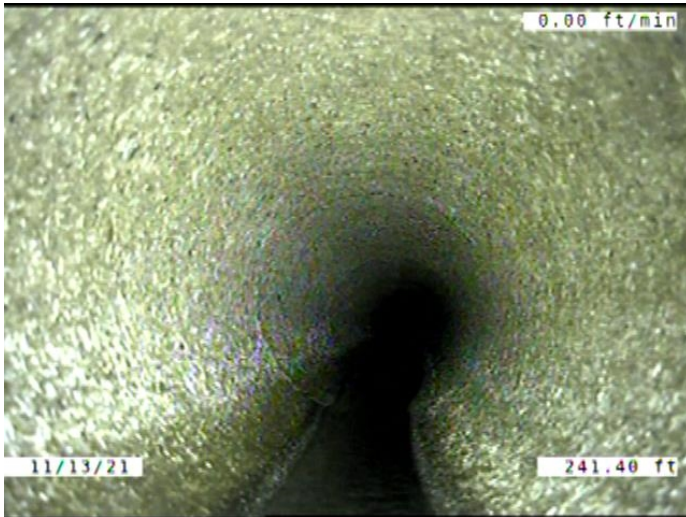
Code: **MWLS**
 Description: **Miscellaneous Water Level Sag**

Distance (ft): **241.4**
 Structural Grade: **2**
 O&M Grade: **0**
 Clock Start/From:
 Clock To:
 1st Value:
 2nd Value:
 Value Percent: **10.000**
 Continuous Index: **F07**
 Within 8" of Joint: **NO**
 Remarks:
