Profile/Photo Observation Report

Date:	11/13/2021	Weather:		Coding:	PACP 7.0
Pipe Length (ft):	282.3	Owner:	City of Hobart	Pre Clean:	Heavy Cleaning
P.O.#:	YES502259	Surveyor:	Steven Bucklin	PSR:	P-604-008-007
Customer:	City of Hobart, IN (Red	Clean Date:	11/13/2021	Shape:	C

Street:	Beverly Boulevard	Flow Control:	Not Controlled
City:	City of Hobart	Year Renewed:	
Location:	Local rural streets with light traffic, t	Tape/Media #:	
Purpose:	Routine Assessment	Dia/Height:	10"
Use:	Sanitary Sewage Pipe	Material:	CP
Drain Area:		Lining:	None
Category:	NA		
Comment:			
Location Details:		Direction of Survey:	Downstream
US MH:	M-604-007	DS MH:	M-604-008
		Total Length Surveyed (ft):	282.3

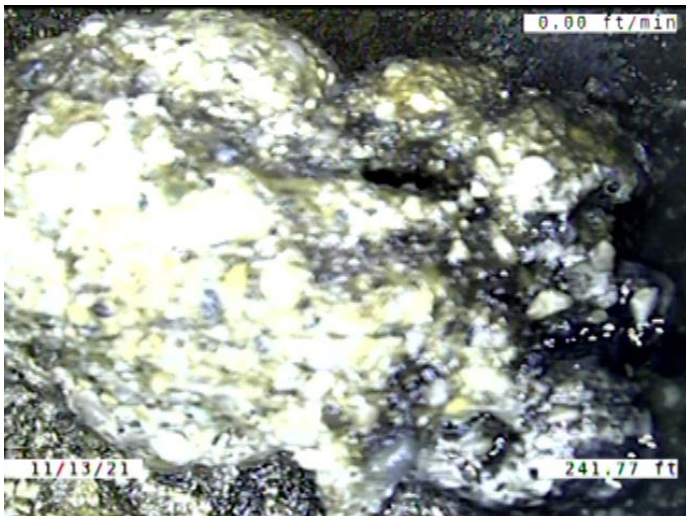
Code: **DAE**
 Description: **Deposits Attached Encrustation**

Distance (ft): **241.8**
 Structural Grade: **0**
 O&M Grade: **2**
 Clock Start/From: **7**
 Clock To: **9**
 1st Value:
 2nd Value:
 Value Percent: **5.000**
 Continuous Index:
 Within 8" of Joint: **YES**
 Remarks:

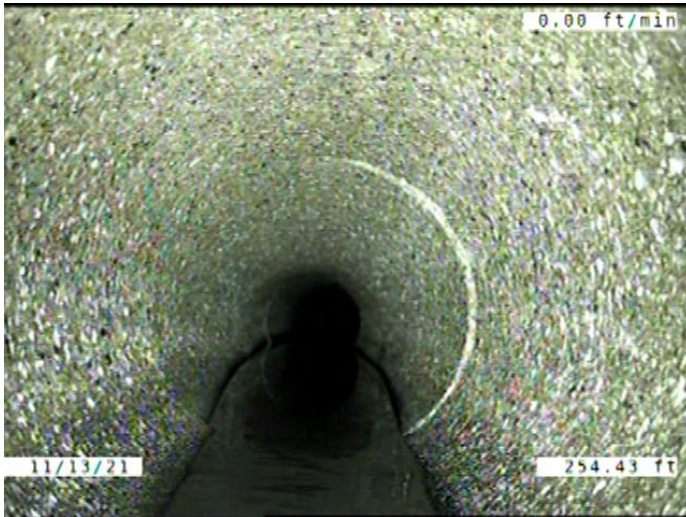
Code: **MWLS**
 Description: **Miscellaneous Water Level Sag**

Distance (ft): **254.4**
 Structural Grade: **2**
 O&M Grade: **0**
 Clock Start/From:
 Clock To:
 1st Value:
 2nd Value:
 Value Percent: **10.000**
 Continuous Index: **S08**
 Within 8" of Joint: **NO**
 Remarks:

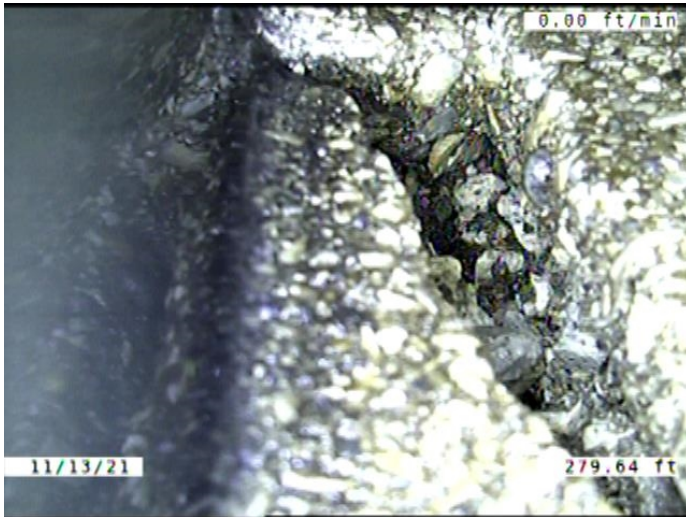
Code: **B**
 Description: **Broken**

Distance (ft): **279.6**
 Structural Grade: **4**
 O&M Grade: **0**
 Clock Start/From: **7**
 Clock To: **5**
 1st Value:
 2nd Value:
 Value Percent:
 Continuous Index:
 Within 8" of Joint: **NO**
 Remarks:

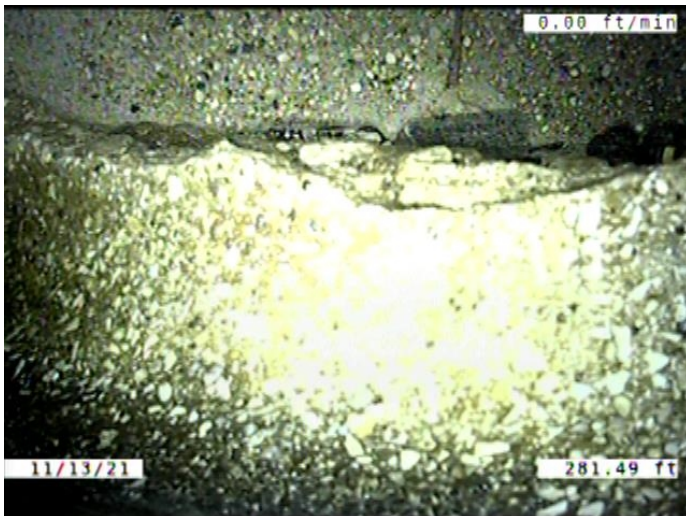
Code: **MWLS**
 Description: **Miscellaneous Water Level Sag**

Distance (ft): **281.5**
 Structural Grade: **2**
 O&M Grade: **0**
 Clock Start/From:
 Clock To:
 1st Value:
 2nd Value:
 Value Percent: **10.000**
 Continuous Index: **F08**
 Within 8" of Joint: **NO**
 Remarks:
