Profile/Photo Observation Report

Date:	04/23/2018	Weather:		Coding:	PACP 6.0
Pipe Length (ft):	200.2	Owner:	NA	Pre Clean:	Not Known
P.O.#:		Surveyor:	Jen Costello	PSR:	P-604-009-008
Customer:		Clean Date:	01/01/1900	Shape:	C

Street:	BEVERLY BLVD	Flow Control:	Not Controlled
City:	Hobart, IN	Year Renewed:	
Location:	Other	Tape/Media #:	
Purpose:	Not Known	Dia/Height:	8"
Use:	Sanitary	Material:	CP
Drain Area:	NA	Lining:	
Category:	NA		
Comment:

Location Details:		Direction of Survey:	Upstream
US MH:	M-604-008	DS MH:	M-604-009
		Total Length Surveyed (ft):	182.2

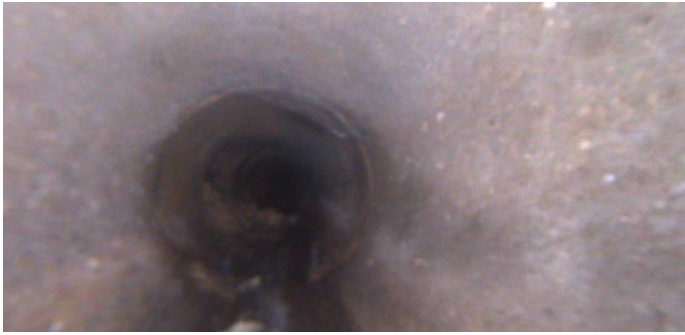
Code: **AMH**
Description: **Manhole**

Distance (ft): **.0**
Structural Grade: **0**
O&M Grade: **0**
Clock Start/From:
Clock To:
1st Value:
2nd Value:
Value Percent:
Continuous Index:
Within 8" of Joint: **NO**
Remarks: **M-604-009**

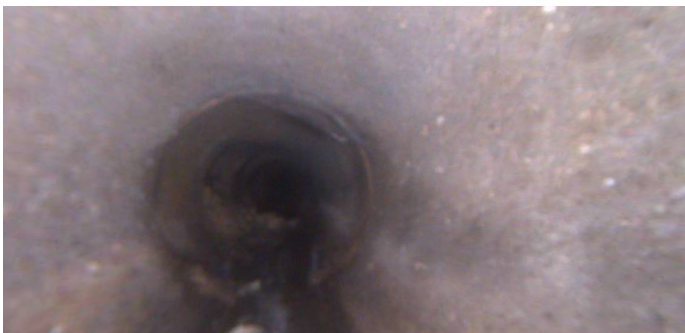
Code: **MWL**
Description: **Water Level**

Distance (ft): **.0**
Structural Grade: **0**
O&M Grade: **0**
Clock Start/From:
Clock To:
1st Value:
2nd Value:
Value Percent: **5.000**
Continuous Index:
Within 8" of Joint: **NO**
Remarks:

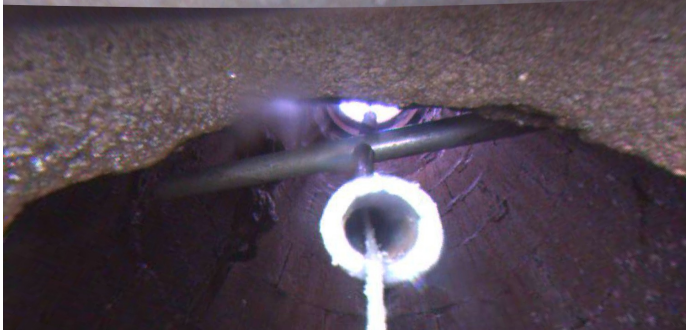
Code: **SAP**
Description: **Surface Aggregate Projecting**

Distance (ft): **.0**
Structural Grade: **3**
O&M Grade: **0**
Clock Start/From: **8**
Clock To: **4**
1st Value:
2nd Value:
Value Percent:
Continuous Index: **S01**
Within 8" of Joint:
Remarks:

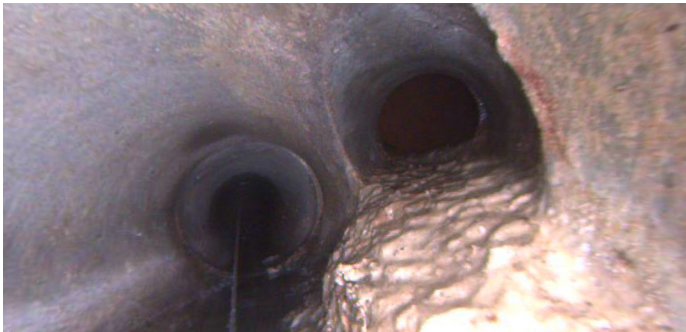
Code: **TFD**
Description: **Tap Factory Defective**

Distance (ft): **3.9**
Structural Grade: **0**
O&M Grade: **2**
Clock Start/From: **3**
Clock To:
1st Value: **4.000**
2nd Value:
Value Percent:
Continuous Index:
Within 8" of Joint:
Remarks: **DAGS**

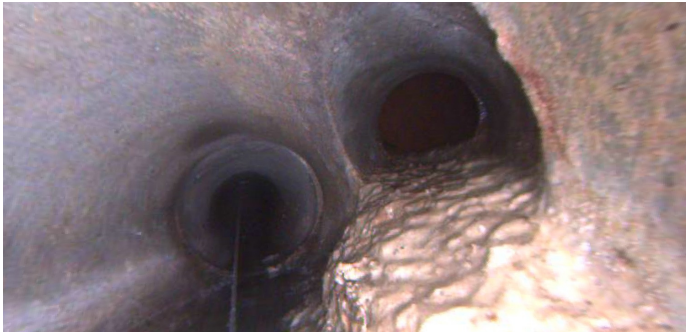
Code: **DAGS**
Description: **Deposits Attached Grease**

Distance (ft): **3.9**
Structural Grade: **0**
O&M Grade: **2**
Clock Start/From: **8**
Clock To: **9**
1st Value:
2nd Value:
Value Percent: **5.000**
Continuous Index:
Within 8" of Joint: **NO**
Remarks:

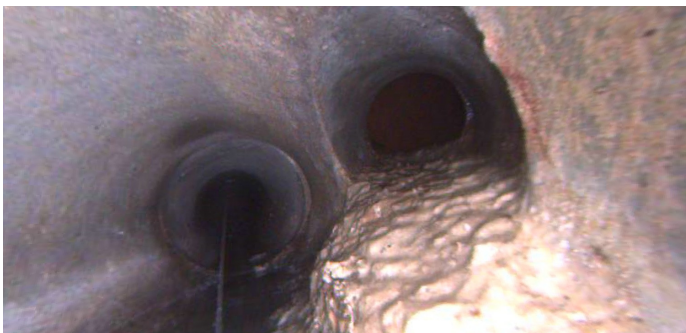
Code: **MGO**
Description: **General Observation**

Distance (ft): **3.9**
Structural Grade: **0**
O&M Grade: **0**
Clock Start/From:
Clock To:
1st Value:
2nd Value:
Value Percent:
Continuous Index:
Within 8" of Joint: **NO**
Remarks: **REAR CAMERA**

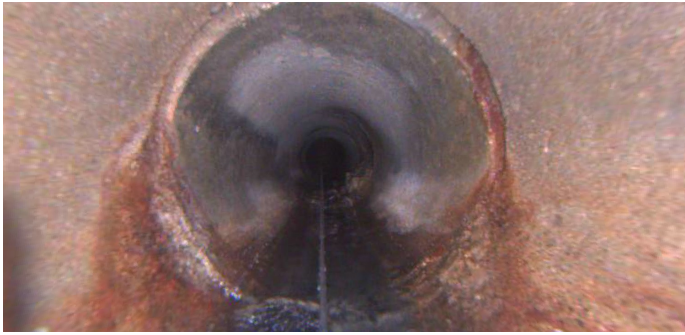
Code: **IS**
Description: **Infil Stain**

Distance (ft): **5.9**
Structural Grade: **0**
O&M Grade: **0**
Clock Start/From: **8**
Clock To: **4**
1st Value:
2nd Value:
Value Percent:
Continuous Index:
Within 8" of Joint: **YES**
Remarks:

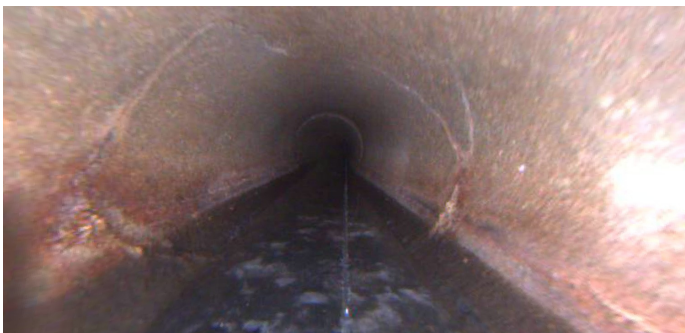
Code: **FM**
Description: **Fracture Multiple**

Distance (ft): **23.4**
Structural Grade: **4**
O&M Grade: **0**
Clock Start/From: **8**
Clock To: **4**
1st Value:
2nd Value:
Value Percent:
Continuous Index:
Within 8" of Joint:
Remarks:

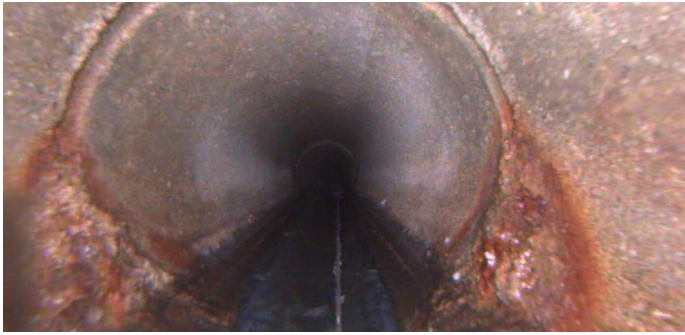
Code: **DAE**
Description: **Deposits Attached Encrustation**

Distance (ft): **29.9**
Structural Grade: **0**
O&M Grade: **2**
Clock Start/From: **8**
Clock To: **4**
1st Value:
2nd Value:
Value Percent: **5.000**
Continuous Index:
Within 8" of Joint: **YES**
Remarks:

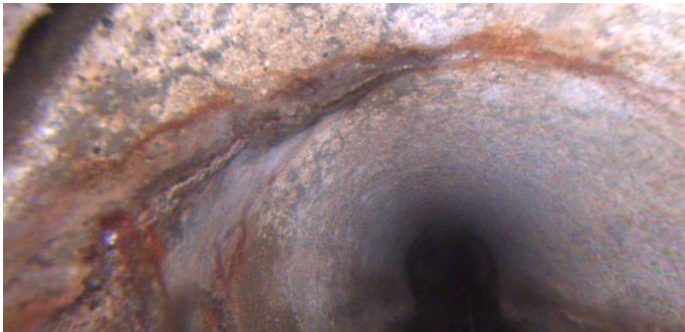
Code: **FC**
Description: **Fracture Circumferential**

Distance (ft): **32.6**
Structural Grade: **2**
O&M Grade: **0**
Clock Start/From: **12**
Clock To: **3**
1st Value:
2nd Value:
Value Percent:
Continuous Index:
Within 8" of Joint: **YES**
Remarks:

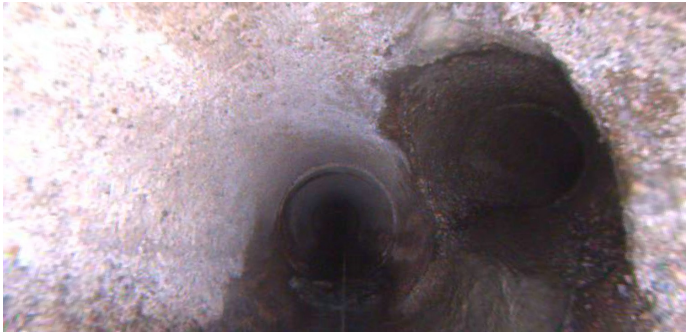
Code: **TF**
Description: **Tap Factory**

Distance (ft): **34.3**
Structural Grade: **0**
O&M Grade: **0**
Clock Start/From: **9**
Clock To:
1st Value: **4.000**
2nd Value:
Value Percent:
Continuous Index:
Within 8" of Joint:
Remarks:

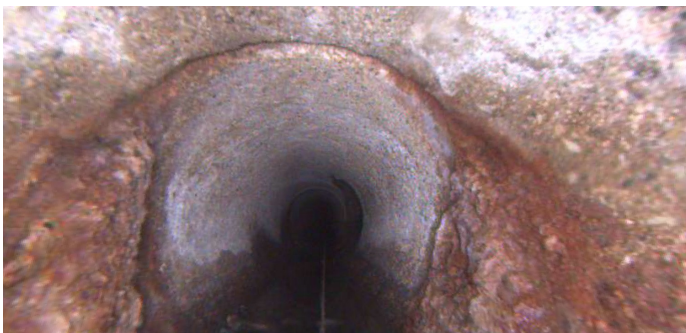
Code: **DAE**
Description: **Deposits Attached Encrustation**

Distance (ft): **36.1**
Structural Grade: **0**
O&M Grade: **2**
Clock Start/From: **8**
Clock To: **4**
1st Value:
2nd Value:
Value Percent: **10.000**
Continuous Index:
Within 8" of Joint: **YES**
Remarks:

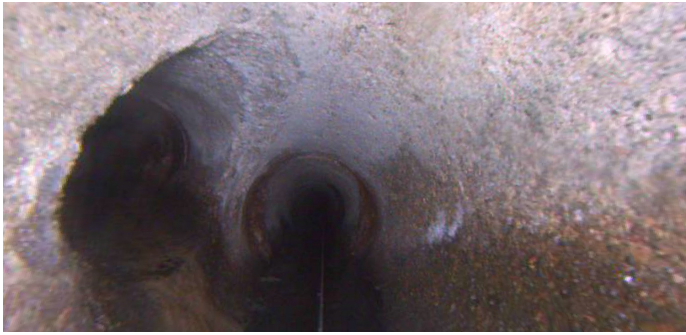
Code: **TF**
Description: **Tap Factory**

Distance (ft): **37.3**
Structural Grade: **0**
O&M Grade: **0**
Clock Start/From: **9**
Clock To:
1st Value: **4.000**
2nd Value:
Value Percent:
Continuous Index:
Within 8" of Joint:
Remarks:

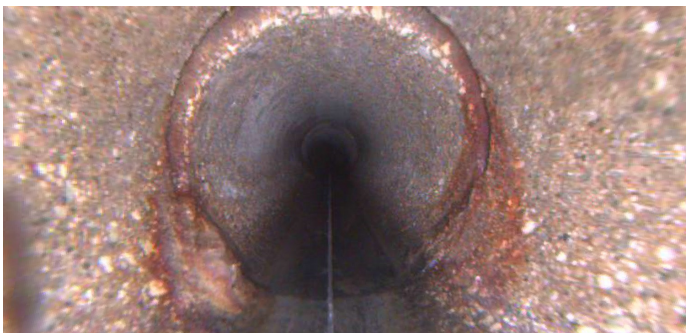
Code: **DAE**
Description: **Deposits Attached Encrustation**

Distance (ft): **42.3**
Structural Grade: **0**
O&M Grade: **2**
Clock Start/From: **8**
Clock To: **4**
1st Value:
2nd Value:
Value Percent: **5.000**
Continuous Index: **S02**
Within 8" of Joint: **YES**
Remarks:

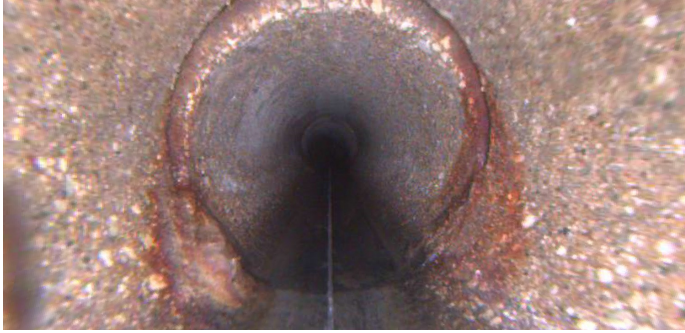
Code: **IS**
Description: **Infil Stain**

Distance (ft): **42.3**
Structural Grade: **0**
O&M Grade: **0**
Clock Start/From: **8**
Clock To: **4**
1st Value:
2nd Value:
Value Percent:
Continuous Index: **S03**
Within 8" of Joint: **YES**
Remarks:

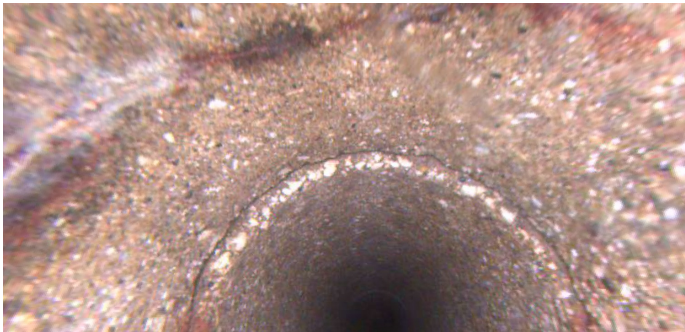
Code: **FC**
Description: **Fracture Circumferential**

Distance (ft): **51.3**
Structural Grade: **2**
O&M Grade: **0**
Clock Start/From: **12**
Clock To: **3**
1st Value:
2nd Value:
Value Percent:
Continuous Index:
Within 8" of Joint: **YES**
Remarks:

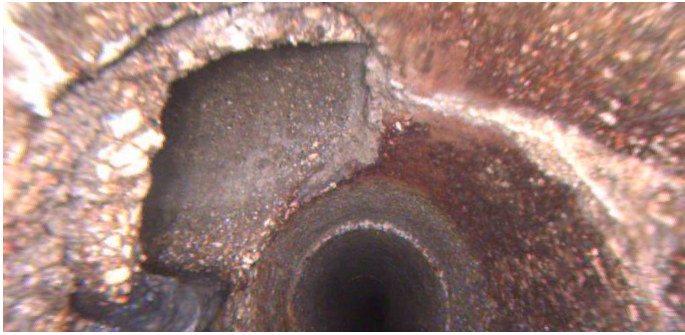
Code: **TBI**
Description: **Tap Break-in Intruding**

Distance (ft): **76.4**
Structural Grade: **0**
O&M Grade: **2**
Clock Start/From: **2**
Clock To:
1st Value: **4.000**
2nd Value: **1.000**
Value Percent:
Continuous Index:
Within 8" of Joint:
Remarks:

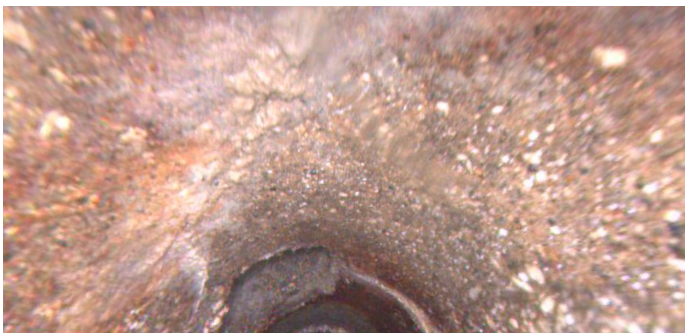
Code: **FS**
Description: **Fracture Spiral**

Distance (ft): **76.9**
Structural Grade: **3**
O&M Grade: **0**
Clock Start/From: **12**
Clock To: **3**
1st Value:
2nd Value:
Value Percent:
Continuous Index:
Within 8" of Joint:
Remarks:

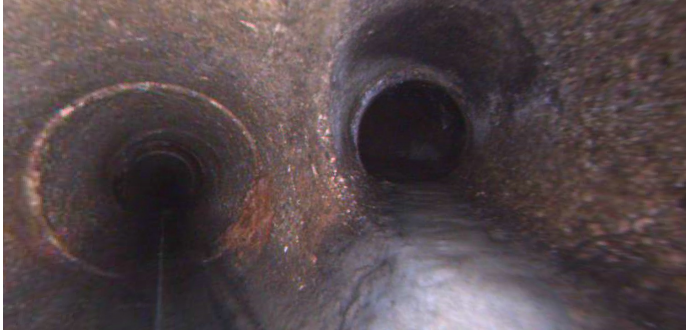
Code: **TFA**
Description: **Tap Factory Active**

Distance (ft): **79.3**
Structural Grade: **0**
O&M Grade: **0**
Clock Start/From: **9**
Clock To:
1st Value: **4.000**
2nd Value:
Value Percent:
Continuous Index:
Within 8" of Joint:
Remarks:

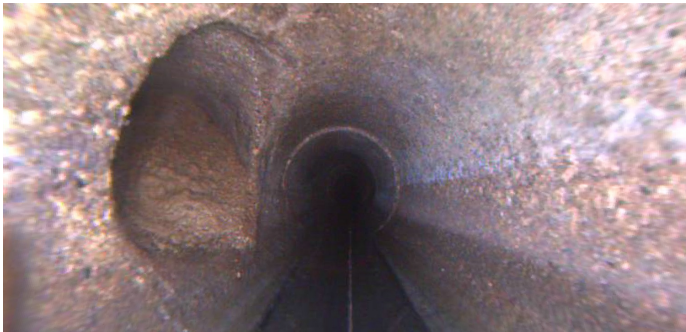
Code: **TFC**
Description: **Tap Factory Capped**

Distance (ft): **82.9**
Structural Grade: **0**
O&M Grade: **0**
Clock Start/From: **3**
Clock To:
1st Value: **4.000**
2nd Value:
Value Percent:
Continuous Index:
Within 8" of Joint:
Remarks:

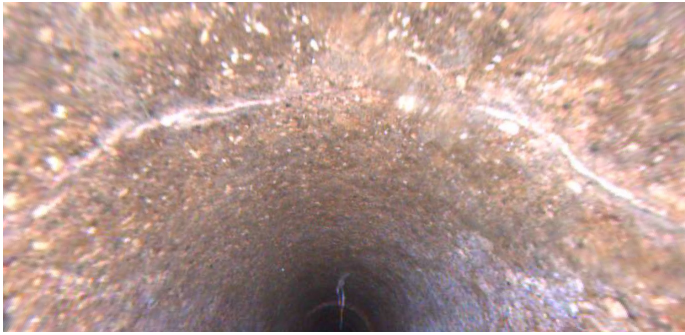
Code: **FC**
Description: **Fracture Circumferential**

Distance (ft): **87.1**
Structural Grade: **2**
O&M Grade: **0**
Clock Start/From: **10**
Clock To: **2**
1st Value:
2nd Value:
Value Percent:
Continuous Index:
Within 8" of Joint:
Remarks:

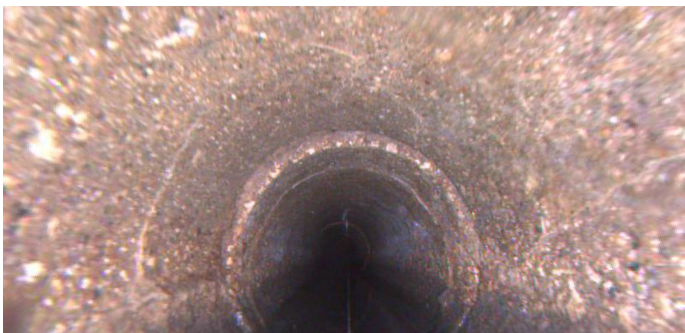
Code: **FM**
Description: **Fracture Multiple**

Distance (ft): **88.0**
Structural Grade: **4**
O&M Grade: **0**
Clock Start/From: **8**
Clock To: **4**
1st Value:
2nd Value:
Value Percent:
Continuous Index:
Within 8" of Joint: **YES**
Remarks:

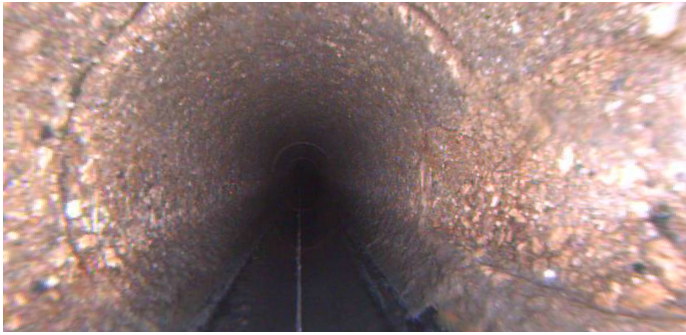
Code: **FL**
Description: **Fracture Longitudinal**

Distance (ft): **96.7**
Structural Grade: **3**
O&M Grade: **0**
Clock Start/From: **8**
Clock To:
1st Value:
2nd Value:
Value Percent:
Continuous Index:
Within 8" of Joint: **YES**
Remarks:

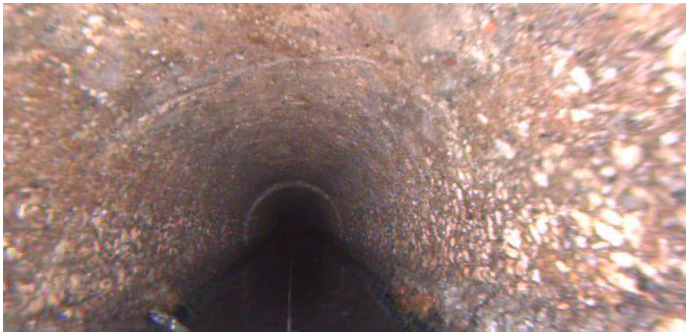
Code: **FC**
Description: **Fracture Circumferential**

Distance (ft): **134.1**
Structural Grade: **2**
O&M Grade: **0**
Clock Start/From: **8**
Clock To: **4**
1st Value:
2nd Value:
Value Percent:
Continuous Index:
Within 8" of Joint:
Remarks:

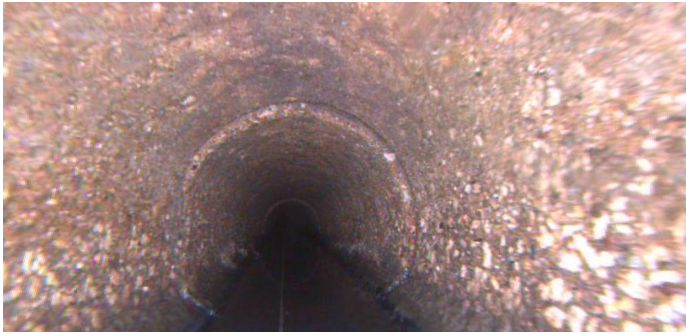
Code: **IS**
Description: **Infil Stain**

Distance (ft): **135.7**
Structural Grade: **0**
O&M Grade: **0**
Clock Start/From: **8**
Clock To: **4**
1st Value:
2nd Value:
Value Percent:
Continuous Index: **F03**
Within 8" of Joint: **YES**
Remarks:

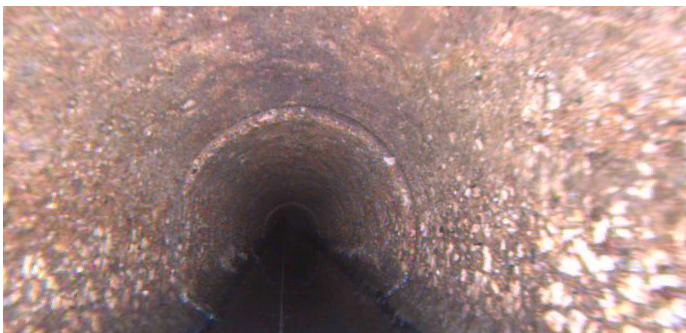
Code: **DAE**
Description: **Deposits Attached Encrustation**

Distance (ft): **135.7**
Structural Grade: **0**
O&M Grade: **2**
Clock Start/From: **8**
Clock To: **4**
1st Value:
2nd Value:
Value Percent: **5.000**
Continuous Index: **F02**
Within 8" of Joint: **YES**
Remarks:

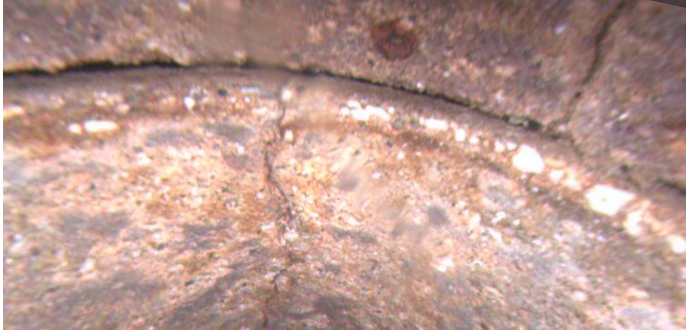
Code: **FM**
Description: **Fracture Multiple**

Distance (ft): **137.9**
Structural Grade: **4**
O&M Grade: **0**
Clock Start/From: **11**
Clock To: **12**
1st Value:
2nd Value:
Value Percent:
Continuous Index:
Within 8" of Joint: **YES**
Remarks:

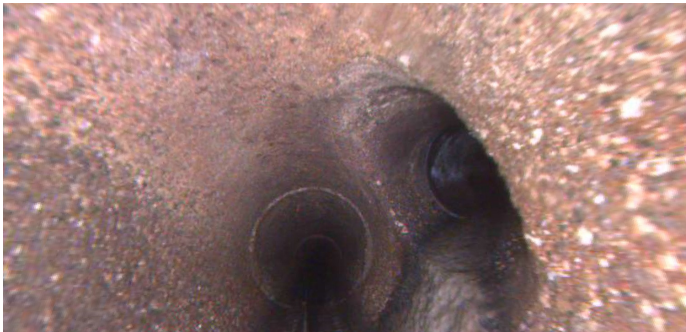
Code: **TF**
Description: **Tap Factory**

Distance (ft): **142.7**
Structural Grade: **0**
O&M Grade: **0**
Clock Start/From: **10**
Clock To:
1st Value: **4.000**
2nd Value:
Value Percent:
Continuous Index:
Within 8" of Joint:
Remarks:

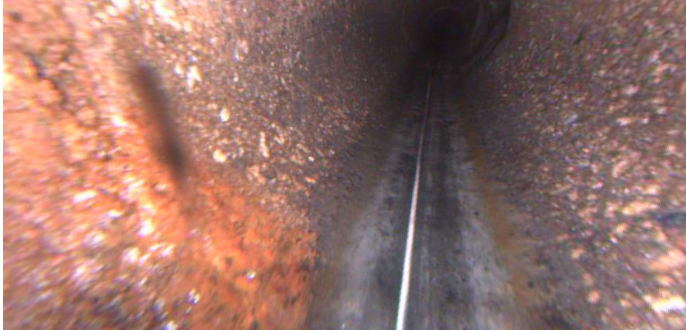
Code: **IW**
Description: **Infil Weeper**

Distance (ft): **144.1**
Structural Grade: **0**
O&M Grade: **2**
Clock Start/From: **3**
Clock To: **5**
1st Value:
2nd Value:
Value Percent:
Continuous Index:
Within 8" of Joint: **YES**
Remarks:

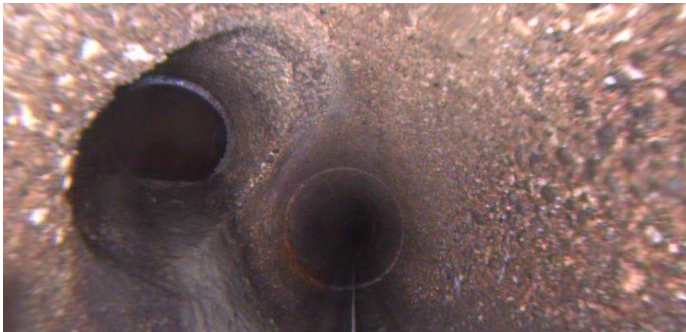
Code: **TFA**
Description: **Tap Factory Active**

Distance (ft): **145.6**
Structural Grade: **0**
O&M Grade: **0**
Clock Start/From: **2**
Clock To:
1st Value: **4.000**
2nd Value:
Value Percent:
Continuous Index:
Within 8" of Joint:
Remarks:

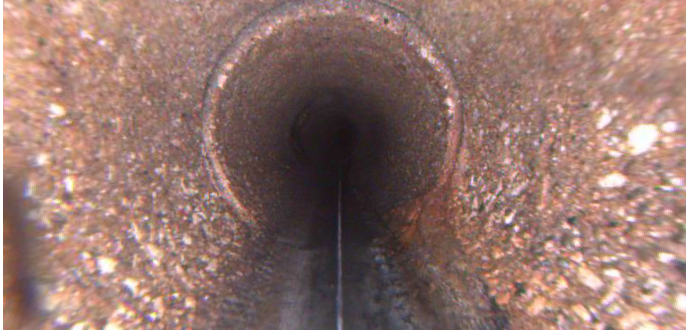
Code: **IS**
Description: **Infil Stain**

Distance (ft): **147.7**
Structural Grade: **0**
O&M Grade: **0**
Clock Start/From: **8**
Clock To: **4**
1st Value:
2nd Value:
Value Percent:
Continuous Index: **S04**
Within 8" of Joint: **YES**
Remarks:

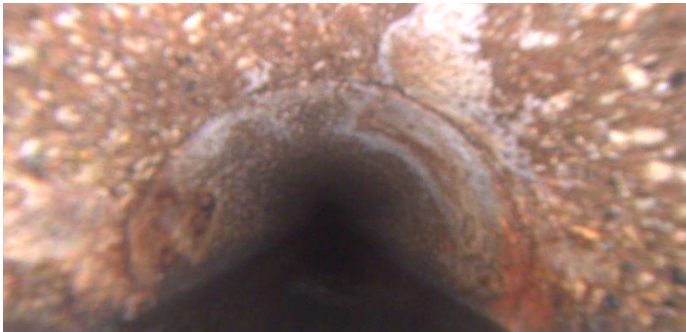
Code: **FL**
Description: **Fracture Longitudinal**

Distance (ft): **179.5**
Structural Grade: **3**
O&M Grade: **0**
Clock Start/From: **1**
Clock To:
1st Value:
2nd Value:
Value Percent:
Continuous Index:
Within 8" of Joint: **YES**
Remarks:

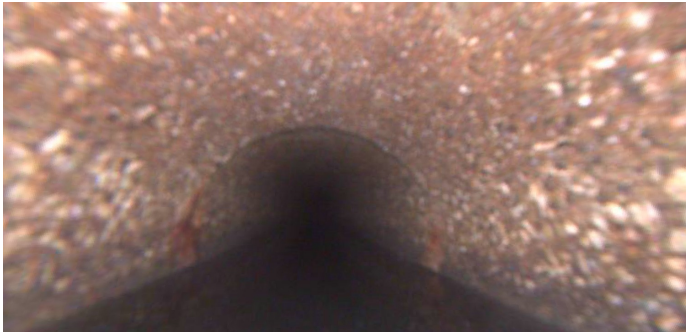
Code: **SAP**
Description: **Surface Aggregate Projecting**

Distance (ft): **182.2**
Structural Grade: **3**
O&M Grade: **0**
Clock Start/From: **8**
Clock To: **4**
1st Value:
2nd Value:
Value Percent:
Continuous Index: **F01**
Within 8" of Joint:
Remarks:

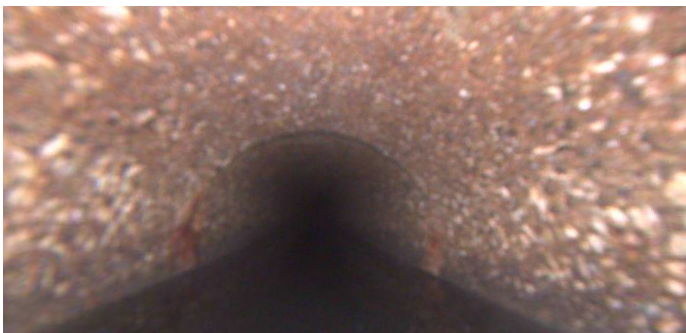
Code: **IS**
Description: **Infil Stain**

Distance (ft): **182.2**
Structural Grade: **0**
O&M Grade: **0**
Clock Start/From: **8**
Clock To: **4**
1st Value:
2nd Value:
Value Percent:
Continuous Index: **F04**
Within 8" of Joint: **YES**
Remarks:

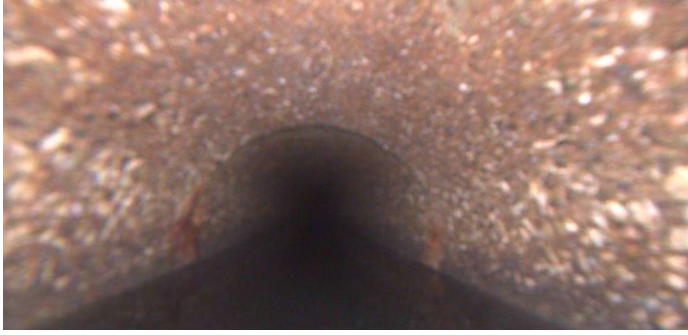
Code:	MSA
Description:	Abandoned Survey
Distance (ft):	182.2
Structural Grade:	0
O&M Grade:	0
Clock Start/From:	
Clock To:	
1st Value:	
2nd Value:	
Value Percent:	
Continuous Index:	
Within 8" of Joint:	NO
Remarks:	UNKNOWN
