## Profile/Photo Observation Report

Street:	<b>Beverly Blvd.</b>	Flow Control:	<b>Not Controlled</b>
City:	<b>Hobart, IN</b>	Year Renewed:	
Location:	<b>Other</b>	Tape/Media #:	
Purpose:	<b>Not Known</b>	Dia/Height:	<b>8"</b>
Use:	<b>Sanitary</b>	Material:	<b>CP</b>
Drain Area:	<b>NA</b>	Lining:	
Category:	<b>NA</b>		
Comment:

Location Details:		Direction of Survey:	<b>Upstream</b>
US MH:	<b>M-604-008</b>	DS MH:	<b>M-604-009</b>
		Total Length Surveyed (ft):	<b>182.2</b>

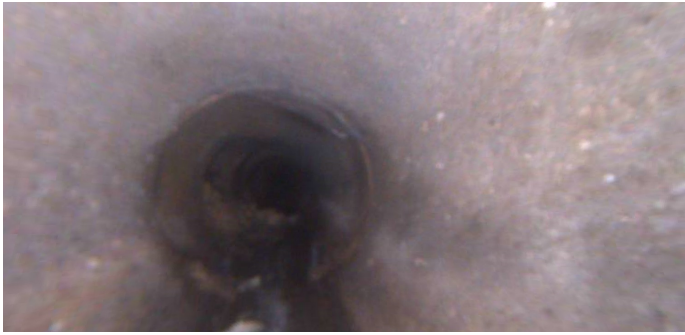
Code: **AMH**  
Description: **Manhole**

Distance (ft): **.0**  
Structural Grade: **0**  
O&M Grade: **0**  
Clock Start/From:  
Clock To:  
1st Value:  
2nd Value:  
Value Percent:  
Continuous Index:  
Within 8" of Joint: **NO**  
Remarks: **M-604-009**

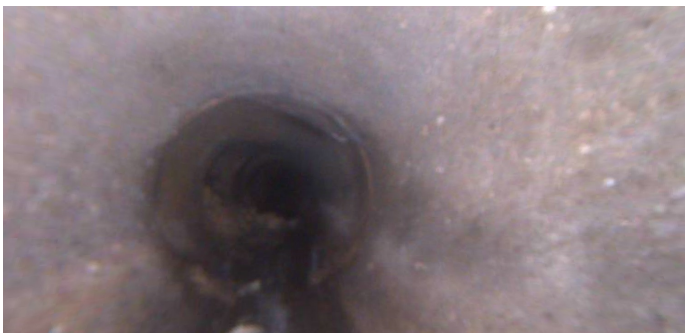
Code: **MWL**  
Description: **Water Level**

Distance (ft): **.0**  
Structural Grade: **0**  
O&M Grade: **0**  
Clock Start/From:  
Clock To:  
1st Value:  
2nd Value:  
Value Percent: **5.000**  
Continuous Index:  
Within 8" of Joint: **NO**  
Remarks:

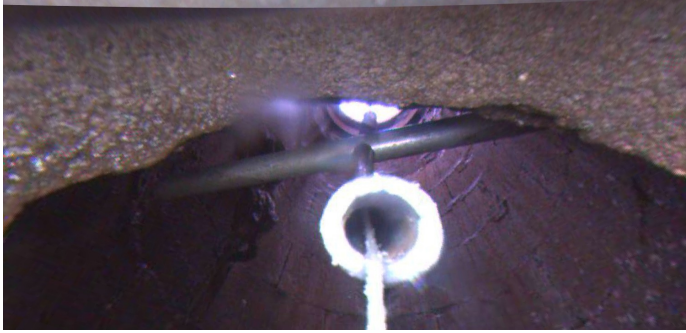
Code: **SAP**  
Description: **Surface Aggregate Projecting**

Distance (ft): **.0**  
Structural Grade: **3**  
O&M Grade: **0**  
Clock Start/From: **8**  
Clock To: **4**  
1st Value:  
2nd Value:  
Value Percent:  
Continuous Index: **S01**  
Within 8" of Joint:  
Remarks:

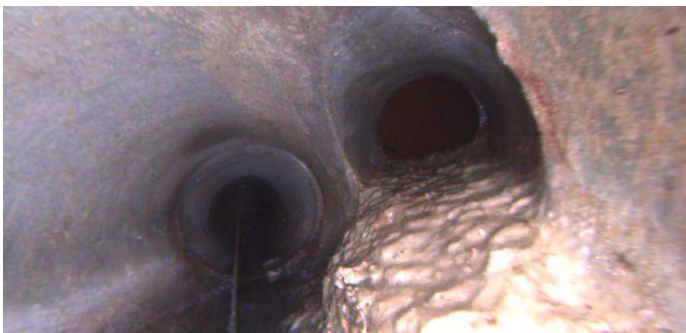
Code: **TFD**  
Description: **Tap Factory Defective**

Distance (ft): **3.9**  
Structural Grade: **0**  
O&M Grade: **2**  
Clock Start/From: **3**  
Clock To:  
1st Value: **4.000**  
2nd Value:  
Value Percent:  
Continuous Index:  
Within 8" of Joint:  
Remarks: **DAGS**

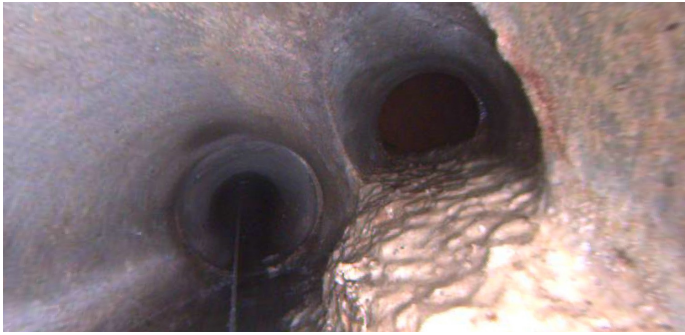
Code: **DAGS**  
Description: **Deposits Attached Grease**

Distance (ft): **3.9**  
Structural Grade: **0**  
O&M Grade: **2**  
Clock Start/From: **8**  
Clock To: **9**  
1st Value:  
2nd Value:  
Value Percent: **5.000**  
Continuous Index:  
Within 8" of Joint: **NO**  
Remarks:

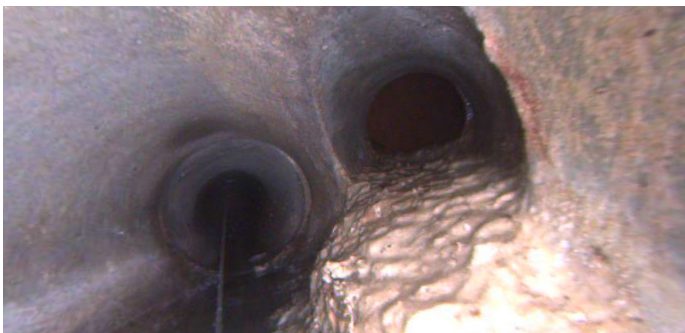
Code: **MGO**  
Description: **General Observation**

Distance (ft): **3.9**  
Structural Grade: **0**  
O&M Grade: **0**  
Clock Start/From:  
Clock To:  
1st Value:  
2nd Value:  
Value Percent:  
Continuous Index:  
Within 8" of Joint: **NO**  
Remarks: **REAR CAMERA**

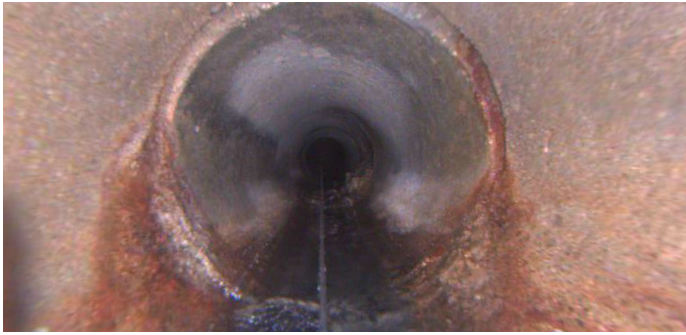
Code: **IS**  
Description: **Infil Stain**

Distance (ft): **5.9**  
Structural Grade: **0**  
O&M Grade: **0**  
Clock Start/From: **8**  
Clock To: **4**  
1st Value:  
2nd Value:  
Value Percent:  
Continuous Index:  
Within 8" of Joint: **YES**  
Remarks:

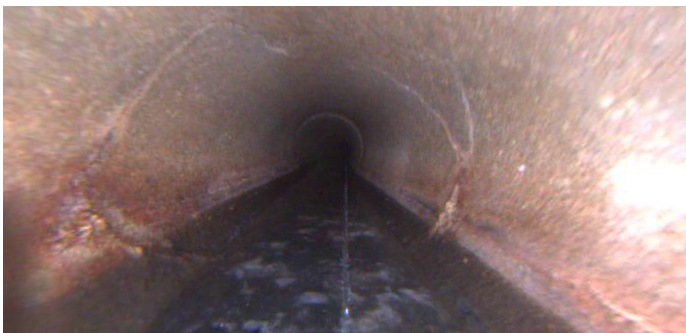
Code: **FM**  
Description: **Fracture Multiple**

Distance (ft): **23.4**  
Structural Grade: **4**  
O&M Grade: **0**  
Clock Start/From: **8**  
Clock To: **4**  
1st Value:  
2nd Value:  
Value Percent:  
Continuous Index:  
Within 8" of Joint:  
Remarks:

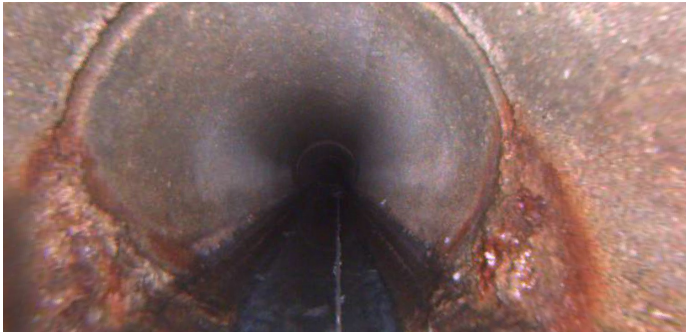
Code: **DAE**  
Description: **Deposits Attached Encrustation**

Distance (ft): **29.9**  
Structural Grade: **0**  
O&M Grade: **2**  
Clock Start/From: **8**  
Clock To: **4**  
1st Value:  
2nd Value:  
Value Percent: **5.000**  
Continuous Index:  
Within 8" of Joint: **YES**  
Remarks:

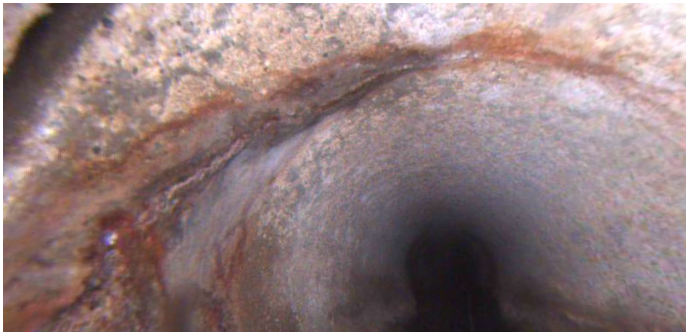
Code: **FC**  
Description: **Fracture Circumferential**

Distance (ft): **32.6**  
Structural Grade: **2**  
O&M Grade: **0**  
Clock Start/From: **12**  
Clock To: **3**  
1st Value:  
2nd Value:  
Value Percent:  
Continuous Index:  
Within 8" of Joint: **YES**  
Remarks:

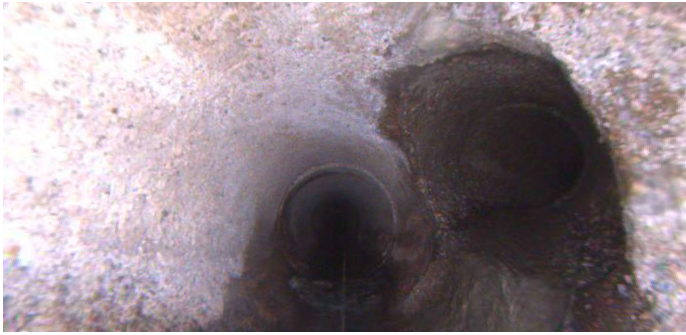
Code: **TF**  
Description: **Tap Factory**

Distance (ft): **34.3**  
Structural Grade: **0**  
O&M Grade: **0**  
Clock Start/From: **9**  
Clock To:  
1st Value: **4.000**  
2nd Value:  
Value Percent:  
Continuous Index:  
Within 8" of Joint:  
Remarks:

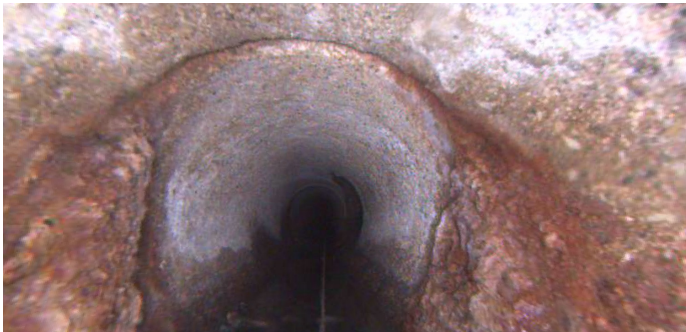
Code: **DAE**  
Description: **Deposits Attached Encrustation**

Distance (ft): **36.1**  
Structural Grade: **0**  
O&M Grade: **2**  
Clock Start/From: **8**  
Clock To: **4**  
1st Value:  
2nd Value:  
Value Percent: **10.000**  
Continuous Index:  
Within 8" of Joint: **YES**  
Remarks:

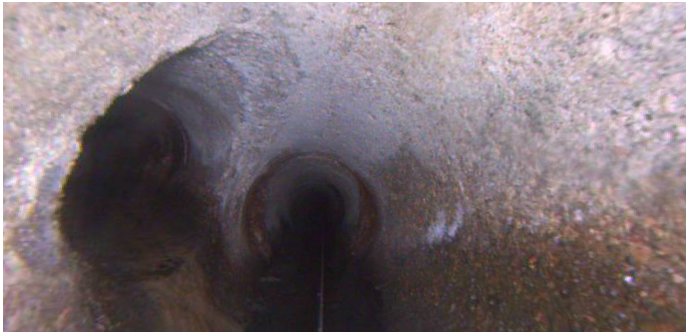
Code: **TF**  
Description: **Tap Factory**

Distance (ft): **37.3**  
Structural Grade: **0**  
O&M Grade: **0**  
Clock Start/From: **9**  
Clock To:  
1st Value: **4.000**  
2nd Value:  
Value Percent:  
Continuous Index:  
Within 8" of Joint:  
Remarks:

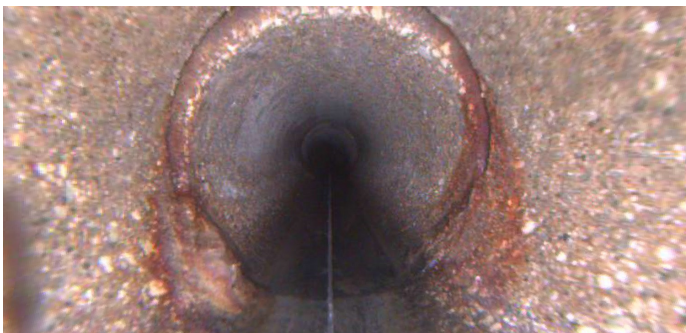
Code: **DAE**  
Description: **Deposits Attached Encrustation**

Distance (ft): **42.3**  
Structural Grade: **0**  
O&M Grade: **2**  
Clock Start/From: **8**  
Clock To: **4**  
1st Value:  
2nd Value:  
Value Percent: **5.000**  
Continuous Index: **S02**  
Within 8" of Joint: **YES**  
Remarks:

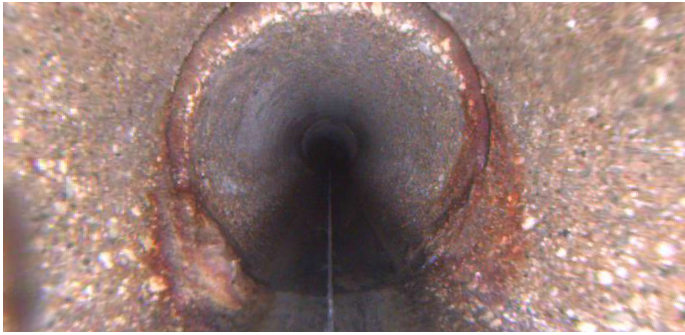
Code: **IS**  
Description: **Infil Stain**

Distance (ft): **42.3**  
Structural Grade: **0**  
O&M Grade: **0**  
Clock Start/From: **8**  
Clock To: **4**  
1st Value:  
2nd Value:  
Value Percent:  
Continuous Index: **S03**  
Within 8" of Joint: **YES**  
Remarks:

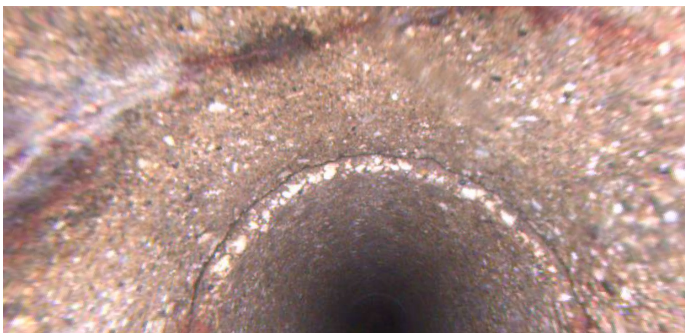
Code: **FC**  
Description: **Fracture Circumferential**

Distance (ft): **51.3**  
Structural Grade: **2**  
O&M Grade: **0**  
Clock Start/From: **12**  
Clock To: **3**  
1st Value:  
2nd Value:  
Value Percent:  
Continuous Index:  
Within 8" of Joint: **YES**  
Remarks:

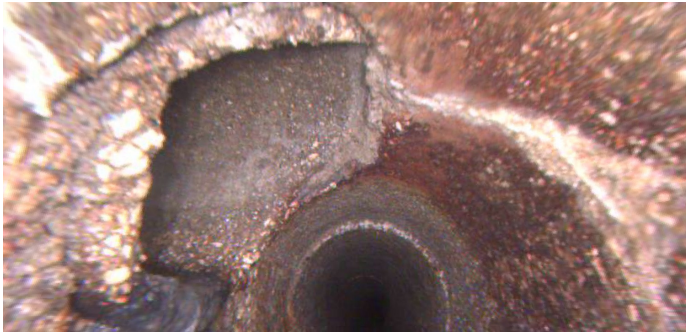
Code: **TBI**  
Description: **Tap Break-in Intruding**

Distance (ft): **76.4**  
Structural Grade: **0**  
O&M Grade: **2**  
Clock Start/From: **2**  
Clock To:  
1st Value: **4.000**  
2nd Value: **1.000**  
Value Percent:  
Continuous Index:  
Within 8" of Joint:  
Remarks:

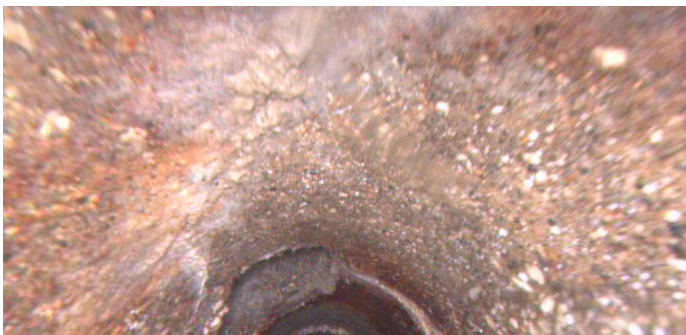
Code: **FS**  
Description: **Fracture Spiral**

Distance (ft): **76.9**  
Structural Grade: **3**  
O&M Grade: **0**  
Clock Start/From: **12**  
Clock To: **3**  
1st Value:  
2nd Value:  
Value Percent:  
Continuous Index:  
Within 8" of Joint:  
Remarks:

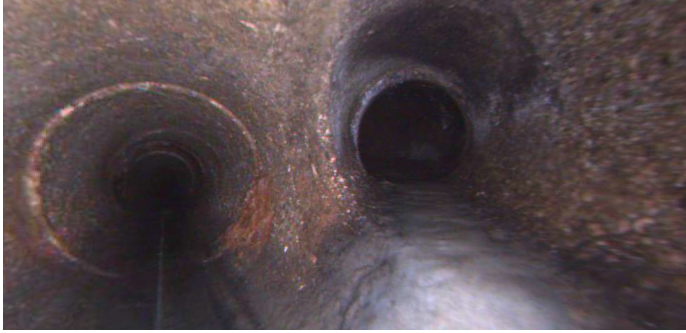
Code: **TFA**  
Description: **Tap Factory Active**

Distance (ft): **79.3**  
Structural Grade: **0**  
O&M Grade: **0**  
Clock Start/From: **9**  
Clock To:  
1st Value: **4.000**  
2nd Value:  
Value Percent:  
Continuous Index:  
Within 8" of Joint:  
Remarks:

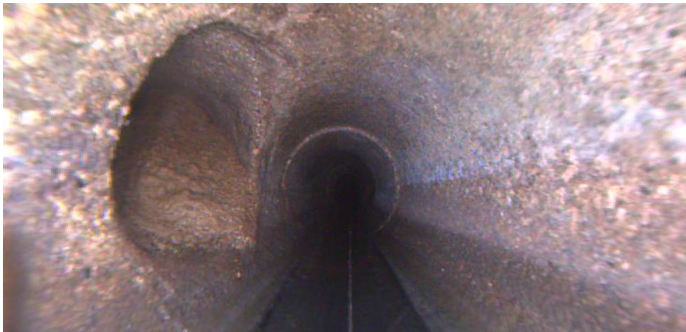
Code: **TFC**  
Description: **Tap Factory Capped**

Distance (ft): **82.9**  
Structural Grade: **0**  
O&M Grade: **0**  
Clock Start/From: **3**  
Clock To:  
1st Value: **4.000**  
2nd Value:  
Value Percent:  
Continuous Index:  
Within 8" of Joint:  
Remarks:

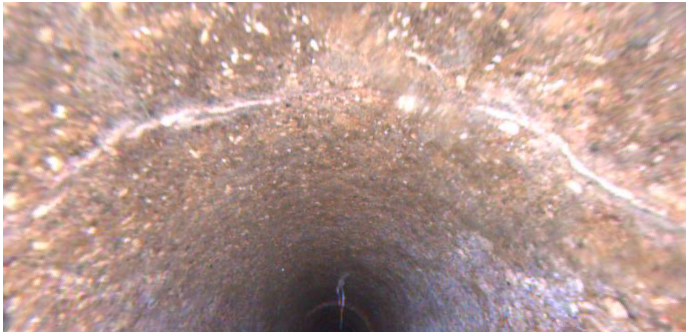
Code: **FC**  
Description: **Fracture Circumferential**

Distance (ft): **87.1**  
Structural Grade: **2**  
O&M Grade: **0**  
Clock Start/From: **10**  
Clock To: **2**  
1st Value:  
2nd Value:  
Value Percent:  
Continuous Index:  
Within 8" of Joint:  
Remarks:

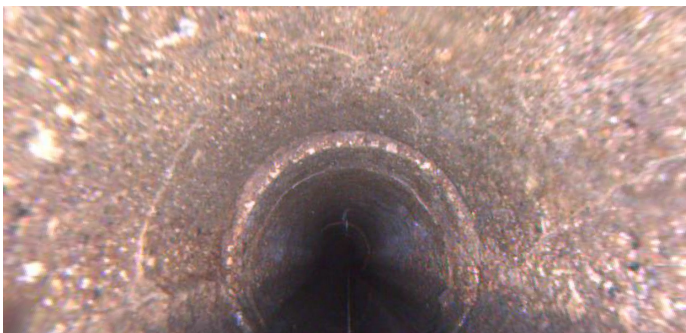
Code: **FM**  
Description: **Fracture Multiple**

Distance (ft): **88.0**  
Structural Grade: **4**  
O&M Grade: **0**  
Clock Start/From: **8**  
Clock To: **4**  
1st Value:  
2nd Value:  
Value Percent:  
Continuous Index:  
Within 8" of Joint: **YES**  
Remarks:

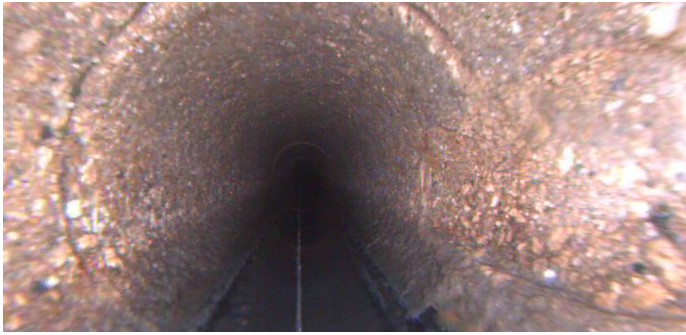
Code: **FL**  
Description: **Fracture Longitudinal**

Distance (ft): **96.7**  
Structural Grade: **3**  
O&M Grade: **0**  
Clock Start/From: **8**  
Clock To:  
1st Value:  
2nd Value:  
Value Percent:  
Continuous Index:  
Within 8" of Joint: **YES**  
Remarks:

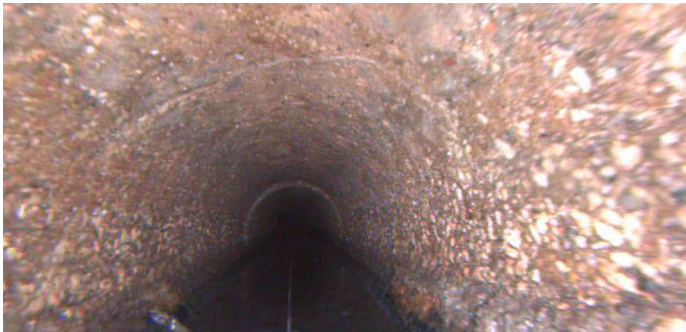
Code: **FC**  
Description: **Fracture Circumferential**

Distance (ft): **134.1**  
Structural Grade: **2**  
O&M Grade: **0**  
Clock Start/From: **8**  
Clock To: **4**  
1st Value:  
2nd Value:  
Value Percent:  
Continuous Index:  
Within 8" of Joint:  
Remarks:

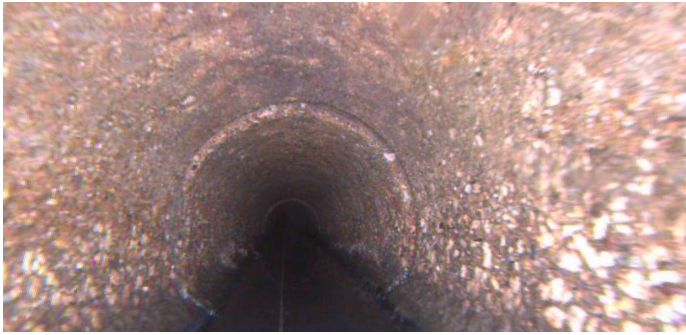
Code: **IS**  
Description: **Infil Stain**

Distance (ft): **135.7**  
Structural Grade: **0**  
O&M Grade: **0**  
Clock Start/From: **8**  
Clock To: **4**  
1st Value:  
2nd Value:  
Value Percent:  
Continuous Index: **F03**  
Within 8" of Joint: **YES**  
Remarks:

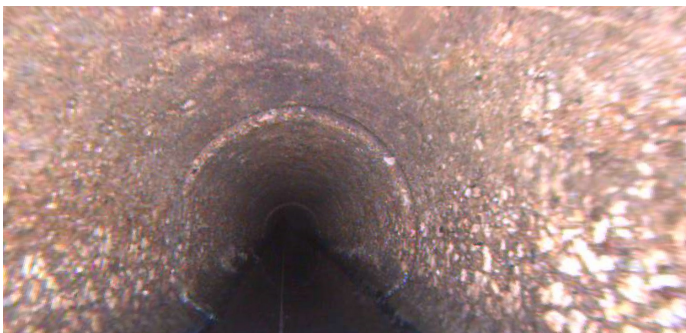
Code: **DAE**  
Description: **Deposits Attached Encrustation**

Distance (ft): **135.7**  
Structural Grade: **0**  
O&M Grade: **2**  
Clock Start/From: **8**  
Clock To: **4**  
1st Value:  
2nd Value:  
Value Percent: **5.000**  
Continuous Index: **F02**  
Within 8" of Joint: **YES**  
Remarks:

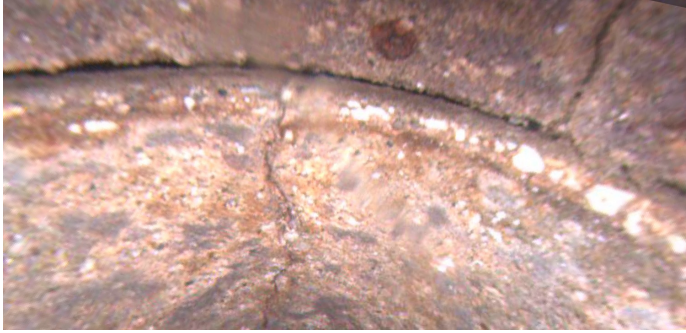
Code: **FM**  
Description: **Fracture Multiple**

Distance (ft): **137.9**  
Structural Grade: **4**  
O&M Grade: **0**  
Clock Start/From: **11**  
Clock To: **12**  
1st Value:  
2nd Value:  
Value Percent:  
Continuous Index:  
Within 8" of Joint: **YES**  
Remarks:

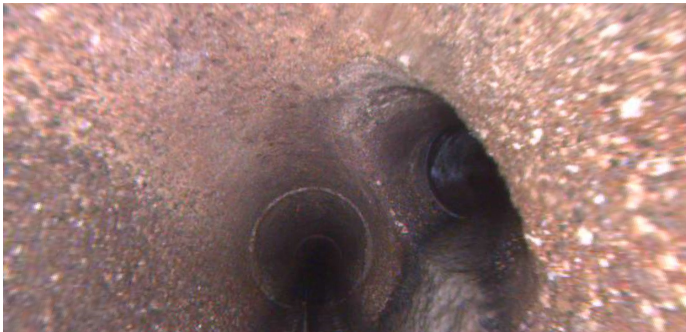
Code: **TF**  
Description: **Tap Factory**

Distance (ft): **142.7**  
Structural Grade: **0**  
O&M Grade: **0**  
Clock Start/From: **10**  
Clock To:  
1st Value: **4.000**  
2nd Value:  
Value Percent:  
Continuous Index:  
Within 8" of Joint:  
Remarks:

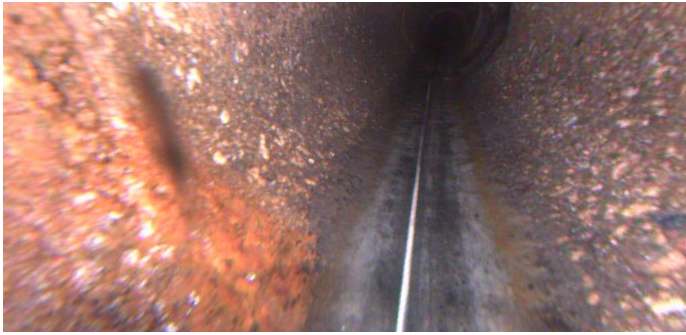
Code: **IW**  
Description: **Infil Weeper**

Distance (ft): **144.1**  
Structural Grade: **0**  
O&M Grade: **2**  
Clock Start/From: **3**  
Clock To: **5**  
1st Value:  
2nd Value:  
Value Percent:  
Continuous Index:  
Within 8" of Joint: **YES**  
Remarks:

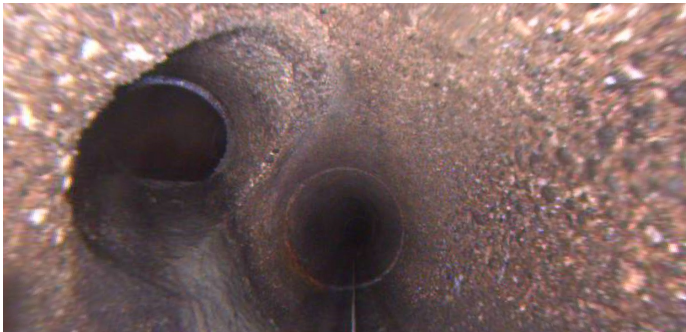
Code: **TFA**  
Description: **Tap Factory Active**

Distance (ft): **145.6**  
Structural Grade: **0**  
O&M Grade: **0**  
Clock Start/From: **2**  
Clock To:  
1st Value: **4.000**  
2nd Value:  
Value Percent:  
Continuous Index:  
Within 8" of Joint:  
Remarks:

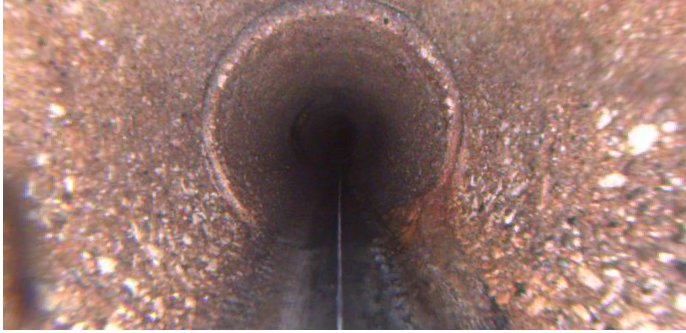
Code: **IS**  
Description: **Infil Stain**

Distance (ft): **147.7**  
Structural Grade: **0**  
O&M Grade: **0**  
Clock Start/From: **8**  
Clock To: **4**  
1st Value:  
2nd Value:  
Value Percent:  
Continuous Index: **S04**  
Within 8" of Joint: **YES**  
Remarks:

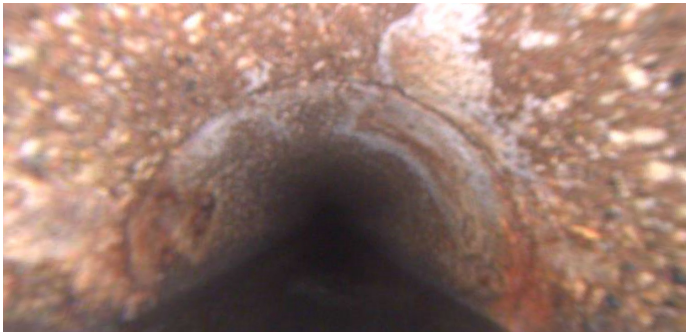
Code: **FL**  
Description: **Fracture Longitudinal**

Distance (ft): **179.5**  
Structural Grade: **3**  
O&M Grade: **0**  
Clock Start/From: **1**  
Clock To:  
1st Value:  
2nd Value:  
Value Percent:  
Continuous Index:  
Within 8" of Joint: **YES**  
Remarks:

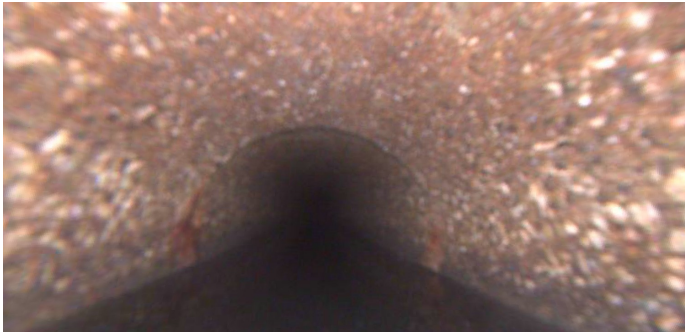
Code: **SAP**  
Description: **Surface Aggregate Projecting**

Distance (ft): **182.2**  
Structural Grade: **3**  
O&M Grade: **0**  
Clock Start/From: **8**  
Clock To: **4**  
1st Value:  
2nd Value:  
Value Percent:  
Continuous Index: **F01**  
Within 8" of Joint:  
Remarks:

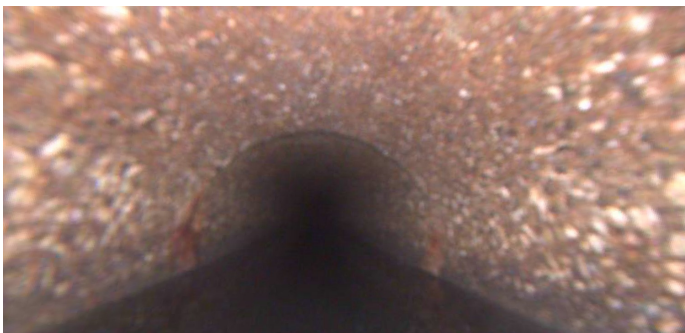
Code: **IS**  
Description: **Infil Stain**

Distance (ft): **182.2**  
Structural Grade: **0**  
O&M Grade: **0**  
Clock Start/From: **8**  
Clock To: **4**  
1st Value:  
2nd Value:  
Value Percent:  
Continuous Index: **F04**  
Within 8" of Joint: **YES**  
Remarks:

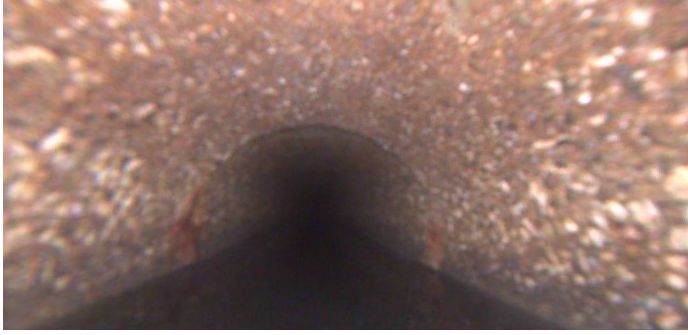
Code:	<b>MSA</b>
Description:	<b>Abandoned Survey</b>
Distance (ft):	<b>182.2</b>
Structural Grade:	<b>0</b>
O&M Grade:	<b>0</b>
Clock Start/From:	
Clock To:	
1st Value:	
2nd Value:	
Value Percent:	
Continuous Index:	
Within 8" of Joint:	<b>NO</b>
Remarks:	<b>UNKNOWN</b>
