Profile/Photo Observation Report

Date:	04/12/2018	Weather:		Coding:	PACP 6.0
Pipe Length (ft):		Owner:	City of Hobart	Pre Clean:	Not Known
P.O.#:	241	Surveyor:	B. Helbling	PSR:	P-604-054-019
Customer:	City of Hobart	Clean Date:		Shape:	C

Street:	North Conneticut Street	Flow Control:	Not Controlled
City:	Hobart, IN	Year Renewed:	
Location:	Light Highway	Tape/Media #:	DEP241
Purpose:	Routine Assessment	Dia/Height:	18"
Use:	Sanitary	Material:	VCP
Drain Area:		Lining:	
Category:	NA		
Comment:	YES501824 Submital 2		
Location Details:		Direction of Survey:	Downstream
US MH:	M-604-019	DS MH:	M-604-054
		Total Length Surveyed (ft):	161.7

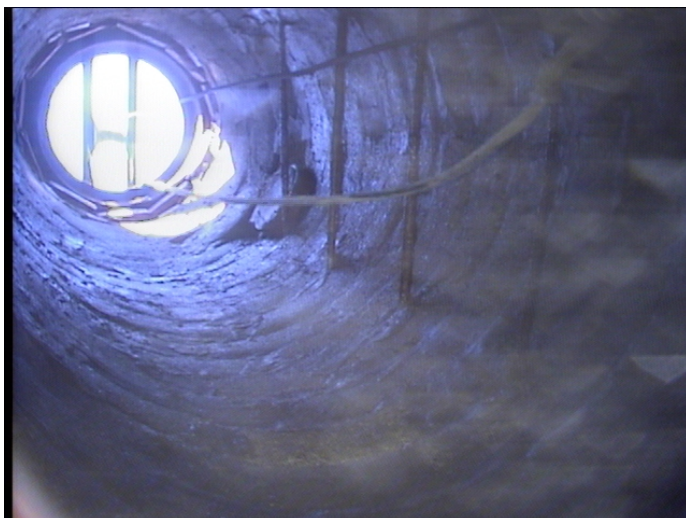
Code: **AMH**
Description: **Manhole**

Distance (ft): **.0**
Structural Grade: **0**
O&M Grade: **0**
Clock Start/From:
Clock To:
1st Value:
2nd Value:
Value Percent:
Continuous Index:
Within 8" of Joint: **NO**
Remarks: **M-604-054**

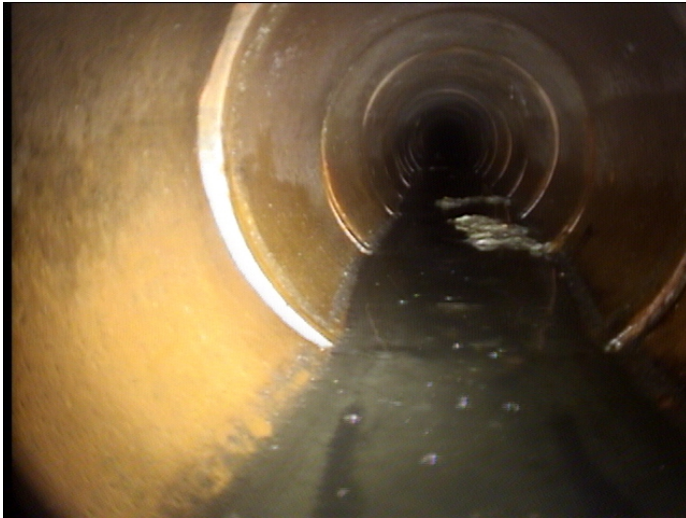
Code: **MWL**
Description: **Water Level**

Distance (ft): **.0**
Structural Grade: **0**
O&M Grade: **0**
Clock Start/From:
Clock To:
1st Value:
2nd Value:
Value Percent: **5.000**
Continuous Index:
Within 8" of Joint: **NO**
Remarks:

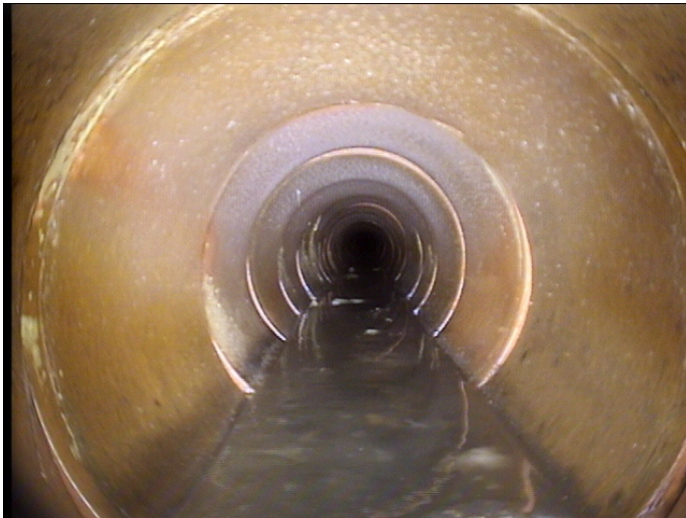
Code: **DSF**
Description: **Deposits Settled Fine**

Distance (ft): **6.2**
Structural Grade: **0**
O&M Grade: **2**
Clock Start/From: **5**
Clock To: **7**
1st Value:
2nd Value:
Value Percent: **5.000**
Continuous Index: **S01**
Within 8" of Joint: **NO**
Remarks:

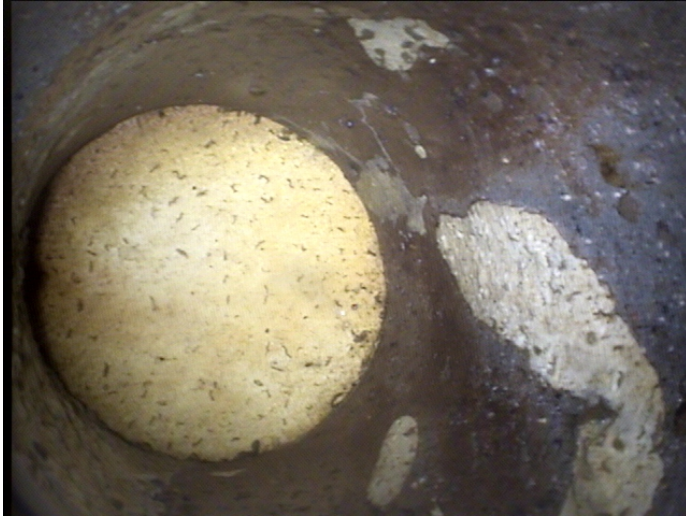
Code: **TFC**
Description: **Tap Factory Capped**

Distance (ft): **46.2**
Structural Grade: **0**
O&M Grade: **0**
Clock Start/From: **10**
Clock To:
1st Value: **4.000**
2nd Value:
Value Percent:
Continuous Index:
Within 8" of Joint: **NO**
Remarks:

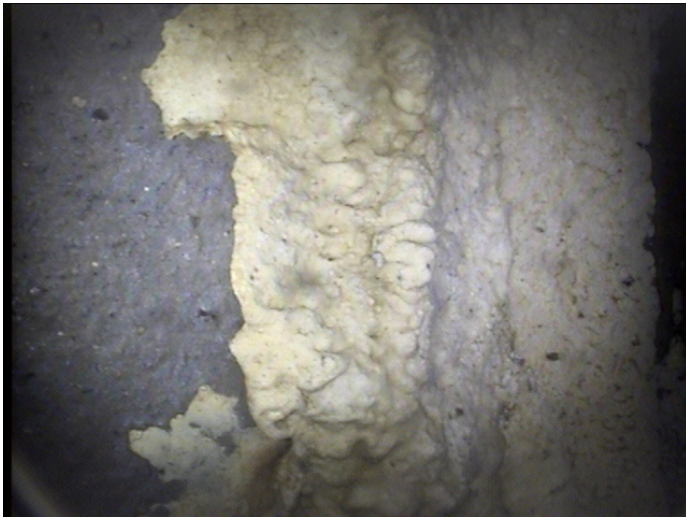
Code: **DAE**
Description: **Deposits Attached Encrustation**

Distance (ft): **71.9**
Structural Grade: **0**
O&M Grade: **2**
Clock Start/From: **7**
Clock To: **12**
1st Value:
2nd Value:
Value Percent: **5.000**
Continuous Index:
Within 8" of Joint: **YES**
Remarks:

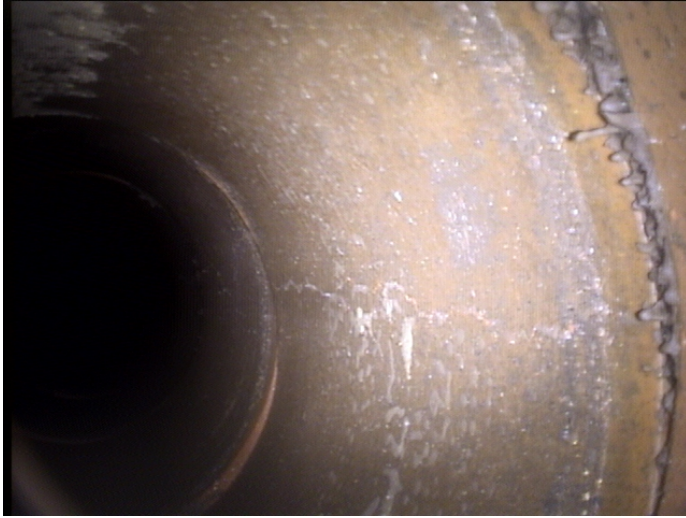
Code: **CL**
Description: **Crack Longitudinal**

Distance (ft): **125.3**
Structural Grade: **2**
O&M Grade: **0**
Clock Start/From: **12**
Clock To:
1st Value:
2nd Value:
Value Percent:
Continuous Index:
Within 8" of Joint: **NO**
Remarks:

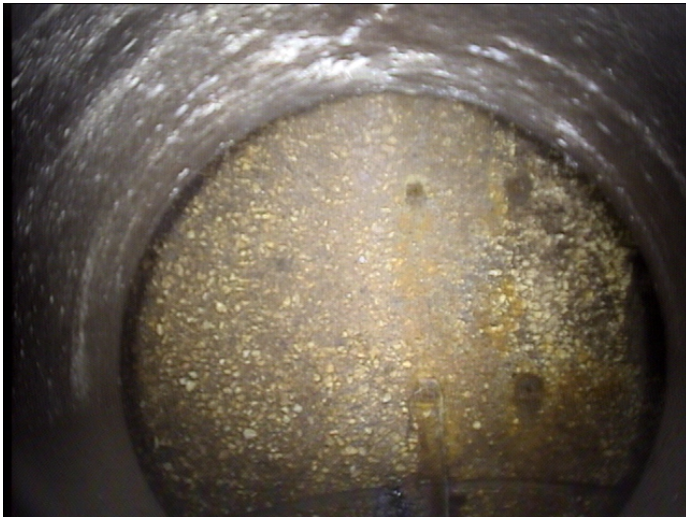
Code: **DSF**
Description: **Deposits Settled Fine**

Distance (ft): **161.7**
Structural Grade: **0**
O&M Grade: **2**
Clock Start/From: **5**
Clock To: **7**
1st Value:
2nd Value:
Value Percent: **5.000**
Continuous Index: **F01**
Within 8" of Joint: **NO**
Remarks:

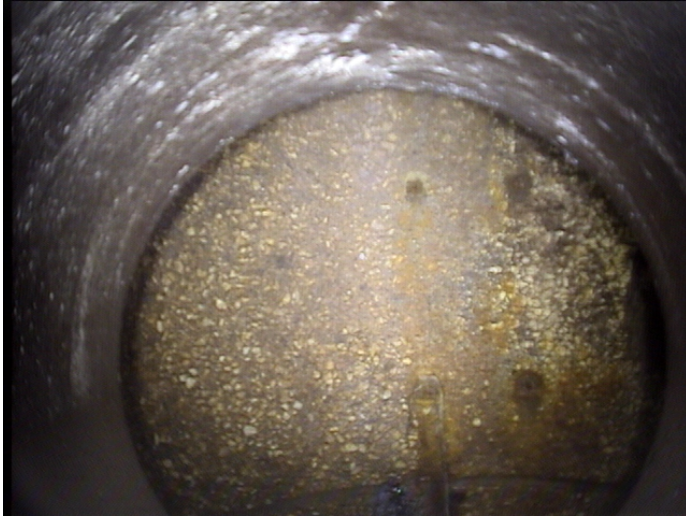
Code:	AMH
Description:	Manhole
Distance (ft):	161.7
Structural Grade:	0
O&M Grade:	0
Clock Start/From:	
Clock To:	
1st Value:	
2nd Value:	
Value Percent:	
Continuous Index:	
Within 8" of Joint:	NO
Remarks:	M-604-019
