Profile/Photo Observation Report

| Street: | Old Ridge Road | Flow Control: | Not Controlled |
| US MH: | M-604-023 | DS MH: | M-704-032 |

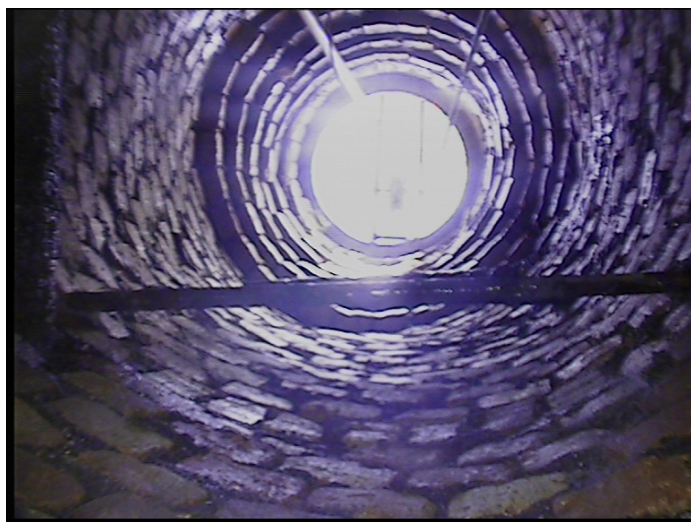
Code: **AMH**
Description: **Manhole**

Distance (ft): **.0**
Structural Grade: **0**
O&M Grade: **0**
Clock Start/From:
Clock To:
1st Value:
2nd Value:
Value Percent:
Continuous Index:
Within 8" of Joint: **NO**
Remarks: **M-704-032**

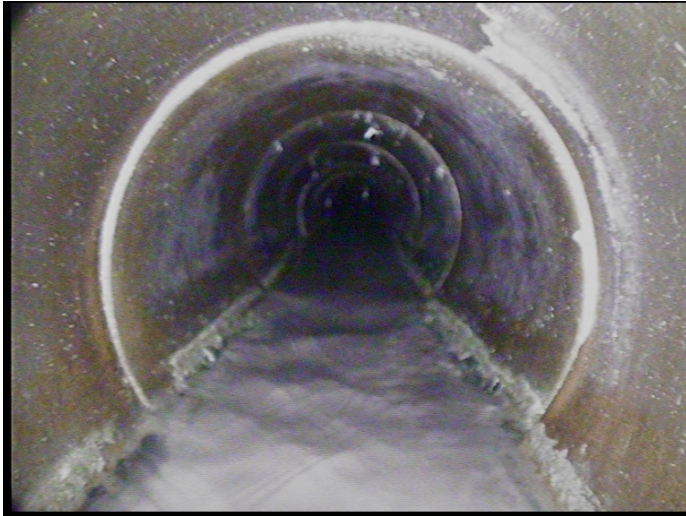
Code: **MWL**
Description: **Water Level**

Distance (ft): **.0**
Structural Grade: **0**
O&M Grade: **0**
Clock Start/From:
Clock To:
1st Value:
2nd Value:
Value Percent: **10.000**
Continuous Index:
Within 8" of Joint: **NO**
Remarks:

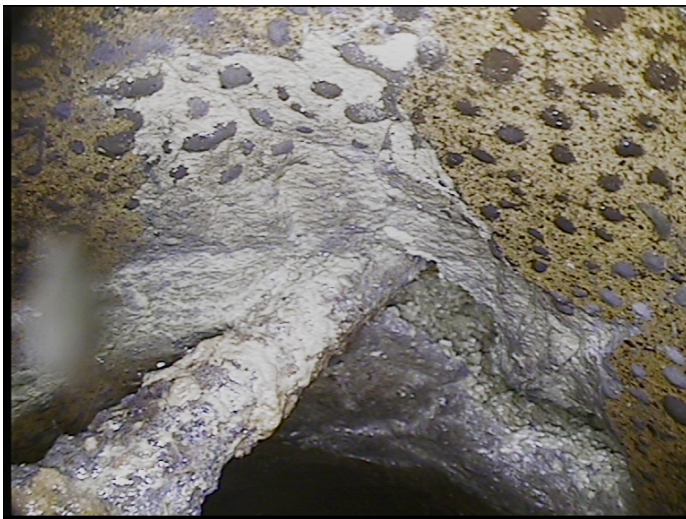
| | Position | Code | Observation | Video (sec) | Grade |
|--|---|---|---|---|---|
| | 137.6 | OBI | Obstacle Intruding Thru Wall | 215 | M 3 |

Code: **OBI**
Description: **Obstacle Intruding Thru Wall**

Distance (ft): **137.6**
Structural Grade: **0**
O&M Grade: **3**
Clock Start/From: **10**
Clock To:
1st Value:
2nd Value:
Value Percent: **15.000**
Continuous Index:
Within 8" of Joint: **NO**
Remarks:

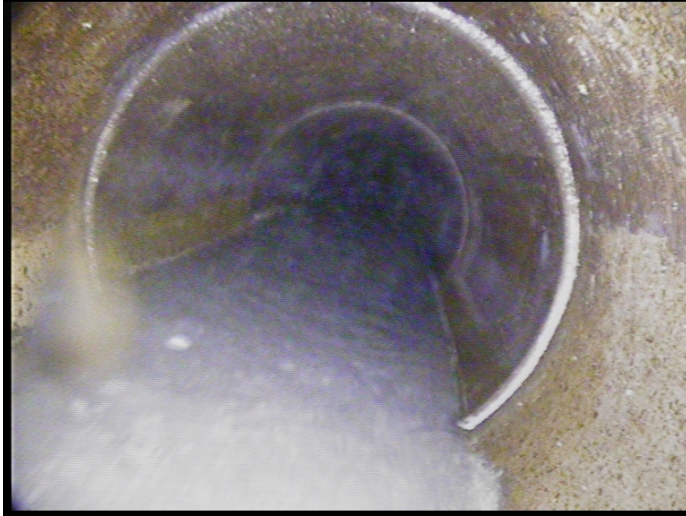
| Code: | MSA |
| Description: | Abandoned Survey |
| Distance (ft): | 137.7 |
| Remarks: | object through wall |
