Profile/Photo Observation Report

Street:	N LAKE PARK AVE	Flow Control:	Not Controlled
City:	Hobart, IN	Year Renewed:	
Location:	Other	Tape/Media #:	
Purpose:	Not Known	Dia/Height:	12"
Use:	Sanitary	Material:	VCP
Drain Area:	NA	Lining:	
Category:	NA		
Comment:

Location Details:		Direction of Survey:	Upstream
US MH:	M-604-024	DS MH:	M-604-025
		Total Length Surveyed (ft):	19.3

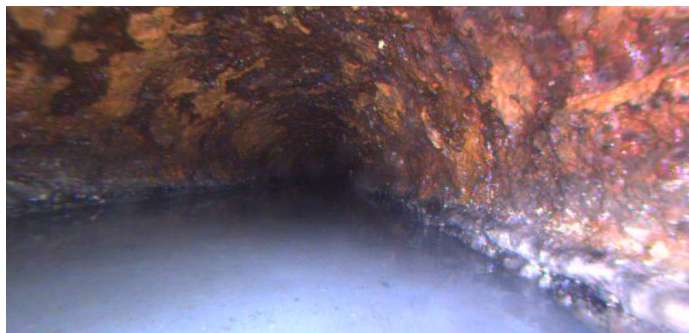
Code: **AMH**
Description: **Manhole**

Distance (ft): **.0**
Structural Grade: **0**
O&M Grade: **0**
Clock Start/From:
Clock To:
1st Value:
2nd Value:
Value Percent:
Continuous Index:
Within 8" of Joint: **NO**
Remarks: **M-604-025**

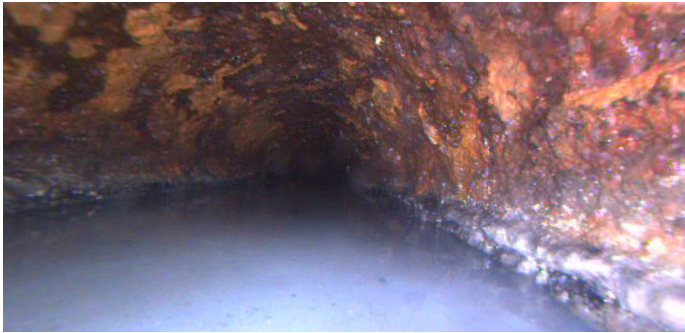
Code:	MWL
Description:	Water Level

Distance (ft):	.0
Structural Grade:	0
O&M Grade:	0
Clock Start/From:	
Clock To:	
1st Value:	
2nd Value:	
Value Percent:	30.000
Continuous Index:	
Within 8" of Joint:	NO
Remarks:

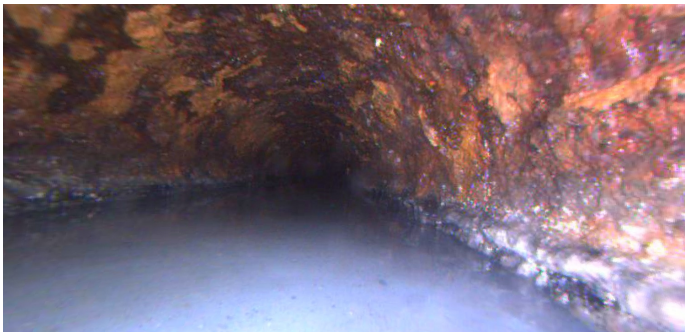
Code:	DAE
Description:	Deposits Attached Encrustation

Distance (ft):	.0
Structural Grade:	0
O&M Grade:	2
Clock Start/From:	8
Clock To:	4
1st Value:	
2nd Value:	
Value Percent:	10.000
Continuous Index:	S01
Within 8" of Joint:	NO
Remarks:

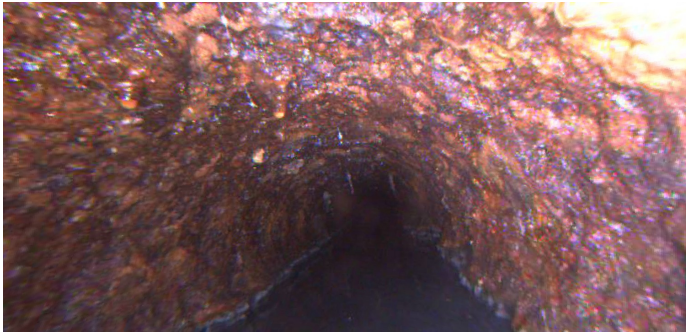
Code: **MSA**
Description: **Abandoned Survey**

Distance (ft): **19.3**
Structural Grade: **0**
O&M Grade: **0**
Clock Start/From:
Clock To:
1st Value:
2nd Value:
Value Percent:
Continuous Index:
Within 8" of Joint: **NO**
Remarks: **dae**

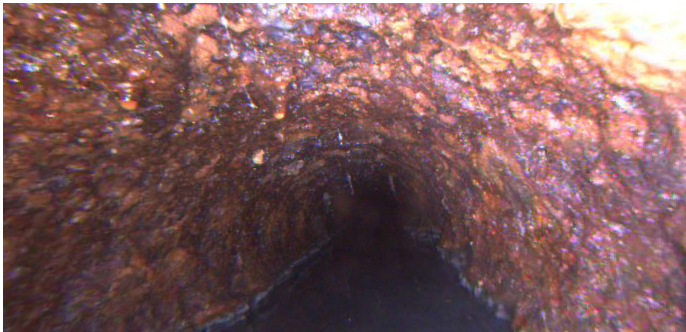
Code: **DAE**
Description: **Deposits Attached Encrustation**

Distance (ft): **19.3**
Structural Grade: **0**
O&M Grade: **2**
Clock Start/From: **8**
Clock To: **4**
1st Value:
2nd Value:
Value Percent: **10.000**
Continuous Index: **F01**
Within 8" of Joint: **NO**
Remarks:
