Profile/Photo Observation Report

Date:	04/25/2018	Weather:		Coding:	PACP 6.0
Pipe Length (ft):	102.0	Owner:	NA	Pre Clean:	Not Known
P.O.#:		Surveyor:	Jen Costello	PSR:	P-604-025-024
Customer:		Clean Date:	01/01/1900	Shape:	C

Street:	N Lake Park Ave	Flow Control:	Not Controlled
City:	Hobart, IN	Year Renewed:	
Location:	Other	Tape/Media #:	
Purpose:	Not Known	Dia/Height:	12"
Use:	Sanitary	Material:	VCP
Drain Area:	NA	Lining:	
Category:	NA		
Comment:

Location Details:		Direction of Survey:	Upstream
US MH:	M-604-024	DS MH:	M-604-025
		Total Length Surveyed (ft):	19.3

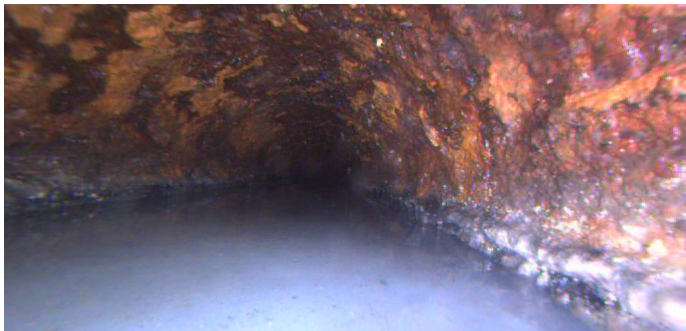
Code: **AMH**
Description: **Manhole**

Distance (ft): **.0**
Structural Grade: **0**
O&M Grade: **0**
Clock Start/From:
Clock To:
1st Value:
2nd Value:
Value Percent:
Continuous Index:
Within 8" of Joint: **NO**
Remarks: **M-604-025**

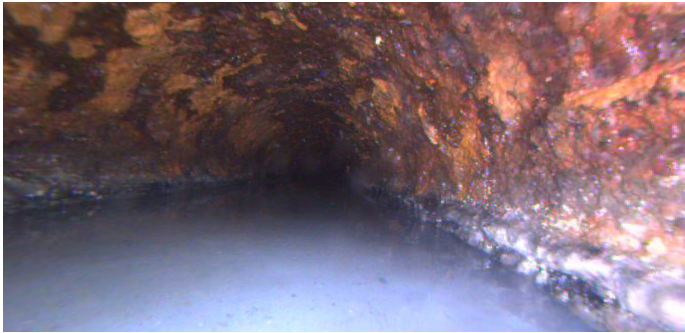
Code:	MWL
Description:	Water Level

Distance (ft):	.0
Structural Grade:	0
O&M Grade:	0
Clock Start/From:	
Clock To:	
1st Value:	
2nd Value:	
Value Percent:	30.000
Continuous Index:	
Within 8" of Joint:	NO
Remarks:

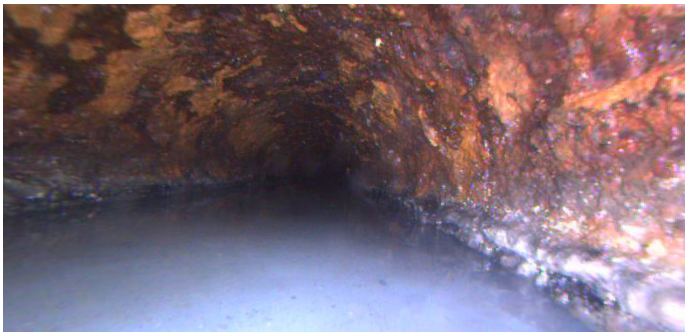
Code:	DAE
Description:	Deposits Attached Encrustation

Distance (ft):	.0
Structural Grade:	0
O&M Grade:	2
Clock Start/From:	8
Clock To:	4
1st Value:	
2nd Value:	
Value Percent:	10.000
Continuous Index:	S01
Within 8" of Joint:	NO
Remarks:

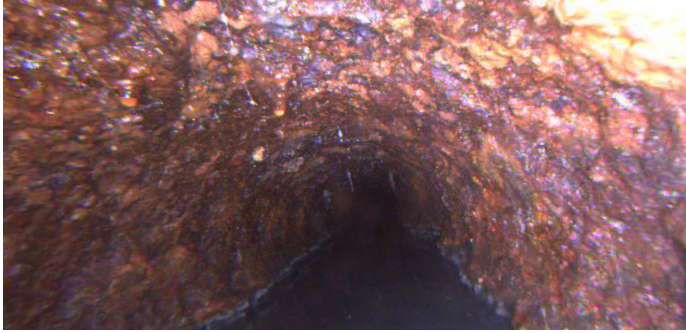
Code: **MSA**
Description: **Abandoned Survey**

Distance (ft): **19.3**
Structural Grade: **0**
O&M Grade: **0**
Clock Start/From:
Clock To:
1st Value:
2nd Value:
Value Percent:
Continuous Index:
Within 8" of Joint: **NO**
Remarks: **dae**

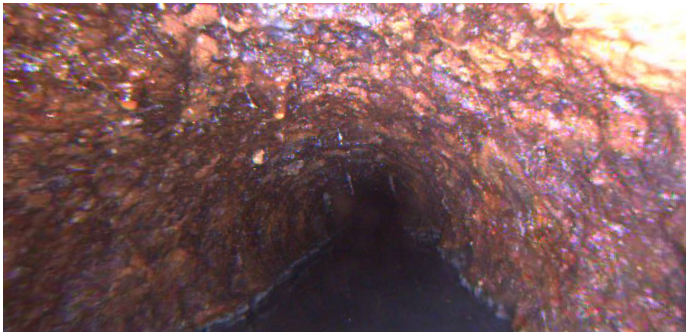
Code: **DAE**
Description: **Deposits Attached Encrustation**

Distance (ft): **19.3**
Structural Grade: **0**
O&M Grade: **2**
Clock Start/From: **8**
Clock To: **4**
1st Value:
2nd Value:
Value Percent: **10.000**
Continuous Index: **F01**
Within 8" of Joint: **NO**
Remarks:
