Profile/Photo Observation Report

Street:	N LAKE PARK AVE & LUKES CT	Flow Control:	Not Controlled
City:	Hobart, IN	Year Renewed:	
Location:	Light Highway	Tape/Media #:	
Purpose:	Not Known	Dia/Height:	10"
Use:	Sanitary	Material:	VCP
Drain Area:	NA	Lining:	
Category:	NA		
Comment:

Location Details:		Direction of Survey:	Downstream
US MH:	M-604-028	DS MH:	M-604-030
		Total Length Surveyed (ft):	277.8

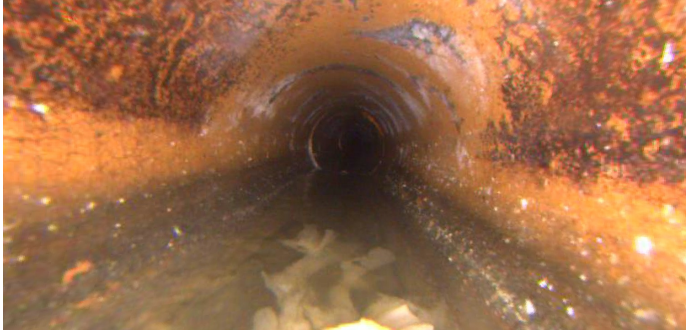
Code: **AMH**
Description: **Manhole**

Distance (ft): **.0**
Structural Grade: **0**
O&M Grade: **0**
Clock Start/From:
Clock To:
1st Value:
2nd Value:
Value Percent:
Continuous Index:
Within 8" of Joint: **NO**
Remarks: **M-604-028**

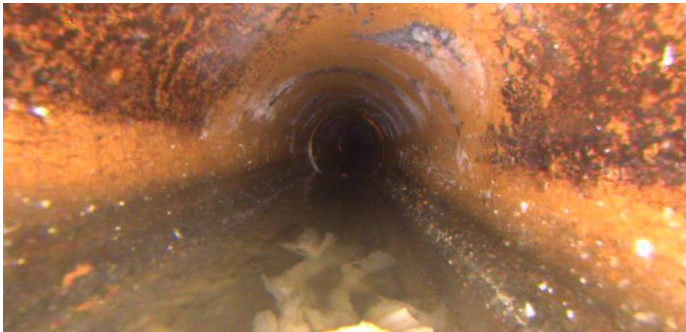
Code: **MWL**
Description: **Water Level**

Distance (ft): **.0**
Structural Grade: **0**
O&M Grade: **0**
Clock Start/From:
Clock To:
1st Value:
2nd Value:
Value Percent: **10.000**
Continuous Index:
Within 8" of Joint: **NO**
Remarks:

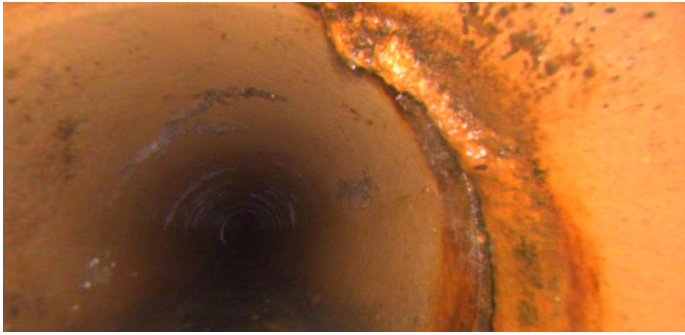
Code: **ID**
Description: **Infil Dripper**

Distance (ft): **3.5**
Structural Grade: **0**
O&M Grade: **3**
Clock Start/From: **1**
Clock To:
1st Value:
2nd Value:
Value Percent:
Continuous Index:
Within 8" of Joint: **YES**
Remarks:

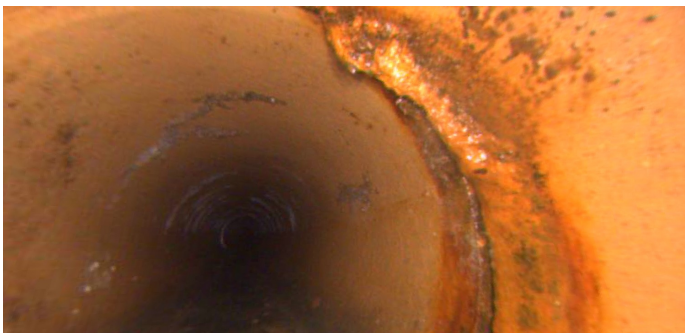
Code: **DAE**
Description: **Deposits Attached Encrustation**

Distance (ft): **3.5**
Structural Grade: **0**
O&M Grade: **2**
Clock Start/From: **1**
Clock To: **4**
1st Value:
2nd Value:
Value Percent: **5.000**
Continuous Index:
Within 8" of Joint: **YES**
Remarks:

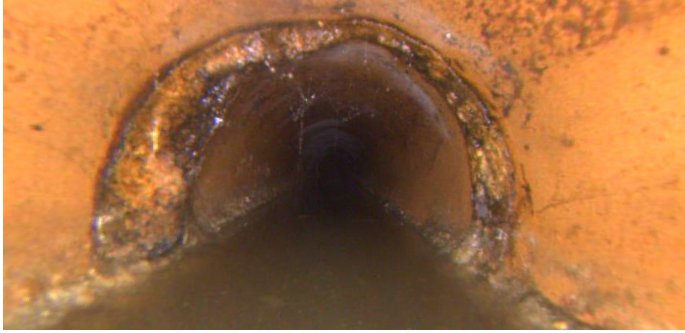
Code: **DAE**
Description: **Deposits Attached Encrustation**

Distance (ft): **22.9**
Structural Grade: **0**
O&M Grade: **2**
Clock Start/From: **8**
Clock To: **4**
1st Value:
2nd Value:
Value Percent: **10.000**
Continuous Index:
Within 8" of Joint: **YES**
Remarks:

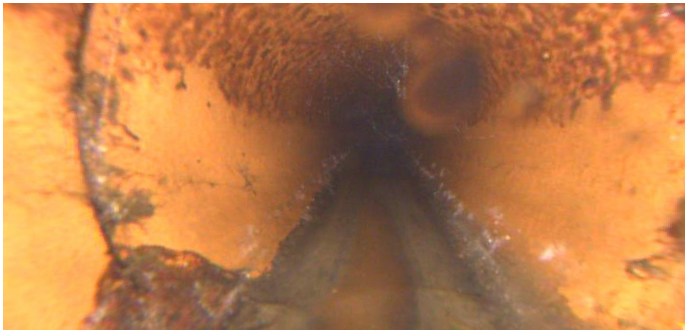
Code: **RFJ**
Description: **Roots Fine Joint**

Distance (ft): **37.2**
Structural Grade: **0**
O&M Grade: **1**
Clock Start/From: **8**
Clock To: **9**
1st Value:
2nd Value:
Value Percent:
Continuous Index:
Within 8" of Joint: **YES**
Remarks:

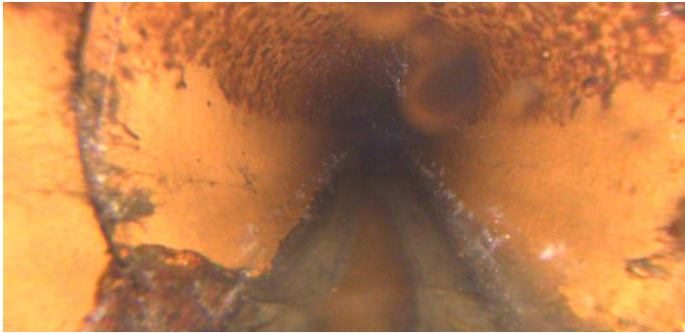
Code: **IW**
Description: **Infil Weeper**

Distance (ft): **37.2**
Structural Grade: **0**
O&M Grade: **2**
Clock Start/From: **8**
Clock To: **9**
1st Value:
2nd Value:
Value Percent:
Continuous Index:
Within 8" of Joint: **YES**
Remarks:

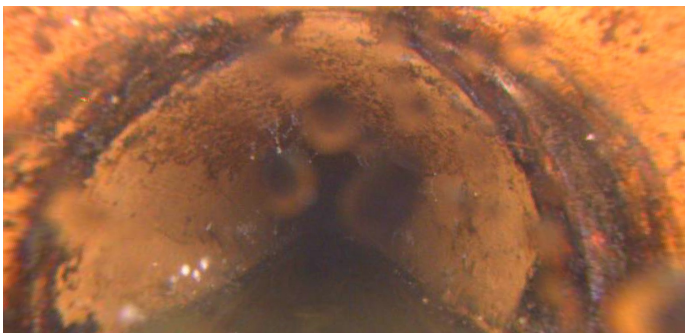
Code: **IW**
Description: **Infil Weeper**

Distance (ft): **42.1**
Structural Grade: **0**
O&M Grade: **2**
Clock Start/From: **8**
Clock To: **4**
1st Value:
2nd Value:
Value Percent:
Continuous Index:
Within 8" of Joint: **YES**
Remarks:

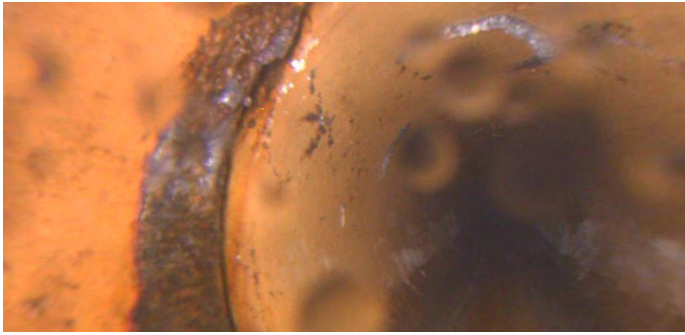
Code: **DAE**
Description: **Deposits Attached Encrustation**

Distance (ft): **52.0**
Structural Grade: **0**
O&M Grade: **2**
Clock Start/From: **8**
Clock To: **10**
1st Value:
2nd Value:
Value Percent: **5.000**
Continuous Index:
Within 8" of Joint: **YES**
Remarks:

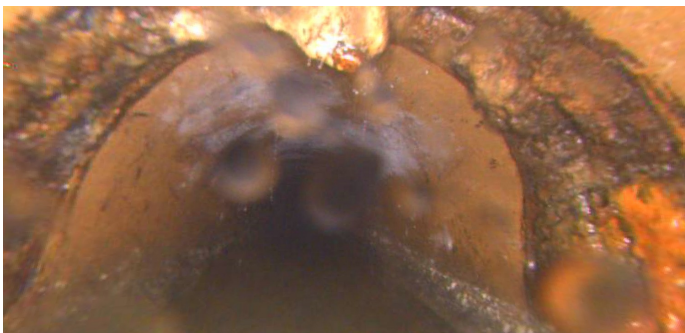
Code: **DAE**
Description: **Deposits Attached Encrustation**

Distance (ft): **56.9**
Structural Grade: **0**
O&M Grade: **2**
Clock Start/From: **8**
Clock To: **4**
1st Value:
2nd Value:
Value Percent: **10.000**
Continuous Index:
Within 8" of Joint: **YES**
Remarks:

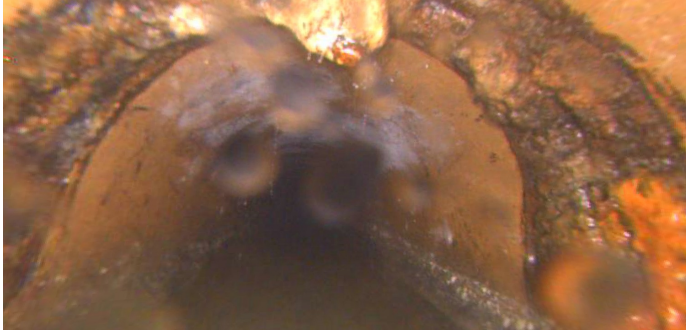
Code: ID
Description: Infil Dripper

Distance (ft): 56.9
Structural Grade: 0
O&M Grade: 3
Clock Start/From: 12
Clock To:
1st Value:
2nd Value:
Value Percent:
Continuous Index:
Within 8" of Joint: YES
Remarks:

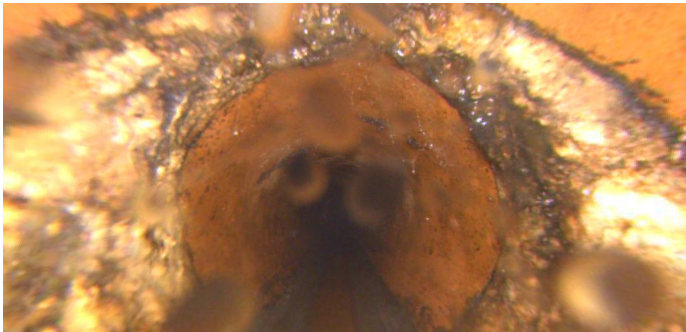
Code: DAE
Description: Deposits Attached Encrustation

Distance (ft): 66.7
Structural Grade: 0
O&M Grade: 2
Clock Start/From: 8
Clock To: 4
1st Value:
2nd Value:
Value Percent: 10.000
Continuous Index:
Within 8" of Joint: YES
Remarks:

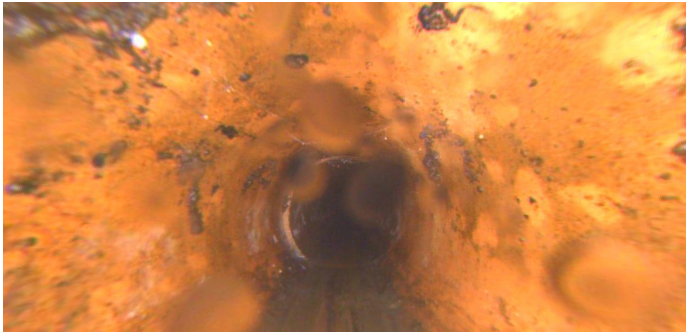
Code: **CL**
Description: **Crack Longitudinal**

Distance (ft): **70.7**
Structural Grade: **2**
O&M Grade: **0**
Clock Start/From: **10**
Clock To:
1st Value:
2nd Value:
Value Percent:
Continuous Index:
Within 8" of Joint:
Remarks:

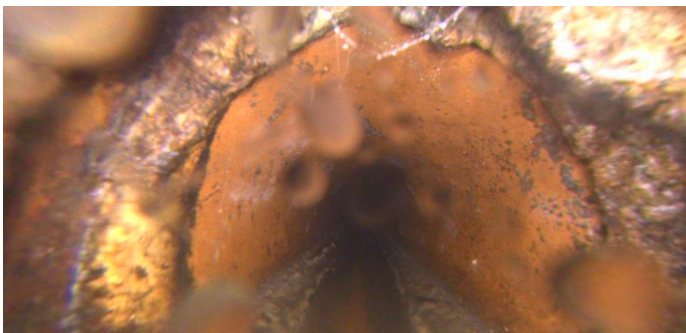
Code: **DAE**
Description: **Deposits Attached Encrustation**

Distance (ft): **76.6**
Structural Grade: **0**
O&M Grade: **2**
Clock Start/From: **8**
Clock To: **4**
1st Value:
2nd Value:
Value Percent: **10.000**
Continuous Index:
Within 8" of Joint: **YES**
Remarks:

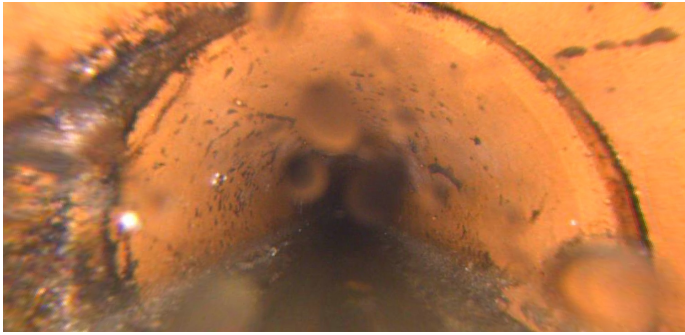
Code: **IW**
Description: **Infil Weeper**

Distance (ft): **81.5**
Structural Grade: **0**
O&M Grade: **2**
Clock Start/From: **8**
Clock To: **11**
1st Value:
2nd Value:
Value Percent:
Continuous Index:
Within 8" of Joint: **NO**
Remarks:

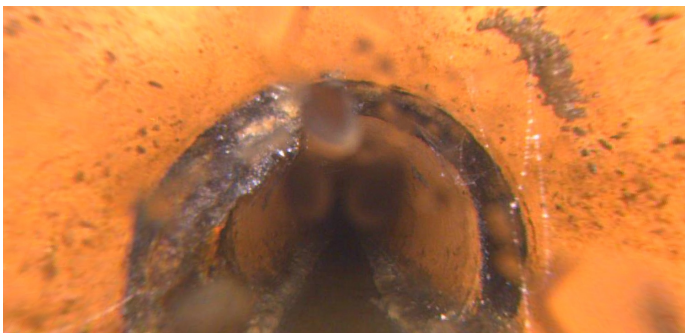
Code: **DAE**
Description: **Deposits Attached Encrustation**

Distance (ft): **90.9**
Structural Grade: **0**
O&M Grade: **2**
Clock Start/From: **8**
Clock To: **4**
1st Value:
2nd Value:
Value Percent: **10.000**
Continuous Index:
Within 8" of Joint: **YES**
Remarks:

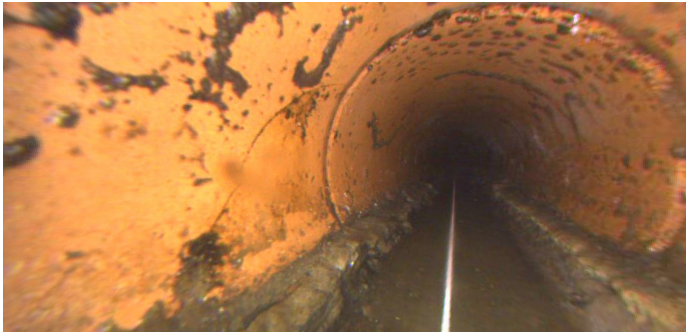
Code: **FS**
Description: **Fracture Spiral**

Distance (ft): **97.0**
Structural Grade: **3**
O&M Grade: **0**
Clock Start/From: **2**
Clock To: **4**
1st Value:
2nd Value:
Value Percent:
Continuous Index:
Within 8" of Joint: **YES**
Remarks:

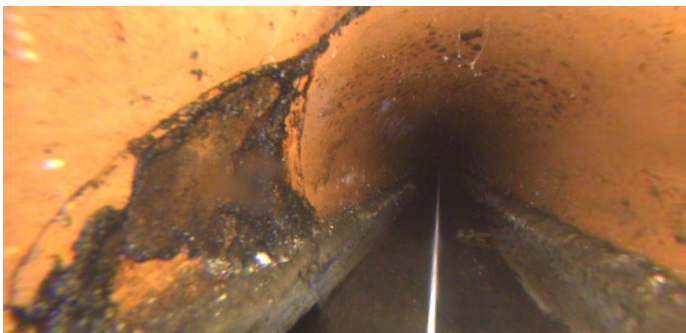
Code: **FS**
Description: **Fracture Spiral**

Distance (ft): **101.7**
Structural Grade: **3**
O&M Grade: **0**
Clock Start/From: **1**
Clock To: **4**
1st Value:
2nd Value:
Value Percent:
Continuous Index:
Within 8" of Joint: **YES**
Remarks:

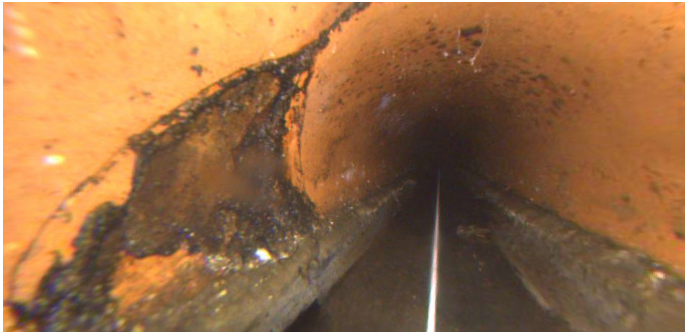
Code: **DAZ**
Description: **Deposits Attached Other**

Distance (ft): **101.7**
Structural Grade: **0**
O&M Grade: **2**
Clock Start/From: **1**
Clock To: **4**
1st Value:
2nd Value:
Value Percent: **5.000**
Continuous Index:
Within 8" of Joint: **NO**
Remarks:

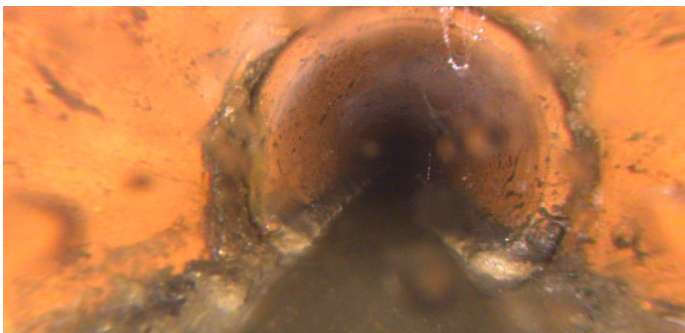
Code: **IW**
Description: **Infil Weeper**

Distance (ft): **140.2**
Structural Grade: **0**
O&M Grade: **2**
Clock Start/From: **8**
Clock To: **4**
1st Value:
2nd Value:
Value Percent:
Continuous Index:
Within 8" of Joint: **YES**
Remarks:

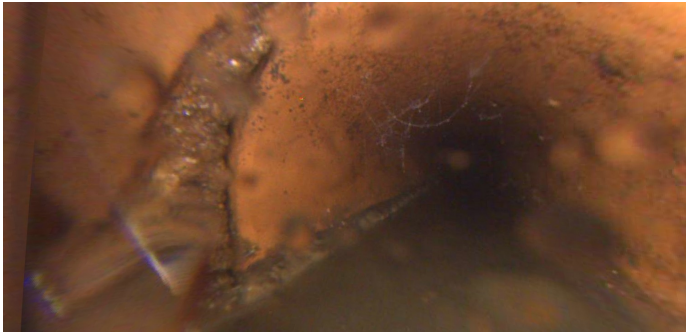
Code: **DAE**
Description: **Deposits Attached Encrustation**

Distance (ft): **150.2**
Structural Grade: **0**
O&M Grade: **2**
Clock Start/From: **8**
Clock To: **11**
1st Value:
2nd Value:
Value Percent: **5.000**
Continuous Index:
Within 8" of Joint: **YES**
Remarks:

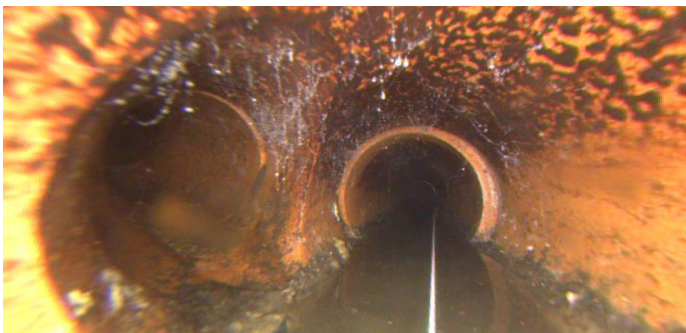
Code: **TFA**
Description: **Tap Factory Active**

Distance (ft): **161.5**
Structural Grade: **0**
O&M Grade: **0**
Clock Start/From: **3**
Clock To:
1st Value: **4.000**
2nd Value:
Value Percent:
Continuous Index:
Within 8" of Joint:
Remarks:

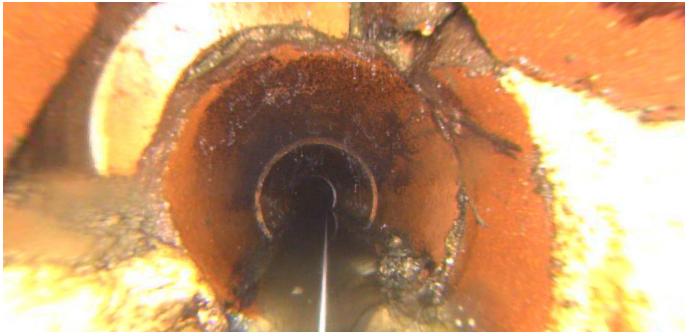
Code: **BVV**
Description: **Broken Void Visible**

Distance (ft): **163.8**
Structural Grade: **5**
O&M Grade: **0**
Clock Start/From: **8**
Clock To: **4**
1st Value:
2nd Value:
Value Percent:
Continuous Index:
Within 8" of Joint: **YES**
Remarks:

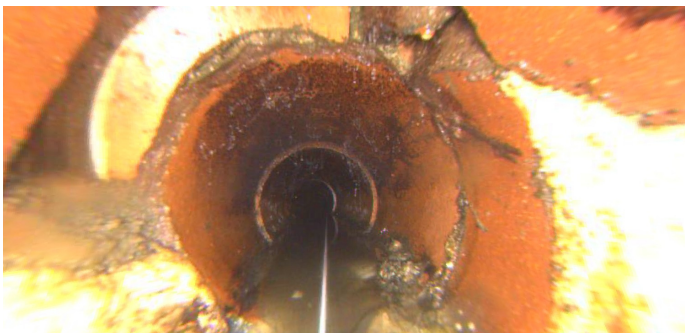
Code: **DAE**
Description: **Deposits Attached Encrustation**

Distance (ft): **163.8**
Structural Grade: **0**
O&M Grade: **2**
Clock Start/From: **8**
Clock To: **4**
1st Value:
2nd Value:
Value Percent: **5.000**
Continuous Index:
Within 8" of Joint: **NO**
Remarks:

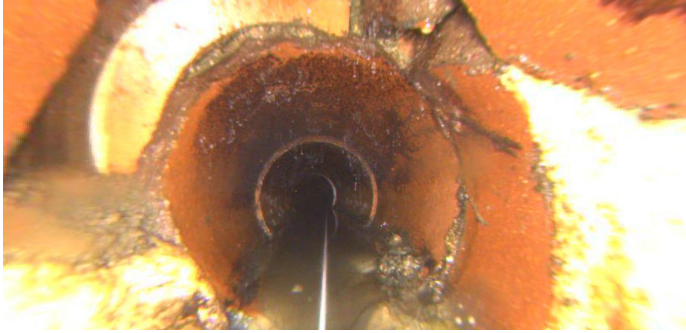
Code: **RFB**
Description: **Roots Fine Barrel**

Distance (ft): **163.8**
Structural Grade: **0**
O&M Grade: **2**
Clock Start/From: **10**
Clock To:
1st Value:
2nd Value:
Value Percent:
Continuous Index:
Within 8" of Joint: **NO**
Remarks:

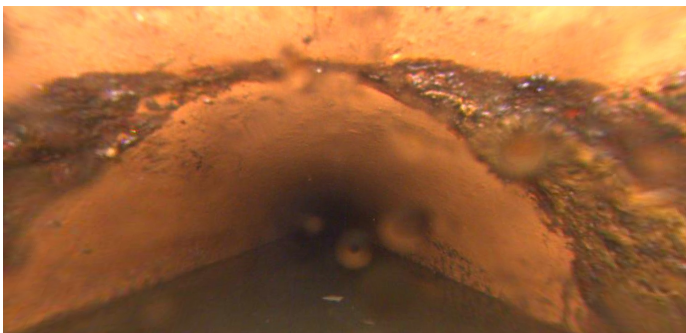
Code: **DAE**
Description: **Deposits Attached Encrustation**

Distance (ft): **191.8**
Structural Grade: **0**
O&M Grade: **2**
Clock Start/From: **8**
Clock To: **4**
1st Value:
2nd Value:
Value Percent: **5.000**
Continuous Index:
Within 8" of Joint: **YES**
Remarks:

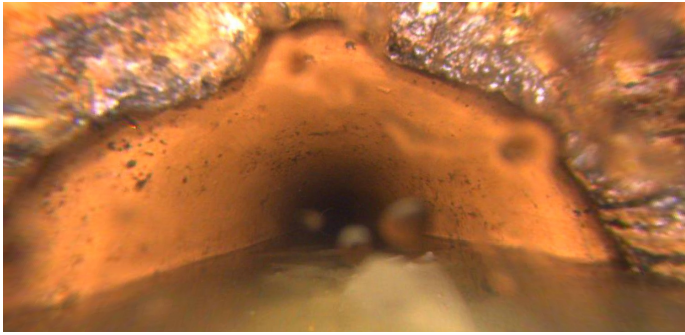
Code: **DAE**
Description: **Deposits Attached Encrustation**

Distance (ft): **231.1**
Structural Grade: **0**
O&M Grade: **2**
Clock Start/From: **8**
Clock To: **4**
1st Value:
2nd Value:
Value Percent: **10.000**
Continuous Index:
Within 8" of Joint: **YES**
Remarks:

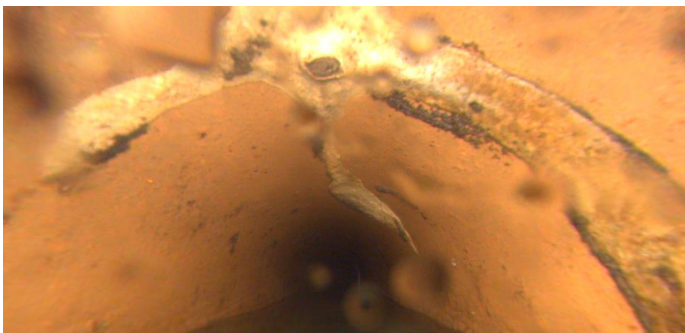
Code: **DAE**
Description: **Deposits Attached Encrustation**

Distance (ft): **256.1**
Structural Grade: **0**
O&M Grade: **2**
Clock Start/From: **8**
Clock To: **4**
1st Value:
2nd Value:
Value Percent: **5.000**
Continuous Index:
Within 8" of Joint: **YES**
Remarks:

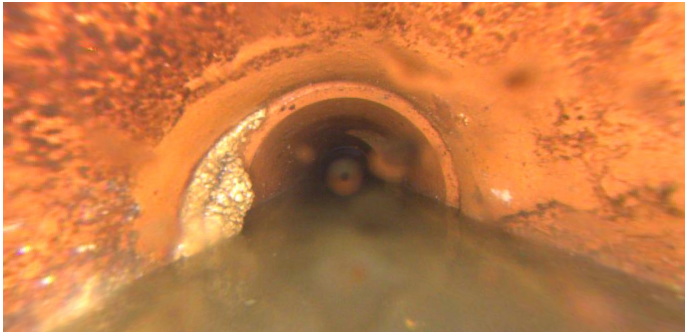
Code: **DAE**
Description: **Deposits Attached Encrustation**

Distance (ft): **270.2**
Structural Grade: **0**
O&M Grade: **2**
Clock Start/From: **9**
Clock To: **10**
1st Value:
2nd Value:
Value Percent: **5.000**
Continuous Index:
Within 8" of Joint: **YES**
Remarks:

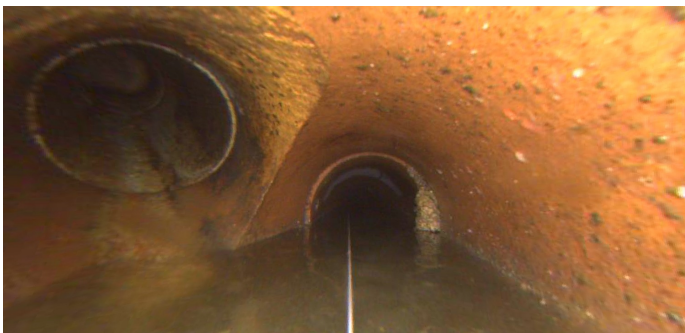
Code: **TFA**
Description: **Tap Factory Active**

Distance (ft): **271.9**
Structural Grade: **0**
O&M Grade: **0**
Clock Start/From: **2**
Clock To:
1st Value: **4.000**
2nd Value:
Value Percent:
Continuous Index:
Within 8" of Joint:
Remarks:

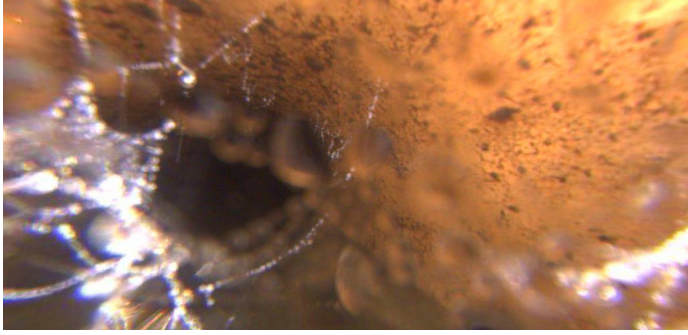
Code:	MSA
Description:	Abandoned Survey
Distance (ft):	277.8
Structural Grade:	0
O&M Grade:	0
Clock Start/From:	
Clock To:	
1st Value:	
2nd Value:	
Value Percent:	
Continuous Index:	
Within 8" of Joint:	NO
Remarks:	debris under water
