Profile/Photo Observation Report

Date:	04/23/2018	Weather:		Coding:	PACP 6.0
Pipe Length (ft):	303.1	Owner:	NA	Pre Clean:	Not Known
P.O.#:		Surveyor:	Jen Costello	PSR:	P-604-030-028
Customer:		Clean Date:	01/01/1900	Shape:	C

Street:	Summerlin	Flow Control:	Not Controlled
City:	Hobart, IN	Year Renewed:	
Location:	Light Highway	Tape/Media #:	
Purpose:	Not Known	Dia/Height:	10"
Use:	Sanitary	Material:	VCP
Drain Area:	NA	Lining:	
Category:	NA		
Comment:

Location Details:		Direction of Survey:	Downstream
US MH:	M-604-028	DS MH:	M-604-030
		Total Length Surveyed (ft):	277.8

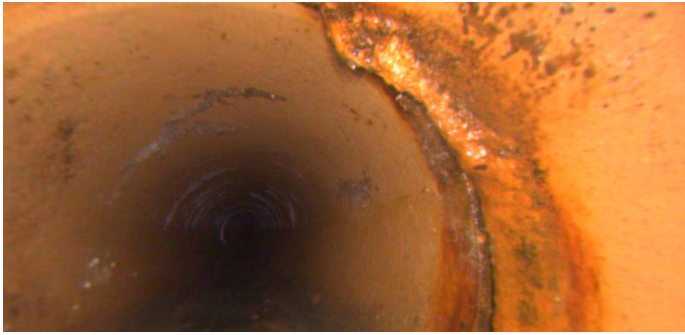
Code: **ID**
Description: **Infil Dripper**

Distance (ft): **3.5**
Structural Grade: **0**
O&M Grade: **3**
Clock Start/From: **1**
Clock To:
1st Value:
2nd Value:
Value Percent:
Continuous Index:
Within 8" of Joint: **YES**
Remarks:

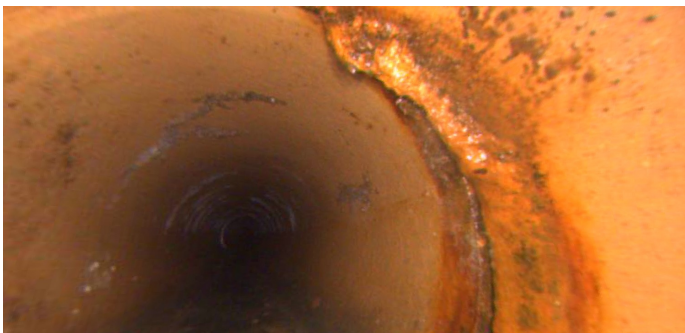
Code: **DAE**
Description: **Deposits Attached Encrustation**

Distance (ft): **3.5**
Structural Grade: **0**
O&M Grade: **2**
Clock Start/From: **1**
Clock To: **4**
1st Value:
2nd Value:
Value Percent: **5.000**
Continuous Index:
Within 8" of Joint: **YES**
Remarks:

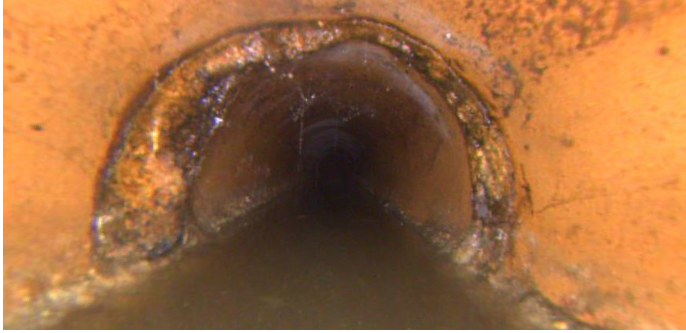
Code: **DAE**
Description: **Deposits Attached Encrustation**

Distance (ft): **22.9**
Structural Grade: **0**
O&M Grade: **2**
Clock Start/From: **8**
Clock To: **4**
1st Value:
2nd Value:
Value Percent: **10.000**
Continuous Index:
Within 8" of Joint: **YES**
Remarks:

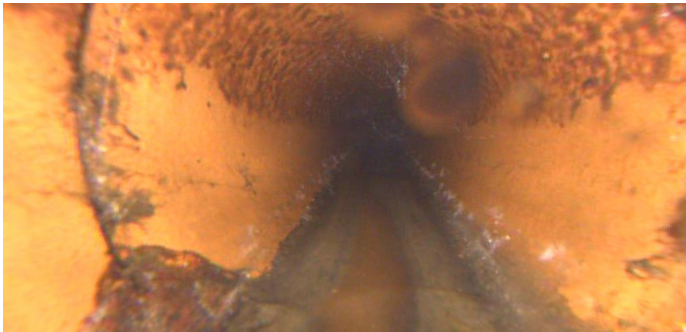
Code: **RFJ**
Description: **Roots Fine Joint**

Distance (ft): **37.2**
Structural Grade: **0**
O&M Grade: **1**
Clock Start/From: **8**
Clock To: **9**
1st Value:
2nd Value:
Value Percent:
Continuous Index:
Within 8" of Joint: **YES**
Remarks:

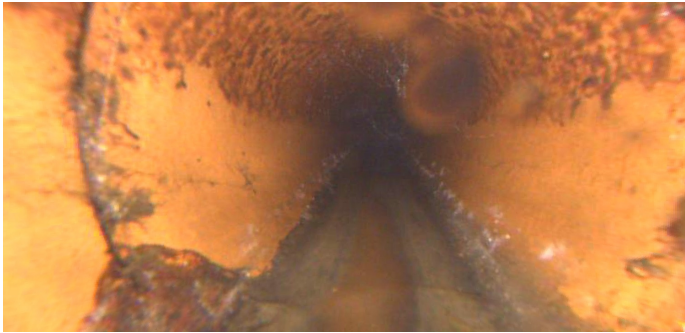
Code: **IW**
Description: **Infil Weeper**

Distance (ft): **37.2**
Structural Grade: **0**
O&M Grade: **2**
Clock Start/From: **8**
Clock To: **9**
1st Value:
2nd Value:
Value Percent:
Continuous Index:
Within 8" of Joint: **YES**
Remarks:

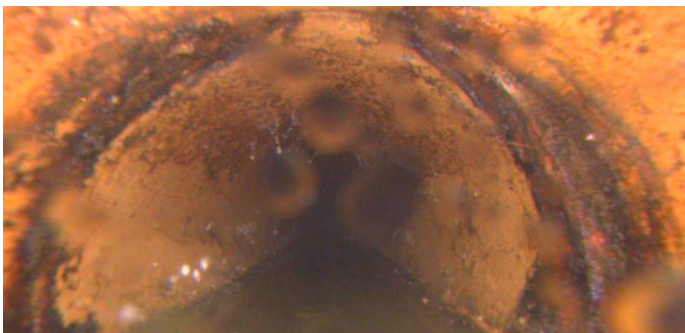
Code: **IW**
Description: **Infil Weeper**

Distance (ft): **42.1**
Structural Grade: **0**
O&M Grade: **2**
Clock Start/From: **8**
Clock To: **4**
1st Value:
2nd Value:
Value Percent:
Continuous Index:
Within 8" of Joint: **YES**
Remarks:

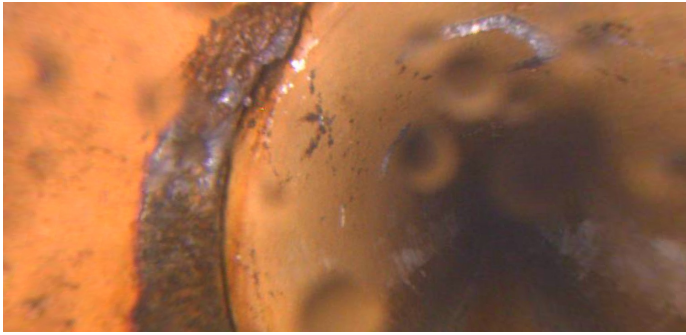
Code: **DAE**
Description: **Deposits Attached Encrustation**

Distance (ft): **52.0**
Structural Grade: **0**
O&M Grade: **2**
Clock Start/From: **8**
Clock To: **10**
1st Value:
2nd Value:
Value Percent: **5.000**
Continuous Index:
Within 8" of Joint: **YES**
Remarks:

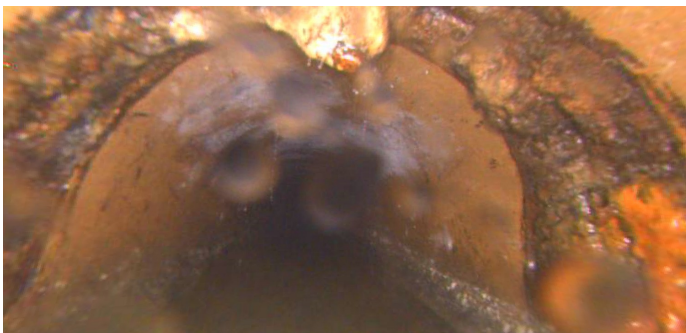
Code: **DAE**
Description: **Deposits Attached Encrustation**

Distance (ft): **56.9**
Structural Grade: **0**
O&M Grade: **2**
Clock Start/From: **8**
Clock To: **4**
1st Value:
2nd Value:
Value Percent: **10.000**
Continuous Index:
Within 8" of Joint: **YES**
Remarks:

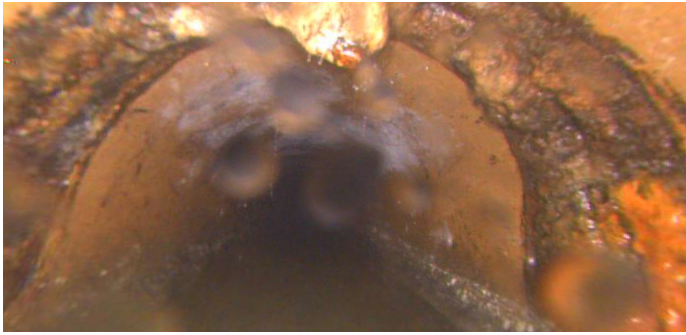
Code: ID
Description: Infil Dripper

Distance (ft): 56.9
Structural Grade: 0
O&M Grade: 3
Clock Start/From: 12
Clock To:
1st Value:
2nd Value:
Value Percent:
Continuous Index:
Within 8" of Joint: YES
Remarks:

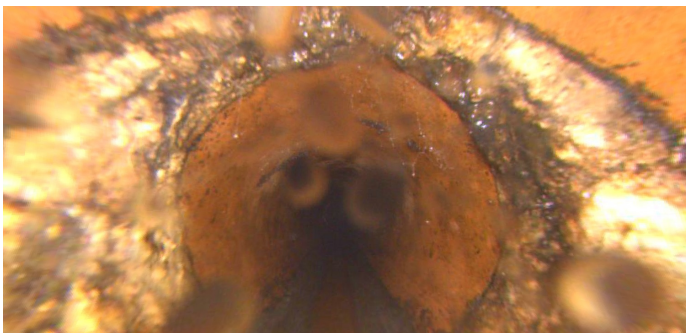
Code: DAE
Description: Deposits Attached Encrustation

Distance (ft): 66.7
Structural Grade: 0
O&M Grade: 2
Clock Start/From: 8
Clock To: 4
1st Value:
2nd Value:
Value Percent: 10.000
Continuous Index:
Within 8" of Joint: YES
Remarks:

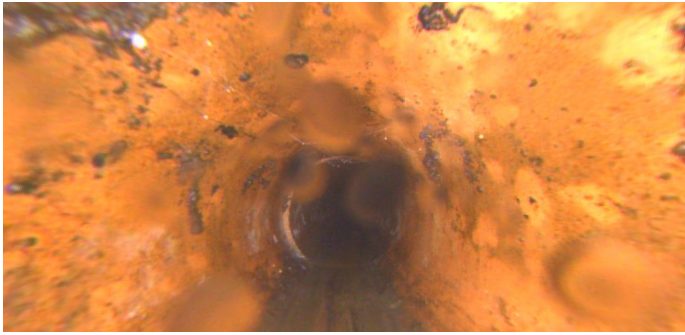
Code: **CL**
Description: **Crack Longitudinal**

Distance (ft): **70.7**
Structural Grade: **2**
O&M Grade: **0**
Clock Start/From: **10**
Clock To:
1st Value:
2nd Value:
Value Percent:
Continuous Index:
Within 8" of Joint:
Remarks:

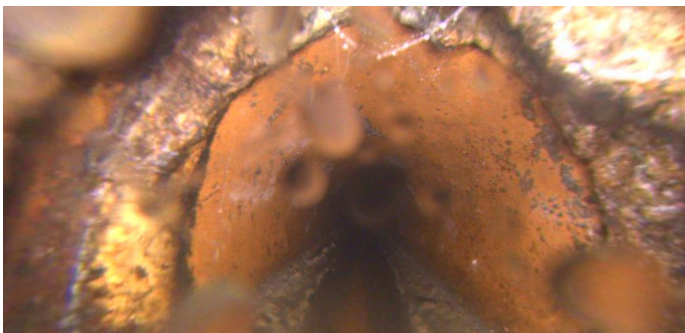
Code: **DAE**
Description: **Deposits Attached Encrustation**

Distance (ft): **76.6**
Structural Grade: **0**
O&M Grade: **2**
Clock Start/From: **8**
Clock To: **4**
1st Value:
2nd Value:
Value Percent: **10.000**
Continuous Index:
Within 8" of Joint: **YES**
Remarks:

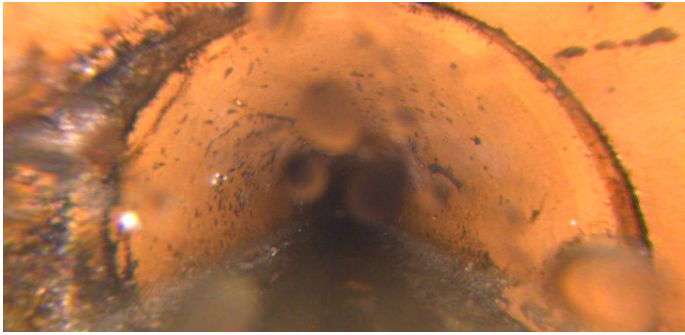
Code: **IW**
Description: **Infil Weeper**

Distance (ft): **81.5**
Structural Grade: **0**
O&M Grade: **2**
Clock Start/From: **8**
Clock To: **11**
1st Value:
2nd Value:
Value Percent:
Continuous Index:
Within 8" of Joint: **NO**
Remarks:

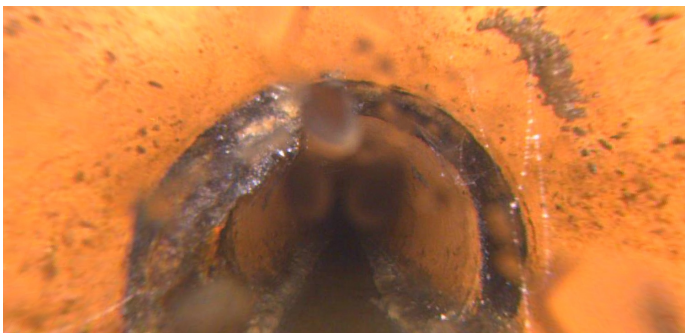
Code: **DAE**
Description: **Deposits Attached Encrustation**

Distance (ft): **90.9**
Structural Grade: **0**
O&M Grade: **2**
Clock Start/From: **8**
Clock To: **4**
1st Value:
2nd Value:
Value Percent: **10.000**
Continuous Index:
Within 8" of Joint: **YES**
Remarks:

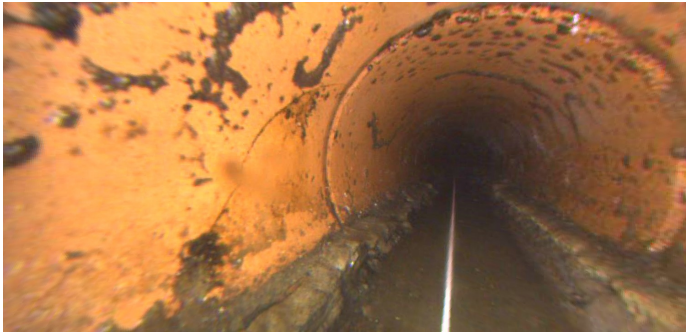
Code: **FS**
Description: **Fracture Spiral**

Distance (ft): **97.0**
Structural Grade: **3**
O&M Grade: **0**
Clock Start/From: **2**
Clock To: **4**
1st Value:
2nd Value:
Value Percent:
Continuous Index:
Within 8" of Joint: **YES**
Remarks:

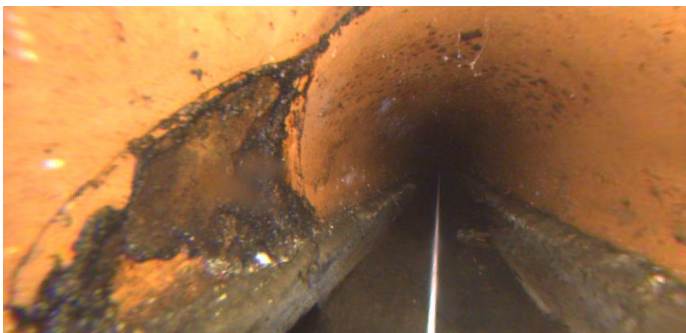
Code: **FS**
Description: **Fracture Spiral**

Distance (ft): **101.7**
Structural Grade: **3**
O&M Grade: **0**
Clock Start/From: **1**
Clock To: **4**
1st Value:
2nd Value:
Value Percent:
Continuous Index:
Within 8" of Joint: **YES**
Remarks:

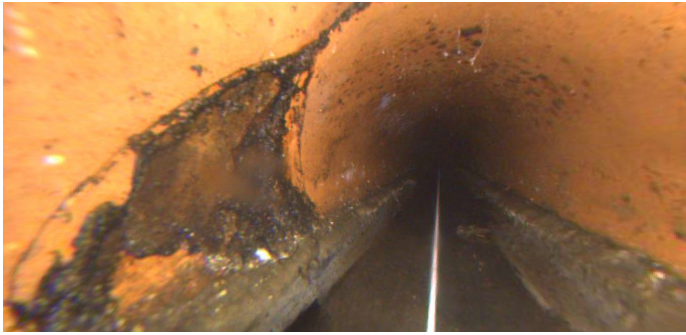
Code: **DAZ**
Description: **Deposits Attached Other**

Distance (ft): **101.7**
Structural Grade: **0**
O&M Grade: **2**
Clock Start/From: **1**
Clock To: **4**
1st Value:
2nd Value:
Value Percent: **5.000**
Continuous Index:
Within 8" of Joint: **NO**
Remarks:

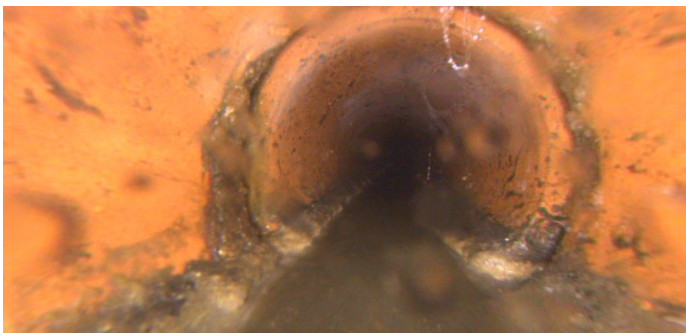
Code: **IW**
Description: **Infil Weeper**

Distance (ft): **140.2**
Structural Grade: **0**
O&M Grade: **2**
Clock Start/From: **8**
Clock To: **4**
1st Value:
2nd Value:
Value Percent:
Continuous Index:
Within 8" of Joint: **YES**
Remarks:

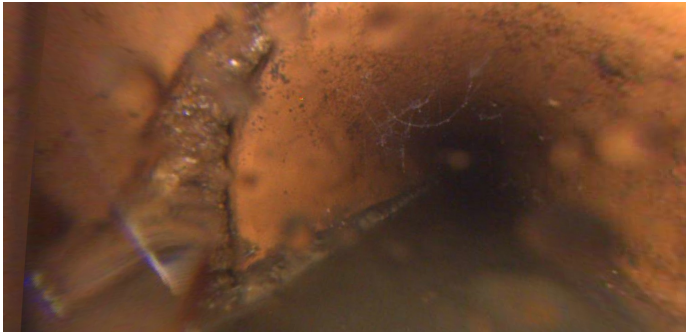
Code: **DAE**
Description: **Deposits Attached Encrustation**

Distance (ft): **150.2**
Structural Grade: **0**
O&M Grade: **2**
Clock Start/From: **8**
Clock To: **11**
1st Value:
2nd Value:
Value Percent: **5.000**
Continuous Index:
Within 8" of Joint: **YES**
Remarks:

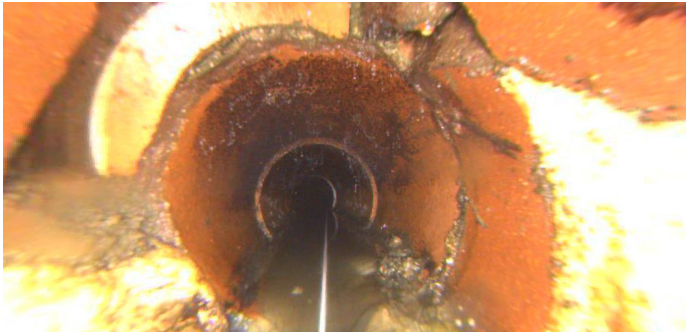
Code: **BVV**
Description: **Broken Void Visible**

Distance (ft): **163.8**
Structural Grade: **5**
O&M Grade: **0**
Clock Start/From: **8**
Clock To: **4**
1st Value:
2nd Value:
Value Percent:
Continuous Index:
Within 8" of Joint: **YES**
Remarks:

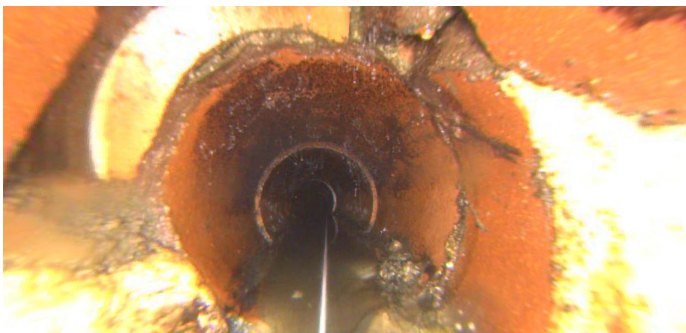
Code: **DAE**
Description: **Deposits Attached Encrustation**

Distance (ft): **163.8**
Structural Grade: **0**
O&M Grade: **2**
Clock Start/From: **8**
Clock To: **4**
1st Value:
2nd Value:
Value Percent: **5.000**
Continuous Index:
Within 8" of Joint: **NO**
Remarks:

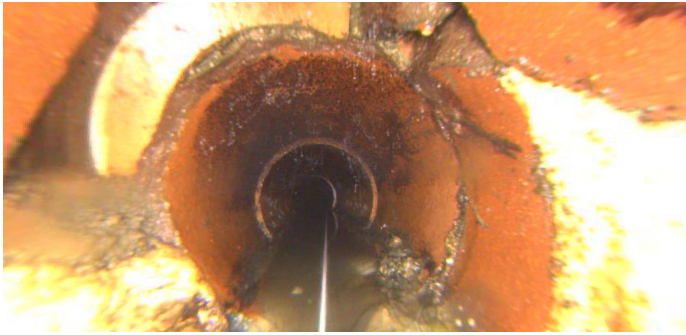
Code: **RFB**
Description: **Roots Fine Barrel**

Distance (ft): **163.8**
Structural Grade: **0**
O&M Grade: **2**
Clock Start/From: **10**
Clock To:
1st Value:
2nd Value:
Value Percent:
Continuous Index:
Within 8" of Joint: **NO**
Remarks:

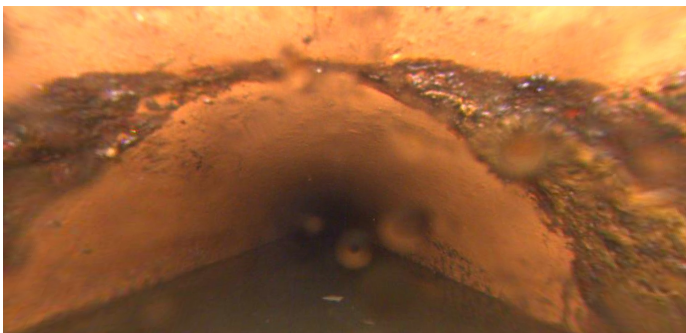
Code: **DAE**
Description: **Deposits Attached Encrustation**

Distance (ft): **191.8**
Structural Grade: **0**
O&M Grade: **2**
Clock Start/From: **8**
Clock To: **4**
1st Value:
2nd Value:
Value Percent: **5.000**
Continuous Index:
Within 8" of Joint: **YES**
Remarks:

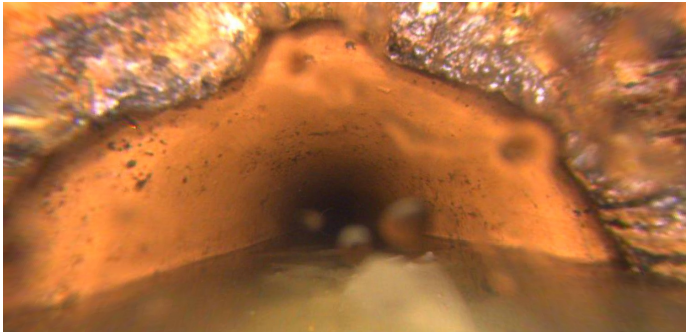
Code: **DAE**
Description: **Deposits Attached Encrustation**

Distance (ft): **231.1**
Structural Grade: **0**
O&M Grade: **2**
Clock Start/From: **8**
Clock To: **4**
1st Value:
2nd Value:
Value Percent: **10.000**
Continuous Index:
Within 8" of Joint: **YES**
Remarks:

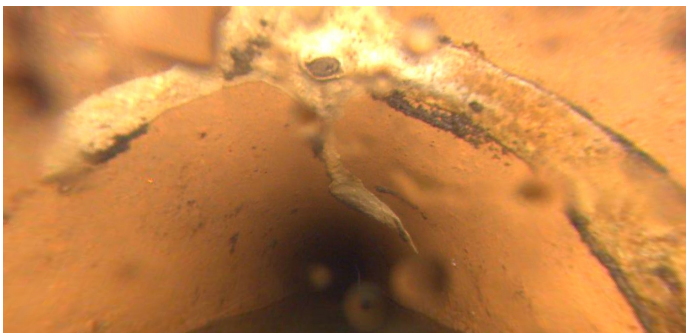
Code: **DAE**
Description: **Deposits Attached Encrustation**

Distance (ft): **256.1**
Structural Grade: **0**
O&M Grade: **2**
Clock Start/From: **8**
Clock To: **4**
1st Value:
2nd Value:
Value Percent: **5.000**
Continuous Index:
Within 8" of Joint: **YES**
Remarks:

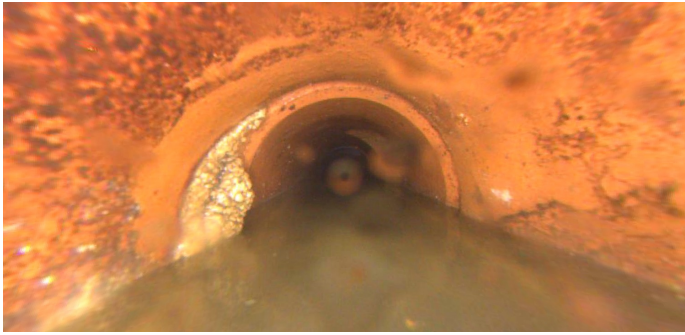
Code: **DAE**
Description: **Deposits Attached Encrustation**

Distance (ft): **270.2**
Structural Grade: **0**
O&M Grade: **2**
Clock Start/From: **9**
Clock To: **10**
1st Value:
2nd Value:
Value Percent: **5.000**
Continuous Index:
Within 8" of Joint: **YES**
Remarks:

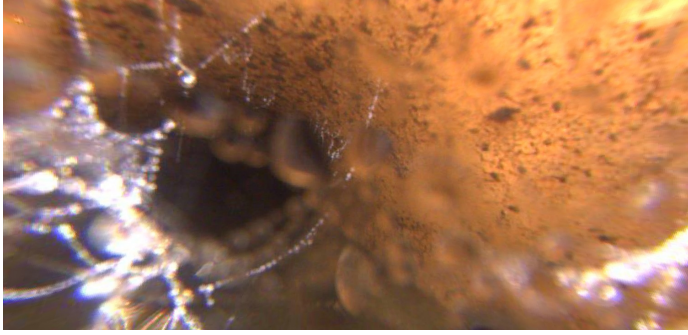
Code:	MSA
Description:	Abandoned Survey
Distance (ft):	277.8
Structural Grade:	0
O&M Grade:	0
Clock Start/From:	
Clock To:	
1st Value:	
2nd Value:	
Value Percent:	
Continuous Index:	
Within 8" of Joint:	NO
Remarks:	debris under water
