## Profile/Photo Observation Report

Street:	<b>N LAKE PARK AVE &amp; LUKES CT</b>	Flow Control:	<b>Not Controlled</b>
City:	<b>Hobart, IN</b>	Year Renewed:	
Location:	<b>Light Highway</b>	Tape/Media #:	
Purpose:	<b>Not Known</b>	Dia/Height:	<b>10"</b>
Use:	<b>Sanitary</b>	Material:	<b>VCP</b>
Drain Area:	<b>NA</b>	Lining:	
Category:	<b>NA</b>		
Comment:

Location Details:		Direction of Survey:	<b>Upstream</b>
US MH:	<b>M-604-028</b>	DS MH:	<b>M-604-030</b>
		Total Length Surveyed (ft):	<b>2.8</b>

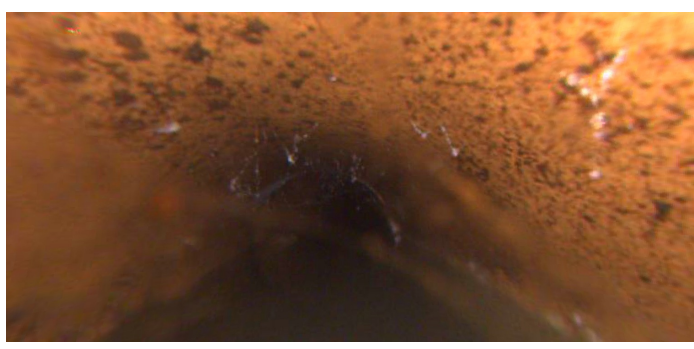
Code: **AMH**  
Description: **Manhole**

Distance (ft): **.0**  
Structural Grade: **0**  
O&M Grade: **0**  
Clock Start/From:  
Clock To:  
1st Value:  
2nd Value:  
Value Percent:  
Continuous Index:  
Within 8" of Joint: **NO**  
Remarks: **M-604-028**

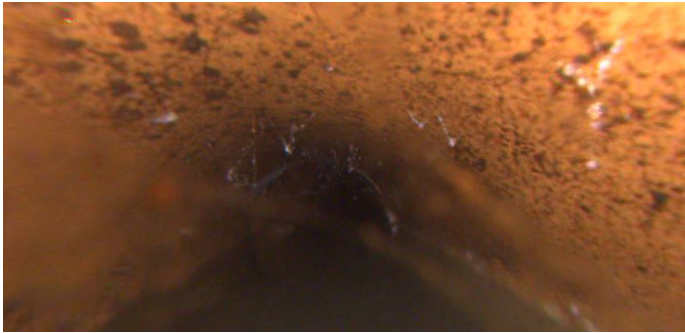
Code:	<b>MWL</b>
Description:	<b>Water Level</b>

Distance (ft):	<b>.0</b>
Structural Grade:	<b>0</b>
O&M Grade:	<b>0</b>
Clock Start/From:	
Clock To:	
1st Value:	
2nd Value:	
Value Percent:	<b>20.000</b>
Continuous Index:	
Within 8" of Joint:	<b>NO</b>
Remarks:

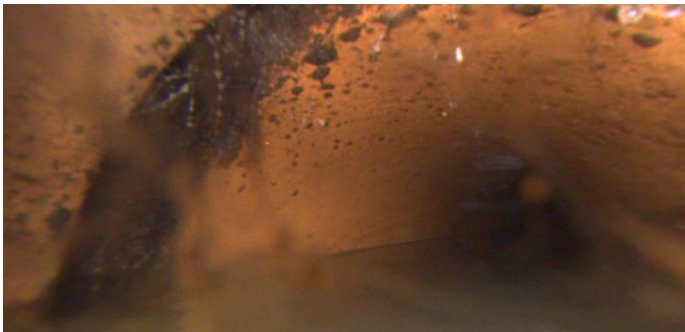
Code:	<b>RFJ</b>
Description:	<b>Roots Fine Joint</b>

Distance (ft):	<b>2.2</b>
Structural Grade:	<b>0</b>
O&M Grade:	<b>1</b>
Clock Start/From:	<b>8</b>
Clock To:	<b>9</b>
1st Value:	
2nd Value:	
Value Percent:	
Continuous Index:	
Within 8" of Joint:	<b>YES</b>
Remarks:

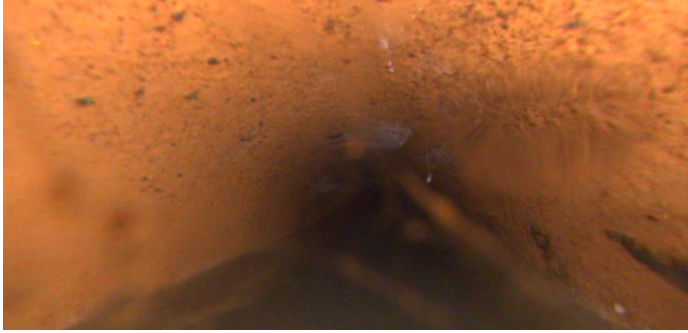
Code:	<b>MSA</b>
Description:	<b>Abandoned Survey</b>
Distance (ft):	<b>2.8</b>
Structural Grade:	<b>0</b>
O&M Grade:	<b>0</b>
Clock Start/From:	
Clock To:	
1st Value:	
2nd Value:	
Value Percent:	
Continuous Index:	
Within 8" of Joint:	<b>NO</b>
Remarks:	<b>debris under water</b>
