Profile/Photo Observation Report

Street:	Summerlin	Flow Control:	Not Controlled
City:	Hobart, IN	Year Renewed:	
Location:	Light Highway	Tape/Media #:	
Purpose:	Not Known	Dia/Height:	10"
Use:	Sanitary	Material:	VCP
Drain Area:	NA	Lining:	
Category:	NA		
Comment:

Location Details:		Direction of Survey:	Upstream
US MH:	M-604-028	DS MH:	M-604-030
		Total Length Surveyed (ft):	2.8

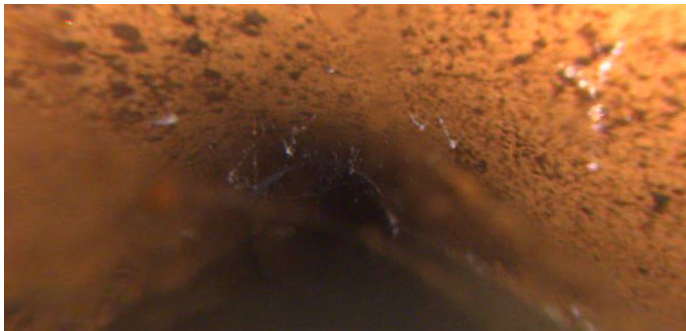
Code: **AMH**
Description: **Manhole**

Distance (ft): **.0**
Structural Grade: **0**
O&M Grade: **0**
Clock Start/From:
Clock To:
1st Value:
2nd Value:
Value Percent:
Continuous Index:
Within 8" of Joint: **NO**
Remarks: **M-604-028**

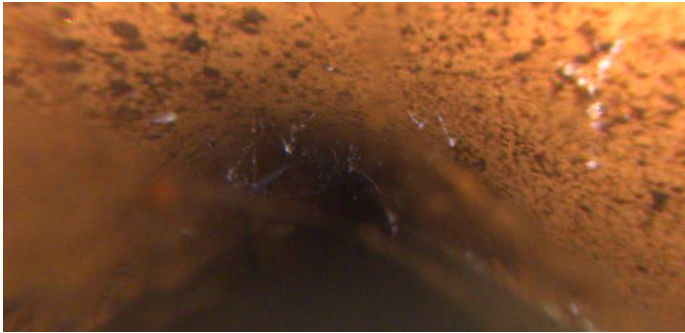
Code:	MWL
Description:	Water Level

Distance (ft):	.0
Structural Grade:	0
O&M Grade:	0
Clock Start/From:	
Clock To:	
1st Value:	
2nd Value:	
Value Percent:	20.000
Continuous Index:	
Within 8" of Joint:	NO
Remarks:

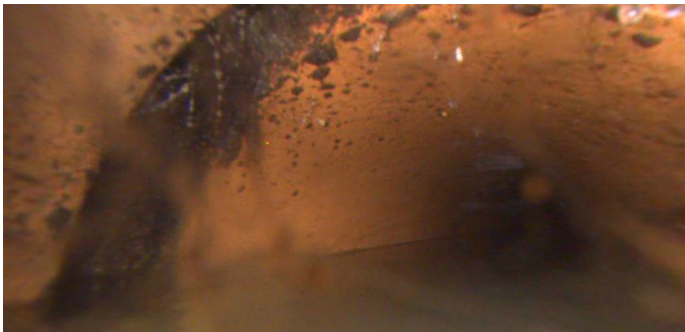
Code:	RFJ
Description:	Roots Fine Joint

Distance (ft):	2.2
Structural Grade:	0
O&M Grade:	1
Clock Start/From:	8
Clock To:	9
1st Value:	
2nd Value:	
Value Percent:	
Continuous Index:	
Within 8" of Joint:	YES
Remarks:

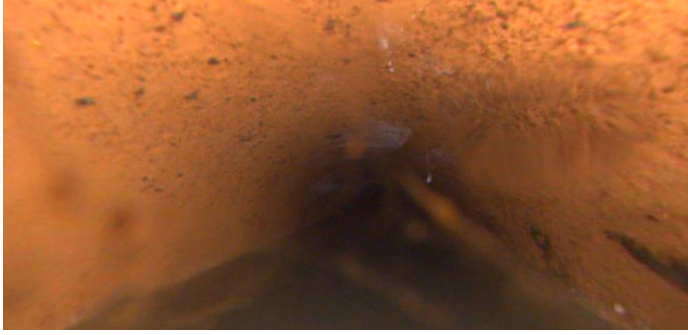
Code:	MSA
Description:	Abandoned Survey
Distance (ft):	2.8
Structural Grade:	0
O&M Grade:	0
Clock Start/From:	
Clock To:	
1st Value:	
2nd Value:	
Value Percent:	
Continuous Index:	
Within 8" of Joint:	NO
Remarks:	debris under water
