Profile/Photo Observation Report

Street:	N LAKE PARK AVE & LUKES CT	Flow Control:	Not Controlled
City:	Hobart, IN	Year Renewed:	
Location:	Light Highway	Tape/Media #:	
Purpose:	Not Known	Dia/Height:	10"
Use:	Sanitary	Material:	VCP
Drain Area:	NA	Lining:	
Category:	NA		
Comment:

Location Details:		Direction of Survey:	Downstream
US MH:	M-604-030	DS MH:	M-604-032
		Total Length Surveyed (ft):	16.4

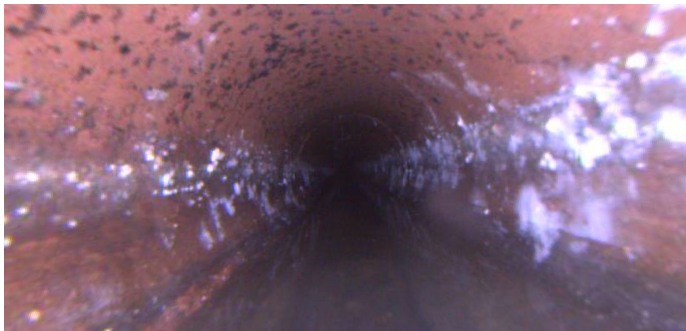
Code: **AMH**
Description: **Manhole**

Distance (ft): **.0**
Structural Grade: **0**
O&M Grade: **0**
Clock Start/From:
Clock To:
1st Value:
2nd Value:
Value Percent:
Continuous Index:
Within 8" of Joint: **NO**
Remarks: **M-604-030**

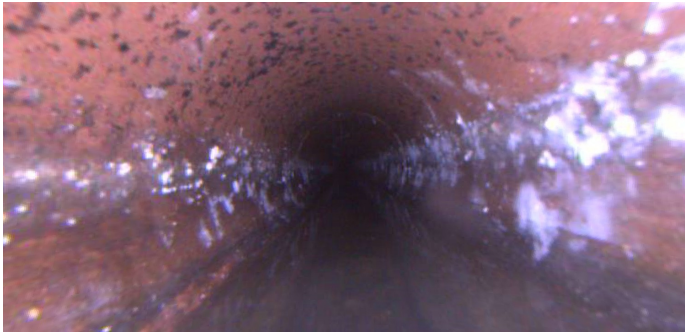
Code:	MWL
Description:	Water Level

Distance (ft):	.0
Structural Grade:	0
O&M Grade:	0
Clock Start/From:	
Clock To:	
1st Value:	
2nd Value:	
Value Percent:	5.000
Continuous Index:	
Within 8" of Joint:	NO
Remarks:

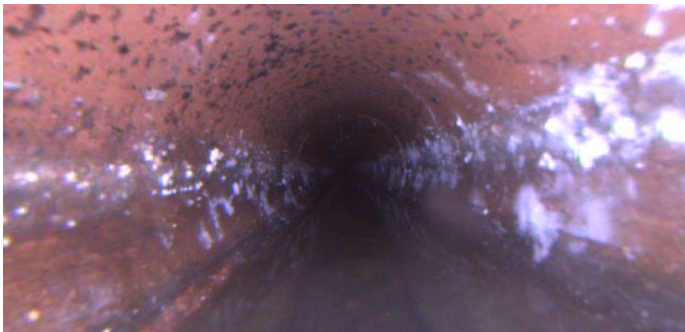
Code:	MWL
Description:	Water Level

Distance (ft):	.0
Structural Grade:	0
O&M Grade:	0
Clock Start/From:	
Clock To:	
1st Value:	
2nd Value:	
Value Percent:	20.000
Continuous Index:	
Within 8" of Joint:	NO
Remarks:

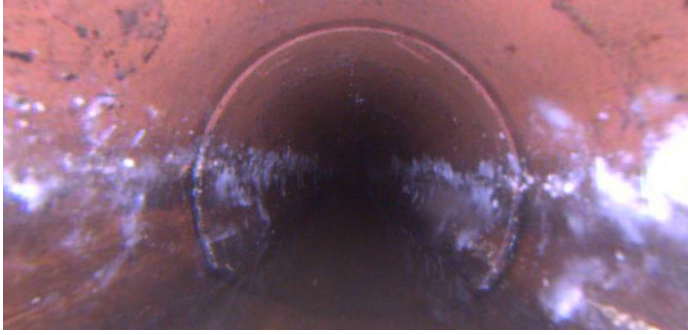
Code:	MSA
Description:	Abandoned Survey
Distance (ft):	16.4
Structural Grade:	0
O&M Grade:	0
Clock Start/From:	
Clock To:	
1st Value:	
2nd Value:	
Value Percent:	
Continuous Index:	
Within 8" of Joint:	NO
Remarks:	UNKNOWN
