Profile/Photo Observation Report

| Street: | N LAKE PARK AVE & NERINGA LN | Flow Control: | Not Controlled |
| City: | Hobart, IN | Year Renewed: | |

| US MH: | M-604-033 | DS MH: | M-604-034 |

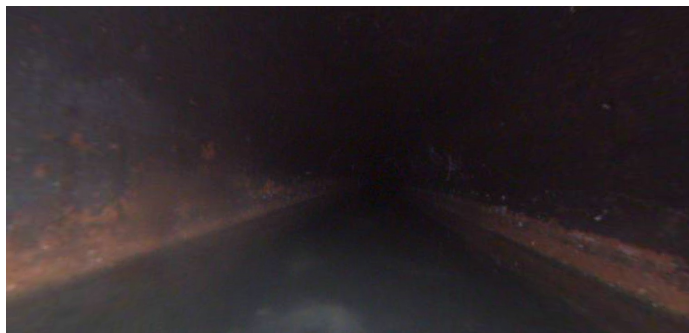
Code: **AMH**
Description: **Manhole**

Distance (ft): **.0**
Structural Grade: **0**
O&M Grade: **0**
Clock Start/From:
Clock To:
1st Value:
2nd Value:
Value Percent:
Continuous Index:
Within 8" of Joint: **NO**
Remarks: **M-604-033**

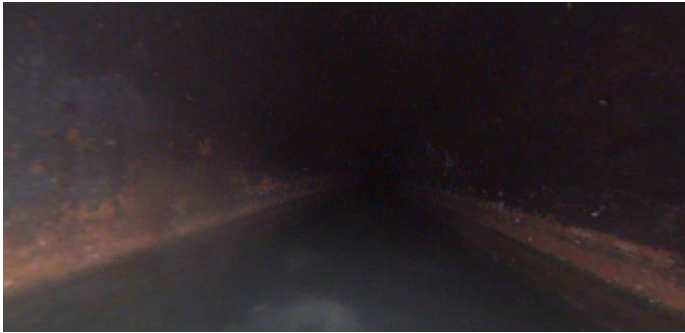
| Code: | MWL |
| Description: | Water Level |

| Value Percent: | 30.000 |

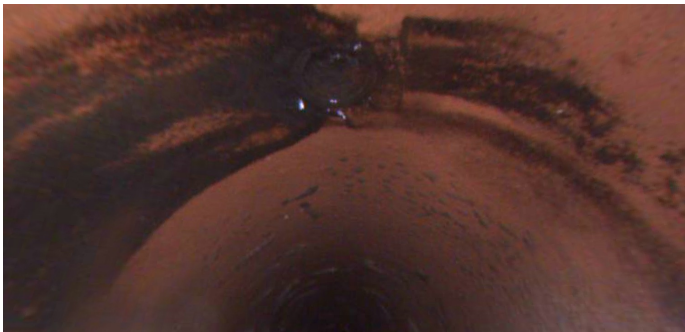
| Code: | TBA |
| Description: | Tap Break-in Active |

| Distance (ft): | 48.7 |
| Clock Start/From: | 12 |
| 1st Value: | 2.000 |

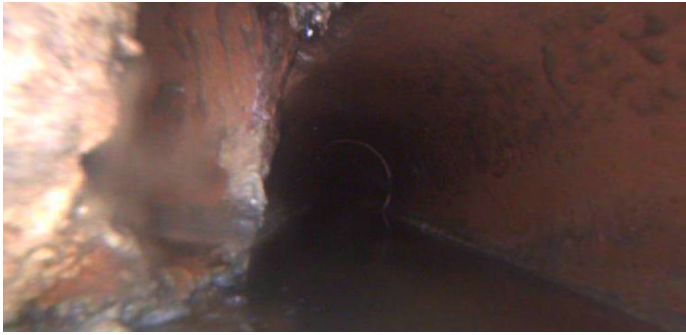
| | Position | Code | Observation | Video (sec) | Grade |
|--|---|---|---|---|---|
| | 134.1 | TBI | Tap Break-in Intruding | 313 | M 2 |

Code: **TBI**
Description: **Tap Break-in Intruding**

Distance (ft): **134.1**
Structural Grade: **0**
O&M Grade: **2**
Clock Start/From: **9**
Clock To:
1st Value: **4.000**
2nd Value: **2.000**
Value Percent:
Continuous Index:
Within 8" of Joint:
Remarks:

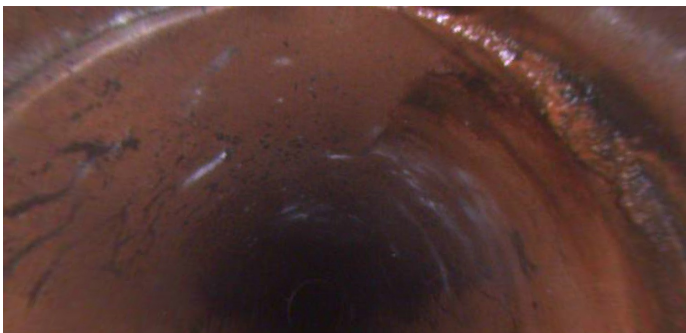
| | Position | Code | Observation | Video (sec) | Grade |
|--|---|---|---|---|---|
| | 197.0 | IW | Infil Weeper | 451 | M 2 |

Code: **IW**
Description: **Infil Weeper**

Distance (ft): **197.0**
Structural Grade: **0**
O&M Grade: **2**
Clock Start/From: **12**
Clock To: **4**
1st Value:
2nd Value:
Value Percent:
Continuous Index:
Within 8" of Joint: **YES**
Remarks:

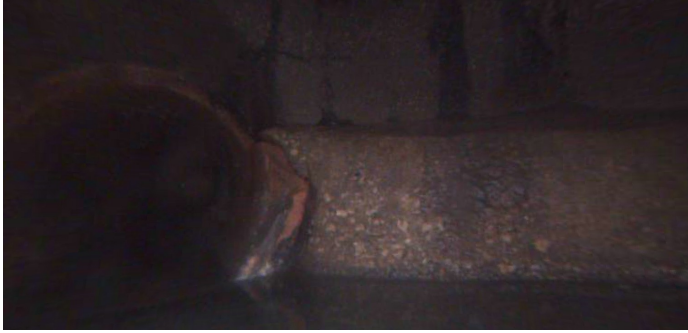
| Code: | AMH |
| Description: | Manhole |
| Distance (ft): | 214.4 |
| Remarks: | M-604-034 |
