Profile/Photo Observation Report

Date:	04/23/2018	Weather:		Coding:	PACP 6.0
Pipe Length (ft):	149.1	Owner:	NA	Pre Clean:	Not Known
P.O.#:		Surveyor:	Jen Costello	PSR:	P-604-035-034
Customer:		Clean Date:	01/01/1900	Shape:	C

Street:	HAMPSHIRE PARK APARTMENTS	Flow Control:	Not Controlled
City:	Hobart, IN	Year Renewed:	
Location:	Light Highway	Tape/Media #:	
Purpose:	Not Known	Dia/Height:	12"
Use:	Sanitary	Material:	VCP
Drain Area:	NA	Lining:	
Category:	NA		
Comment:

Location Details:		Direction of Survey:	Downstream
US MH:	M-604-034	DS MH:	M-604-035
		Total Length Surveyed (ft):	142.6

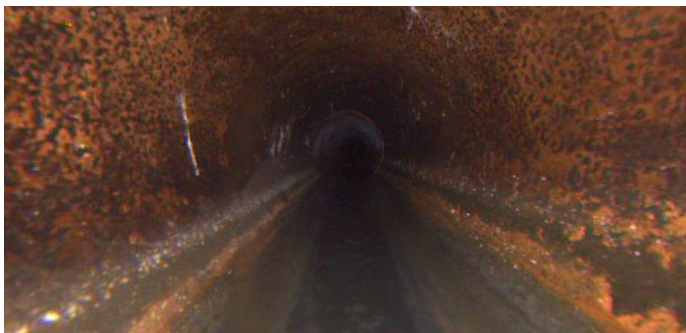
Code: **AMH**
Description: **Manhole**

Distance (ft): **.0**
Structural Grade: **0**
O&M Grade: **0**
Clock Start/From:
Clock To:
1st Value:
2nd Value:
Value Percent:
Continuous Index:
Within 8" of Joint: **NO**
Remarks: **M-604-034**

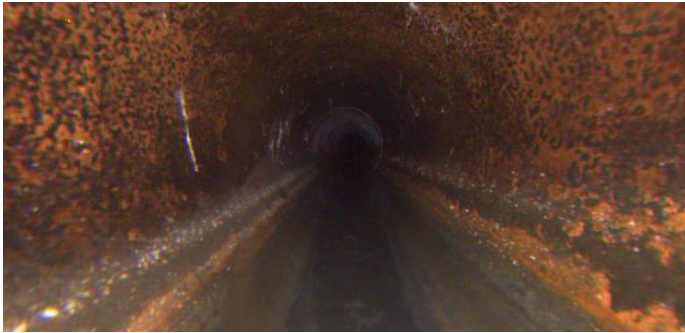
Code:	MWL
Description:	Water Level

Distance (ft):	.0
Structural Grade:	0
O&M Grade:	0
Clock Start/From:	
Clock To:	
1st Value:	
2nd Value:	
Value Percent:	5.000
Continuous Index:	
Within 8" of Joint:	NO
Remarks:

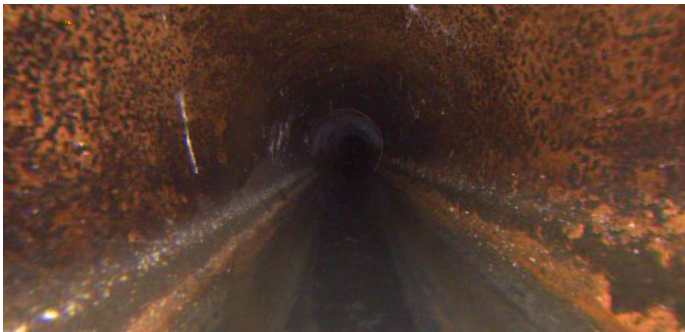
Code:	DAGS
Description:	Deposits Attached Grease

Distance (ft):	.0
Structural Grade:	0
O&M Grade:	2
Clock Start/From:	8
Clock To:	4
1st Value:	
2nd Value:	
Value Percent:	5.000
Continuous Index:	S01
Within 8" of Joint:	NO
Remarks:

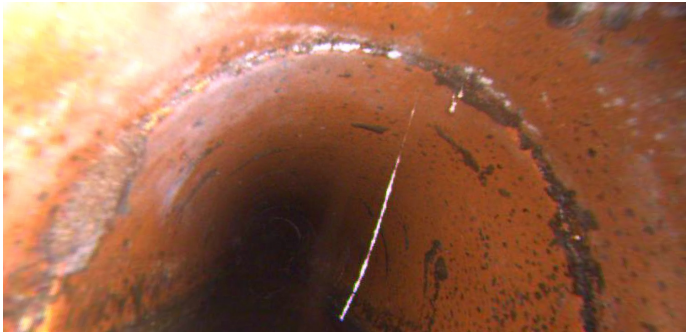
Code: **RFJ**
Description: **Roots Fine Joint**

Distance (ft): **10.1**
Structural Grade: **0**
O&M Grade: **1**
Clock Start/From: **12**
Clock To:
1st Value:
2nd Value:
Value Percent:
Continuous Index:
Within 8" of Joint: **YES**
Remarks:

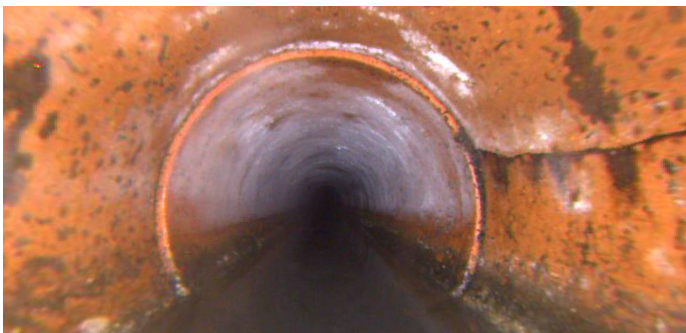
Code: **FL**
Description: **Fracture Longitudinal**

Distance (ft): **21.7**
Structural Grade: **3**
O&M Grade: **0**
Clock Start/From: **3**
Clock To:
1st Value:
2nd Value:
Value Percent:
Continuous Index:
Within 8" of Joint: **YES**
Remarks:

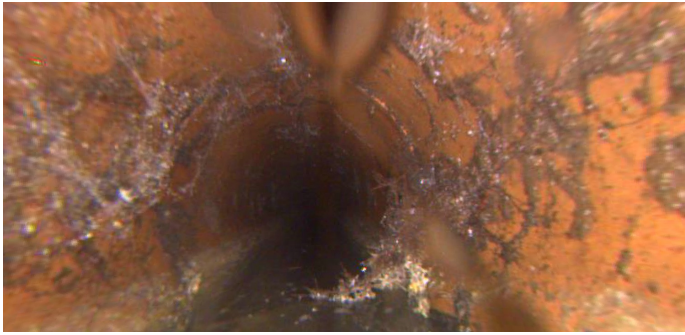
Code: **RMJ**
Description: **Roots Medium Joint**

Distance (ft): **98.7**
Structural Grade: **0**
O&M Grade: **3**
Clock Start/From: **8**
Clock To: **4**
1st Value:
2nd Value:
Value Percent: **10.000**
Continuous Index:
Within 8" of Joint: **YES**
Remarks:

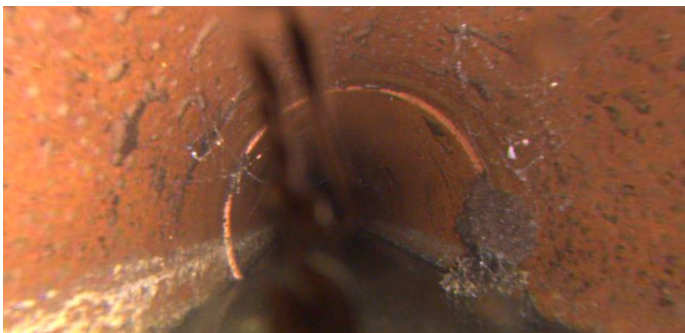
Code: **RMJ**
Description: **Roots Medium Joint**

Distance (ft): **110.7**
Structural Grade: **0**
O&M Grade: **3**
Clock Start/From: **3**
Clock To: **4**
1st Value:
2nd Value:
Value Percent: **5.000**
Continuous Index:
Within 8" of Joint: **YES**
Remarks:

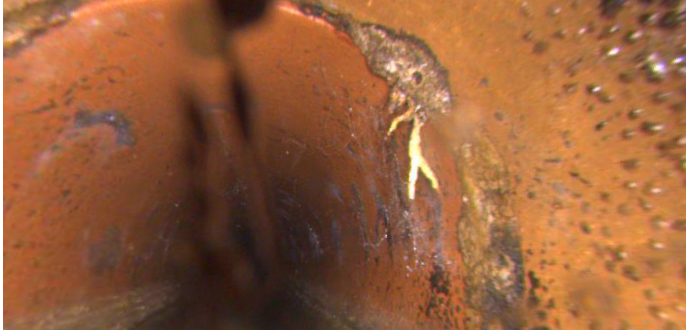
Code: **RFJ**
Description: **Roots Fine Joint**

Distance (ft): **123.1**
Structural Grade: **0**
O&M Grade: **1**
Clock Start/From: **2**
Clock To:
1st Value:
2nd Value:
Value Percent:
Continuous Index:
Within 8" of Joint: **YES**
Remarks:

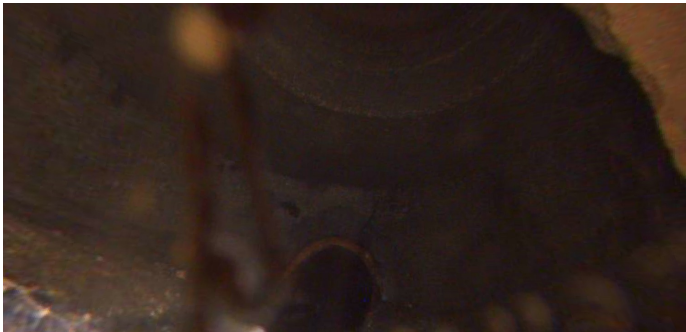
Code: **DAGS**
Description: **Deposits Attached Grease**

Distance (ft): **140.7**
Structural Grade: **0**
O&M Grade: **2**
Clock Start/From: **8**
Clock To: **4**
1st Value:
2nd Value:
Value Percent: **5.000**
Continuous Index: **F01**
Within 8" of Joint: **NO**
Remarks:

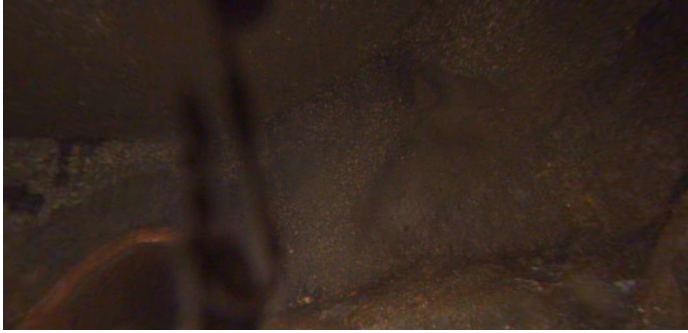
Code:	AMH
Description:	Manhole
Distance (ft):	142.6
Structural Grade:	0
O&M Grade:	0
Clock Start/From:	
Clock To:	
1st Value:	
2nd Value:	
Value Percent:	
Continuous Index:	
Within 8" of Joint:	NO
Remarks:	M-604-035
