Profile/Photo Observation Report

Date:	04/23/2018	Weather:		Coding:	PACP 6.0
Pipe Length (ft):	149.1	Owner:	NA	Pre Clean:	Not Known
P.O.#:		Surveyor:	Jen Costello	PSR:	P-604-035-034
Customer:		Clean Date:	01/01/1900	Shape:	C

Location Details:		Direction of Survey:	Downstream
US MH:	M-604-034	DS MH:	M-604-035
		Total Length Surveyed (ft):	142.6

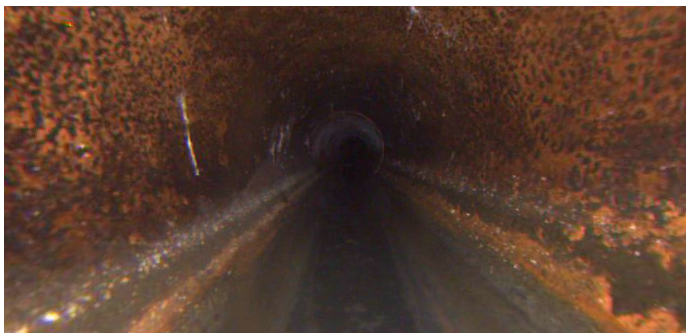
Code: **AMH**
Description: **Manhole**

Distance (ft): **.0**
Structural Grade: **0**
O&M Grade: **0**
Clock Start/From:
Clock To:
1st Value:
2nd Value:
Value Percent:
Continuous Index:
Within 8" of Joint: **NO**
Remarks: **M-604-034**

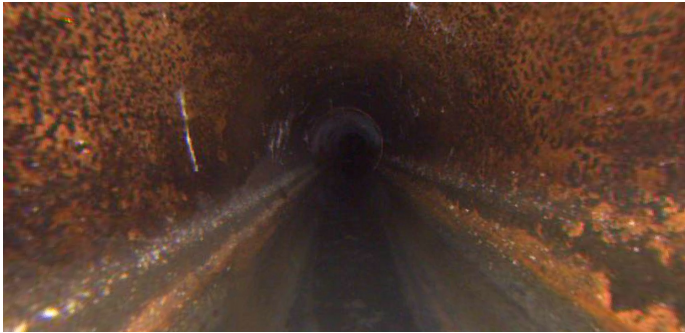
Code:	MWL
Description:	Water Level

Distance (ft):	.0
Structural Grade:	0
O&M Grade:	0
Clock Start/From:	
Clock To:	
1st Value:	
2nd Value:	
Value Percent:	5.000
Continuous Index:	
Within 8" of Joint:	NO
Remarks:

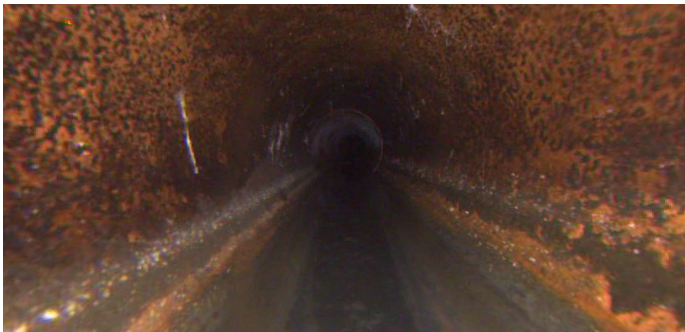
Code:	DAGS
Description:	Deposits Attached Grease

Distance (ft):	.0
Structural Grade:	0
O&M Grade:	2
Clock Start/From:	8
Clock To:	4
1st Value:	
2nd Value:	
Value Percent:	5.000
Continuous Index:	S01
Within 8" of Joint:	NO
Remarks:

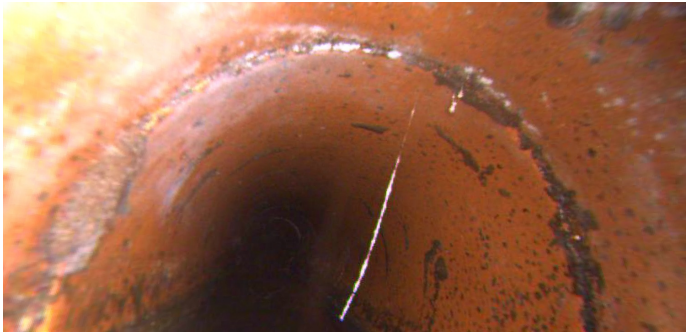
Code: **RFJ**
Description: **Roots Fine Joint**

Distance (ft): **10.1**
Structural Grade: **0**
O&M Grade: **1**
Clock Start/From: **12**
Clock To:
1st Value:
2nd Value:
Value Percent:
Continuous Index:
Within 8" of Joint: **YES**
Remarks:

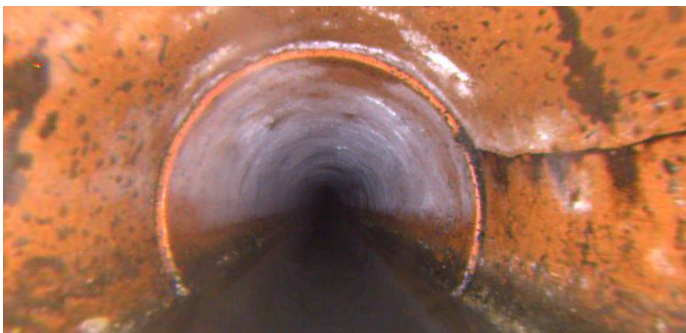
Code: **FL**
Description: **Fracture Longitudinal**

Distance (ft): **21.7**
Structural Grade: **3**
O&M Grade: **0**
Clock Start/From: **3**
Clock To:
1st Value:
2nd Value:
Value Percent:
Continuous Index:
Within 8" of Joint: **YES**
Remarks:

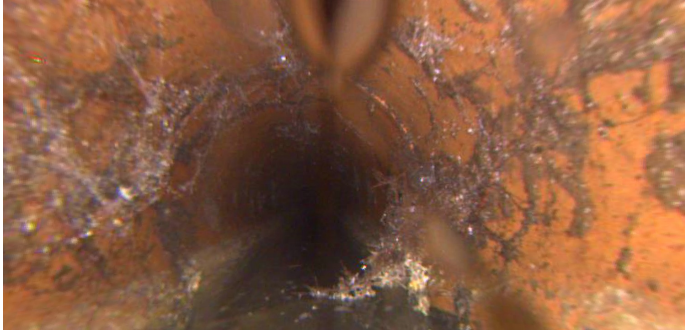
Code: **RMJ**
Description: **Roots Medium Joint**

Distance (ft): **98.7**
Structural Grade: **0**
O&M Grade: **3**
Clock Start/From: **8**
Clock To: **4**
1st Value:
2nd Value:
Value Percent: **10.000**
Continuous Index:
Within 8" of Joint: **YES**
Remarks:

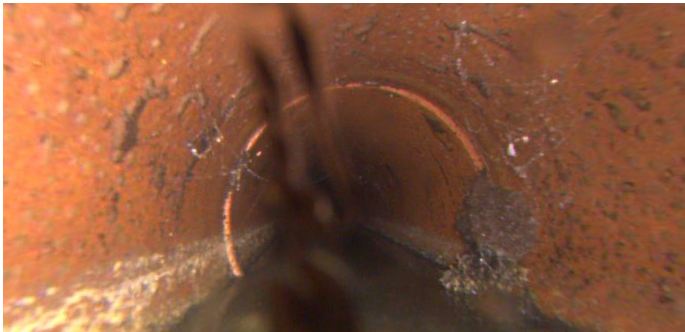
Code: **RMJ**
Description: **Roots Medium Joint**

Distance (ft): **110.7**
Structural Grade: **0**
O&M Grade: **3**
Clock Start/From: **3**
Clock To: **4**
1st Value:
2nd Value:
Value Percent: **5.000**
Continuous Index:
Within 8" of Joint: **YES**
Remarks:

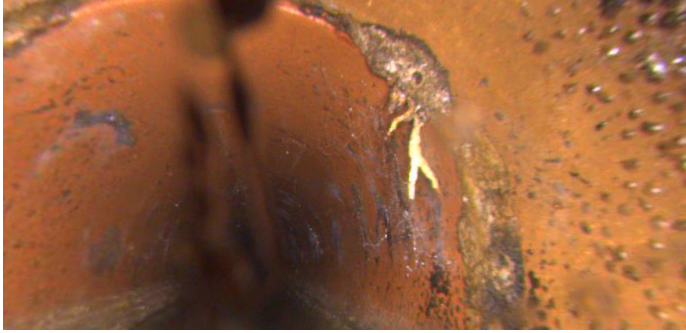
Code: **RFJ**
Description: **Roots Fine Joint**

Distance (ft): **123.1**
Structural Grade: **0**
O&M Grade: **1**
Clock Start/From: **2**
Clock To:
1st Value:
2nd Value:
Value Percent:
Continuous Index:
Within 8" of Joint: **YES**
Remarks:

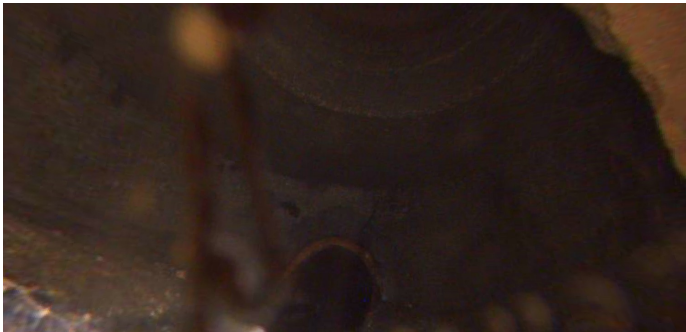
Code: **DAGS**
Description: **Deposits Attached Grease**

Distance (ft): **140.7**
Structural Grade: **0**
O&M Grade: **2**
Clock Start/From: **8**
Clock To: **4**
1st Value:
2nd Value:
Value Percent: **5.000**
Continuous Index: **F01**
Within 8" of Joint: **NO**
Remarks:

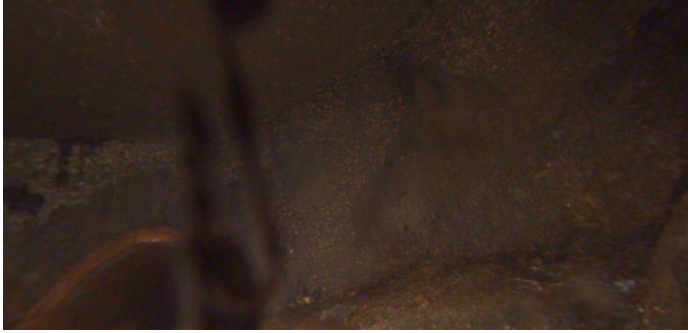
Code:	AMH
Description:	Manhole
Distance (ft):	142.6
Structural Grade:	0
O&M Grade:	0
Clock Start/From:	
Clock To:	
1st Value:	
2nd Value:	
Value Percent:	
Continuous Index:	
Within 8" of Joint:	NO
Remarks:	M-604-035
