Profile/Photo Observation Report

Date:	04/23/2018	Weather:		Coding:	PACP 6.0
Pipe Length (ft):	285.9	Owner:	NA	Pre Clean:	Not Known
P.O.#:		Surveyor:	Jen Costello	PSR:	P-604-039-034
Customer:		Clean Date:	01/01/1900	Shape:	C

Street:	HAMPSHIRE PARK APARTMENTS	Flow Control:	Not Controlled
City:	Hobart, IN	Year Renewed:	
Location:	Light Highway	Tape/Media #:	
Purpose:	Not Known	Dia/Height:	12"
Use:	Sanitary	Material:	VCP
Drain Area:	NA	Lining:	
Category:	NA		
Comment:

Location Details:		Direction of Survey:	Downstream
US MH:	M-604-034	DS MH:	M-604-039
		Total Length Surveyed (ft):	283.8

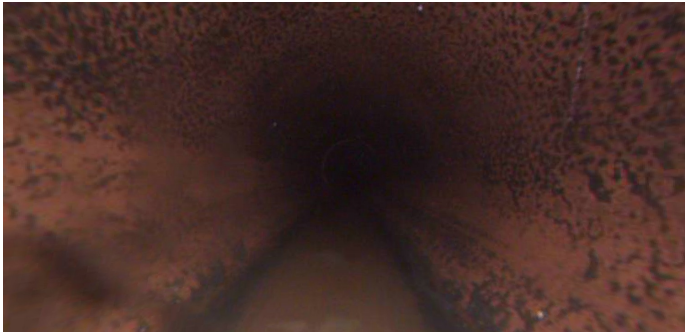
Code:	MWL
Description:	Water Level

Distance (ft):	.0
Structural Grade:	0
O&M Grade:	0
Clock Start/From:	
Clock To:	
1st Value:	
2nd Value:	
Value Percent:	5.000
Continuous Index:	
Within 8" of Joint:	NO
Remarks:

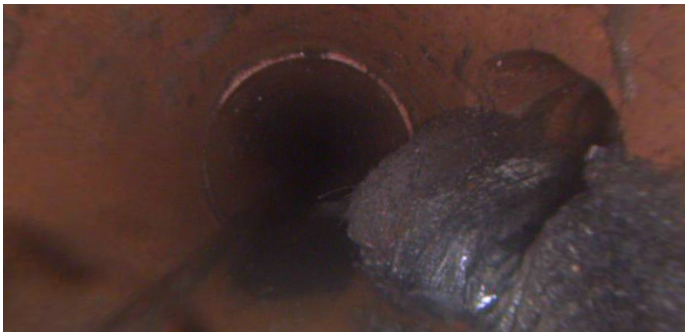
Code:	TFD
Description:	Tap Factory Defective

Distance (ft):	101.6
Structural Grade:	0
O&M Grade:	2
Clock Start/From:	3
Clock To:	
1st Value:	4.000
2nd Value:	
Value Percent:	
Continuous Index:	
Within 8" of Joint:	
Remarks:	Roots

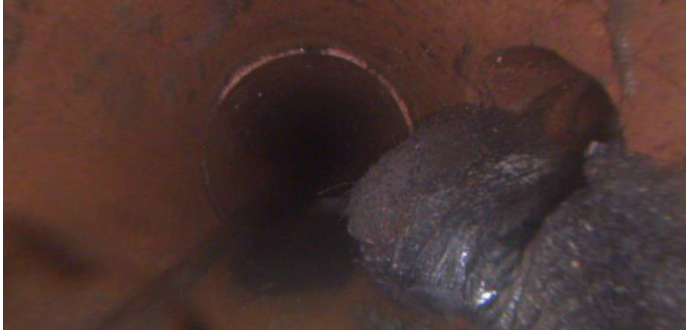
Code: **RML**
Description: **Roots Medium Lateral**

Distance (ft): **101.6**
Structural Grade: **0**
O&M Grade: **3**
Clock Start/From: **3**
Clock To: **5**
1st Value:
2nd Value:
Value Percent: **20.000**
Continuous Index:
Within 8" of Joint: **NO**
Remarks:

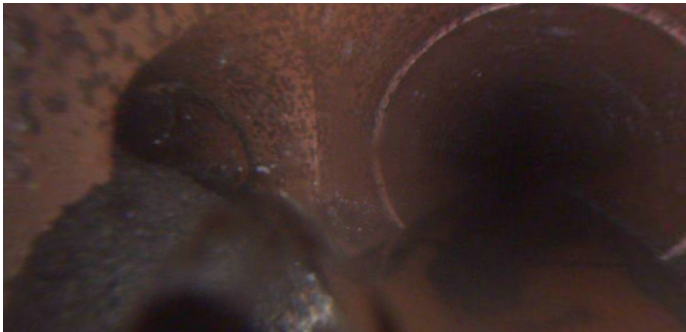
Code: **TFD**
Description: **Tap Factory Defective**

Distance (ft): **121.7**
Structural Grade: **0**
O&M Grade: **2**
Clock Start/From: **9**
Clock To:
1st Value: **4.000**
2nd Value:
Value Percent:
Continuous Index:
Within 8" of Joint:
Remarks: **roots**

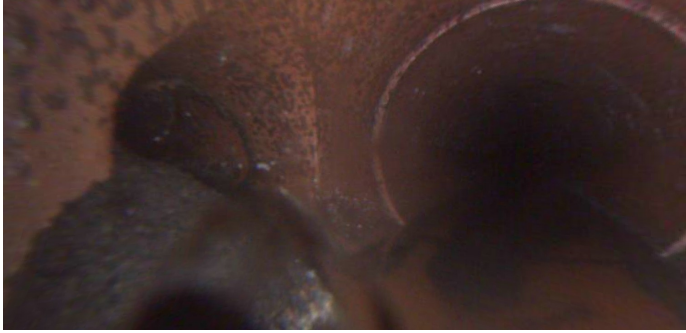
Code: **RML**
Description: **Roots Medium Lateral**

Distance (ft): **121.7**
Structural Grade: **0**
O&M Grade: **3**
Clock Start/From: **7**
Clock To: **9**
1st Value:
2nd Value:
Value Percent: **10.000**
Continuous Index:
Within 8" of Joint: **NO**
Remarks:

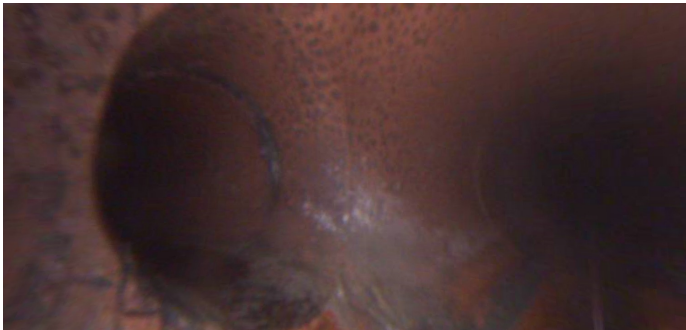
Code: **TFA**
Description: **Tap Factory Active**

Distance (ft): **172.4**
Structural Grade: **0**
O&M Grade: **0**
Clock Start/From: **3**
Clock To:
1st Value: **4.000**
2nd Value:
Value Percent:
Continuous Index:
Within 8" of Joint:
Remarks:

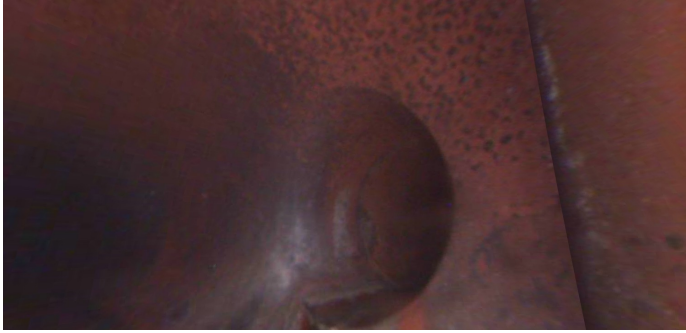
Code: **TFA**
Description: **Tap Factory Active**

Distance (ft): **192.4**
Structural Grade: **0**
O&M Grade: **0**
Clock Start/From: **9**
Clock To:
1st Value: **4.000**
2nd Value:
Value Percent:
Continuous Index:
Within 8" of Joint:
Remarks:

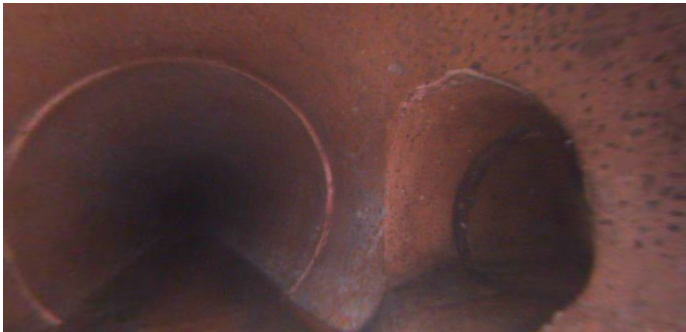
Code: **TFA**
Description: **Tap Factory Active**

Distance (ft): **235.5**
Structural Grade: **0**
O&M Grade: **0**
Clock Start/From: **3**
Clock To:
1st Value: **4.000**
2nd Value:
Value Percent:
Continuous Index:
Within 8" of Joint:
Remarks:

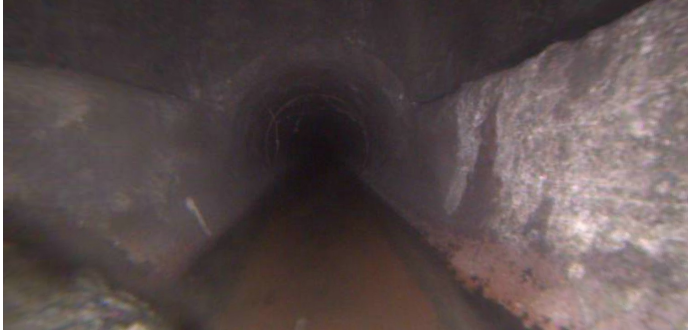
Code:	AMH
Description:	Manhole
Distance (ft):	283.8
Structural Grade:	0
O&M Grade:	0
Clock Start/From:	
Clock To:	
1st Value:	
2nd Value:	
Value Percent:	
Continuous Index:	
Within 8" of Joint:	NO
Remarks:	M-604-039
