Profile/Photo Observation Report

Date:	04/23/2018	Weather:		Coding:	PACP 6.0
Pipe Length (ft):	223.9	Owner:	NA	Pre Clean:	Not Known
P.O.#:		Surveyor:	Jen Costello	PSR:	P-604-036-035
Customer:		Clean Date:	01/01/1900	Shape:	C

Street:	HAMPSHIRE PARK APARTMENTS	Flow Control:	Not Controlled
City:	Hobart, IN	Year Renewed:	
Location:	Light Highway	Tape/Media #:	
Purpose:	Not Known	Dia/Height:	12"
Use:	Sanitary	Material:	VCP
Drain Area:	NA	Lining:	
Category:	NA		
Comment:

Location Details:		Direction of Survey:	Downstream
US MH:	M-604-035	DS MH:	M-604-036
		Total Length Surveyed (ft):	19.0

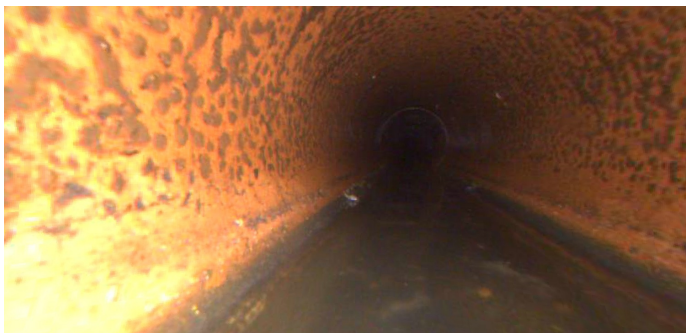
Code: **AMH**
Description: **Manhole**

Distance (ft): **.0**
Structural Grade: **0**
O&M Grade: **0**
Clock Start/From:
Clock To:
1st Value:
2nd Value:
Value Percent:
Continuous Index:
Within 8" of Joint: **NO**
Remarks: **M-604-035**

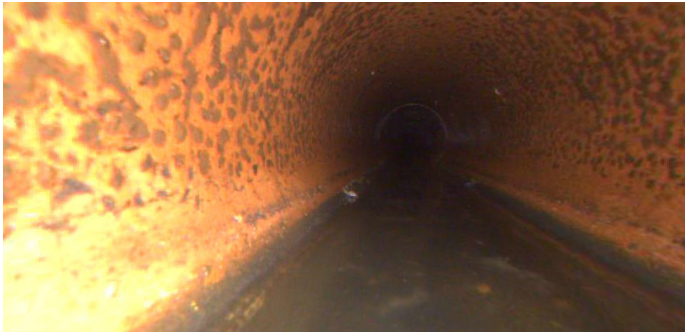
Code:	MWL
Description:	Water Level

Distance (ft):	.0
Structural Grade:	0
O&M Grade:	0
Clock Start/From:	
Clock To:	
1st Value:	
2nd Value:	
Value Percent:	10.000
Continuous Index:	
Within 8" of Joint:	NO
Remarks:

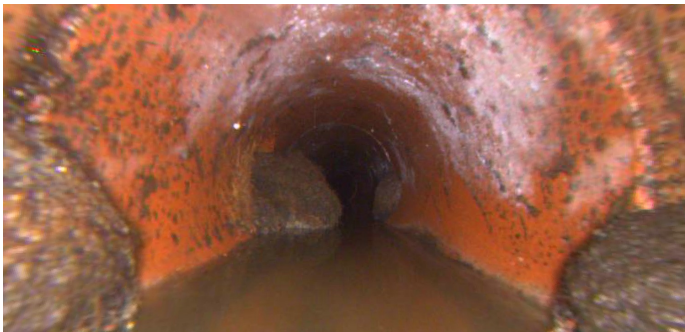
Code:	DAZ
Description:	Deposits Attached Other

Distance (ft):	16.4
Structural Grade:	0
O&M Grade:	2
Clock Start/From:	8
Clock To:	4
1st Value:	
2nd Value:	
Value Percent:	10.000
Continuous Index:	
Within 8" of Joint:	YES
Remarks:

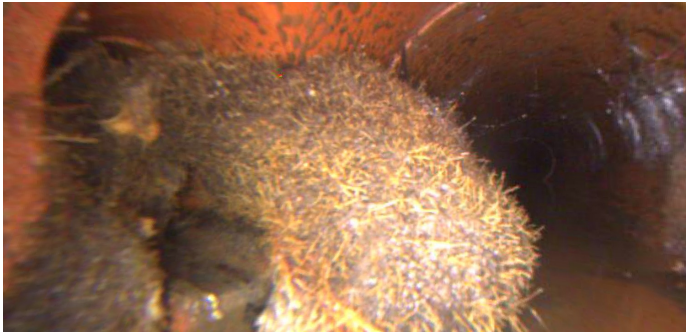
Code: **TFD**
Description: **Tap Factory Defective**

Distance (ft): **17.9**
Structural Grade: **0**
O&M Grade: **2**
Clock Start/From: **9**
Clock To:
1st Value: **4.000**
2nd Value:
Value Percent:
Continuous Index:
Within 8" of Joint:
Remarks: **RML**

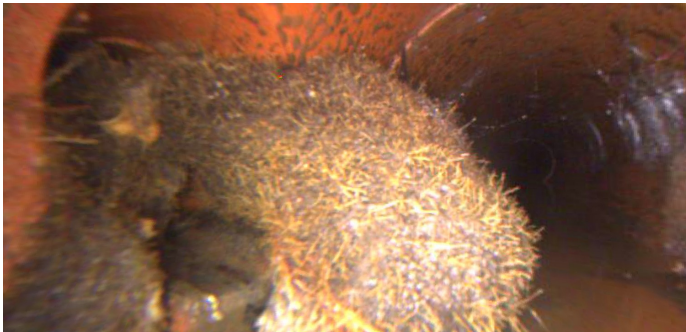
Code: **RML**
Description: **Roots Medium Lateral**

Distance (ft): **17.9**
Structural Grade: **0**
O&M Grade: **3**
Clock Start/From: **6**
Clock To: **11**
1st Value:
2nd Value:
Value Percent: **40.000**
Continuous Index:
Within 8" of Joint: **NO**
Remarks:

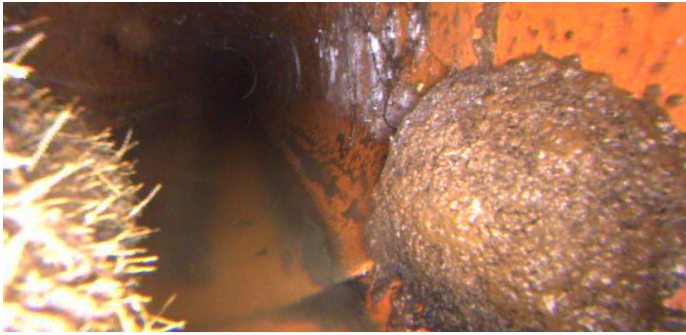
Code: **DAZ**
Description: **Deposits Attached Other**

Distance (ft): **19.0**
Structural Grade: **0**
O&M Grade: **2**
Clock Start/From: **2**
Clock To: **4**
1st Value:
2nd Value:
Value Percent: **10.000**
Continuous Index:
Within 8" of Joint: **YES**
Remarks:

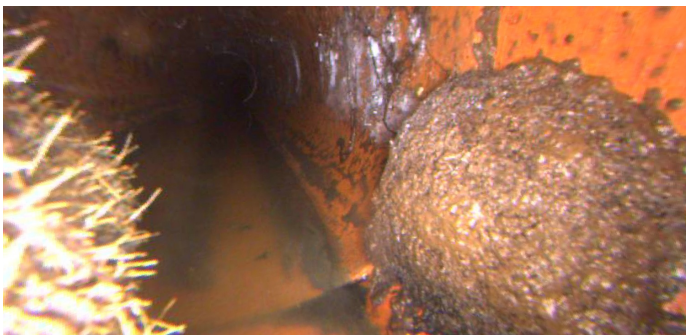
Code: **MSA**
Description: **Abandoned Survey**

Distance (ft): **19.0**
Structural Grade: **0**
O&M Grade: **0**
Clock Start/From:
Clock To:
1st Value:
2nd Value:
Value Percent:
Continuous Index:
Within 8" of Joint: **NO**
Remarks: **ROOTS**
