Profile/Photo Observation Report

Street:	Summerlin	Flow Control:	Not Controlled
City:	Hobart, IN	Year Renewed:	
Location:	Light Highway	Tape/Media #:	
Purpose:	Not Known	Dia/Height:	12"
Use:	Sanitary	Material:	VCP
Drain Area:	NA	Lining:	
Category:	NA		
Comment:

Location Details:		Direction of Survey:	Downstream
US MH:	M-604-035	DS MH:	M-604-036
		Total Length Surveyed (ft):	19.0

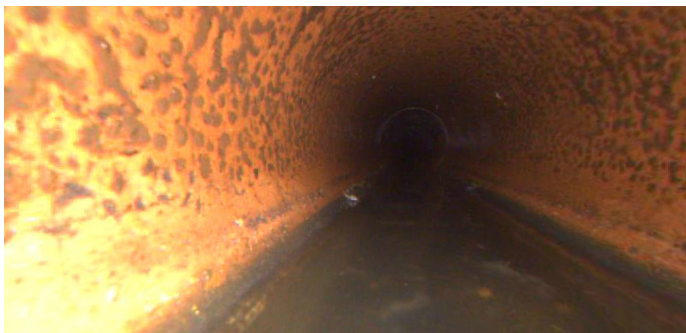
Code: **AMH**
Description: **Manhole**

Distance (ft): **.0**
Structural Grade: **0**
O&M Grade: **0**
Clock Start/From:
Clock To:
1st Value:
2nd Value:
Value Percent:
Continuous Index:
Within 8" of Joint: **NO**
Remarks: **M-604-035**

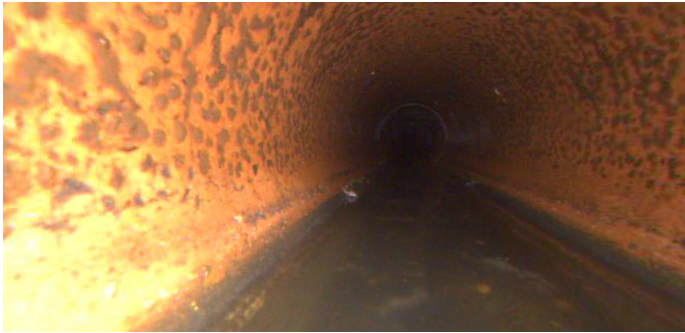
Code:	MWL
Description:	Water Level

Distance (ft):	.0
Structural Grade:	0
O&M Grade:	0
Clock Start/From:	
Clock To:	
1st Value:	
2nd Value:	
Value Percent:	10.000
Continuous Index:	
Within 8" of Joint:	NO
Remarks:

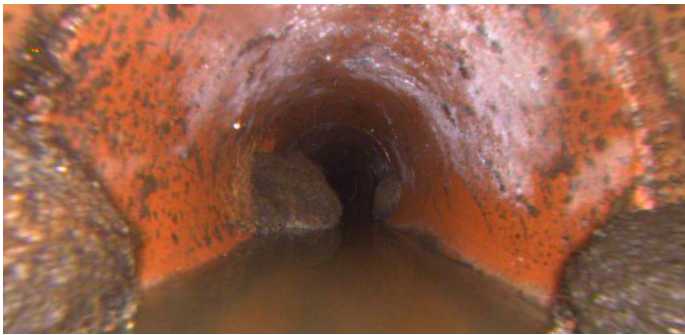
Code:	DAZ
Description:	Deposits Attached Other

Distance (ft):	16.4
Structural Grade:	0
O&M Grade:	2
Clock Start/From:	8
Clock To:	4
1st Value:	
2nd Value:	
Value Percent:	10.000
Continuous Index:	
Within 8" of Joint:	YES
Remarks:

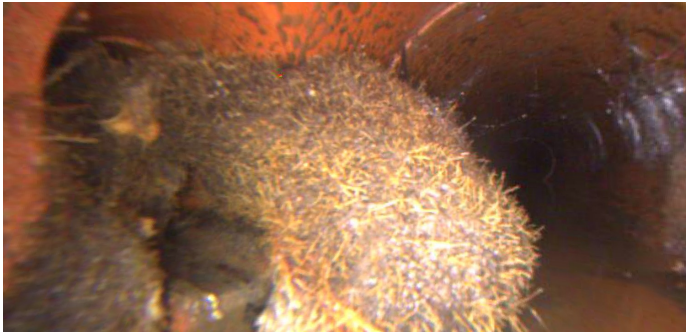
Code: **TFD**
Description: **Tap Factory Defective**

Distance (ft): **17.9**
Structural Grade: **0**
O&M Grade: **2**
Clock Start/From: **9**
Clock To:
1st Value: **4.000**
2nd Value:
Value Percent:
Continuous Index:
Within 8" of Joint:
Remarks: **RML**

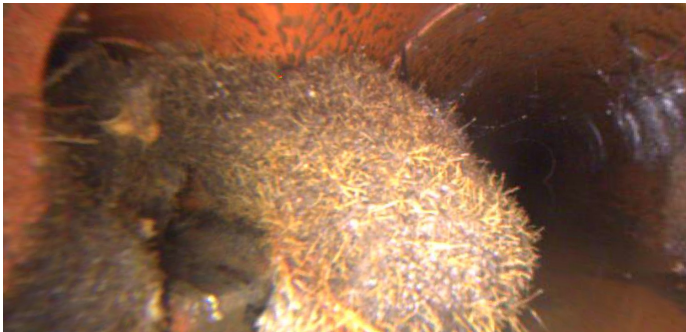
Code: **RML**
Description: **Roots Medium Lateral**

Distance (ft): **17.9**
Structural Grade: **0**
O&M Grade: **3**
Clock Start/From: **6**
Clock To: **11**
1st Value:
2nd Value:
Value Percent: **40.000**
Continuous Index:
Within 8" of Joint: **NO**
Remarks:

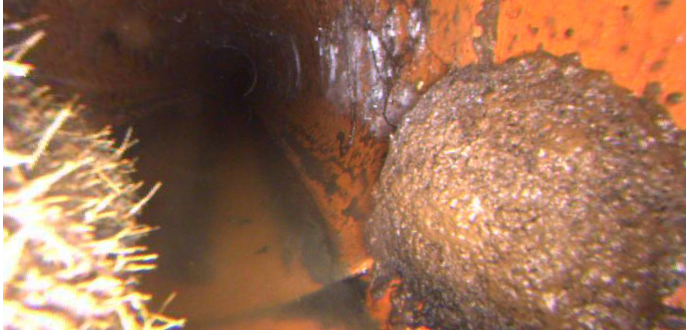
Code: **DAZ**
Description: **Deposits Attached Other**

Distance (ft): **19.0**
Structural Grade: **0**
O&M Grade: **2**
Clock Start/From: **2**
Clock To: **4**
1st Value:
2nd Value:
Value Percent: **10.000**
Continuous Index:
Within 8" of Joint: **YES**
Remarks:

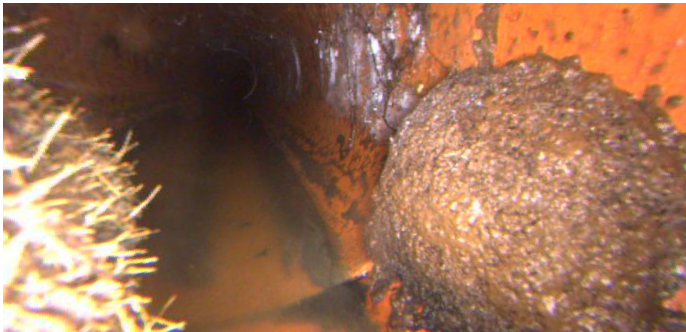
Code: **MSA**
Description: **Abandoned Survey**

Distance (ft): **19.0**
Structural Grade: **0**
O&M Grade: **0**
Clock Start/From:
Clock To:
1st Value:
2nd Value:
Value Percent:
Continuous Index:
Within 8" of Joint: **NO**
Remarks: **ROOTS**
