Profile/Photo Observation Report

Date:	04/23/2018	Weather:		Coding:	PACP 6.0
Pipe Length (ft):	113.9	Owner:	NA	Pre Clean:	Not Known
P.O.#:		Surveyor:	Jen Costello	PSR:	P-604-037-036
Customer:		Clean Date:	01/01/1900	Shape:	C

Street:	HAMPSHIRE PARK APARTMENTS	Flow Control:	Not Controlled
City:	Hobart, IN	Year Renewed:	
Location:	Light Highway	Tape/Media #:	
Purpose:	Not Known	Dia/Height:	8"
Use:	Sanitary	Material:	VCP
Drain Area:	NA	Lining:	
Category:	NA		
Comment:

Location Details:		Direction of Survey:	Downstream
US MH:	M-604-036	DS MH:	M-604-037
		Total Length Surveyed (ft):	114.7

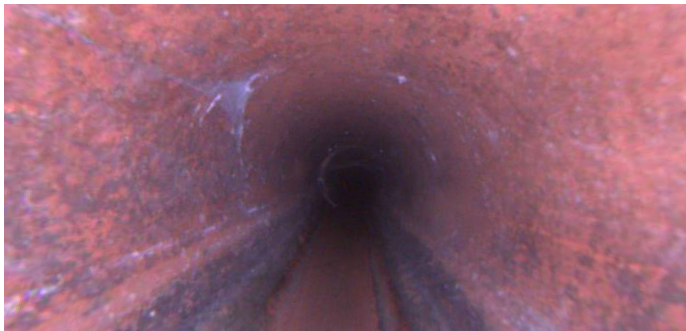
Code: **AMH**
Description: **Manhole**

Distance (ft): **.0**
Structural Grade: **0**
O&M Grade: **0**
Clock Start/From:
Clock To:
1st Value:
2nd Value:
Value Percent:
Continuous Index:
Within 8" of Joint: **NO**
Remarks: **M-604-036**

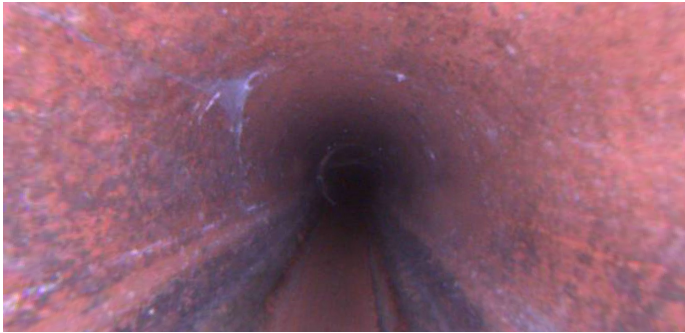
Code:	MWL
Description:	Water Level

Distance (ft):	.0
Structural Grade:	0
O&M Grade:	0
Clock Start/From:	
Clock To:	
1st Value:	
2nd Value:	
Value Percent:	5.000
Continuous Index:	
Within 8" of Joint:	NO
Remarks:

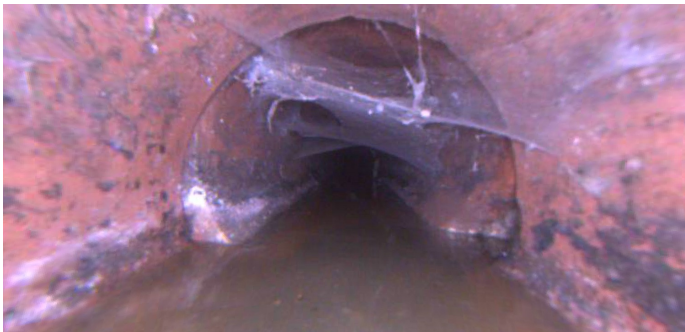
Code:	JOM
Description:	Joint Offset Medium

Distance (ft):	7.9
Structural Grade:	1
O&M Grade:	0
Clock Start/From:	
Clock To:	
1st Value:	
2nd Value:	
Value Percent:	
Continuous Index:	
Within 8" of Joint:	NO
Remarks:

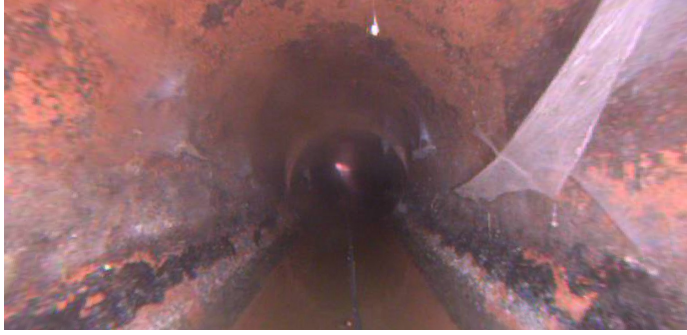
Code:	MGO
Description:	General Observation
Distance (ft):	10.0
Structural Grade:	0
O&M Grade:	0
Clock Start/From:	
Clock To:	
1st Value:	
2nd Value:	
Value Percent:	
Continuous Index:	
Within 8" of Joint:	NO
Remarks:	REAR CAMERA

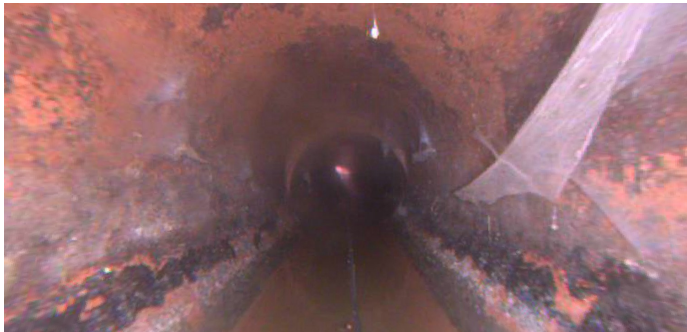
Code:	DAGS
Description:	Deposits Attached Grease
Distance (ft):	10.0
Structural Grade:	0
O&M Grade:	2
Clock Start/From:	8
Clock To:	4
1st Value:	
2nd Value:	
Value Percent:	5.000
Continuous Index:	S01
Within 8" of Joint:	NO
Remarks:

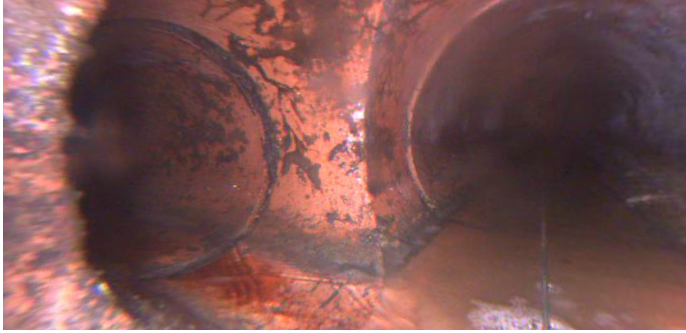
Code: **TFA**
Description: **Tap Factory Active**

Distance (ft): **33.1**
Structural Grade: **0**
O&M Grade: **0**
Clock Start/From: **3**
Clock To:
1st Value: **4.000**
2nd Value:
Value Percent:
Continuous Index:
Within 8" of Joint:
Remarks:

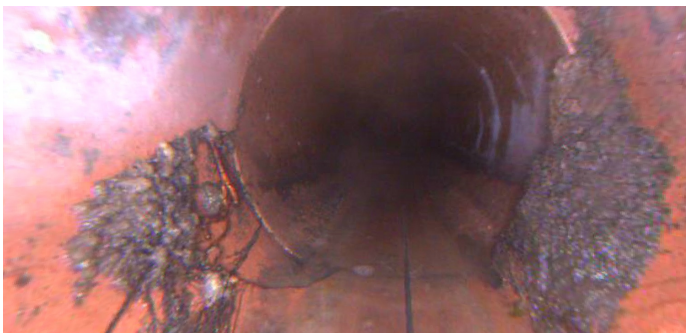
Code: **FS**
Description: **Fracture Spiral**

Distance (ft): **39.5**
Structural Grade: **3**
O&M Grade: **0**
Clock Start/From: **3**
Clock To: **5**
1st Value:
2nd Value:
Value Percent:
Continuous Index:
Within 8" of Joint: **YES**
Remarks:

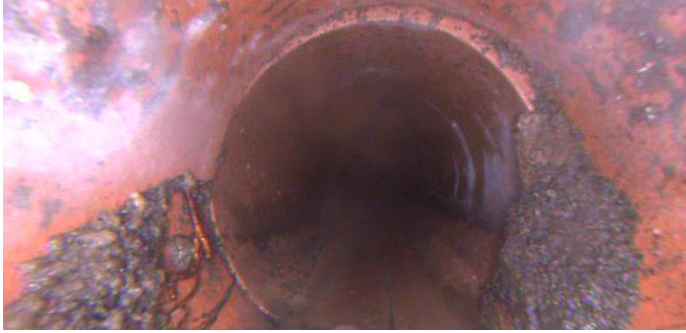
Code: **RMJ**
Description: **Roots Medium Joint**

Distance (ft): **39.5**
Structural Grade: **0**
O&M Grade: **3**
Clock Start/From: **8**
Clock To: **4**
1st Value:
2nd Value:
Value Percent: **10.000**
Continuous Index:
Within 8" of Joint: **YES**
Remarks:

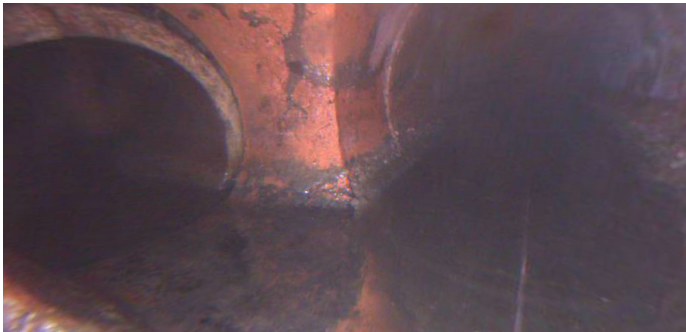
Code: **TFA**
Description: **Tap Factory Active**

Distance (ft): **92.8**
Structural Grade: **0**
O&M Grade: **0**
Clock Start/From: **3**
Clock To:
1st Value: **4.000**
2nd Value:
Value Percent:
Continuous Index:
Within 8" of Joint:
Remarks:

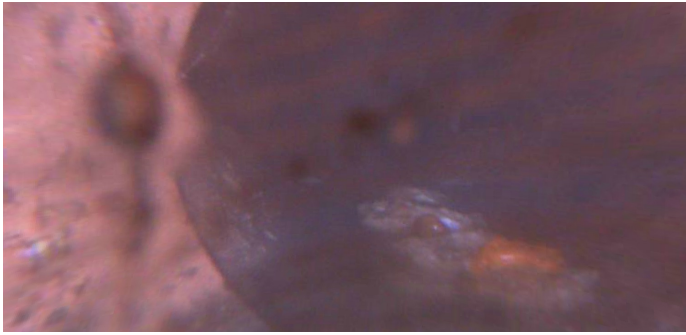
Code: **DAGS**
Description: **Deposits Attached Grease**

Distance (ft): **113.1**
Structural Grade: **0**
O&M Grade: **2**
Clock Start/From: **8**
Clock To: **4**
1st Value:
2nd Value:
Value Percent: **5.000**
Continuous Index: **F01**
Within 8" of Joint: **NO**
Remarks:

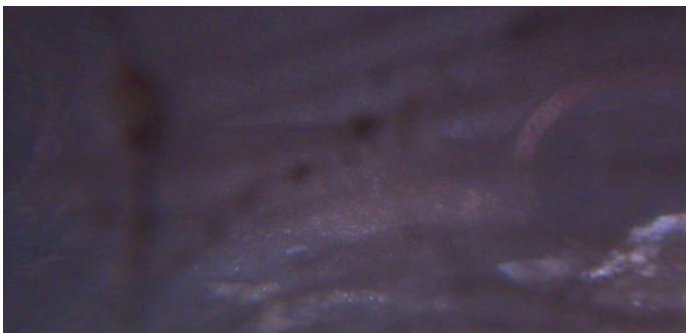
Code: **AMH**
Description: **Manhole**

Distance (ft): **114.7**
Structural Grade: **0**
O&M Grade: **0**
Clock Start/From:
Clock To:
1st Value:
2nd Value:
Value Percent:
Continuous Index:
Within 8" of Joint: **NO**
Remarks: **M-604-037**
