Profile/Photo Observation Report

Date:	04/23/2018	Weather:		Coding:	PACP 6.0
Pipe Length (ft):	113.9	Owner:	NA	Pre Clean:	Not Known
P.O.#:		Surveyor:	Jen Costello	PSR:	P-604-037-036
Customer:		Clean Date:	01/01/1900	Shape:	C

Street:	Summerlin	Flow Control:	Not Controlled
City:	Hobart, IN	Year Renewed:	
Location:	Light Highway	Tape/Media #:	
Purpose:	Not Known	Dia/Height:	8"
Use:	Sanitary	Material:	VCP
Drain Area:	NA	Lining:	
Category:	NA		
Comment:

Location Details:		Direction of Survey:	Downstream
US MH:	M-604-036	DS MH:	M-604-037
		Total Length Surveyed (ft):	114.7

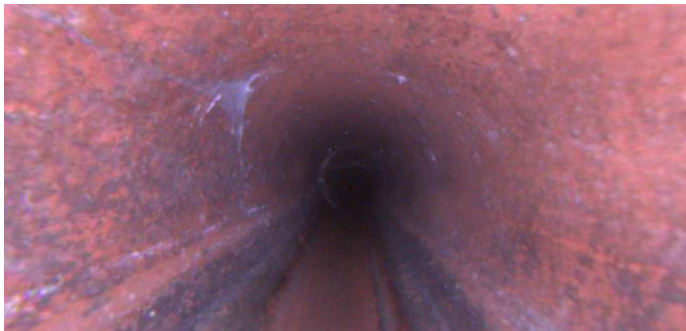
Code: **AMH**
Description: **Manhole**

Distance (ft): **.0**
Structural Grade: **0**
O&M Grade: **0**
Clock Start/From:
Clock To:
1st Value:
2nd Value:
Value Percent:
Continuous Index:
Within 8" of Joint: **NO**
Remarks: **M-604-036**

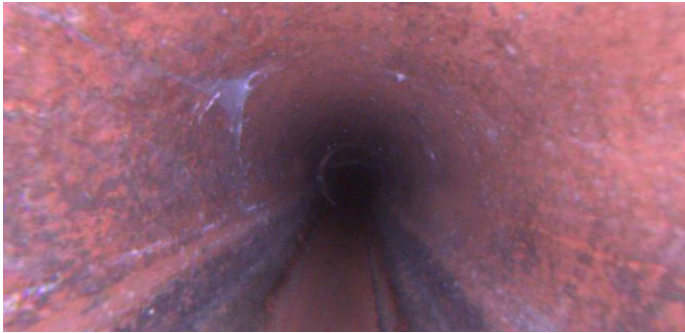
Code:	MWL
Description:	Water Level

Distance (ft):	.0
Structural Grade:	0
O&M Grade:	0
Clock Start/From:	
Clock To:	
1st Value:	
2nd Value:	
Value Percent:	5.000
Continuous Index:	
Within 8" of Joint:	NO
Remarks:

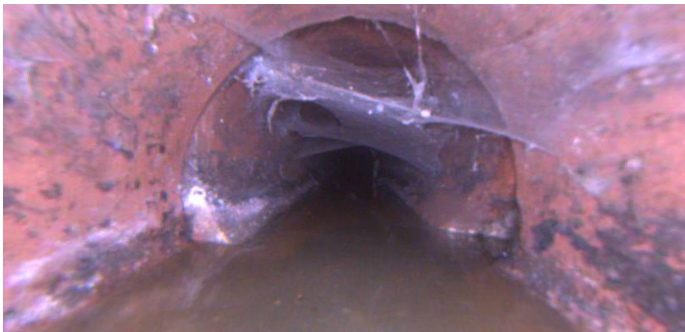
Code:	JOM
Description:	Joint Offset Medium

Distance (ft):	7.9
Structural Grade:	1
O&M Grade:	0
Clock Start/From:	
Clock To:	
1st Value:	
2nd Value:	
Value Percent:	
Continuous Index:	
Within 8" of Joint:	NO
Remarks:

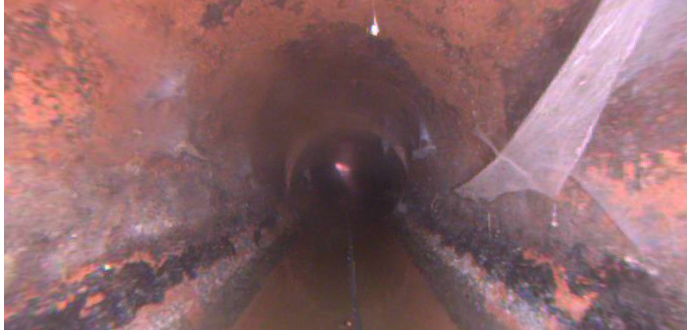
Code:	MGO
Description:	General Observation
Distance (ft):	10.0
Structural Grade:	0
O&M Grade:	0
Clock Start/From:	
Clock To:	
1st Value:	
2nd Value:	
Value Percent:	
Continuous Index:	
Within 8" of Joint:	NO
Remarks:	REAR CAMERA

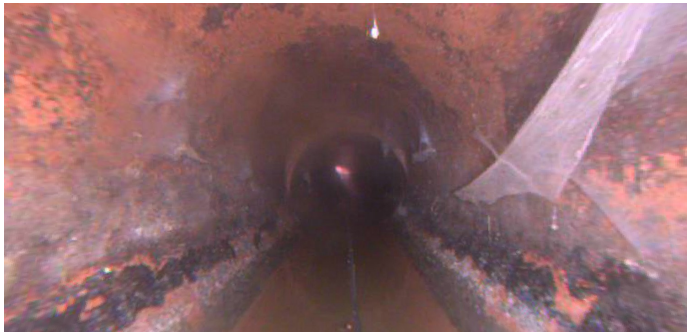
Code:	DAGS
Description:	Deposits Attached Grease
Distance (ft):	10.0
Structural Grade:	0
O&M Grade:	2
Clock Start/From:	8
Clock To:	4
1st Value:	
2nd Value:	
Value Percent:	5.000
Continuous Index:	S01
Within 8" of Joint:	NO
Remarks:

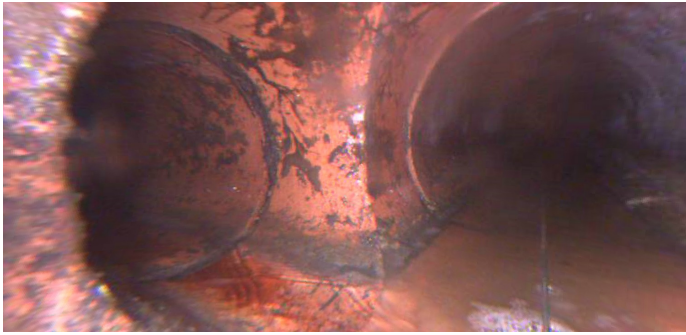
Code: **TFA**
Description: **Tap Factory Active**

Distance (ft): **33.1**
Structural Grade: **0**
O&M Grade: **0**
Clock Start/From: **3**
Clock To:
1st Value: **4.000**
2nd Value:
Value Percent:
Continuous Index:
Within 8" of Joint:
Remarks:

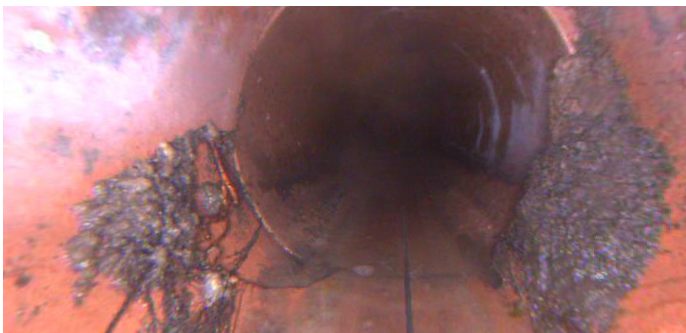
Code: **FS**
Description: **Fracture Spiral**

Distance (ft): **39.5**
Structural Grade: **3**
O&M Grade: **0**
Clock Start/From: **3**
Clock To: **5**
1st Value:
2nd Value:
Value Percent:
Continuous Index:
Within 8" of Joint: **YES**
Remarks:

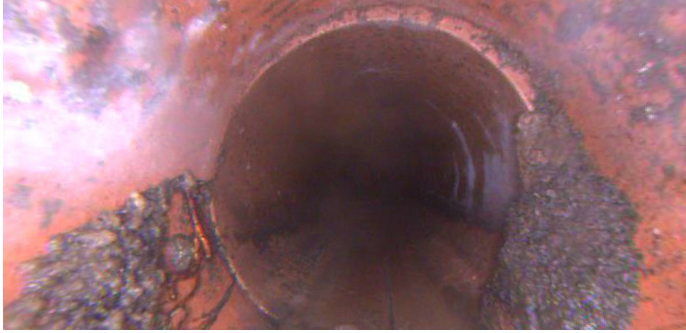
Code: **RMJ**
Description: **Roots Medium Joint**

Distance (ft): **39.5**
Structural Grade: **0**
O&M Grade: **3**
Clock Start/From: **8**
Clock To: **4**
1st Value:
2nd Value:
Value Percent: **10.000**
Continuous Index:
Within 8" of Joint: **YES**
Remarks:

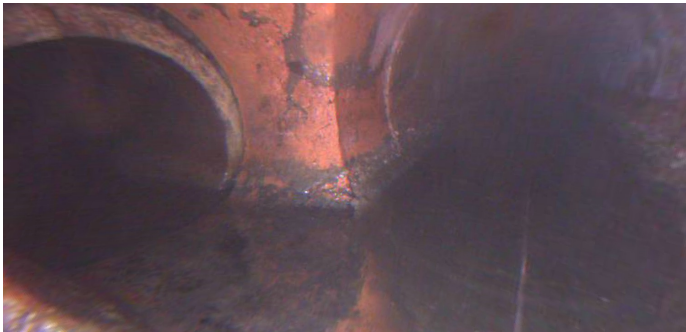
Code: **TFA**
Description: **Tap Factory Active**

Distance (ft): **92.8**
Structural Grade: **0**
O&M Grade: **0**
Clock Start/From: **3**
Clock To:
1st Value: **4.000**
2nd Value:
Value Percent:
Continuous Index:
Within 8" of Joint:
Remarks:

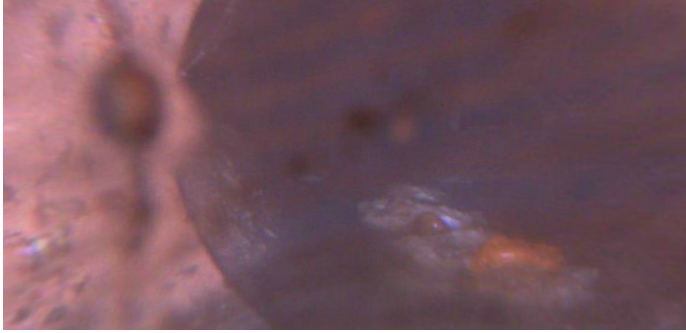
Code: **DAGS**
Description: **Deposits Attached Grease**

Distance (ft): **113.1**
Structural Grade: **0**
O&M Grade: **2**
Clock Start/From: **8**
Clock To: **4**
1st Value:
2nd Value:
Value Percent: **5.000**
Continuous Index: **F01**
Within 8" of Joint: **NO**
Remarks:

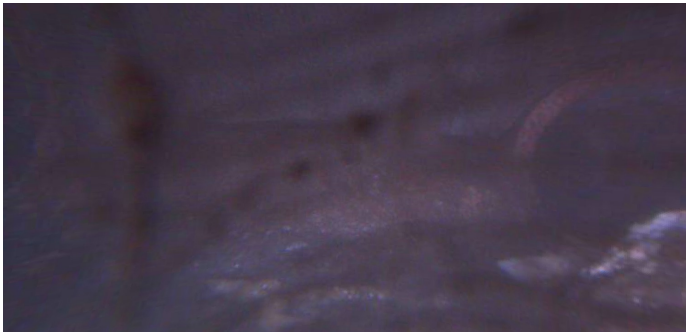
Code: **AMH**
Description: **Manhole**

Distance (ft): **114.7**
Structural Grade: **0**
O&M Grade: **0**
Clock Start/From:
Clock To:
1st Value:
2nd Value:
Value Percent:
Continuous Index:
Within 8" of Joint: **NO**
Remarks: **M-604-037**
