Profile/Photo Observation Report

Street:	HAMPSHIRE PARK APARTMENTS	Flow Control:	Not Controlled
City:	Hobart, IN	Year Renewed:	
Location:	Other	Tape/Media #:	
Purpose:	Not Known	Dia/Height:	12"
Use:	Sanitary	Material:	VCP
Drain Area:	NA	Lining:	
Category:	NA		
Comment:

Location Details:		Direction of Survey:	Downstream
US MH:	M-604-039	DS MH:	M-604-040
		Total Length Surveyed (ft):	2.9

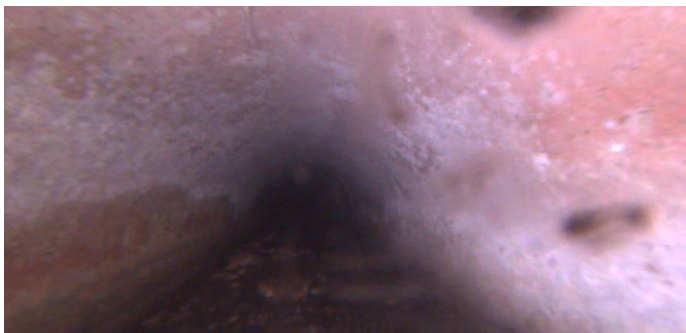
Code: **AMH**
Description: **Manhole**

Distance (ft): **.0**
Structural Grade: **0**
O&M Grade: **0**
Clock Start/From:
Clock To:
1st Value:
2nd Value:
Value Percent:
Continuous Index:
Within 8" of Joint: **NO**
Remarks: **M-604-039**

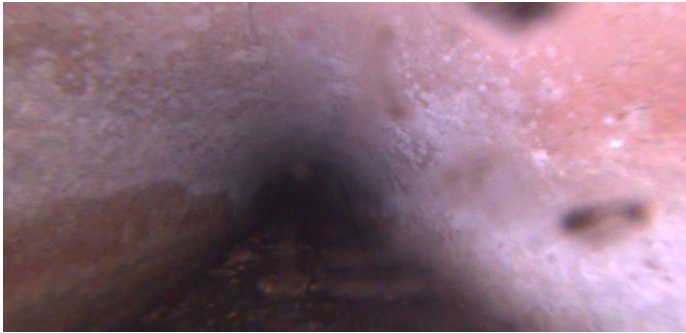
Code:	MWL
Description:	Water Level

Distance (ft):	.0
Structural Grade:	0
O&M Grade:	0
Clock Start/From:	
Clock To:	
1st Value:	
2nd Value:	
Value Percent:	10.000
Continuous Index:	
Within 8" of Joint:	NO
Remarks:

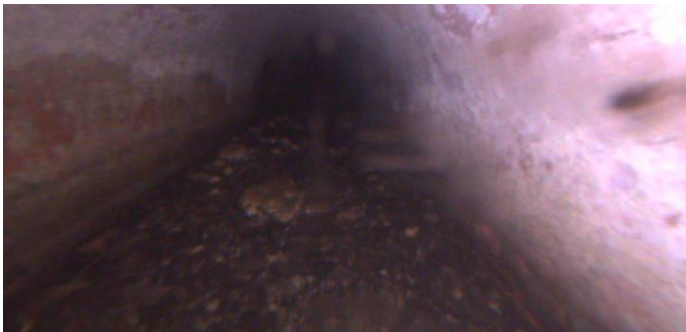
Code:	DSGV
Description:	Deposits Settled Gravel

Distance (ft):	1.0
Structural Grade:	0
O&M Grade:	3
Clock Start/From:	4
Clock To:	8
1st Value:	
2nd Value:	
Value Percent:	20.000
Continuous Index:	
Within 8" of Joint:	NO
Remarks:

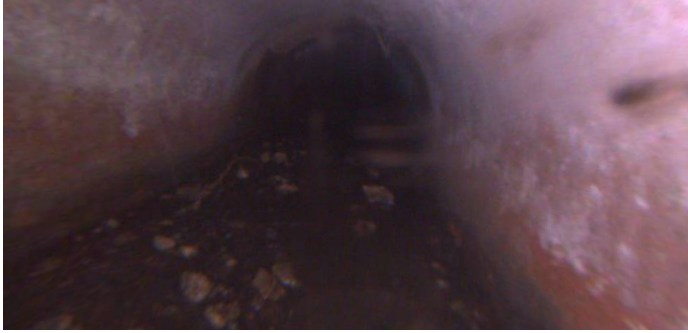
Code:	MSA
Description:	Abandoned Survey
Distance (ft):	2.9
Structural Grade:	0
O&M Grade:	0
Clock Start/From:	
Clock To:	
1st Value:	
2nd Value:	
Value Percent:	
Continuous Index:	
Within 8" of Joint:	NO
Remarks:	debris under water
