Profile/Photo Observation Report

Date:	04/12/2018	Weather:		Coding:	PACP 6.0
Pipe Length (ft):	82.0	Owner:	NA	Pre Clean:	Not Known
P.O.#:		Surveyor:	Jen Costello	PSR:	P-604-040-039
Customer:		Clean Date:	01/01/1900	Shape:	C

Street:	W 40th ave	Flow Control:	Not Controlled
City:	Hobart, IN	Year Renewed:	
Location:	Other	Tape/Media #:	
Purpose:	Not Known	Dia/Height:	12"
Use:	Sanitary	Material:	VCP
Drain Area:	NA	Lining:	
Category:	NA		
Comment:

Location Details:		Direction of Survey:	Downstream
US MH:	M-604-039	DS MH:	M-604-040
		Total Length Surveyed (ft):	2.9

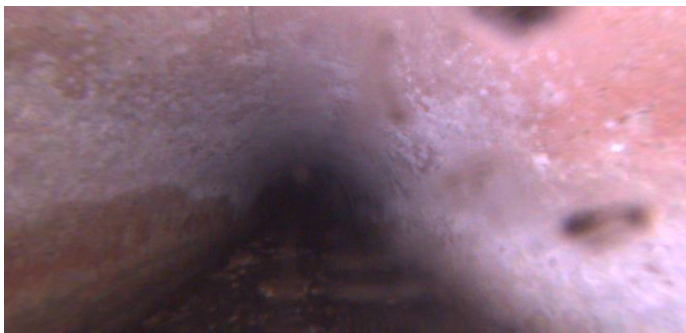
Code: **AMH**
Description: **Manhole**

Distance (ft): **.0**
Structural Grade: **0**
O&M Grade: **0**
Clock Start/From:
Clock To:
1st Value:
2nd Value:
Value Percent:
Continuous Index:
Within 8" of Joint: **NO**
Remarks: **M-604-039**

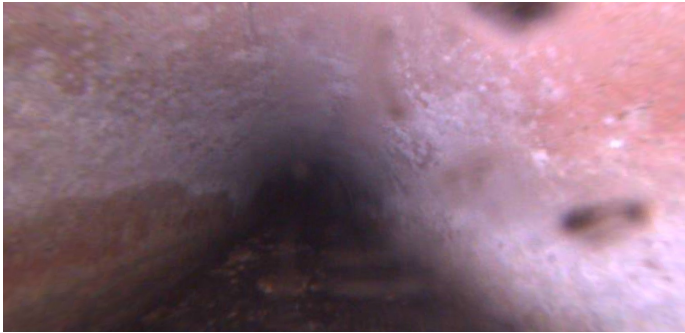
Code:	MWL
Description:	Water Level

Distance (ft):	.0
Structural Grade:	0
O&M Grade:	0
Clock Start/From:	
Clock To:	
1st Value:	
2nd Value:	
Value Percent:	10.000
Continuous Index:	
Within 8" of Joint:	NO
Remarks:

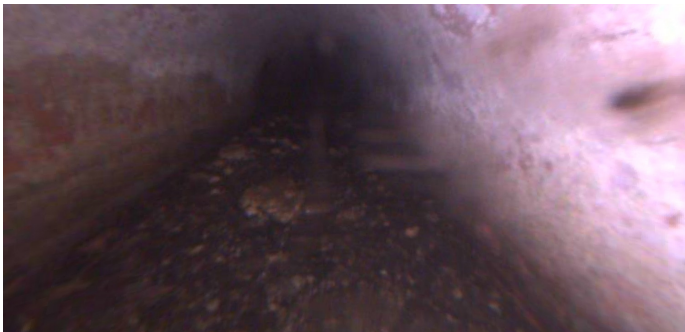
Code:	DSGV
Description:	Deposits Settled Gravel

Distance (ft):	1.0
Structural Grade:	0
O&M Grade:	3
Clock Start/From:	4
Clock To:	8
1st Value:	
2nd Value:	
Value Percent:	20.000
Continuous Index:	
Within 8" of Joint:	NO
Remarks:

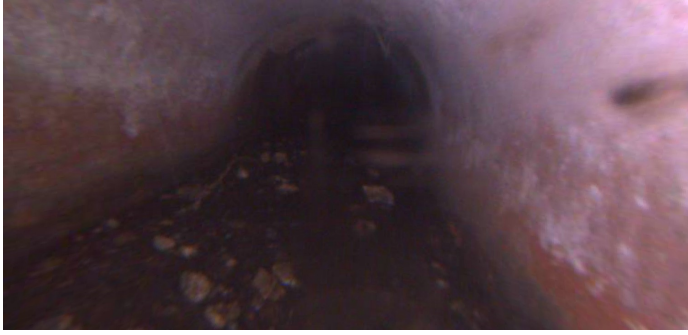
Code:	MSA
Description:	Abandoned Survey
Distance (ft):	2.9
Structural Grade:	0
O&M Grade:	0
Clock Start/From:	
Clock To:	
1st Value:	
2nd Value:	
Value Percent:	
Continuous Index:	
Within 8" of Joint:	NO
Remarks:	debris under water
