Profile/Photo Observation Report

Date:	04/12/2018	Weather:		Coding:	PACP 6.0
Pipe Length (ft):		Owner:	City of Hobart	Pre Clean:	Not Known
P.O.#:	240	Surveyor:	B. Helbling	PSR:	P-604-044-043
Customer:	City of Hobart	Clean Date:		Shape:	C

Street:	North Ash Street	Flow Control:	Not Controlled
City:	Hobart, IN	Year Renewed:	
Location:	Light Highway	Tape/Media #:	DEP240
Purpose:	Routine Assessment	Dia/Height:	15"
Use:	Sanitary	Material:	VCP
Drain Area:		Lining:	
Category:	NA		
Comment:	YES501824 Submittal 2		
Location Details:		Direction of Survey:	Downstream
US MH:	M-604-043	DS MH:	M-604-044
		Total Length Surveyed (ft):	44.3

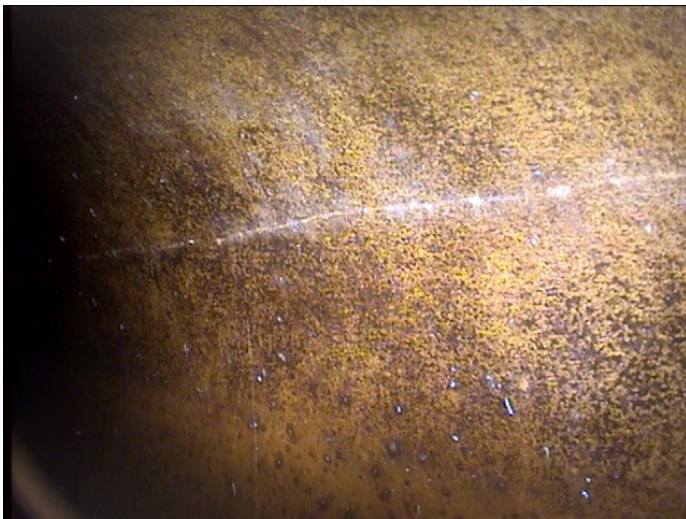
Code: **CL**
Description: **Crack Longitudinal**

Distance (ft): **4.1**
Structural Grade: **2**
O&M Grade: **0**
Clock Start/From: **3**
Clock To:
1st Value:
2nd Value:
Value Percent:
Continuous Index:
Within 8" of Joint: **NO**
Remarks:

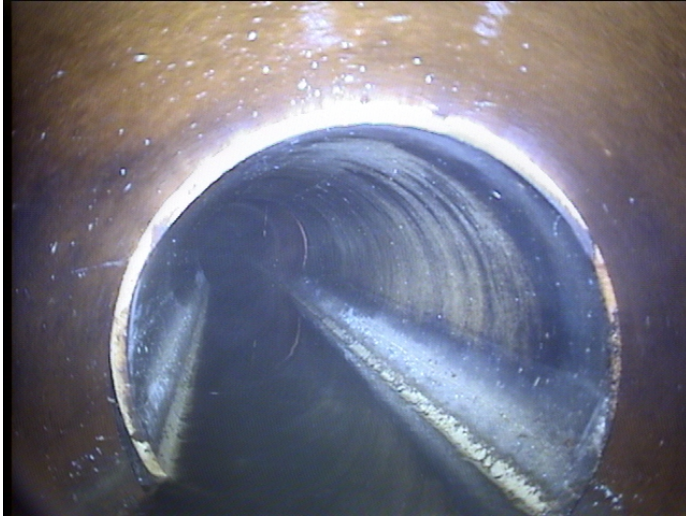
Code: **LL**
Description: **Alignment Left**

Distance (ft): **5.9**
Structural Grade: **0**
O&M Grade: **1**
Clock Start/From:
Clock To:
1st Value:
2nd Value:
Value Percent: **10.000**
Continuous Index:
Within 8" of Joint: **NO**
Remarks:

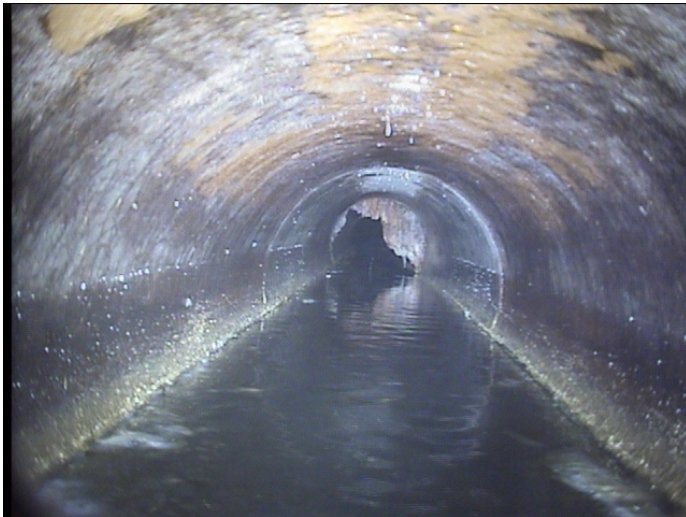
Code: **DSF**
Description: **Deposits Settled Fine**

Distance (ft): **33.6**
Structural Grade: **0**
O&M Grade: **2**
Clock Start/From: **4**
Clock To: **8**
1st Value:
2nd Value:
Value Percent: **10.000**
Continuous Index: **S01**
Within 8" of Joint: **NO**
Remarks:

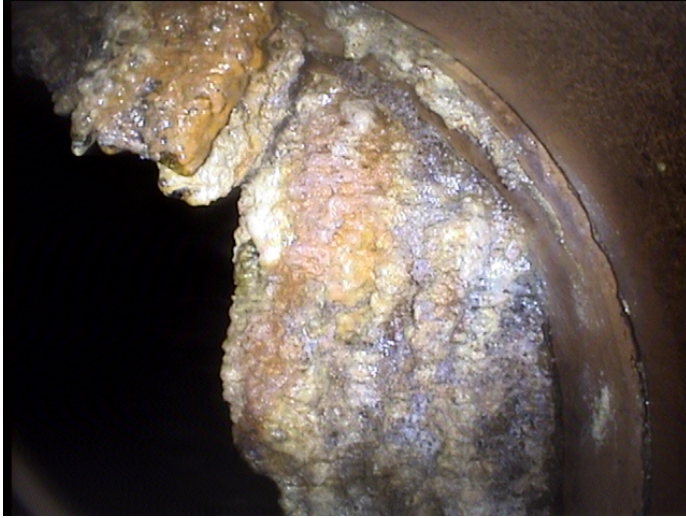
Code:	DAE
Description:	Deposits Attached Encrustation
Distance (ft):	43.3
Structural Grade:	0
O&M Grade:	3
Clock Start/From:	9
Clock To:	4
1st Value:	
2nd Value:	
Value Percent:	20.000
Continuous Index:	
Within 8" of Joint:	YES
Remarks:

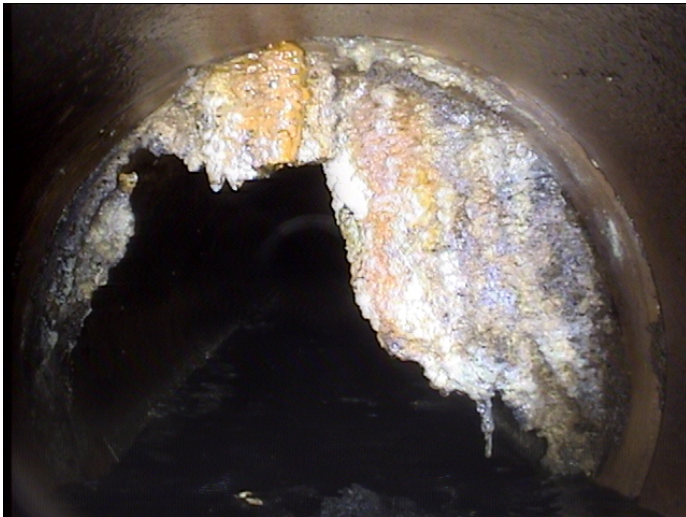
Code:	DSF
Description:	Deposits Settled Fine
Distance (ft):	44.3
Structural Grade:	0
O&M Grade:	2
Clock Start/From:	4
Clock To:	8
1st Value:	
2nd Value:	
Value Percent:	10.000
Continuous Index:	F01
Within 8" of Joint:	NO
Remarks:

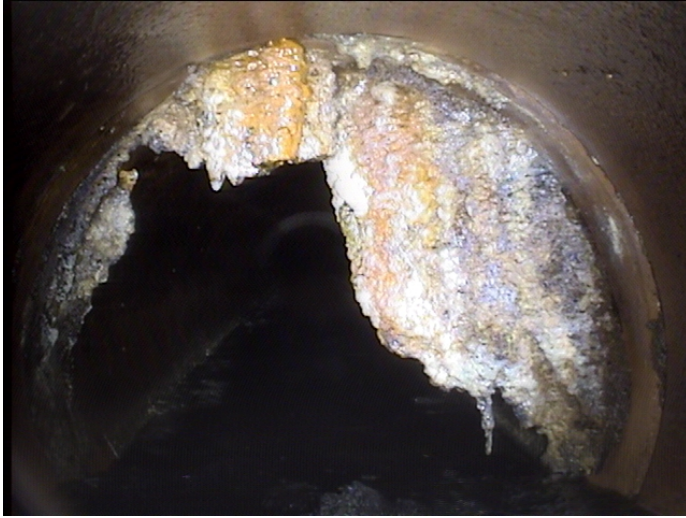
Code:	MSA
Description:	Abandoned Survey
Distance (ft):	44.3
Structural Grade:	0
O&M Grade:	0
Clock Start/From:	
Clock To:	
1st Value:	
2nd Value:	
Value Percent:	
Continuous Index:	
Within 8" of Joint:	NO
Remarks:	Cannot pass mineral deposits
