Profile/Photo Observation Report

| Street: | North Ash Street | Flow Control: | Not Controlled |
| City: | Hobart, IN | Year Renewed: | |
| US MH: | M-604-043 | DS MH: | M-604-044 |

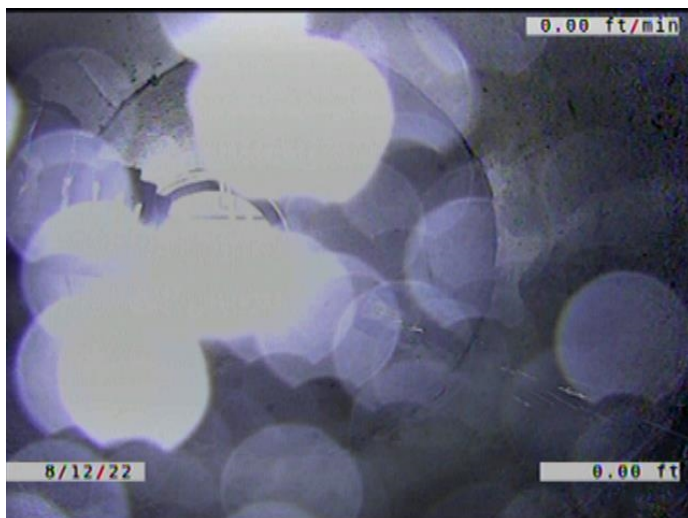
Code: **AMH**
 Description: **Manhole**

Distance (ft): **.0**
 Structural Grade: **0**
 O&M Grade: **0**
 Clock Start/From:
 Clock To:
 1st Value:
 2nd Value:
 Value Percent:
 Continuous Index:
 Within 8" of Joint: **NO**
 Remarks: **M-604-044**

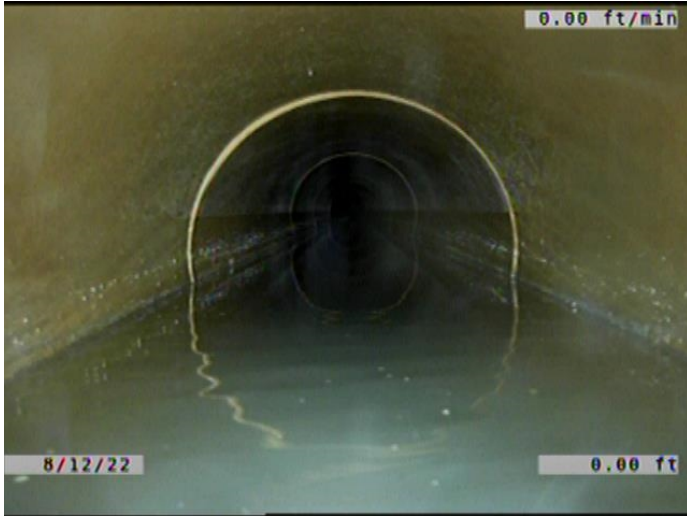
Code: **MWL**
Description: **Miscellaneous Water Level**

Distance (ft): **.0**
Structural Grade: **0**
O&M Grade: **0**
Clock Start/From:
Clock To:
1st Value:
2nd Value:
Value Percent: **30.000**
Continuous Index:
Within 8" of Joint: **NO**
Remarks:

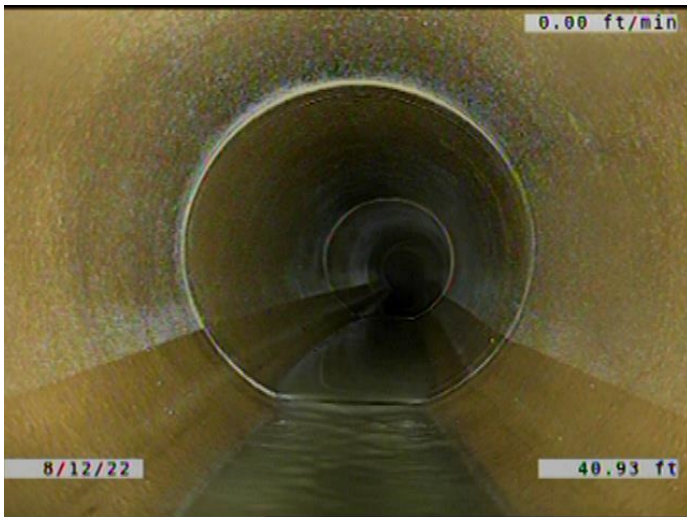
Code: **MWL**
Description: **Miscellaneous Water Level**

Distance (ft): **40.9**
Structural Grade: **0**
O&M Grade: **0**
Clock Start/From:
Clock To:
1st Value:
2nd Value:
Value Percent: **5.000**
Continuous Index:
Within 8" of Joint: **NO**
Remarks:

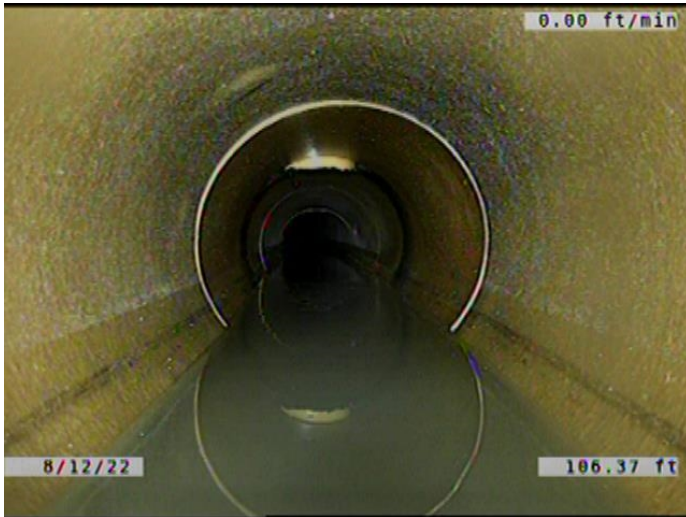
| | Position | Code | Observation | Video (sec) | Grade |
|--|---|---|---|---|---|
| | 106.4 | MWLS(S01) | Miscellaneous Water Level Sag | 351 | S 2 |

Code: **MWLS**
Description: **Miscellaneous Water Level Sag**

Distance (ft): **106.4**
Structural Grade: **2**
O&M Grade: **0**
Clock Start/From:
Clock To:
1st Value:
2nd Value:
Value Percent: **25.000**
Continuous Index: **S01**
Within 8" of Joint: **NO**
Remarks:

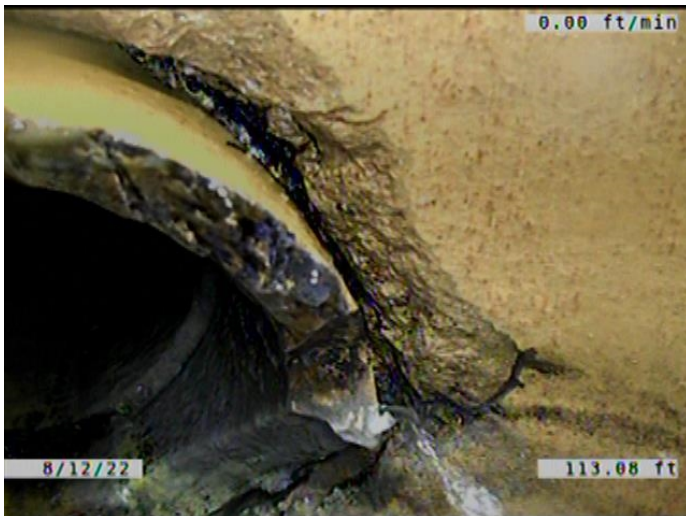
| | Position | Code | Observation | Video (sec) | Grade |
|--|---|---|---|---|---|
| | 113.1 | B | Broken | 400 | S 4 |

Code: **B**
Description: **Broken**

Distance (ft): **113.1**
Structural Grade: **4**
O&M Grade: **0**
Clock Start/From: **10**
Clock To: **1**
1st Value:
2nd Value:
Value Percent:
Continuous Index:
Within 8" of Joint: **NO**
Remarks:

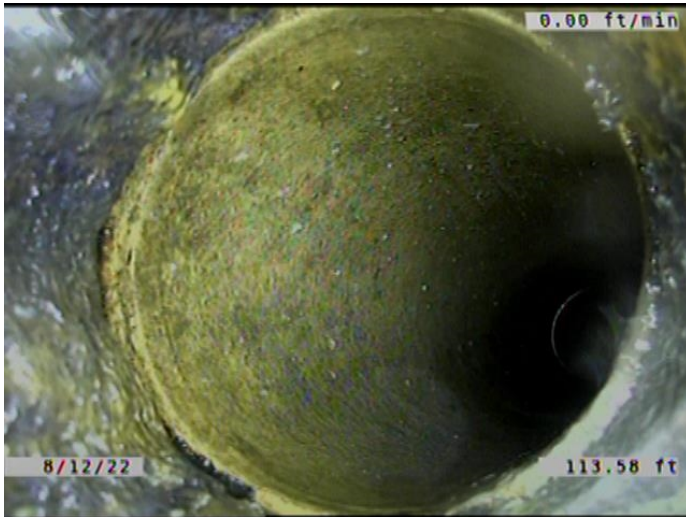
Code: **TBA**
 Description: **Tap Break-in Activity**

Distance (ft): **113.6**
 Structural Grade: **0**
 O&M Grade: **0**
 Clock Start/From: **12**
 Clock To:
 1st Value: **6.000**
 2nd Value:
 Value Percent:
 Continuous Index:
 Within 8" of Joint: **NO**
 Remarks:

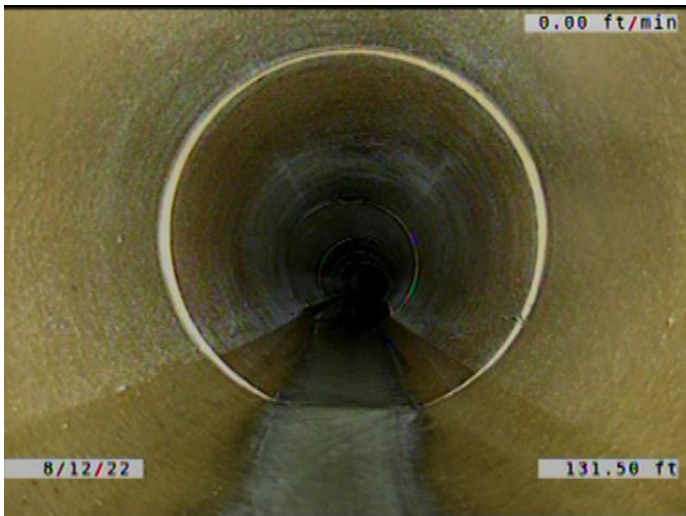
Code: **MWLS**
 Description: **Miscellaneous Water Level Sag**

Distance (ft): **131.5**
 Structural Grade: **2**
 O&M Grade: **0**
 Clock Start/From:
 Clock To:
 1st Value:
 2nd Value:
 Value Percent: **25.000**
 Continuous Index: **F01**
 Within 8" of Joint: **NO**
 Remarks:

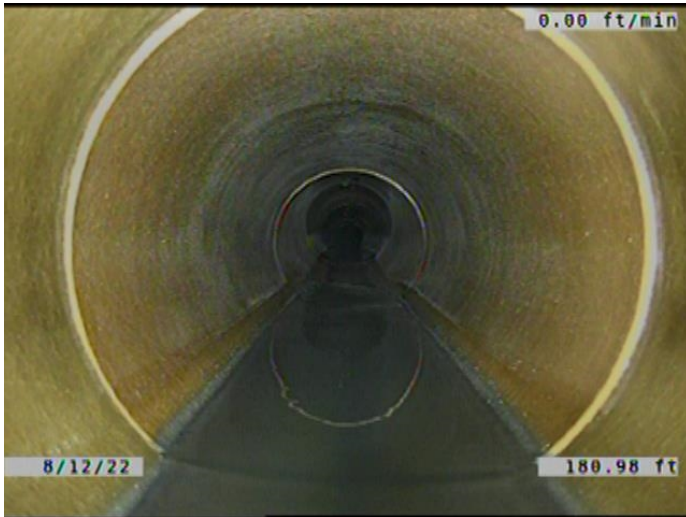
Code: **MWLS**
Description: **Miscellaneous Water Level Sag**

Distance (ft): **181.0**
Structural Grade: **2**
O&M Grade: **0**
Clock Start/From:
Clock To:
1st Value:
2nd Value:
Value Percent: **10.000**
Continuous Index: **S02**
Within 8" of Joint: **NO**
Remarks:

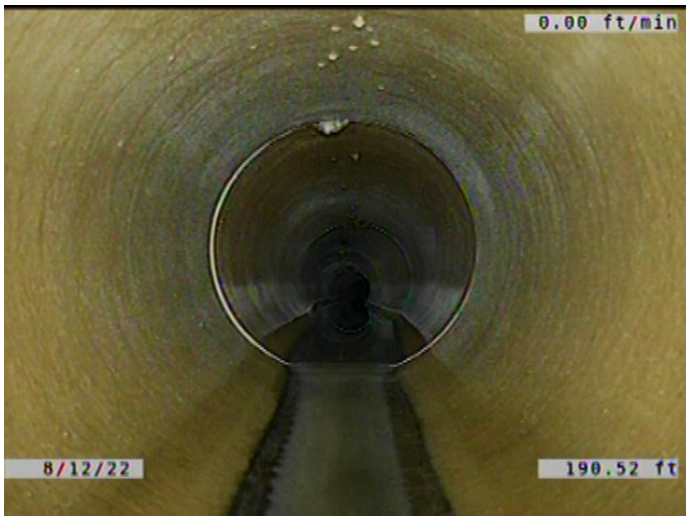
Code: **MWLS**
Description: **Miscellaneous Water Level Sag**

Distance (ft): **190.5**
Structural Grade: **2**
O&M Grade: **0**
Clock Start/From:
Clock To:
1st Value:
2nd Value:
Value Percent: **10.000**
Continuous Index: **F02**
Within 8" of Joint: **NO**
Remarks:

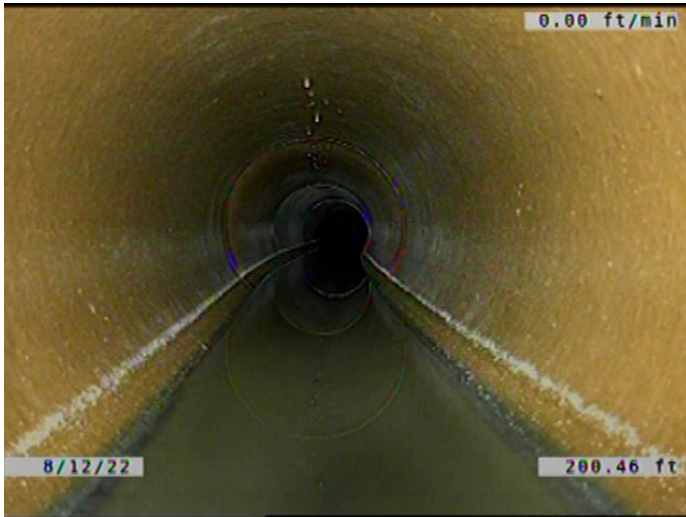
Code: **MWLS**
 Description: **Miscellaneous Water Level Sag**

Distance (ft): **200.5**
 Structural Grade: **2**
 O&M Grade: **0**
 Clock Start/From:
 Clock To:
 1st Value:
 2nd Value:
 Value Percent: **20.000**
 Continuous Index: **S03**
 Within 8" of Joint: **NO**
 Remarks:

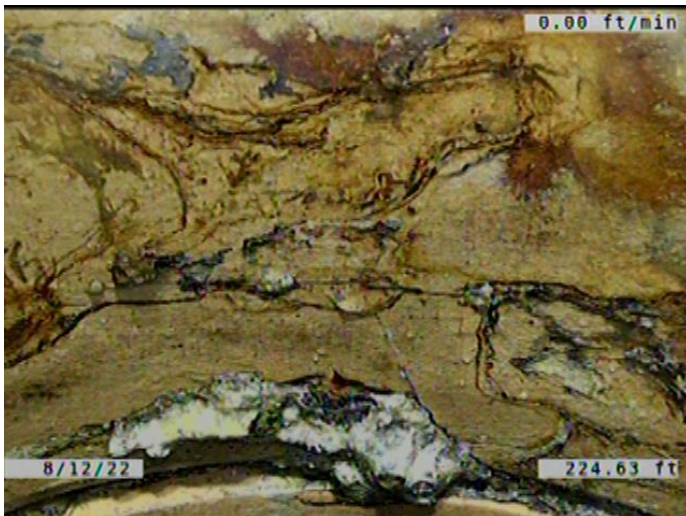
| | Position | Code | Observation | Video (sec) | Grade |
|--|---|---|---|---|---|
| | 224.6 | CM | Crack Multiple | 784 | S 3 |

Code: **CM**
 Description: **Crack Multiple**

Distance (ft): **224.6**
 Structural Grade: **3**
 O&M Grade: **0**
 Clock Start/From: **8**
 Clock To: **4**
 1st Value:
 2nd Value:
 Value Percent:
 Continuous Index:
 Within 8" of Joint: **YES**
 Remarks:

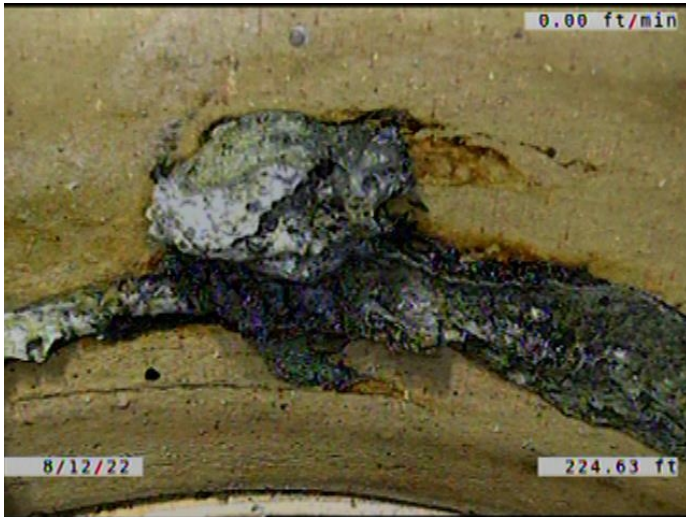
| | Position | Code | Observation | Video (sec) | Grade |
|--|---|---|---|---|---|
| | 224.6 | DAE | Deposits Attached Encrustation | 798 | M 2 |

Code: **DAE**
 Description: **Deposits Attached Encrustation**

Distance (ft): **224.6**
 Structural Grade: **0**
 O&M Grade: **2**
 Clock Start/From: **8**
 Clock To: **4**
 1st Value:
 2nd Value:
 Value Percent: **5.000**
 Continuous Index:
 Within 8" of Joint: **YES**
 Remarks:

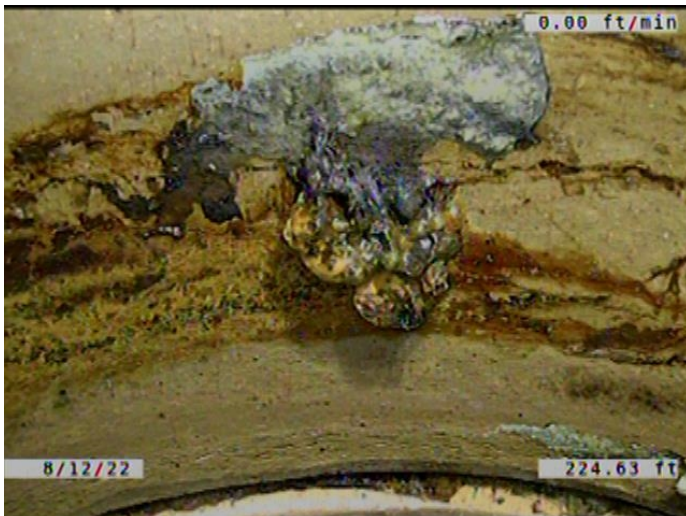
| | Position | Code | Observation | Video (sec) | Grade |
|--|---|---|---|---|---|
| | 224.6 | IDB | Infiltration Dripper Barrel | 813 | M 3 |

Code: **IDB**
 Description: **Infiltration Dripper Barrel**

Distance (ft): **224.6**
 Structural Grade: **0**
 O&M Grade: **3**
 Clock Start/From: **10**
 Clock To: **2**
 1st Value:
 2nd Value:
 Value Percent:
 Continuous Index:
 Within 8" of Joint: **YES**
 Remarks:

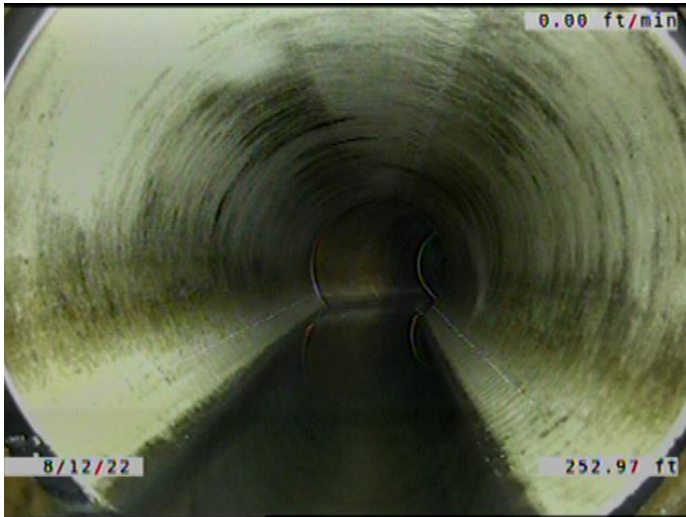
Code: **MWLS**
 Description: **Miscellaneous Water Level Sag**

Distance (ft): **253.0**
 Structural Grade: **2**
 O&M Grade: **0**
 Clock Start/From:
 Clock To:
 1st Value:
 2nd Value:
 Value Percent: **20.000**
 Continuous Index: **F03**
 Within 8" of Joint: **NO**
 Remarks:

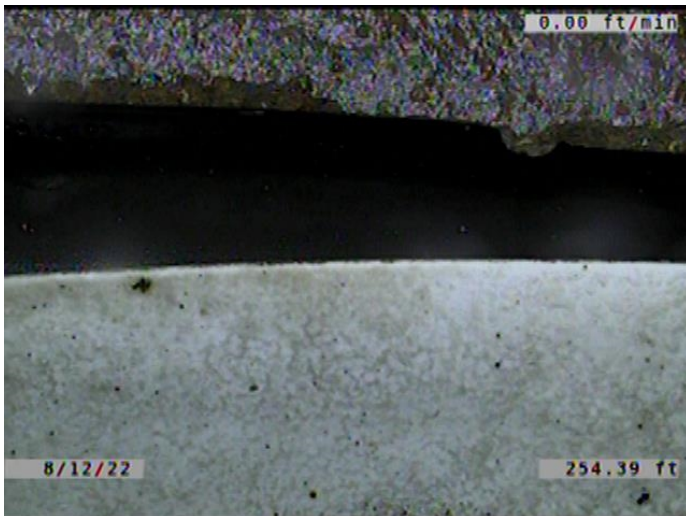
Code: **RPR**
 Description: **Point Repair Replacement**

Distance (ft): **254.4**
 Structural Grade: **0**
 O&M Grade: **0**
 Clock Start/From:
 Clock To:
 1st Value:
 2nd Value:
 Value Percent:
 Continuous Index: **S04**
 Within 8" of Joint: **YES**
 Remarks: **REPLACED WITH PVC**

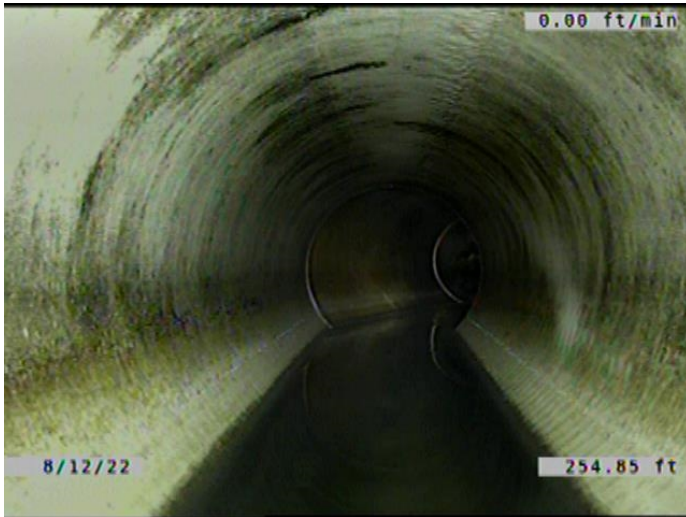
Code: **LR**
Description: **Line Right**

Distance (ft): **254.8**
Structural Grade: **0**
O&M Grade: **2**
Clock Start/From:
Clock To:
1st Value:
2nd Value:
Value Percent: **20.000**
Continuous Index: **S05**
Within 8" of Joint: **NO**
Remarks:

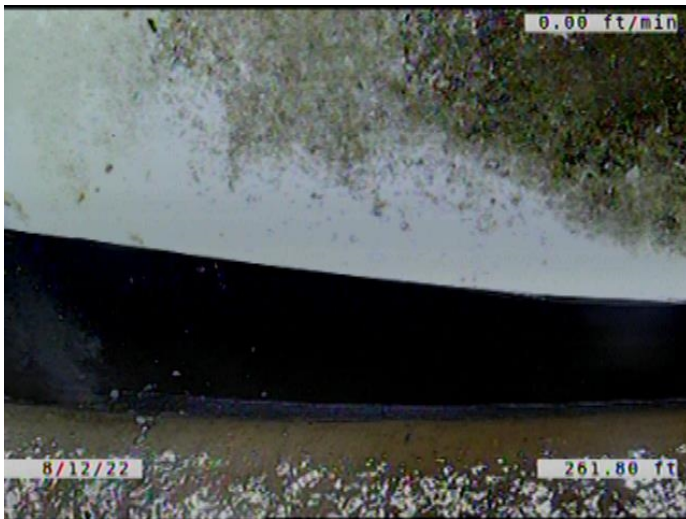
| | Position | Code | Observation | Video (sec) | Grade |
|--|---|---|---|---|---|
| | 261.8 | JAM | Joint Angular Medium | 1025 | S 3 |

Code: **JAM**
Description: **Joint Angular Medium**

Distance (ft): **261.8**
Structural Grade: **3**
O&M Grade: **0**
Clock Start/From:
Clock To:
1st Value:
2nd Value:
Value Percent:
Continuous Index:
Within 8" of Joint: **NO**
Remarks:

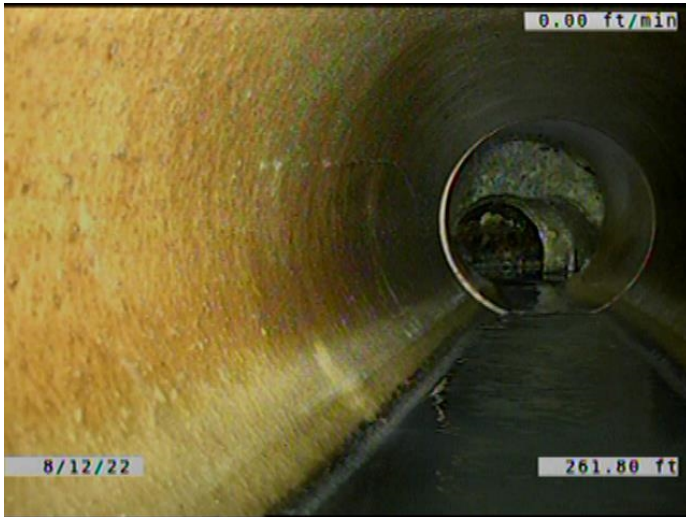
Code: **RPR**
Description: **Point Repair Replacement**

Distance (ft): **261.8**
Structural Grade: **0**
O&M Grade: **0**
Clock Start/From:
Clock To:
1st Value:
2nd Value:
Value Percent:
Continuous Index: **F04**
Within 8" of Joint: **YES**
Remarks: **REPLACED WITH PVC**

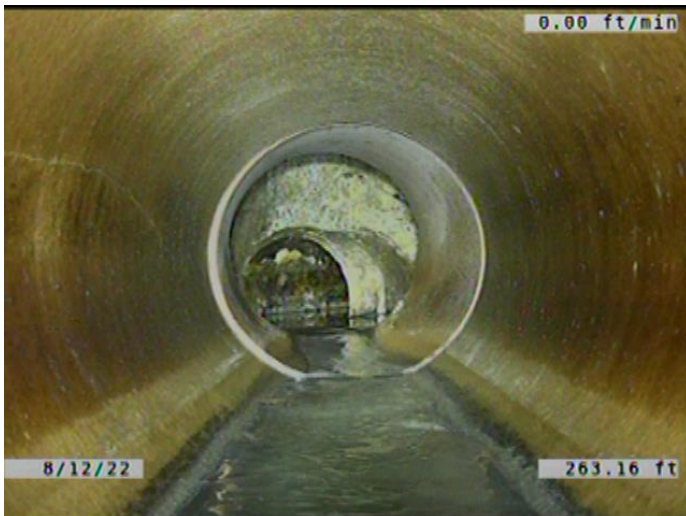
Code: **LR**
Description: **Line Right**

Distance (ft): **263.2**
Structural Grade: **0**
O&M Grade: **2**
Clock Start/From:
Clock To:
1st Value:
2nd Value:
Value Percent: **20.000**
Continuous Index: **F05**
Within 8" of Joint: **NO**
Remarks:

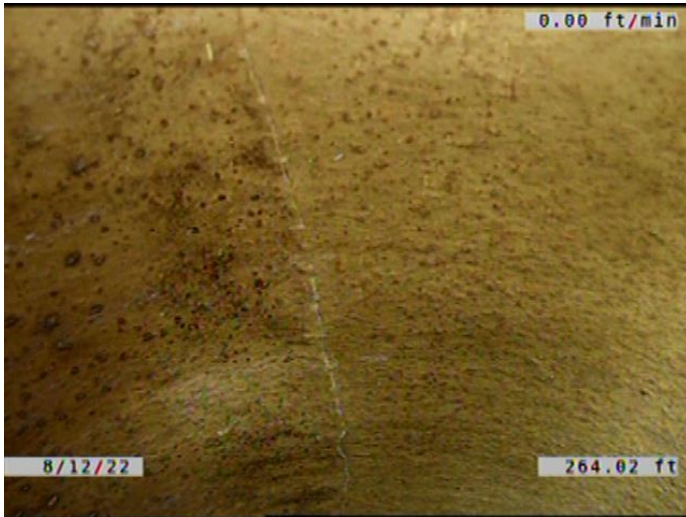
Code: **CS**
 Description: **Crack Spiral**

Distance (ft): **264.0**
 Structural Grade: **2**
 O&M Grade: **0**
 Clock Start/From: **9**
 Clock To: **10**
 1st Value:
 2nd Value:
 Value Percent:
 Continuous Index:
 Within 8" of Joint: **NO**
 Remarks:

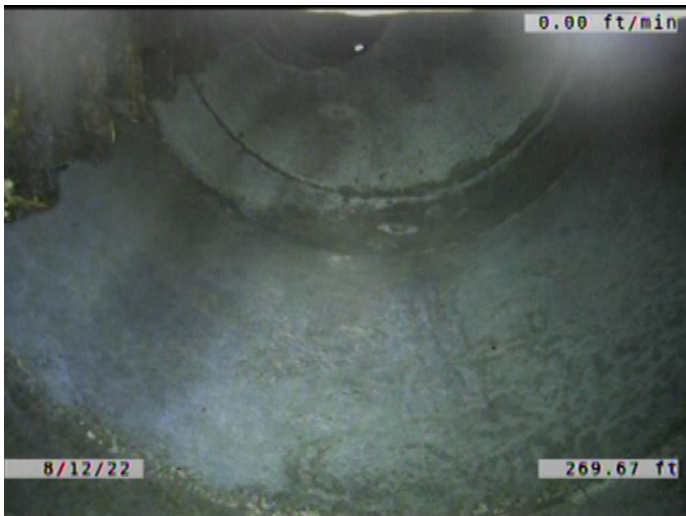
Code: **AMH**
 Description: **Manhole**

Distance (ft): **269.7**
 Structural Grade: **0**
 O&M Grade: **0**
 Clock Start/From:
 Clock To:
 1st Value:
 2nd Value:
 Value Percent:
 Continuous Index:
 Within 8" of Joint: **NO**
 Remarks: **M-604-043**
