Profile/Photo Observation Report

Date:	08/12/2022	Weather:		Coding:	PACP 7.0
Pipe Length (ft):	110.0	Owner:	City of Hobart	Pre Clean:	Heavy Cleaning
P.O.#:	YES502259	Surveyor:	S. Bucklin	PSR:	P-604-045-044
Customer:	City of Hobart	Clean Date:	07/31/2022	Shape:	C

Street:	North Ash Street	Flow Control:	Not Controlled
City:	Hobart, IN	Year Renewed:	
Location:	Local rural streets with light traffic, t	Tape/Media #:	
Purpose:	Routine Assessment	Dia/Height:	12"
Use:	Sanitary Sewage Pipe	Material:	DIP
Drain Area:		Lining:	None
Category:	NA		
Comment:			
Location Details:	PIPE COMES FROM THE NE AND RU	Direction of Survey:	Upstream
US MH:	M-604-044	DS MH:	M-604-045
		Total Length Surveyed (ft):	109.7

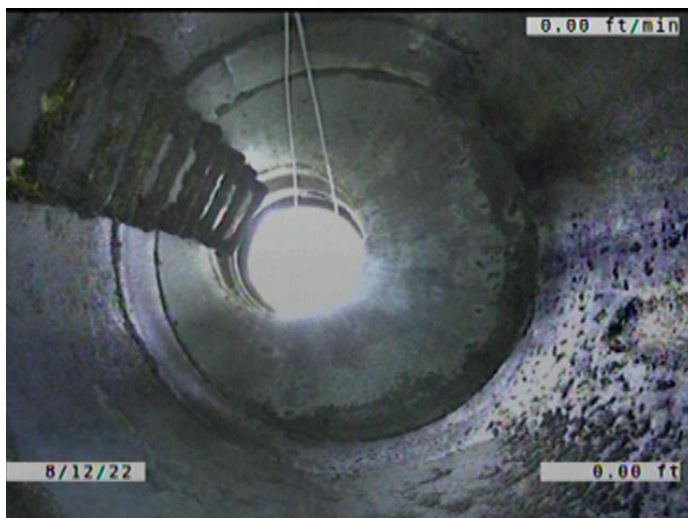
Code: **AMH**
Description: **Manhole**

Distance (ft): **.0**
Structural Grade: **0**
O&M Grade: **0**
Clock Start/From:
Clock To:
1st Value:
2nd Value:
Value Percent:
Continuous Index:
Within 8" of Joint: **NO**
Remarks: **M-604-045**

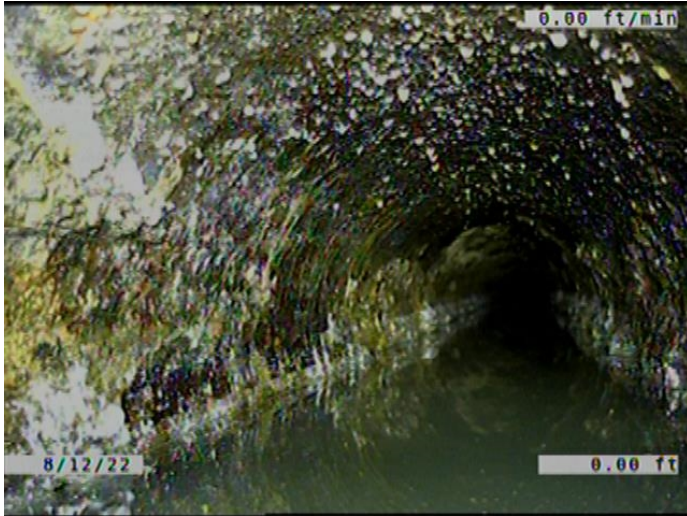
Code: **MWL**
Description: **Miscellaneous Water Level**

Distance (ft): **.0**
Structural Grade: **0**
O&M Grade: **0**
Clock Start/From:
Clock To:
1st Value:
2nd Value:
Value Percent: **40.000**
Continuous Index:
Within 8" of Joint: **NO**
Remarks:

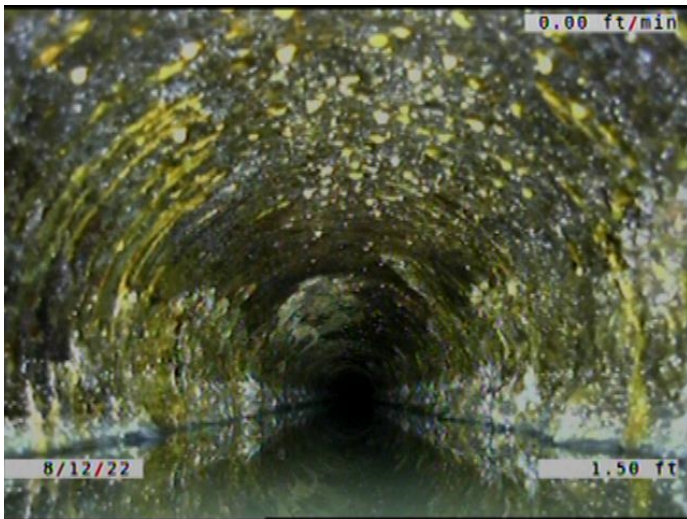
Code: **SSS**
Description: **Surface Damage Surface Spalling**

Distance (ft): **1.5**
Structural Grade: **2**
O&M Grade: **0**
Clock Start/From: **8**
Clock To: **4**
1st Value:
2nd Value:
Value Percent:
Continuous Index: **S01**
Within 8" of Joint: **YES**
Remarks:

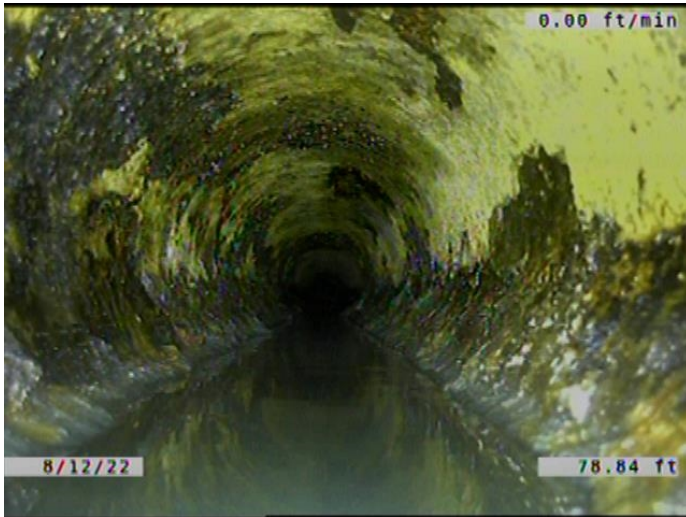
Code: **MWL**
 Description: **Miscellaneous Water Level**

Distance (ft): **78.8**
 Structural Grade: **0**
 O&M Grade: **0**
 Clock Start/From:
 Clock To:
 1st Value:
 2nd Value:
 Value Percent: **10.000**
 Continuous Index:
 Within 8" of Joint: **NO**
 Remarks:

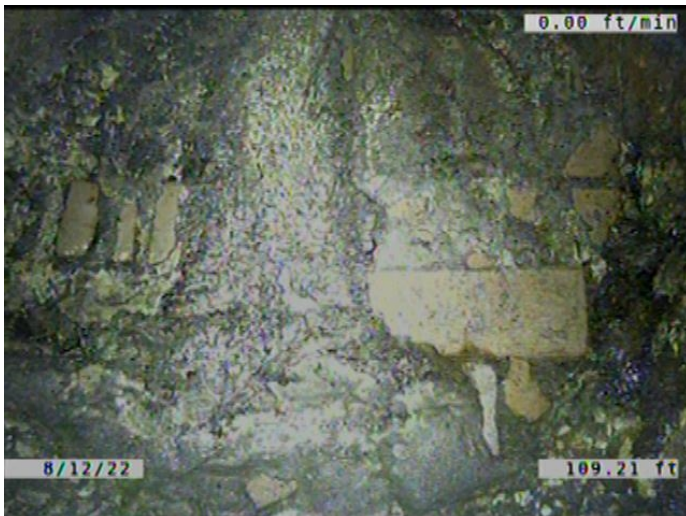
Code: **SSS**
 Description: **Surface Damage Surface Spalling**

Distance (ft): **109.2**
 Structural Grade: **2**
 O&M Grade: **0**
 Clock Start/From: **8**
 Clock To: **4**
 1st Value:
 2nd Value:
 Value Percent:
 Continuous Index: **F01**
 Within 8" of Joint: **YES**
 Remarks:

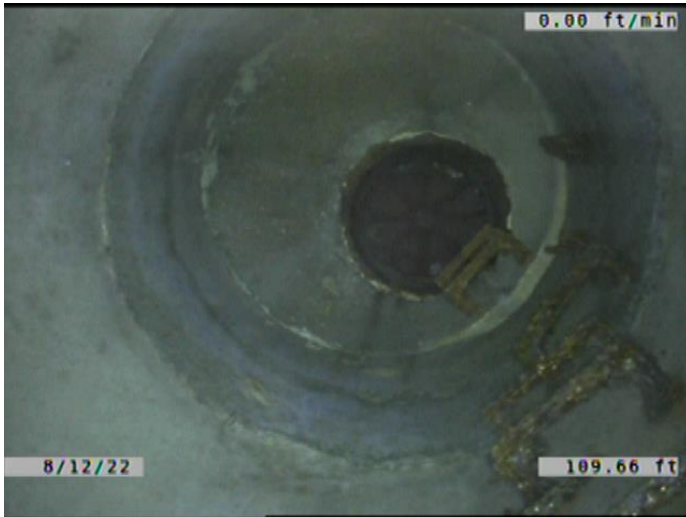
Code:	AMH
Description:	Manhole
Distance (ft):	109.7
Structural Grade:	0
O&M Grade:	0
Clock Start/From:	
Clock To:	
1st Value:	
2nd Value:	
Value Percent:	
Continuous Index:	
Within 8" of Joint:	NO
Remarks:	M-604-044
