Profile/Photo Observation Report

Date:	02/01/2025	Weather:		Coding:	PACP 7.0
Pipe Length (ft):	240.0	Owner:	City of Hobart	Pre Clean:	Heavy Cleaning
P.O.#:		Surveyor:	S. Bucklin	PSR:	P-604-049-048
Customer:	City of Hobart	Clean Date:	04/23/2024	Shape:	C

Street:	West 40th Place	Flow Control:	Not Controlled
City:	Hobart, IN	Year Renewed:	
Location:	Easement/Right of Way	Tape/Media #:	
Purpose:	Sewer System Evaluation Survey (SS	Dia/Height:	10"
Use:	Sanitary Sewage Pipe	Material:	VCP
Drain Area:		Lining:	None
Category:	NA		
Comment:			
Location Details:		Direction of Survey:	Downstream
US MH:	M-604-049	DS MH:	M-604-048
		Total Length Surveyed (ft):	43.9

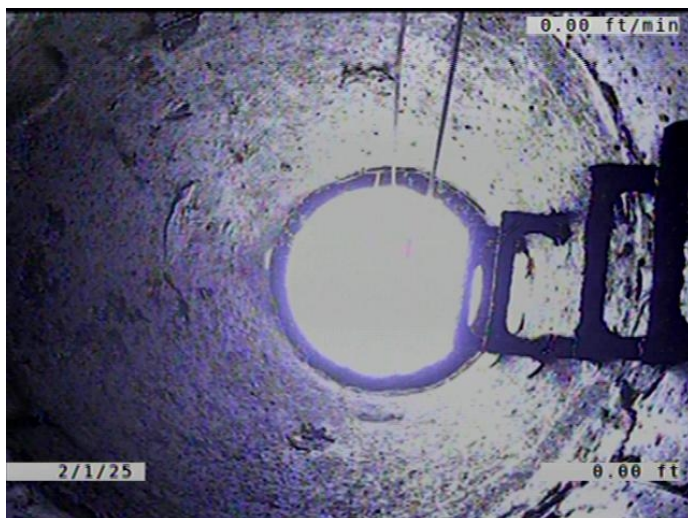
Code: **AMH**
Description: **Manhole**

Distance (ft): **.0**
Structural Grade: **0**
O&M Grade: **0**
Clock Start/From:
Clock To:
1st Value:
2nd Value:
Value Percent:
Continuous Index:
Within 8" of Joint: **NO**
Remarks: **M-604-049**

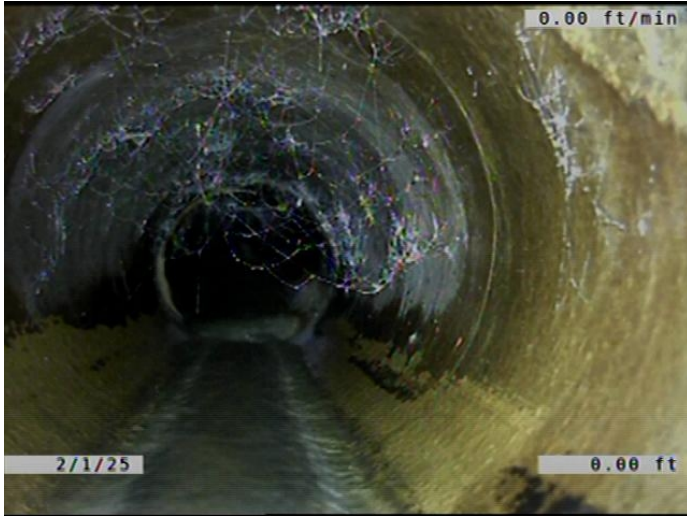
Code: **MWL**
Description: **Miscellaneous Water Level**

Distance (ft): **.0**
Structural Grade: **0**
O&M Grade: **0**
Clock Start/From:
Clock To:
1st Value:
2nd Value:
Value Percent: **5.000**
Continuous Index:
Within 8" of Joint: **NO**
Remarks:

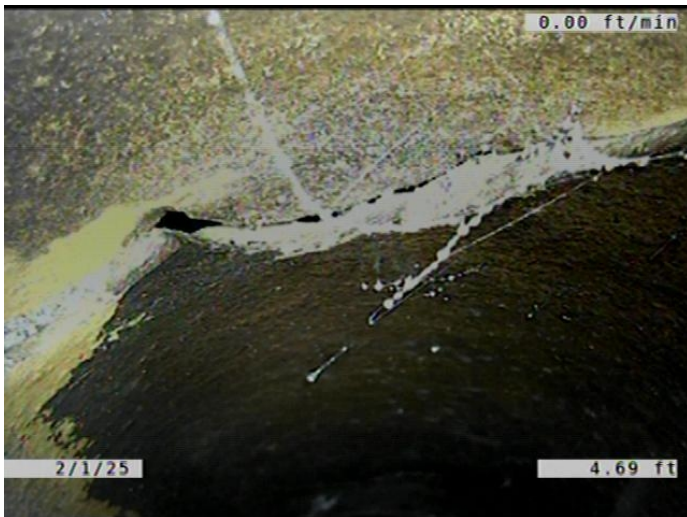
Code: **BVV**
Description: **Broken Void Visible**

Distance (ft): **4.7**
Structural Grade: **5**
O&M Grade: **0**
Clock Start/From: **12**
Clock To: **12**
1st Value:
2nd Value:
Value Percent:
Continuous Index:
Within 8" of Joint: **YES**
Remarks: **SOIL VISIBLE ALSO.**

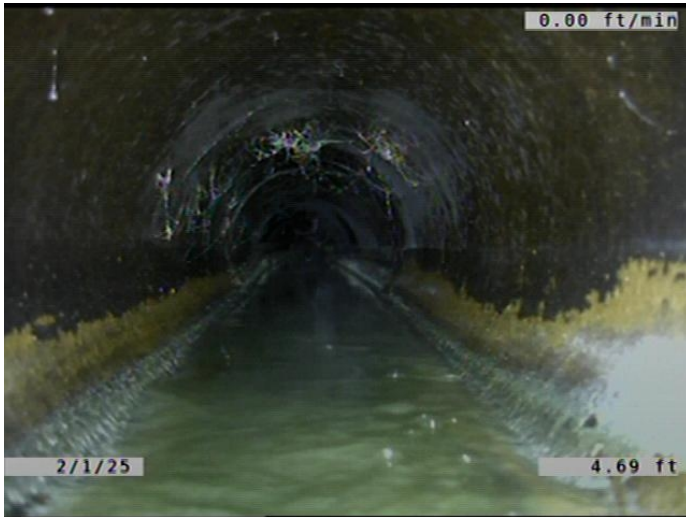
Code: **MWLS**
 Description: **Miscellaneous Water Level Sag**

Distance (ft): **4.7**
 Structural Grade: **3**
 O&M Grade: **0**
 Clock Start/From:
 Clock To:
 1st Value:
 2nd Value:
 Value Percent: **35.000**
 Continuous Index: **S01**
 Within 8" of Joint: **NO**
 Remarks:

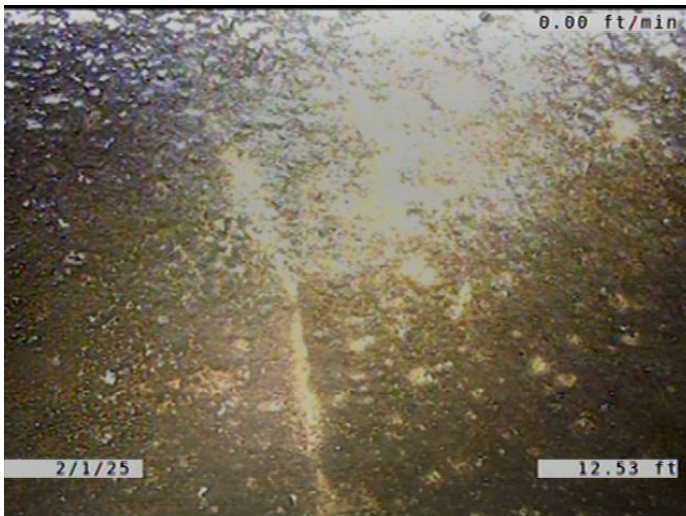
Code: **CS**
 Description: **Crack Spiral**

Distance (ft): **12.5**
 Structural Grade: **2**
 O&M Grade: **0**
 Clock Start/From: **11**
 Clock To: **12**
 1st Value:
 2nd Value:
 Value Percent:
 Continuous Index:
 Within 8" of Joint: **YES**
 Remarks:

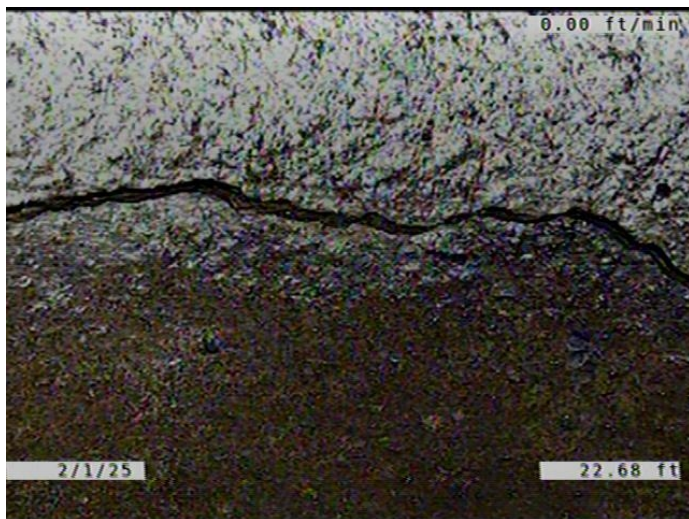
Code: **B**
Description: **Broken**

Distance (ft): **22.7**
Structural Grade: **4**
O&M Grade: **0**
Clock Start/From: **8**
Clock To: **4**
1st Value:
2nd Value:
Value Percent:
Continuous Index: **S02**
Within 8" of Joint: **YES**
Remarks:

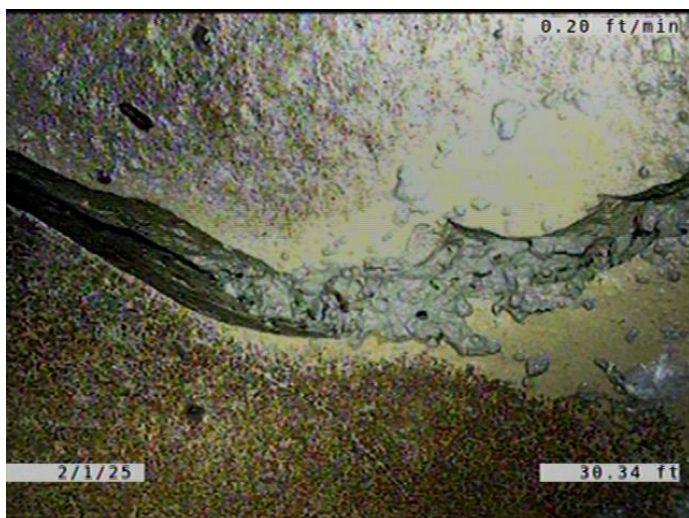
Code: **RFB**
Description: **Roots Fine Barrel**

Distance (ft): **30.3**
Structural Grade: **0**
O&M Grade: **2**
Clock Start/From: **2**
Clock To: **3**
1st Value:
2nd Value:
Value Percent:
Continuous Index:
Within 8" of Joint: **NO**
Remarks:

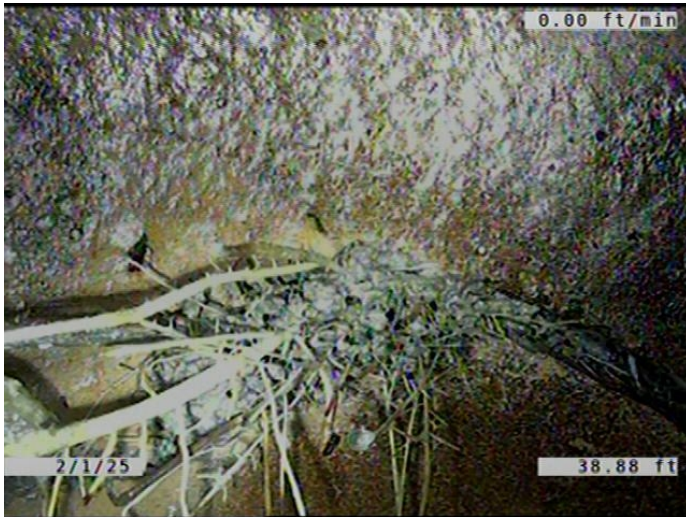
Code: **RFB**
Description: **Roots Fine Barrel**

Distance (ft): **38.9**
Structural Grade: **0**
O&M Grade: **2**
Clock Start/From: **8**
Clock To: **4**
1st Value:
2nd Value:
Value Percent:
Continuous Index:
Within 8" of Joint: **NO**
Remarks:

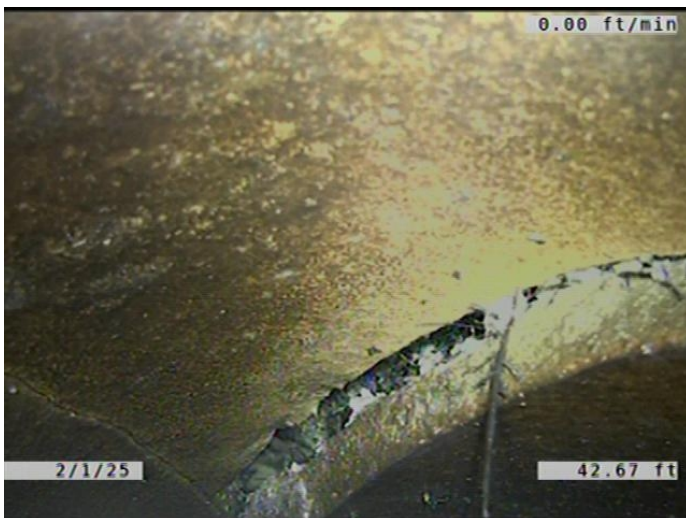
Code: **B**
Description: **Broken**

Distance (ft): **42.7**
Structural Grade: **4**
O&M Grade: **0**
Clock Start/From: **8**
Clock To: **4**
1st Value:
2nd Value:
Value Percent:
Continuous Index: **F02**
Within 8" of Joint: **YES**
Remarks:

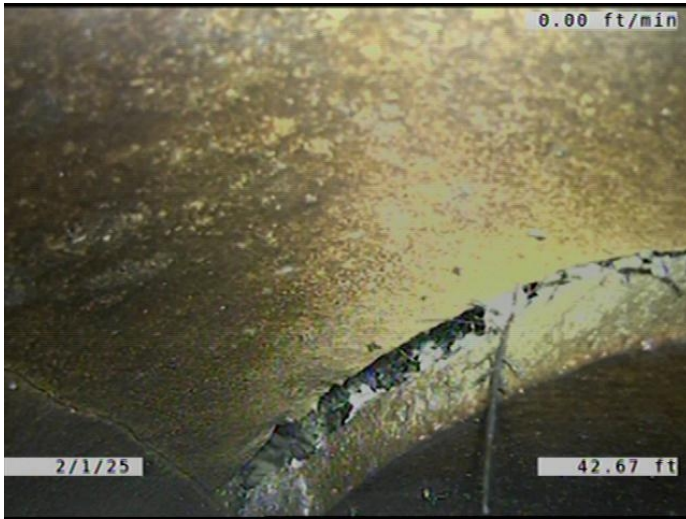
Code: **BSV**
Description: **Broken Soil Visible**

Distance (ft): **42.7**
Structural Grade: **5**
O&M Grade: **0**
Clock Start/From: **8**
Clock To: **4**
1st Value:
2nd Value:
Value Percent:
Continuous Index:
Within 8" of Joint: **YES**
Remarks:

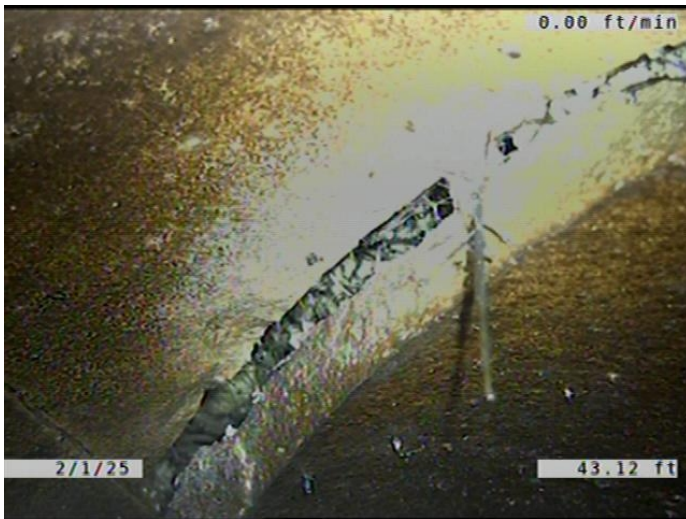
Code: **RFB**
Description: **Roots Fine Barrel**

Distance (ft): **43.1**
Structural Grade: **0**
O&M Grade: **2**
Clock Start/From: **11**
Clock To: **1**
1st Value:
2nd Value:
Value Percent:
Continuous Index:
Within 8" of Joint: **NO**
Remarks:

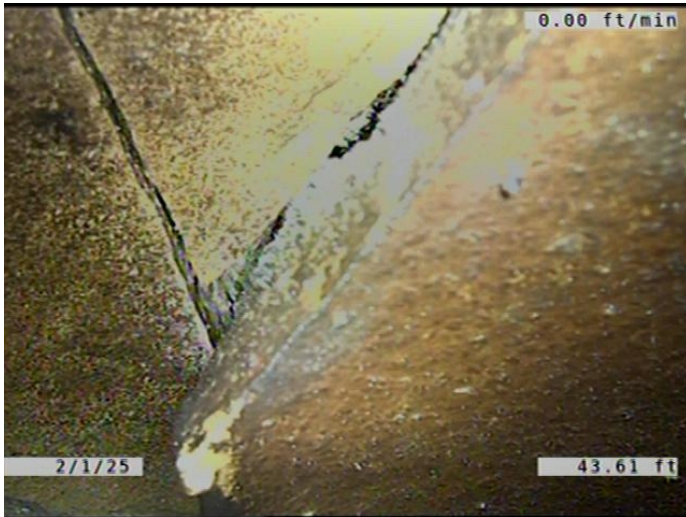
Code: **DR**
 Description: **Deformed Rigid**

Distance (ft): **43.6**
 Structural Grade: **5**
 O&M Grade: **0**
 Clock Start/From:
 Clock To:
 1st Value:
 2nd Value:
 Value Percent: **15.000**
 Continuous Index:
 Within 8" of Joint: **NO**
 Remarks:

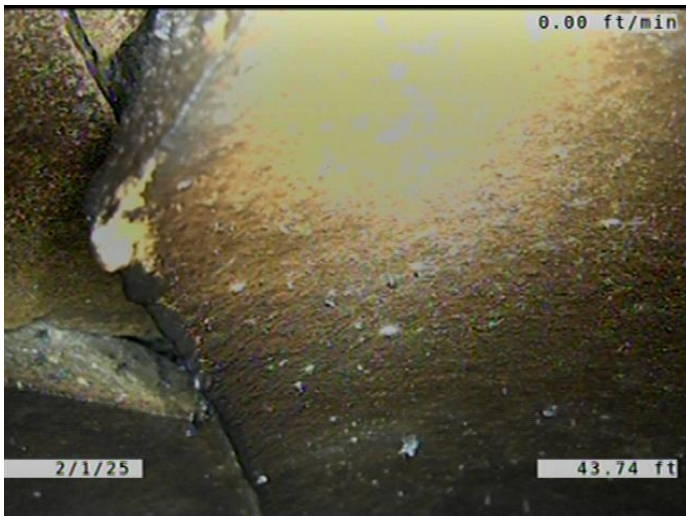
Code: **MWLS**
 Description: **Miscellaneous Water Level Sag**

Distance (ft): **43.7**
 Structural Grade: **3**
 O&M Grade: **0**
 Clock Start/From:
 Clock To:
 1st Value:
 2nd Value:
 Value Percent: **35.000**
 Continuous Index: **F01**
 Within 8" of Joint: **NO**
 Remarks:

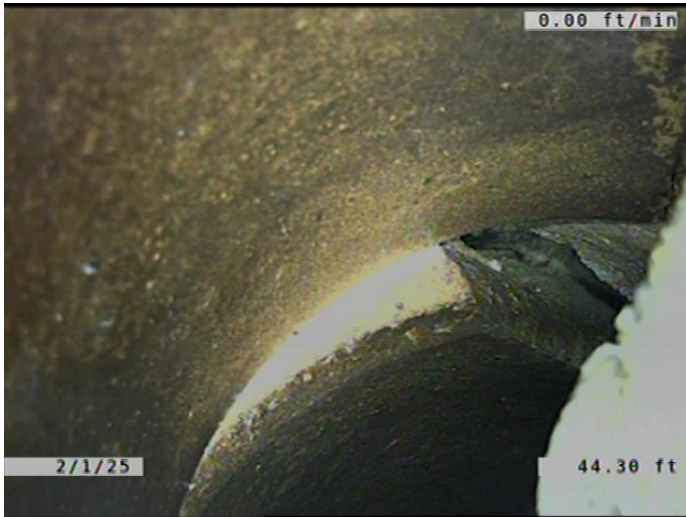
MSA

Miscellaneous Survey Abandoned

**MADE IT TO THE POINT OF OVERLAP.
REVERSAL COMPLETE.**
