## Profile/Photo Observation Report

Street:	<b>Summerlin</b>	Flow Control:	<b>Not Controlled</b>
City:	<b>Hobart, IN</b>	Year Renewed:	
Location:	<b>Light Highway</b>	Tape/Media #:	
Purpose:	<b>Not Known</b>	Dia/Height:	<b>12"</b>
Use:	<b>Sanitary</b>	Material:	<b>PVC</b>
Drain Area:	<b>NA</b>	Lining:	
Category:	<b>NA</b>		
Comment:

Location Details:		Direction of Survey:	<b>Downstream</b>
US MH:	<b>M-604-050</b>	DS MH:	<b>M-604-051</b>
		Total Length Surveyed (ft):	<b>2.5</b>

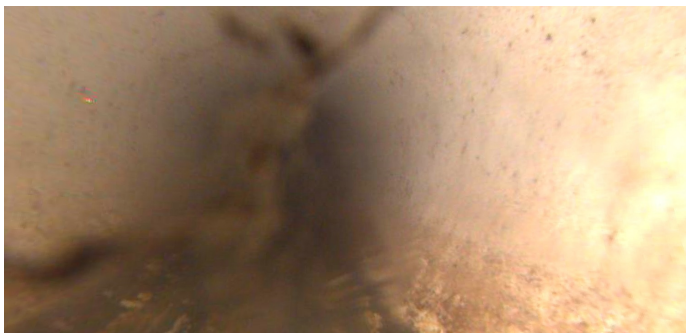
Code: **AMH**  
Description: **Manhole**

Distance (ft): **.0**  
Structural Grade: **0**  
O&M Grade: **0**  
Clock Start/From:  
Clock To:  
1st Value:  
2nd Value:  
Value Percent:  
Continuous Index:  
Within 8" of Joint: **NO**  
Remarks: **M-604-050**

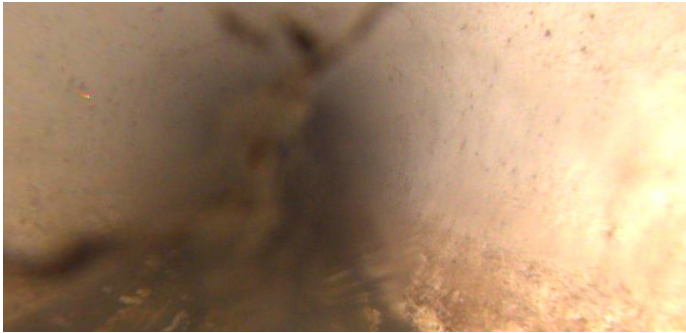
Code:	<b>MWL</b>
Description:	<b>Water Level</b>

Distance (ft):	<b>.0</b>
Structural Grade:	<b>0</b>
O&M Grade:	<b>0</b>
Clock Start/From:	
Clock To:	
1st Value:	
2nd Value:	
Value Percent:	<b>5.000</b>
Continuous Index:	
Within 8" of Joint:	<b>NO</b>
Remarks:

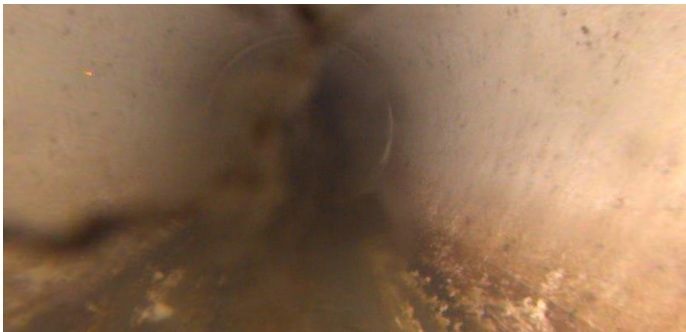
Code:	<b>MSA</b>
Description:	<b>Abandoned Survey</b>

Distance (ft):	<b>2.5</b>
Structural Grade:	<b>0</b>
O&M Grade:	<b>0</b>
Clock Start/From:	
Clock To:	
1st Value:	
2nd Value:	
Value Percent:	
Continuous Index:	
Within 8" of Joint:	<b>NO</b>
Remarks:	<b>unknown</b>
