Profile/Photo Observation Report

Street:	N CONNECTICUT ST	Flow Control:	Not Controlled
City:	Hobart, IN	Year Renewed:	
Location:	Light Highway	Tape/Media #:	
Purpose:	Not Known	Dia/Height:	12"
Use:	Sanitary	Material:	VCP
Drain Area:	NA	Lining:	
Category:	NA		
Comment:

Location Details:		Direction of Survey:	Downstream
US MH:	M-604-054	DS MH:	M-604-089
		Total Length Surveyed (ft):	164.8

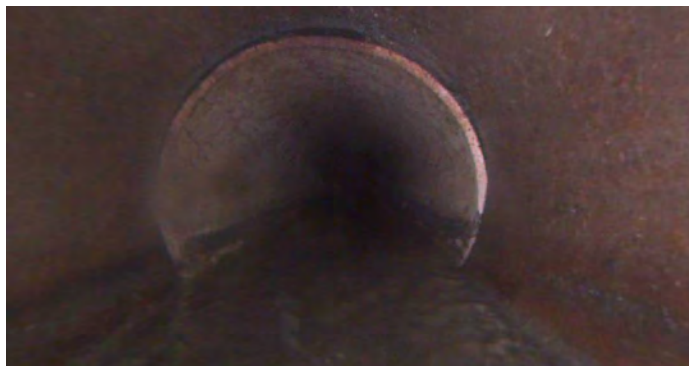
Code: **AMH**
Description: **Manhole**

Distance (ft): **.0**
Structural Grade: **0**
O&M Grade: **0**
Clock Start/From:
Clock To:
1st Value:
2nd Value:
Value Percent:
Continuous Index:
Within 8" of Joint: **NO**
Remarks: **M-604-054**

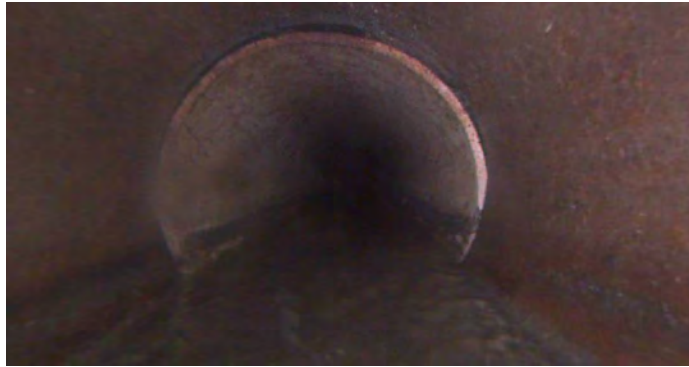
Code: **MWL**
Description: **Water Level**

Distance (ft): **.0**
Structural Grade: **0**
O&M Grade: **0**
Clock Start/From:
Clock To:
1st Value:
2nd Value:
Value Percent: **10.000**
Continuous Index:
Within 8" of Joint: **NO**
Remarks:

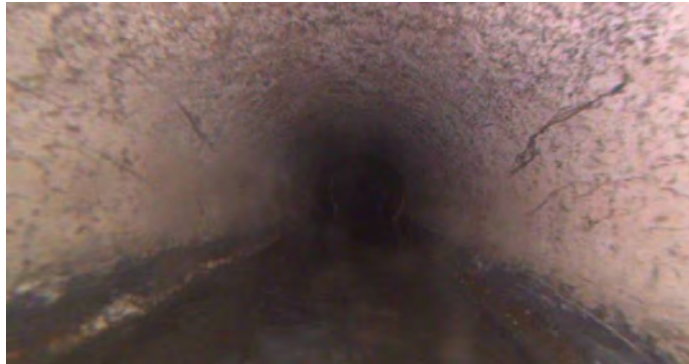
Code: **MMC**
Description: **Material Change**

Distance (ft): **3.4**
Structural Grade: **0**
O&M Grade: **0**
Clock Start/From:
Clock To:
1st Value:
2nd Value:
Value Percent:
Continuous Index:
Within 8" of Joint: **NO**
Remarks: **PVC**

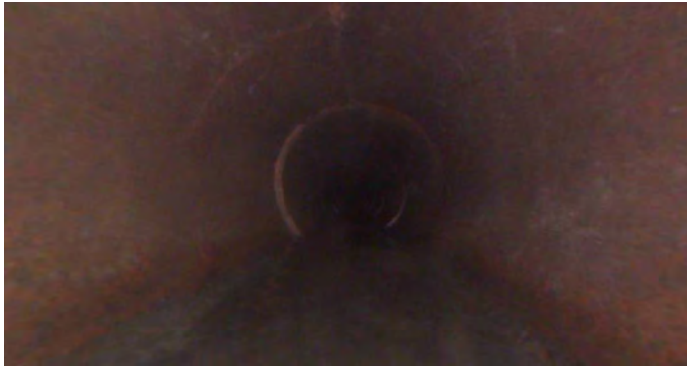
Code: **MMC**
Description: **Material Change**

Distance (ft): **6.4**
Structural Grade: **0**
O&M Grade: **0**
Clock Start/From:
Clock To:
1st Value:
2nd Value:
Value Percent:
Continuous Index:
Within 8" of Joint: **NO**
Remarks: **VCP**

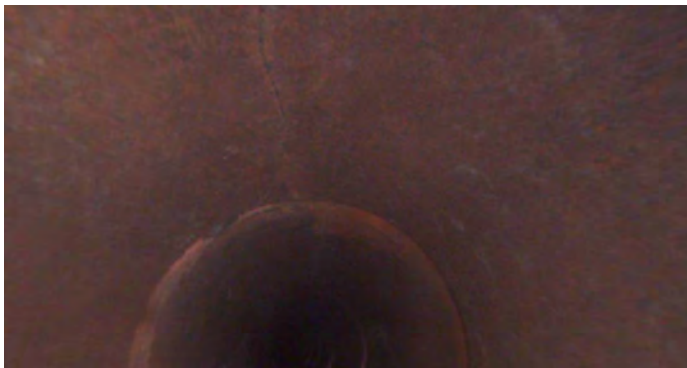
Code: **CM**
Description: **Crack Multiple**

Distance (ft): **7.2**
Structural Grade: **3**
O&M Grade: **0**
Clock Start/From: **8**
Clock To: **2**
1st Value:
2nd Value:
Value Percent:
Continuous Index:
Within 8" of Joint:
Remarks:

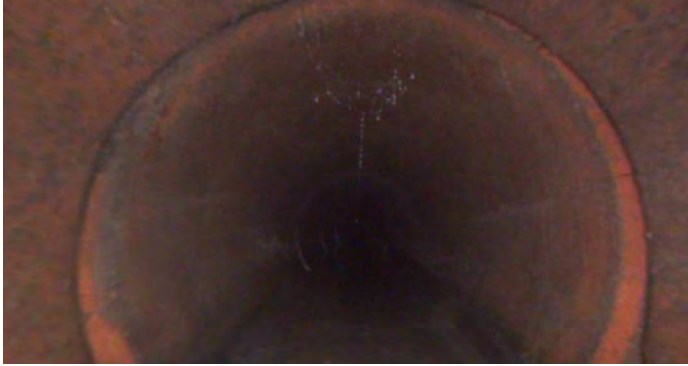
Code: **CL**
Description: **Crack Longitudinal**

Distance (ft): **21.9**
Structural Grade: **2**
O&M Grade: **0**
Clock Start/From: **3**
Clock To:
1st Value:
2nd Value:
Value Percent:
Continuous Index:
Within 8" of Joint: **YES**
Remarks:

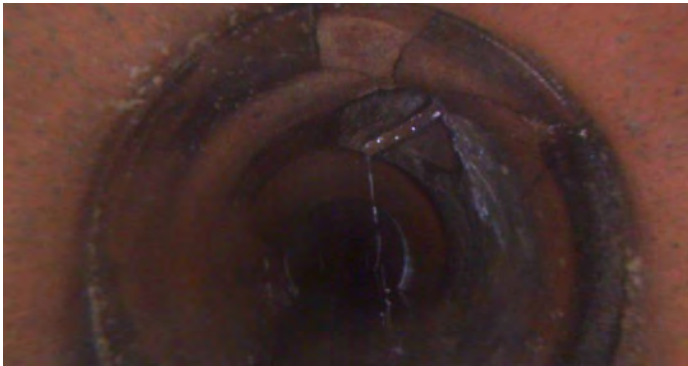
Code: **CM**
Description: **Crack Multiple**

Distance (ft): **34.2**
Structural Grade: **3**
O&M Grade: **0**
Clock Start/From: **10**
Clock To: **3**
1st Value:
2nd Value:
Value Percent:
Continuous Index:
Within 8" of Joint:
Remarks:

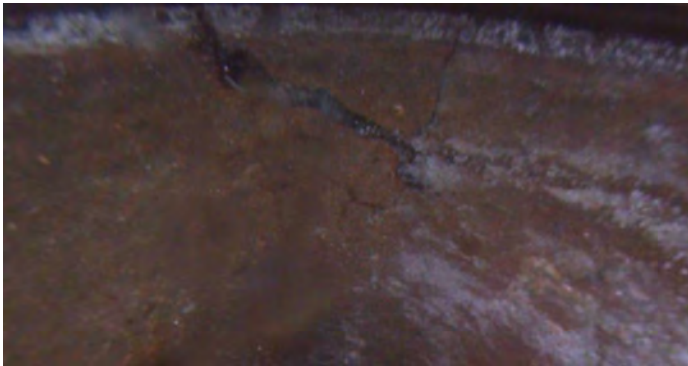
Code: **CM**
Description: **Crack Multiple**

Distance (ft): **79.8**
Structural Grade: **3**
O&M Grade: **0**
Clock Start/From: **11**
Clock To: **2**
1st Value:
2nd Value:
Value Percent:
Continuous Index:
Within 8" of Joint: **YES**
Remarks:

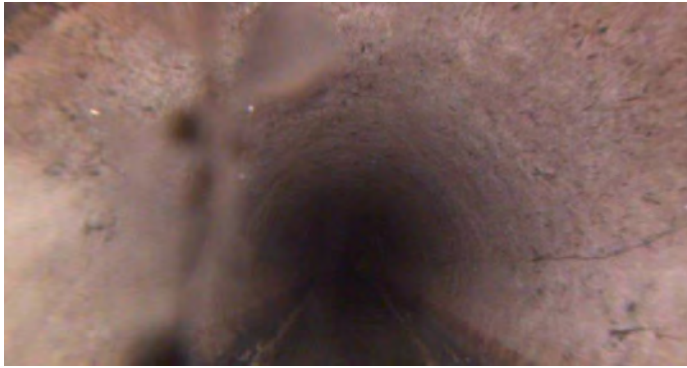
Code: **MMC**
Description: **Material Change**

Distance (ft): **81.6**
Structural Grade: **0**
O&M Grade: **0**
Clock Start/From:
Clock To:
1st Value:
2nd Value:
Value Percent:
Continuous Index:
Within 8" of Joint: **NO**
Remarks: **PVC**

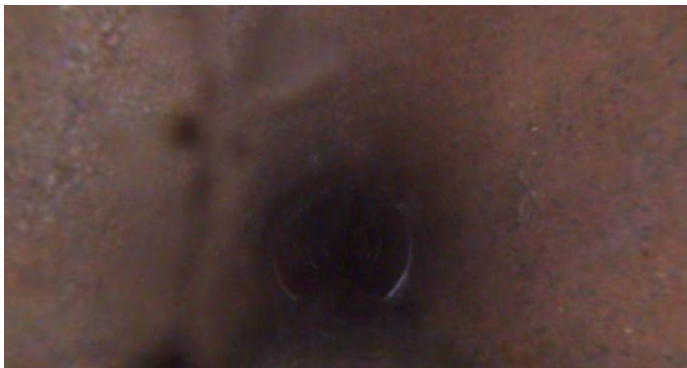
Code: **MMC**
Description: **Material Change**

Distance (ft): **92.0**
Structural Grade: **0**
O&M Grade: **0**
Clock Start/From:
Clock To:
1st Value:
2nd Value:
Value Percent:
Continuous Index:
Within 8" of Joint: **NO**
Remarks: **VCP**

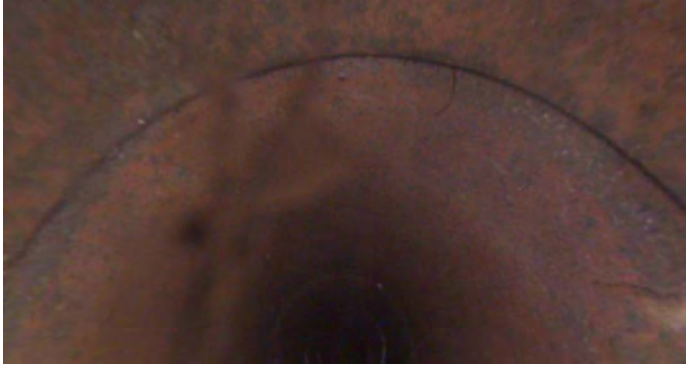
Code: **CS**
Description: **Crack Spiral**

Distance (ft): **114.5**
Structural Grade: **2**
O&M Grade: **0**
Clock Start/From: **1**
Clock To: **3**
1st Value:
2nd Value:
Value Percent:
Continuous Index:
Within 8" of Joint: **YES**
Remarks:

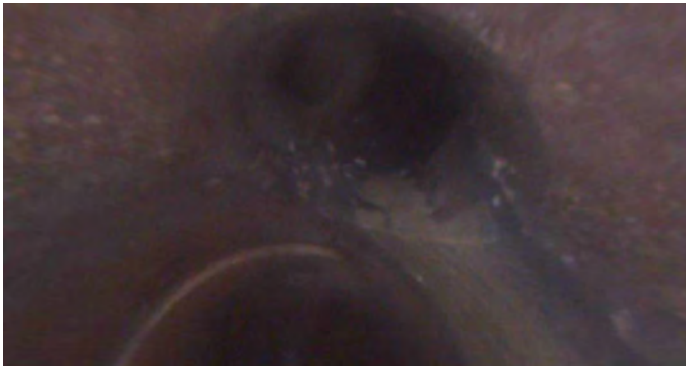
Code: **TF**
Description: **Tap Factory**

Distance (ft): **128.3**
Structural Grade: **0**
O&M Grade: **0**
Clock Start/From: **11**
Clock To:
1st Value: **4.000**
2nd Value:
Value Percent:
Continuous Index:
Within 8" of Joint:
Remarks:

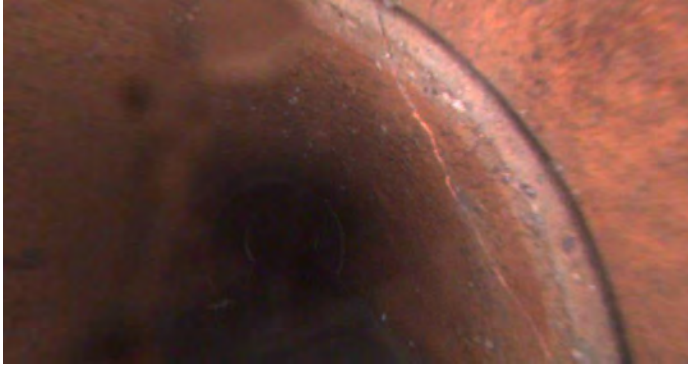
Code: **CS**
Description: **Crack Spiral**

Distance (ft): **139.2**
Structural Grade: **2**
O&M Grade: **0**
Clock Start/From: **1**
Clock To: **5**
1st Value:
2nd Value:
Value Percent:
Continuous Index:
Within 8" of Joint: **YES**
Remarks:

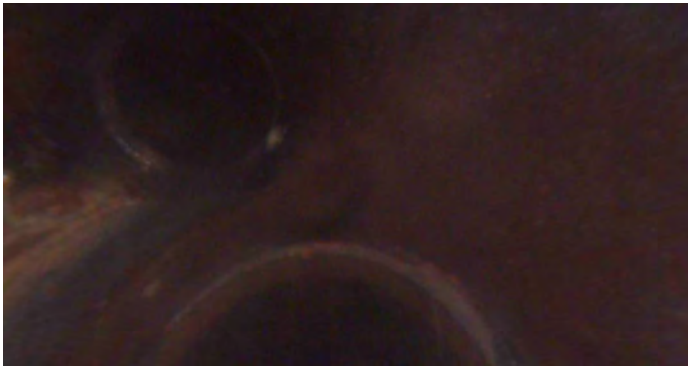
Code: **TF**
Description: **Tap Factory**

Distance (ft): **146.6**
Structural Grade: **0**
O&M Grade: **0**
Clock Start/From: **2**
Clock To:
1st Value: **4.000**
2nd Value:
Value Percent:
Continuous Index:
Within 8" of Joint:
Remarks:

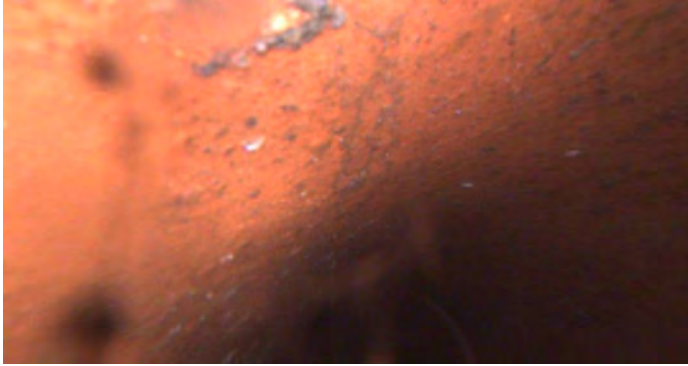
Code:	MSA
Description:	Abandoned Survey
Distance (ft):	164.8
Structural Grade:	0
O&M Grade:	0
Clock Start/From:	
Clock To:	
1st Value:	
2nd Value:	
Value Percent:	
Continuous Index:	
Within 8" of Joint:	NO
Remarks:	Debris
