## Profile/Photo Observation Report

Date:	<b>04/22/2018</b>	Weather:		Coding:	<b>PACP 6.0</b>
Pipe Length (ft):	<b>194.4</b>	Owner:	<b>NA</b>	Pre Clean:	<b>Not Known</b>
P.O.#:		Surveyor:	<b>Mark Ruby</b>	PSR:	<b>P-604-089-054</b>
Customer:		Clean Date:	<b>01/01/1900</b>	Shape:	<b>C</b>

Street:	<b>Summerlin</b>	Flow Control:	<b>Not Controlled</b>
City:	<b>Hobart, IN</b>	Year Renewed:	
Location:	<b>Light Highway</b>	Tape/Media #:	
Purpose:	<b>Not Known</b>	Dia/Height:	<b>12"</b>
Use:	<b>Sanitary</b>	Material:	<b>VCP</b>
Drain Area:	<b>NA</b>	Lining:	
Category:	<b>NA</b>		
Comment:

Location Details:		Direction of Survey:	<b>Downstream</b>
US MH:	<b>M-604-054</b>	DS MH:	<b>M-604-089</b>
		Total Length Surveyed (ft):	<b>164.8</b>

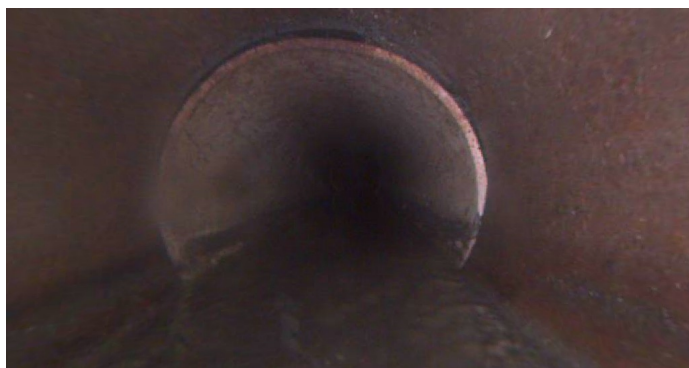
Code: **AMH**  
 Description: **Manhole**

Distance (ft): **.0**  
 Structural Grade: **0**  
 O&M Grade: **0**  
 Clock Start/From:  
 Clock To:  
 1st Value:  
 2nd Value:  
 Value Percent:  
 Continuous Index:  
 Within 8" of Joint: **NO**  
 Remarks: **M-604-054**

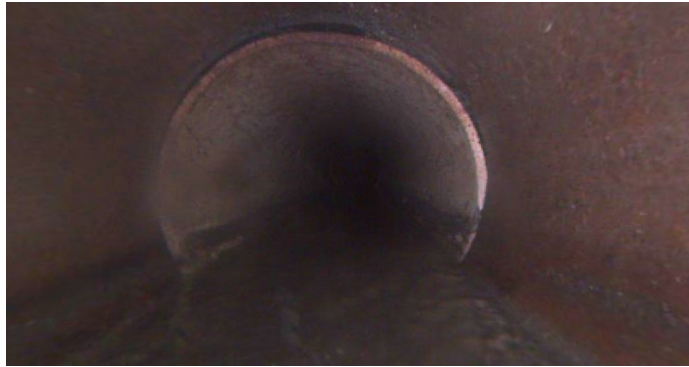
Code: **MWL**  
Description: **Water Level**

Distance (ft): **.0**  
Structural Grade: **0**  
O&M Grade: **0**  
Clock Start/From:  
Clock To:  
1st Value:  
2nd Value:  
Value Percent: **10.000**  
Continuous Index:  
Within 8" of Joint: **NO**  
Remarks:

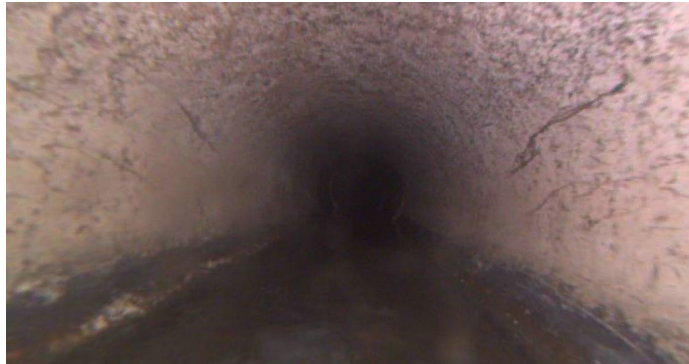
Code: **MMC**  
Description: **Material Change**

Distance (ft): **3.4**  
Structural Grade: **0**  
O&M Grade: **0**  
Clock Start/From:  
Clock To:  
1st Value:  
2nd Value:  
Value Percent:  
Continuous Index:  
Within 8" of Joint: **NO**  
Remarks: **PVC**

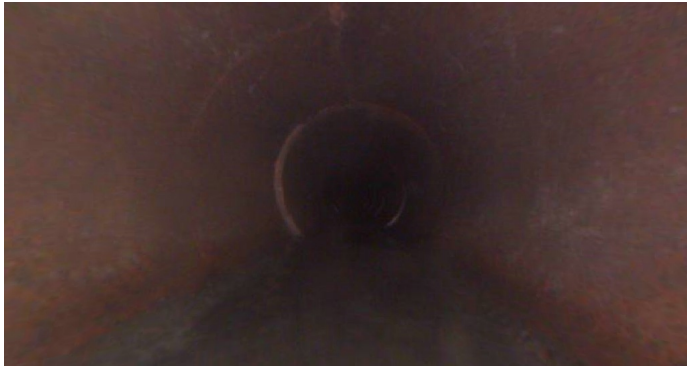
Code: **MMC**  
Description: **Material Change**

Distance (ft): **6.4**  
Structural Grade: **0**  
O&M Grade: **0**  
Clock Start/From:  
Clock To:  
1st Value:  
2nd Value:  
Value Percent:  
Continuous Index:  
Within 8" of Joint: **NO**  
Remarks: **VCP**

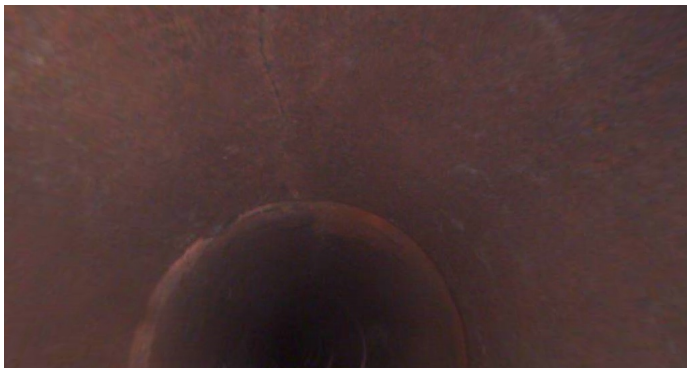
Code: **CM**  
Description: **Crack Multiple**

Distance (ft): **7.2**  
Structural Grade: **3**  
O&M Grade: **0**  
Clock Start/From: **8**  
Clock To: **2**  
1st Value:  
2nd Value:  
Value Percent:  
Continuous Index:  
Within 8" of Joint:  
Remarks:

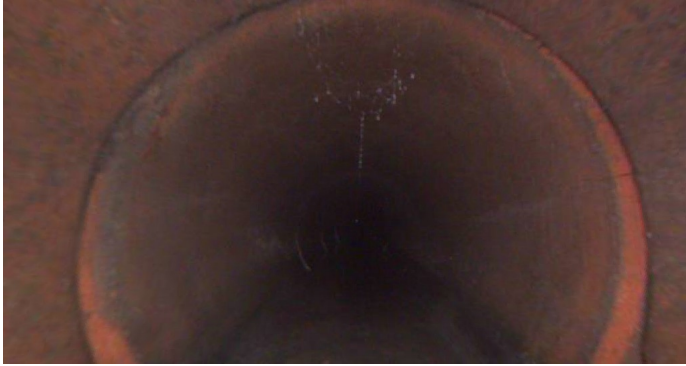
Code: **CL**  
Description: **Crack Longitudinal**

Distance (ft): **21.9**  
Structural Grade: **2**  
O&M Grade: **0**  
Clock Start/From: **3**  
Clock To:  
1st Value:  
2nd Value:  
Value Percent:  
Continuous Index:  
Within 8" of Joint: **YES**  
Remarks:

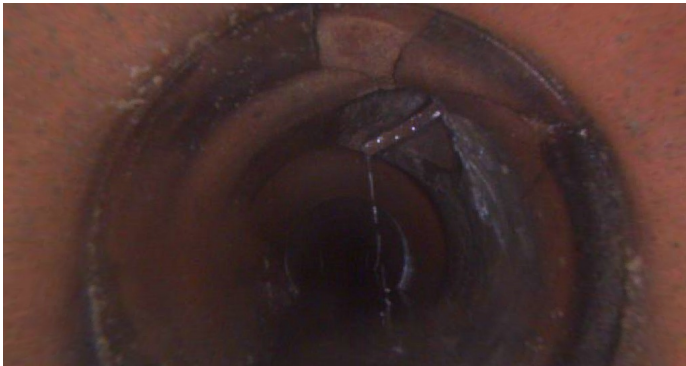
Code: **CM**  
Description: **Crack Multiple**

Distance (ft): **34.2**  
Structural Grade: **3**  
O&M Grade: **0**  
Clock Start/From: **10**  
Clock To: **3**  
1st Value:  
2nd Value:  
Value Percent:  
Continuous Index:  
Within 8" of Joint:  
Remarks:

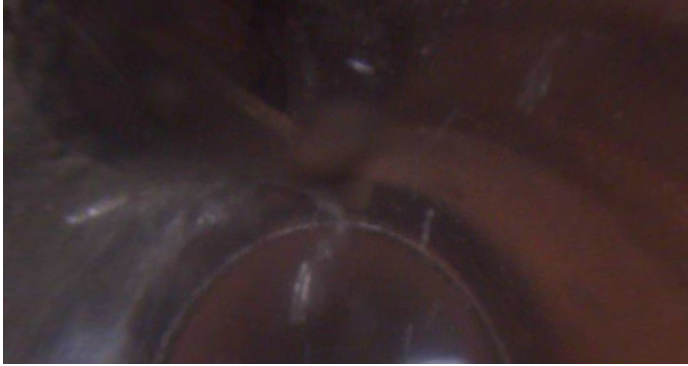
Code: **TF**  
Description: **Tap Factory**

Distance (ft): **35.8**  
Structural Grade: **0**  
O&M Grade: **0**  
Clock Start/From: **1**  
Clock To:  
1st Value: **4.000**  
2nd Value:  
Value Percent:  
Continuous Index:  
Within 8" of Joint:  
Remarks:

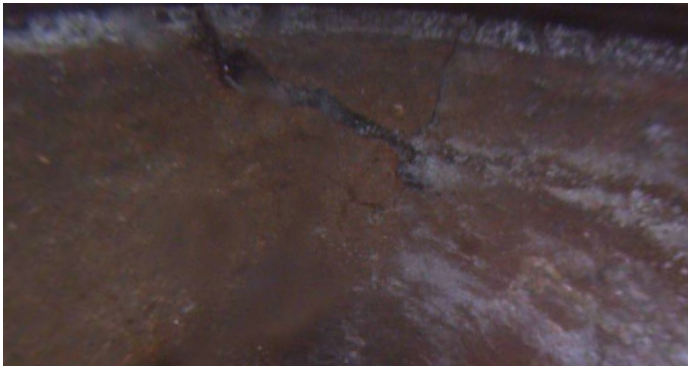
Code: **CM**  
Description: **Crack Multiple**

Distance (ft): **79.8**  
Structural Grade: **3**  
O&M Grade: **0**  
Clock Start/From: **11**  
Clock To: **2**  
1st Value:  
2nd Value:  
Value Percent:  
Continuous Index:  
Within 8" of Joint: **YES**  
Remarks:

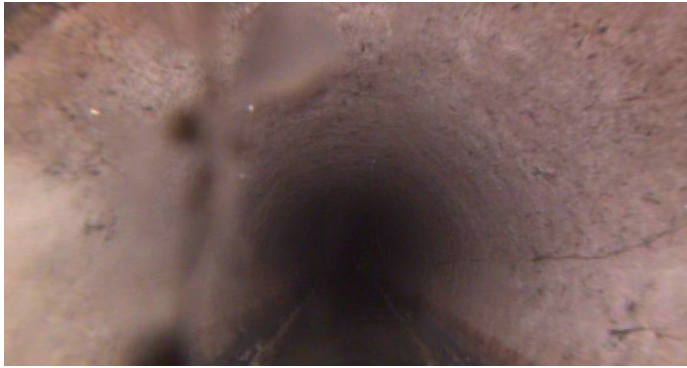
Code: **MMC**  
Description: **Material Change**

Distance (ft): **81.6**  
Structural Grade: **0**  
O&M Grade: **0**  
Clock Start/From:  
Clock To:  
1st Value:  
2nd Value:  
Value Percent:  
Continuous Index:  
Within 8" of Joint: **NO**  
Remarks: **PVC**

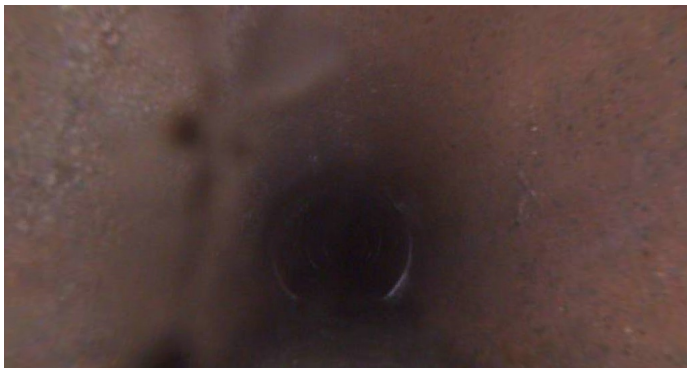
Code: **MMC**  
Description: **Material Change**

Distance (ft): **92.0**  
Structural Grade: **0**  
O&M Grade: **0**  
Clock Start/From:  
Clock To:  
1st Value:  
2nd Value:  
Value Percent:  
Continuous Index:  
Within 8" of Joint: **NO**  
Remarks: **VCP**

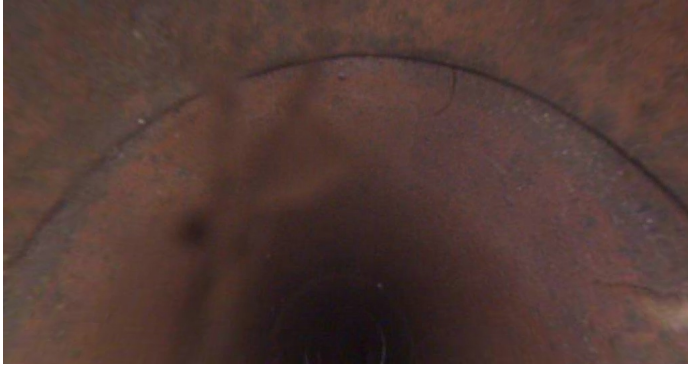
Code: **CS**  
Description: **Crack Spiral**

Distance (ft): **114.5**  
Structural Grade: **2**  
O&M Grade: **0**  
Clock Start/From: **1**  
Clock To: **3**  
1st Value:  
2nd Value:  
Value Percent:  
Continuous Index:  
Within 8" of Joint: **YES**  
Remarks:

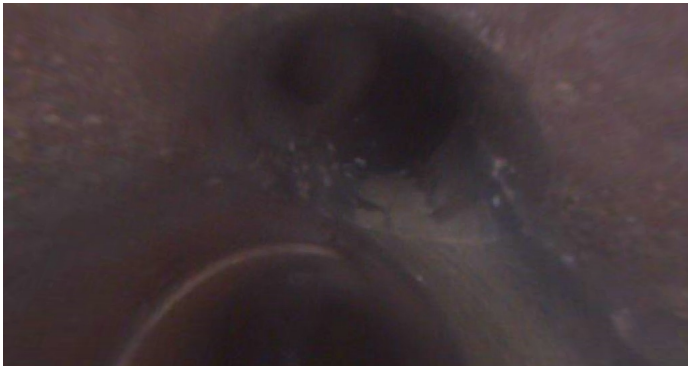
Code: **TF**  
Description: **Tap Factory**

Distance (ft): **128.3**  
Structural Grade: **0**  
O&M Grade: **0**  
Clock Start/From: **11**  
Clock To:  
1st Value: **4.000**  
2nd Value:  
Value Percent:  
Continuous Index:  
Within 8" of Joint:  
Remarks:

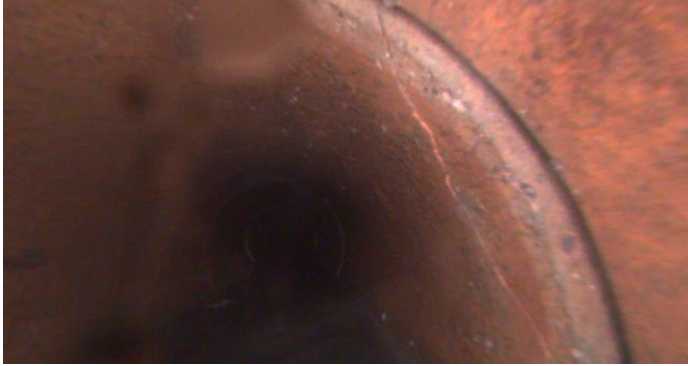
Code: **CS**  
Description: **Crack Spiral**

Distance (ft): **139.2**  
Structural Grade: **2**  
O&M Grade: **0**  
Clock Start/From: **1**  
Clock To: **5**  
1st Value:  
2nd Value:  
Value Percent:  
Continuous Index:  
Within 8" of Joint: **YES**  
Remarks:

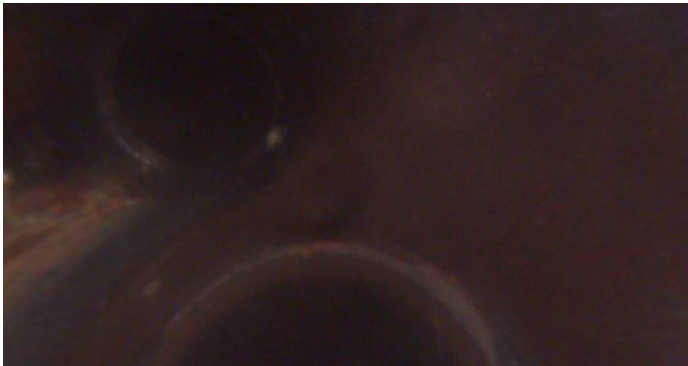
Code: **TF**  
Description: **Tap Factory**

Distance (ft): **146.6**  
Structural Grade: **0**  
O&M Grade: **0**  
Clock Start/From: **2**  
Clock To:  
1st Value: **4.000**  
2nd Value:  
Value Percent:  
Continuous Index:  
Within 8" of Joint:  
Remarks:

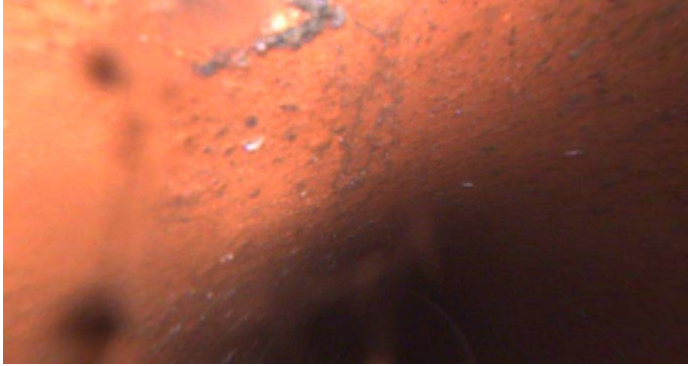
Code:	<b>MSA</b>
Description:	<b>Abandoned Survey</b>
Distance (ft):	<b>164.8</b>
Structural Grade:	<b>0</b>
O&M Grade:	<b>0</b>
Clock Start/From:	
Clock To:	
1st Value:	
2nd Value:	
Value Percent:	
Continuous Index:	
Within 8" of Joint:	<b>NO</b>
Remarks:	<b>Debris</b>
