Profile/Photo Observation Report

Date:	04/22/2018	Weather:		Coding:	PACP 6.0
Pipe Length (ft):	194.4	Owner:	NA	Pre Clean:	Not Known
P.O.#:		Surveyor:	Jen Costello	PSR:	P-604-089-054
Customer:		Clean Date:	01/01/1900	Shape:	C

Street:	N CONNECTICUT ST	Flow Control:	Not Controlled
City:	Hobart, IN	Year Renewed:	
Location:	Light Highway	Tape/Media #:	
Purpose:	Not Known	Dia/Height:	12"
Use:	Sanitary	Material:	VCP
Drain Area:	NA	Lining:	
Category:	NA		
Comment:

Location Details:		Direction of Survey:	Upstream
US MH:	M-604-054	DS MH:	M-604-089
		Total Length Surveyed (ft):	24.8

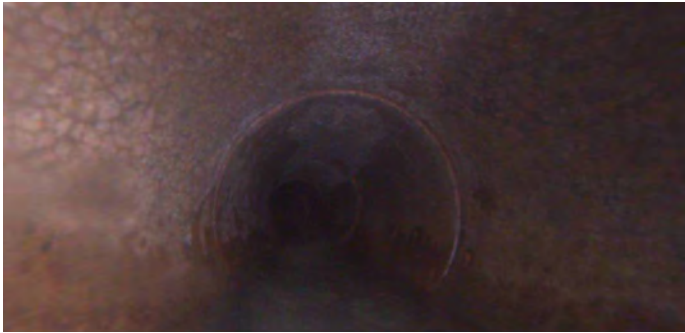
Code:	MWL
Description:	Water Level

Distance (ft):	.0
Structural Grade:	0
O&M Grade:	0
Clock Start/From:	
Clock To:	
1st Value:	
2nd Value:	
Value Percent:	10.000
Continuous Index:	
Within 8" of Joint:	NO
Remarks:

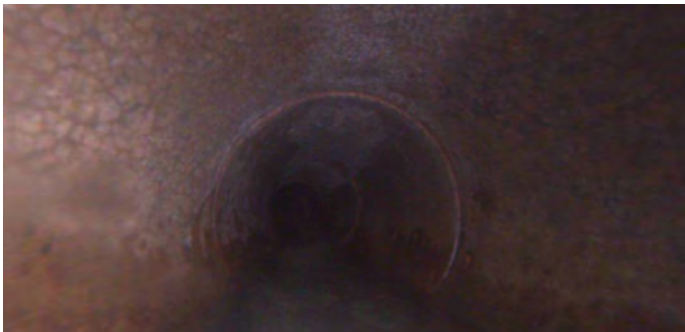
Code:	CM
Description:	Crack Multiple

Distance (ft):	.0
Structural Grade:	3
O&M Grade:	0
Clock Start/From:	8
Clock To:	4
1st Value:	
2nd Value:	
Value Percent:	
Continuous Index:	S01
Within 8" of Joint:	
Remarks:

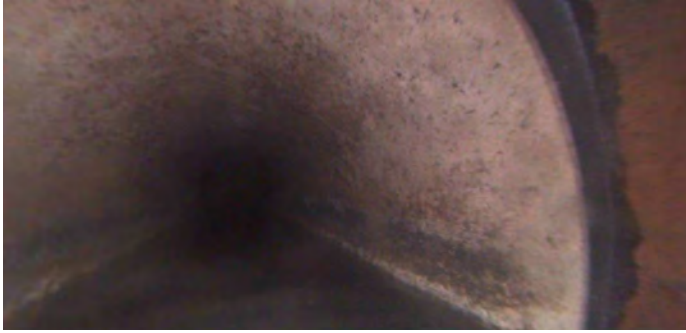
Code: **CM**
Description: **Crack Multiple**

Distance (ft): **7.2**
Structural Grade: **3**
O&M Grade: **0**
Clock Start/From: **8**
Clock To: **4**
1st Value:
2nd Value:
Value Percent:
Continuous Index: **F01**
Within 8" of Joint:
Remarks:

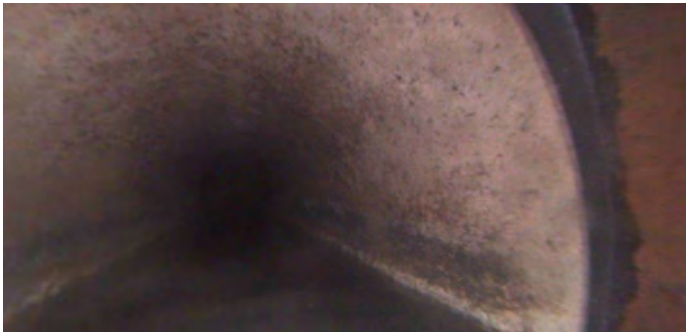
Code: **MMC**
Description: **Material Change**

Distance (ft): **7.2**
Structural Grade: **0**
O&M Grade: **0**
Clock Start/From:
Clock To:
1st Value:
2nd Value:
Value Percent:
Continuous Index:
Within 8" of Joint: **NO**
Remarks: **PVC**

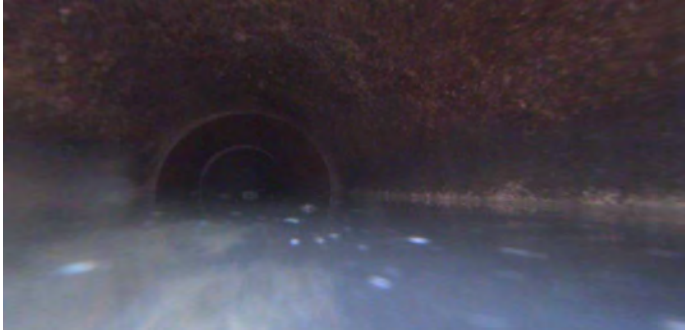
Code: **MWL**
Description: **Water Level**

Distance (ft): **12.0**
Structural Grade: **0**
O&M Grade: **0**
Clock Start/From:
Clock To:
1st Value:
2nd Value:
Value Percent: **60.000**
Continuous Index:
Within 8" of Joint: **NO**
Remarks:

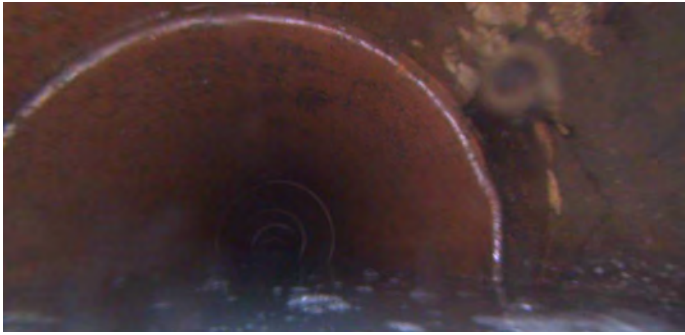
Code: **FM**
Description: **Fracture Multiple**

Distance (ft): **17.3**
Structural Grade: **4**
O&M Grade: **0**
Clock Start/From: **2**
Clock To: **4**
1st Value:
2nd Value:
Value Percent:
Continuous Index:
Within 8" of Joint: **YES**
Remarks:

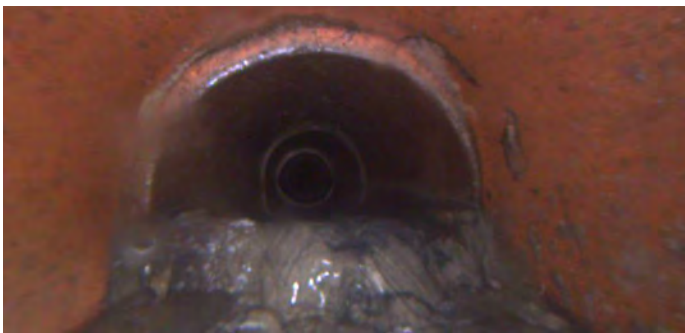
Code: **DSZ**
Description: **Deposits Settled Other**

Distance (ft): **23.4**
Structural Grade: **0**
O&M Grade: **5**
Clock Start/From: **3**
Clock To: **9**
1st Value:
2nd Value:
Value Percent: **40.000**
Continuous Index:
Within 8" of Joint: **NO**
Remarks: **MISC**

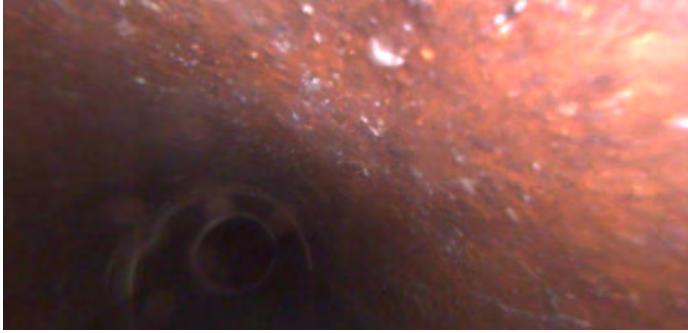
Code:	MSA
Description:	Abandoned Survey
Distance (ft):	24.8
Structural Grade:	0
O&M Grade:	0
Clock Start/From:	
Clock To:	
1st Value:	
2nd Value:	
Value Percent:	
Continuous Index:	
Within 8" of Joint:	NO
Remarks:	UNKNOWN
