Profile/Photo Observation Report

Street:	Summerlin	Flow Control:	Not Controlled
City:	Hobart, IN	Year Renewed:	
Location:	Light Highway	Tape/Media #:	
Purpose:	Not Known	Dia/Height:	12"
Use:	Sanitary	Material:	VCP
Drain Area:	NA	Lining:	
Category:	NA		
Comment:

Location Details:		Direction of Survey:	Upstream
US MH:	M-604-054	DS MH:	M-604-089
		Total Length Surveyed (ft):	24.8

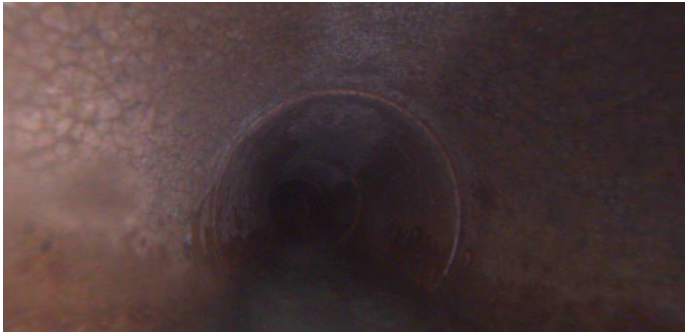
Code:	MWL
Description:	Water Level

Distance (ft):	.0
Structural Grade:	0
O&M Grade:	0
Clock Start/From:	
Clock To:	
1st Value:	
2nd Value:	
Value Percent:	10.000
Continuous Index:	
Within 8" of Joint:	NO
Remarks:

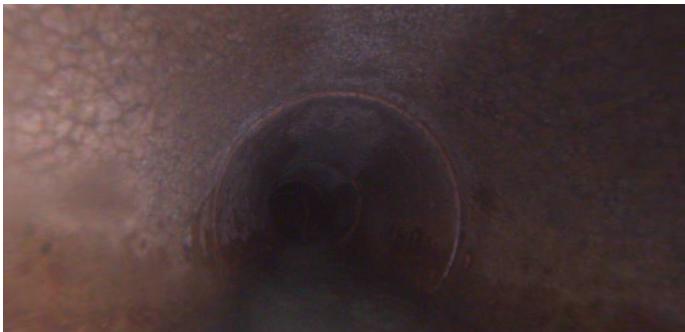
Code:	CM
Description:	Crack Multiple

Distance (ft):	.0
Structural Grade:	3
O&M Grade:	0
Clock Start/From:	8
Clock To:	4
1st Value:	
2nd Value:	
Value Percent:	
Continuous Index:	S01
Within 8" of Joint:	
Remarks:

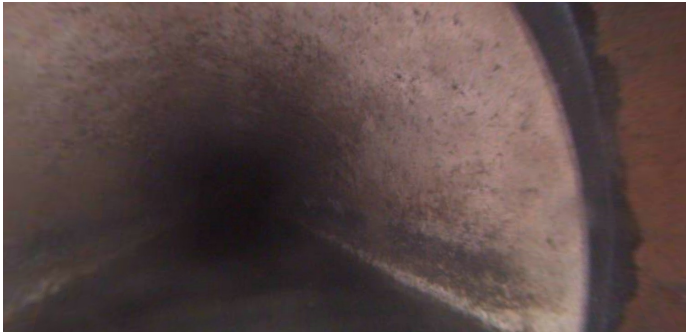
Code: **CM**
Description: **Crack Multiple**

Distance (ft): **7.2**
Structural Grade: **3**
O&M Grade: **0**
Clock Start/From: **8**
Clock To: **4**
1st Value:
2nd Value:
Value Percent:
Continuous Index: **F01**
Within 8" of Joint:
Remarks:

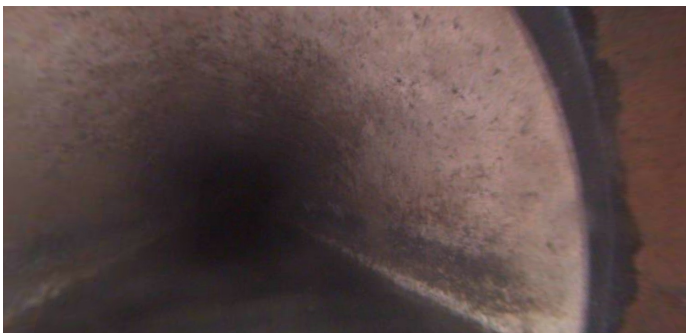
Code: **MMC**
Description: **Material Change**

Distance (ft): **7.2**
Structural Grade: **0**
O&M Grade: **0**
Clock Start/From:
Clock To:
1st Value:
2nd Value:
Value Percent:
Continuous Index:
Within 8" of Joint: **NO**
Remarks: **PVC**

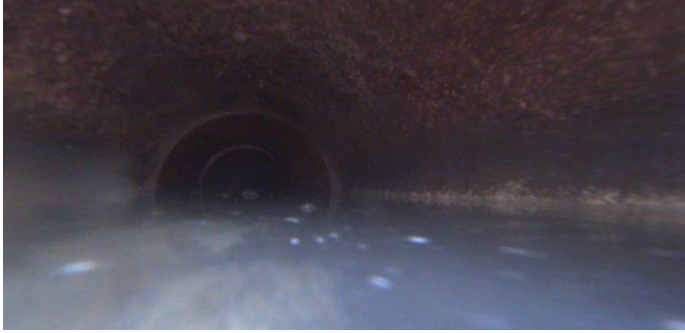
Code: **MWL**
Description: **Water Level**

Distance (ft): **12.0**
Structural Grade: **0**
O&M Grade: **0**
Clock Start/From:
Clock To:
1st Value:
2nd Value:
Value Percent: **60.000**
Continuous Index:
Within 8" of Joint: **NO**
Remarks:

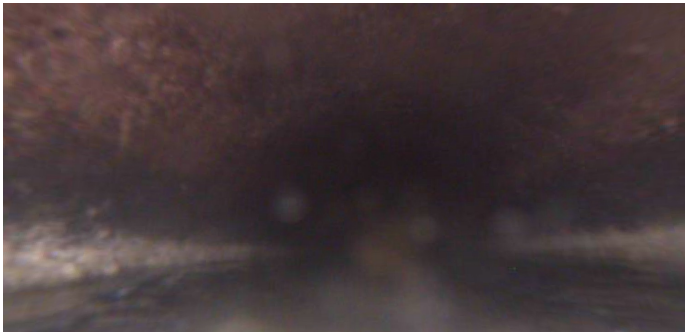
Code: **MMC**
Description: **Material Change**

Distance (ft): **13.6**
Structural Grade: **0**
O&M Grade: **0**
Clock Start/From:
Clock To:
1st Value:
2nd Value:
Value Percent:
Continuous Index:
Within 8" of Joint: **NO**
Remarks: **VCP**

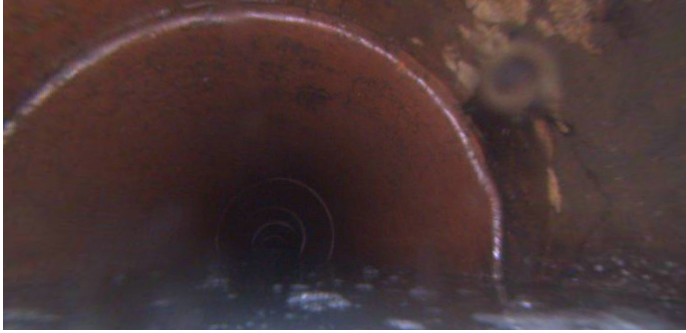
Code: **FM**
Description: **Fracture Multiple**

Distance (ft): **17.3**
Structural Grade: **4**
O&M Grade: **0**
Clock Start/From: **2**
Clock To: **4**
1st Value:
2nd Value:
Value Percent:
Continuous Index:
Within 8" of Joint: **YES**
Remarks:

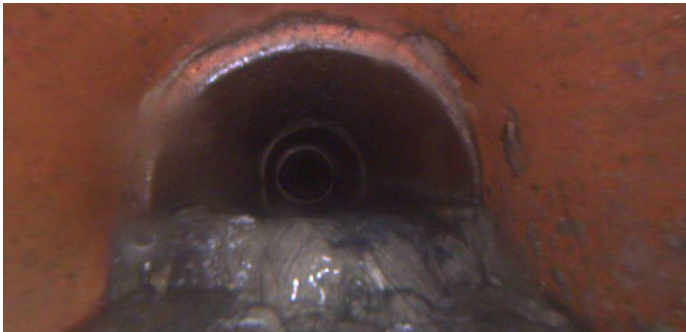
Code: **DSZ**
Description: **Deposits Settled Other**

Distance (ft): **23.4**
Structural Grade: **0**
O&M Grade: **5**
Clock Start/From: **3**
Clock To: **9**
1st Value:
2nd Value:
Value Percent: **40.000**
Continuous Index:
Within 8" of Joint: **NO**
Remarks: **MISC**

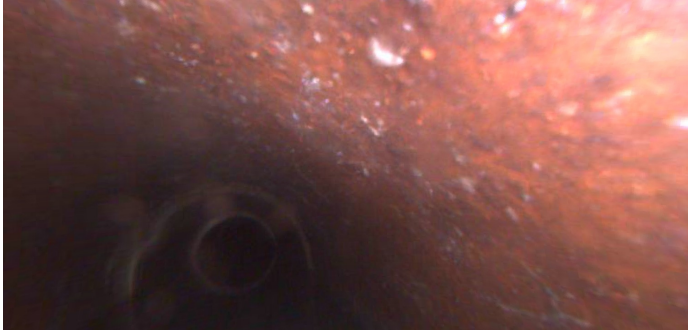
Code:	MSA
Description:	Abandoned Survey
Distance (ft):	24.8
Structural Grade:	0
O&M Grade:	0
Clock Start/From:	
Clock To:	
1st Value:	
2nd Value:	
Value Percent:	
Continuous Index:	
Within 8" of Joint:	NO
Remarks:	UNKNOWN
