Profile/Photo Observation Report

Street:	Connecticut Street	Flow Control:	Not Controlled
City:	Hobart, IN	Year Renewed:	
Location:	Light Highway	Tape/Media #:	DEP 63
Purpose:	Routine Assessment	Dia/Height:	18"
Use:	Sanitary	Material:	VCP
Drain Area:		Lining:	
Category:	NA		
Comment:

Location Details:		Direction of Survey:	Upstream
US MH:	M-604-056	DS MH:	M-604-057
		Total Length Surveyed (ft):	126.8

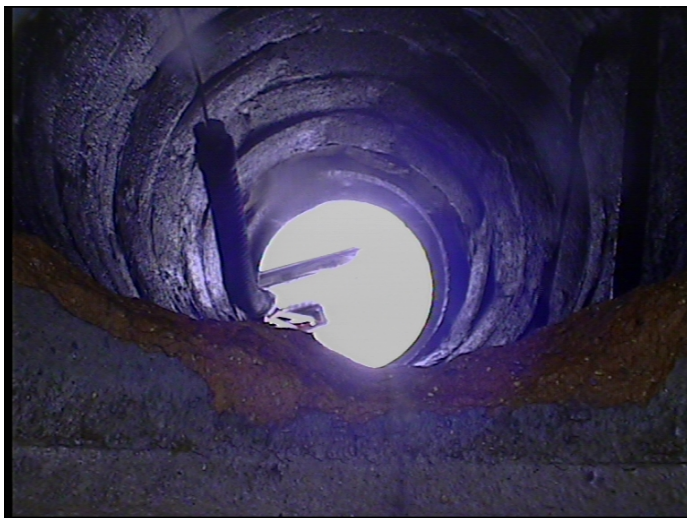
Code:	AMH
Description:	Manhole
Distance (ft):	.0
Structural Grade:	0
O&M Grade:	0
Clock Start/From:	
Clock To:	
1st Value:	
2nd Value:	
Value Percent:	
Continuous Index:	
Within 8" of Joint:	NO
Remarks:	M-604-057

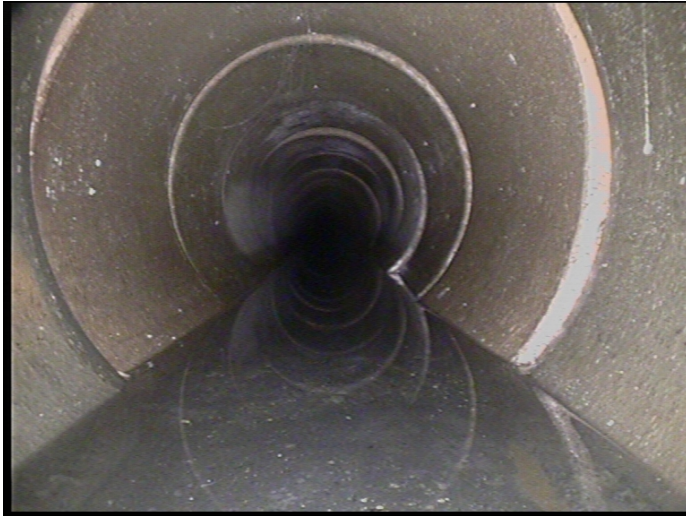
Code: **MWL**
Description: **Water Level**

Distance (ft): **.0**
Structural Grade: **0**
O&M Grade: **0**
Clock Start/From:
Clock To:
1st Value:
2nd Value:
Value Percent: **10.000**
Continuous Index:
Within 8" of Joint: **NO**
Remarks:

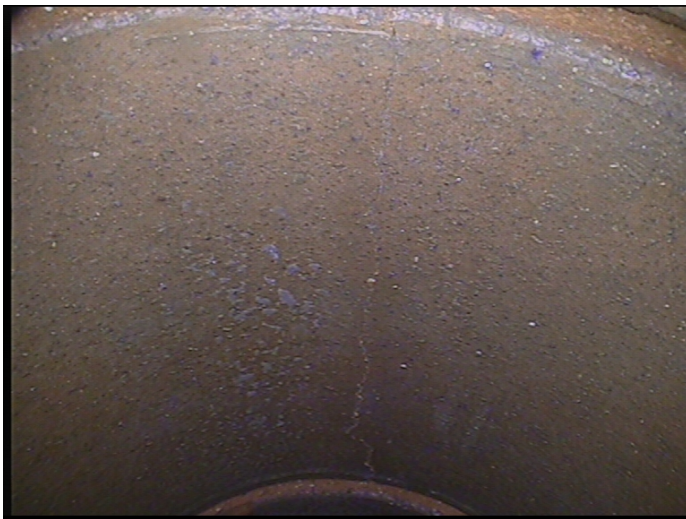
Code: **CL**
Description: **Crack Longitudinal**

Distance (ft): **50.3**
Structural Grade: **2**
O&M Grade: **0**
Clock Start/From: **12**
Clock To:
1st Value:
2nd Value:
Value Percent:
Continuous Index: **S01**
Within 8" of Joint: **YES**
Remarks:

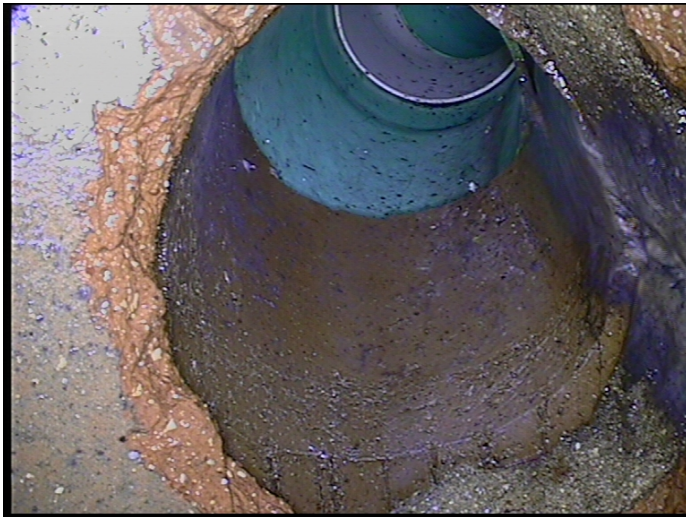
Code: **TFA**
Description: **Tap Factory Active**

Distance (ft): **57.9**
Structural Grade: **0**
O&M Grade: **0**
Clock Start/From: **2**
Clock To:
1st Value: **4.000**
2nd Value:
Value Percent:
Continuous Index:
Within 8" of Joint: **NO**
Remarks:

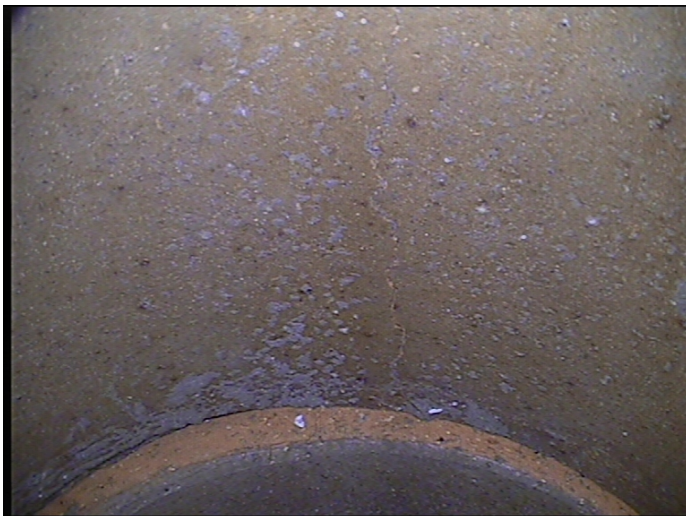
Code: **CL**
Description: **Crack Longitudinal**

Distance (ft): **72.2**
Structural Grade: **2**
O&M Grade: **0**
Clock Start/From: **12**
Clock To:
1st Value:
2nd Value:
Value Percent:
Continuous Index: **F01**
Within 8" of Joint: **NO**
Remarks:

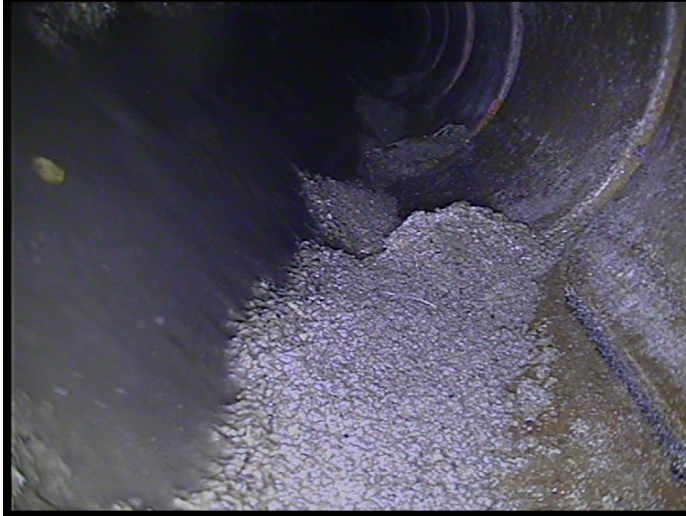
Code: **DAZ**
Description: **Deposits Attached Other**

Distance (ft): **107.2**
Structural Grade: **0**
O&M Grade: **2**
Clock Start/From: **4**
Clock To: **5**
1st Value:
2nd Value:
Value Percent: **10.000**
Continuous Index: **S02**
Within 8" of Joint: **YES**
Remarks: **Deposits**

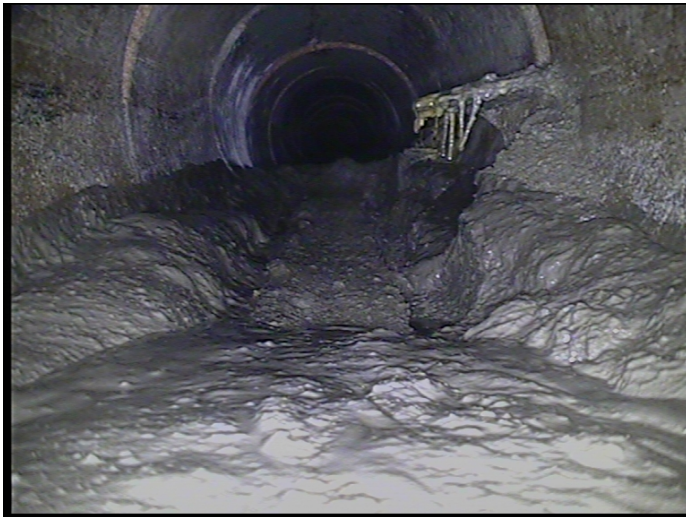
Code: **DAZ**
Description: **Deposits Attached Other**

Distance (ft): **118.5**
Structural Grade: **0**
O&M Grade: **4**
Clock Start/From: **4**
Clock To: **5**
1st Value:
2nd Value:
Value Percent: **25.000**
Continuous Index: **F02**
Within 8" of Joint: **NO**
Remarks: **Deposits**

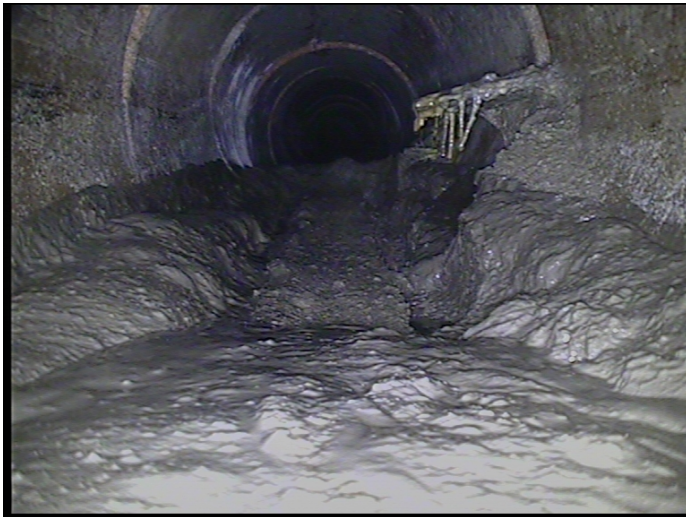
Code:	MSA
Description:	Abandoned Survey
Distance (ft):	118.5
Structural Grade:	0
O&M Grade:	0
Clock Start/From:	
Clock To:	
1st Value:	
2nd Value:	
Value Percent:	
Continuous Index:	
Within 8" of Joint:	NO
Remarks:	heavy sediment
