## Profile/Photo Observation Report

Date:	<b>08/10/2022</b>	Weather:		Coding:	<b>PACP 7.0</b>
Pipe Length (ft):	<b>176.0</b>	Owner:	<b>City of Hobart</b>	Pre Clean:	<b>Heavy Cleaning</b>
P.O.#:	<b>YES502259</b>	Surveyor:	<b>S. Bucklin</b>	PSR:	<b>P-604-056-057</b>
Customer:	<b>City of Hobart</b>	Clean Date:	<b>08/03/2022</b>	Shape:	<b>C</b>

Street:	<b>North Connecticut Street</b>	Flow Control:	<b>Not Controlled</b>
City:	<b>Hobart, IN</b>	Year Renewed:	
Location:	<b>Local rural streets with light traffic, t</b>	Tape/Media #:	
Purpose:	<b>Routine Assessment</b>	Dia/Height:	<b>18"</b>
Use:	<b>Sanitary Sewage Pipe</b>	Material:	<b>VCP</b>
Drain Area:		Lining:	<b>None</b>
Category:	<b>NA</b>		
Comment:			
Location Details:		Direction of Survey:	<b>Downstream</b>
US MH:	<b>M-604-056</b>	DS MH:	<b>M-604-057</b>
		Total Length Surveyed (ft):	<b>173.7</b>

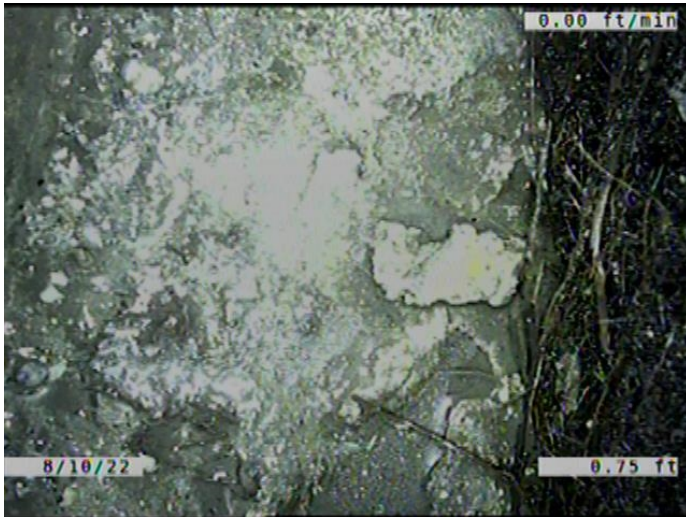
Code: **DSC**  
 Description: **Deposits Settled Hard/Compacted**

Distance (ft): **.7**  
 Structural Grade: **0**  
 O&M Grade: **2**  
 Clock Start/From: **5**  
 Clock To: **7**  
 1st Value:  
 2nd Value:  
 Value Percent: **5.000**  
 Continuous Index:  
 Within 8" of Joint: **YES**  
 Remarks:

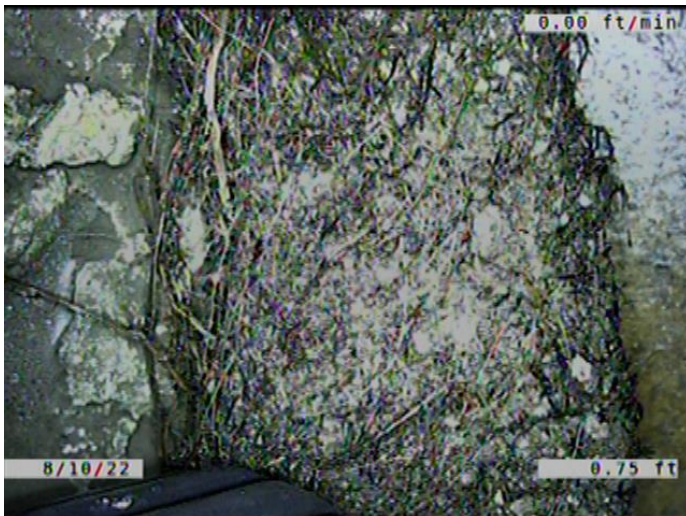
Code: **RMJ**  
 Description: **Roots Medium Joint**

Distance (ft): **.7**  
 Structural Grade: **0**  
 O&M Grade: **3**  
 Clock Start/From: **4**  
 Clock To: **5**  
 1st Value:  
 2nd Value:  
 Value Percent: **5.000**  
 Continuous Index:  
 Within 8" of Joint: **YES**  
 Remarks: **ROOTS GROWING IN THE MAINHOLE INTO THE PIPE.**

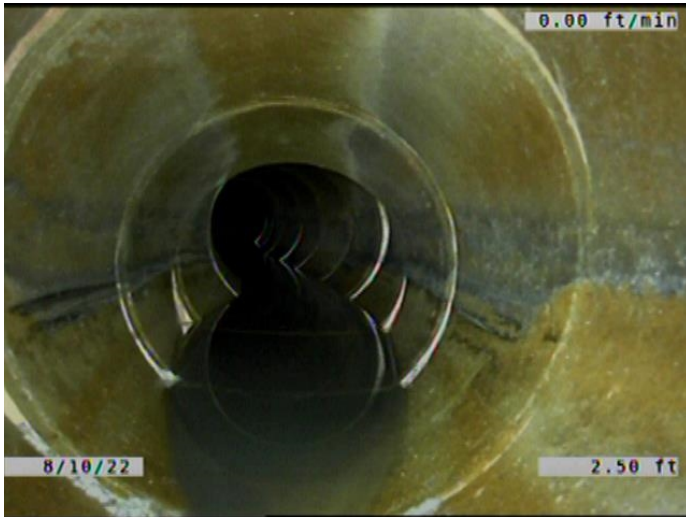
Code: **MWLS**  
Description: **Miscellaneous Water Level Sag**

Distance (ft): **2.5**  
Structural Grade: **2**  
O&M Grade: **0**  
Clock Start/From:  
Clock To:  
1st Value:  
2nd Value:  
Value Percent: **10.000**  
Continuous Index: **S01**  
Within 8" of Joint: **NO**  
Remarks:

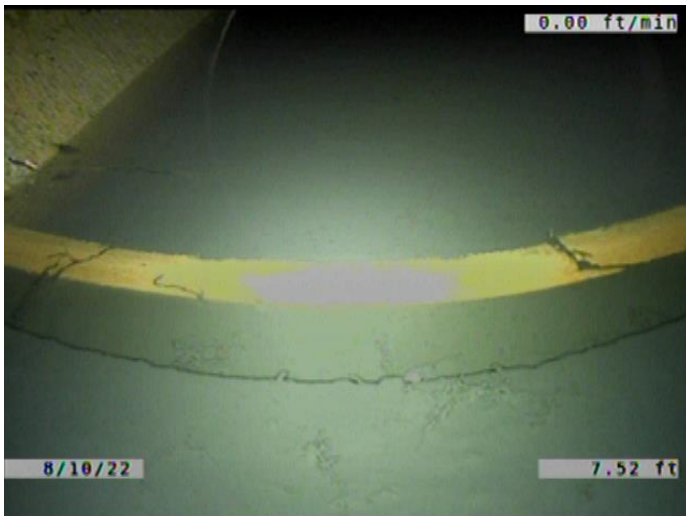
Code: **JOMD**  
Description: **Joint Offset Medium Defective**

Distance (ft): **7.5**  
Structural Grade: **3**  
O&M Grade: **0**  
Clock Start/From:  
Clock To:  
1st Value:  
2nd Value:  
Value Percent:  
Continuous Index:  
Within 8" of Joint: **NO**  
Remarks:

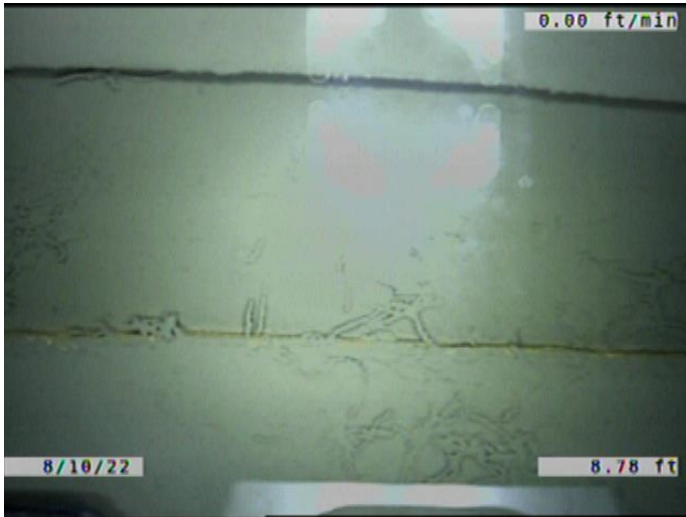
Code: **JAL**  
 Description: **Joint Angular Large**

Distance (ft): **8.8**  
 Structural Grade: **4**  
 O&M Grade: **0**  
 Clock Start/From:  
 Clock To:  
 1st Value:  
 2nd Value:  
 Value Percent:  
 Continuous Index:  
 Within 8" of Joint: **NO**  
 Remarks:

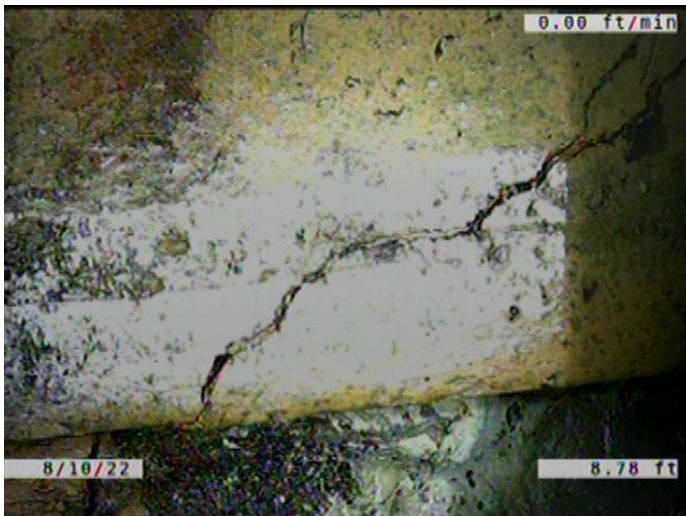
Code: **FM**  
 Description: **Fracture Multiple**

Distance (ft): **8.8**  
 Structural Grade: **4**  
 O&M Grade: **0**  
 Clock Start/From: **4**  
 Clock To: **8**  
 1st Value:  
 2nd Value:  
 Value Percent:  
 Continuous Index:  
 Within 8" of Joint: **YES**  
 Remarks:

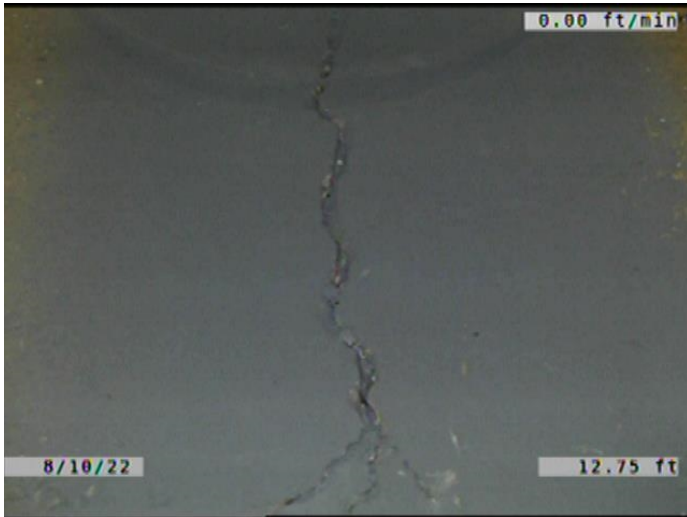
Code: **FM**  
 Description: **Fracture Multiple**

Distance (ft): **12.8**  
 Structural Grade: **4**  
 O&M Grade: **0**  
 Clock Start/From: **12**  
 Clock To: **12**  
 1st Value:  
 2nd Value:  
 Value Percent:  
 Continuous Index: **S02**  
 Within 8" of Joint: **YES**  
 Remarks:

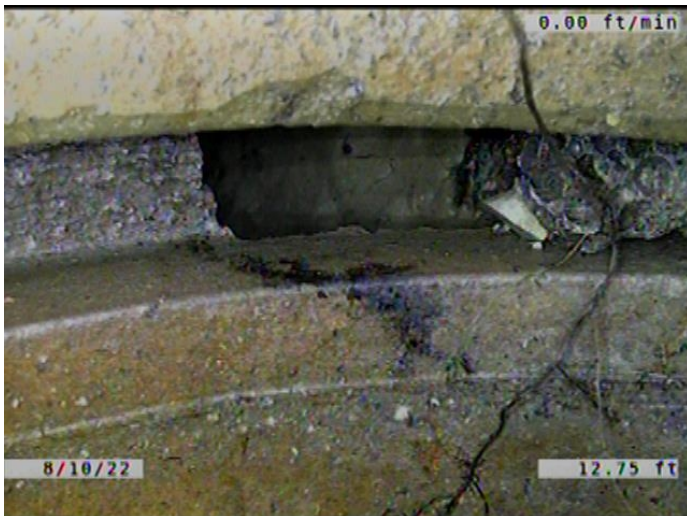
Code: **HVV**  
 Description: **Hole Void Visible**

Distance (ft): **12.8**  
 Structural Grade: **5**  
 O&M Grade: **0**  
 Clock Start/From: **3**  
 Clock To: **4**  
 1st Value:  
 2nd Value:  
 Value Percent:  
 Continuous Index:  
 Within 8" of Joint: **YES**  
 Remarks:

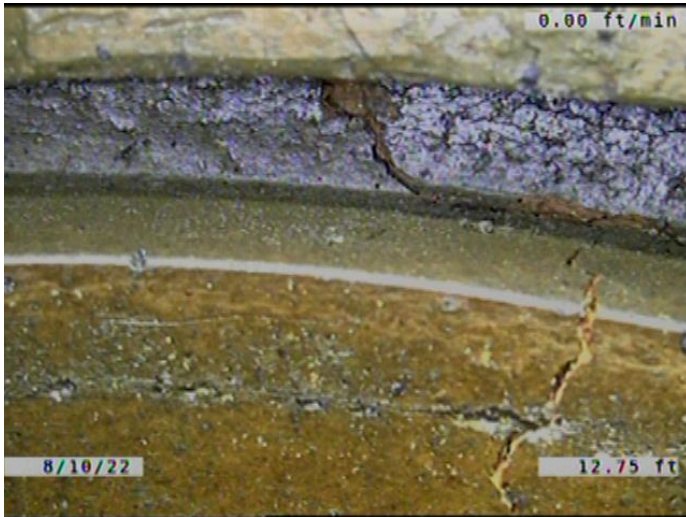
Code: **JAM**  
 Description: **Joint Angular Medium**

Distance (ft): **12.8**  
 Structural Grade: **3**  
 O&M Grade: **0**  
 Clock Start/From:  
 Clock To:  
 1st Value:  
 2nd Value:  
 Value Percent:  
 Continuous Index:  
 Within 8" of Joint: **NO**  
 Remarks:

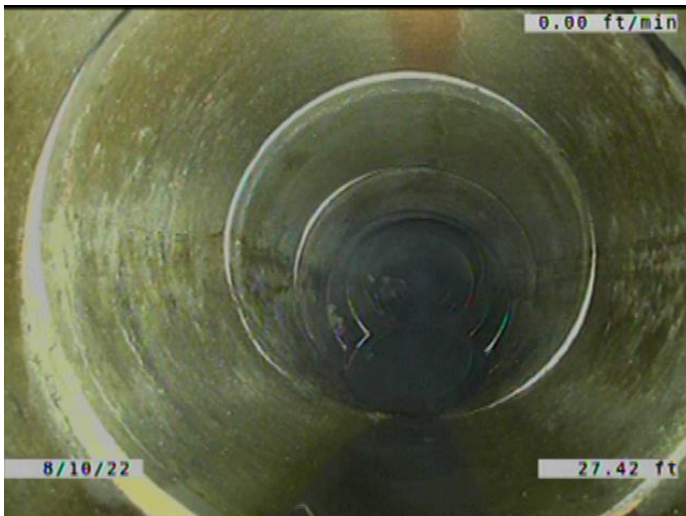
Code: **MWLS**  
 Description: **Miscellaneous Water Level Sag**

Distance (ft): **27.4**  
 Structural Grade: **2**  
 O&M Grade: **0**  
 Clock Start/From:  
 Clock To:  
 1st Value:  
 2nd Value:  
 Value Percent: **10.000**  
 Continuous Index: **F01**  
 Within 8" of Joint: **NO**  
 Remarks:

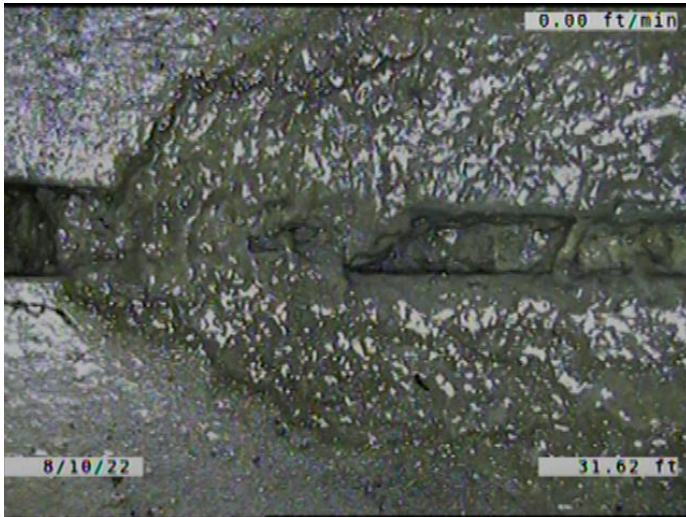
Code: **DAE**  
 Description: **Deposits Attached Encrustation**

Distance (ft): **31.6**  
 Structural Grade: **0**  
 O&M Grade: **2**  
 Clock Start/From: **2**  
 Clock To: **10**  
 1st Value:  
 2nd Value:  
 Value Percent: **5.000**  
 Continuous Index: **S03**  
 Within 8" of Joint: **YES**  
 Remarks:

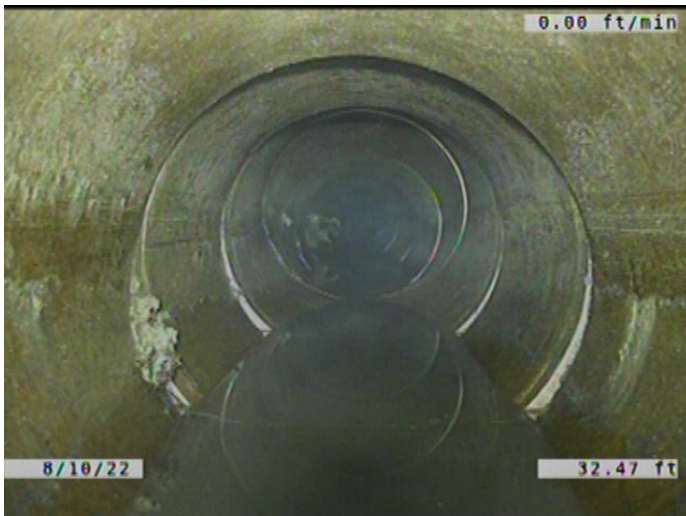
Code: **MWLS**  
 Description: **Miscellaneous Water Level Sag**

Distance (ft): **32.5**  
 Structural Grade: **2**  
 O&M Grade: **0**  
 Clock Start/From:  
 Clock To:  
 1st Value:  
 2nd Value:  
 Value Percent: **10.000**  
 Continuous Index: **S04**  
 Within 8" of Joint: **NO**  
 Remarks:

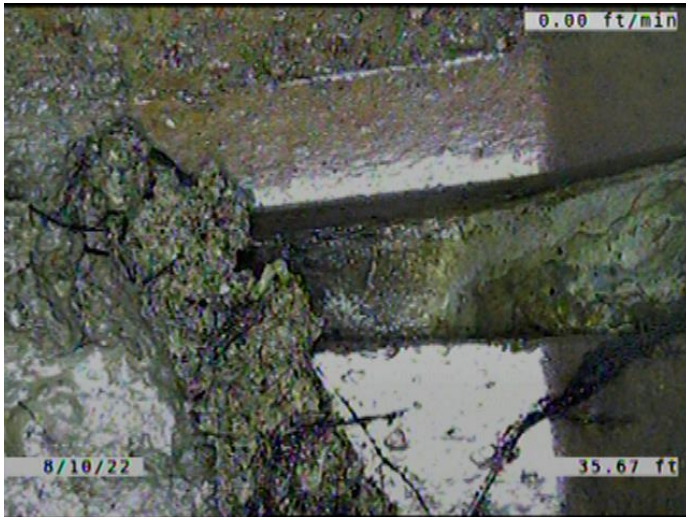
Code: **RFJ**  
 Description: **Roots Fine Joint**

Distance (ft): **35.7**  
 Structural Grade: **0**  
 O&M Grade: **1**  
 Clock Start/From: **7**  
 Clock To: **10**  
 1st Value:  
 2nd Value:  
 Value Percent:  
 Continuous Index:  
 Within 8" of Joint: **YES**  
 Remarks:

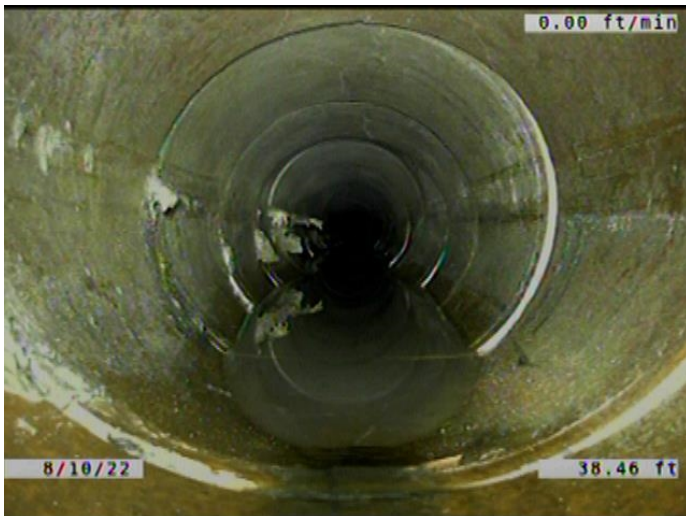
Code: **MWLS**  
 Description: **Miscellaneous Water Level Sag**

Distance (ft): **38.5**  
 Structural Grade: **2**  
 O&M Grade: **0**  
 Clock Start/From:  
 Clock To:  
 1st Value:  
 2nd Value:  
 Value Percent: **10.000**  
 Continuous Index: **F04**  
 Within 8" of Joint: **NO**  
 Remarks:

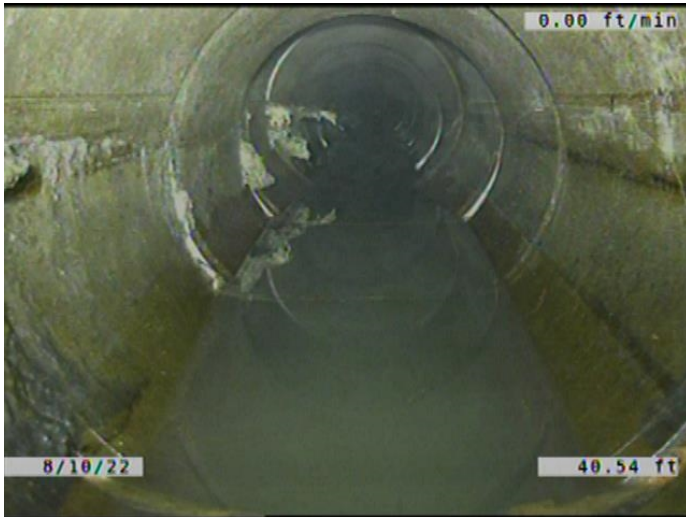
Code: **MWLS**  
 Description: **Miscellaneous Water Level Sag**

Distance (ft): **40.5**  
 Structural Grade: **2**  
 O&M Grade: **0**  
 Clock Start/From:  
 Clock To:  
 1st Value:  
 2nd Value:  
 Value Percent: **10.000**  
 Continuous Index: **S05**  
 Within 8" of Joint: **NO**  
 Remarks:

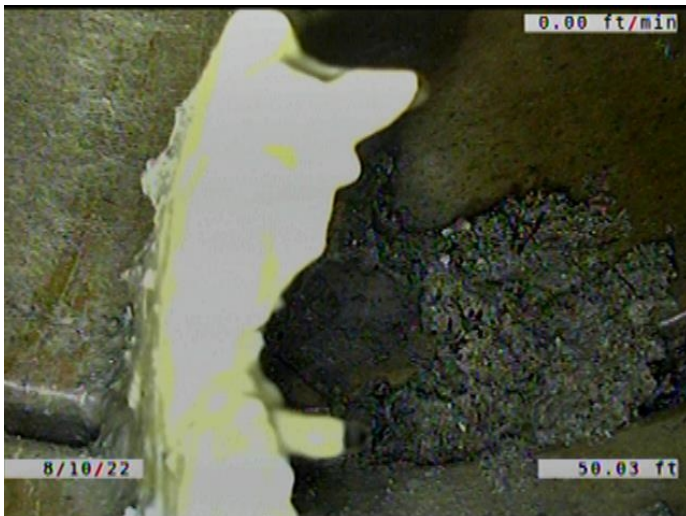
Code: **IWJ**  
 Description: **Infiltration Weeper Joint**

Distance (ft): **50.0**  
 Structural Grade: **0**  
 O&M Grade: **2**  
 Clock Start/From: **9**  
 Clock To: **10**  
 1st Value:  
 2nd Value:  
 Value Percent:  
 Continuous Index:  
 Within 8" of Joint: **YES**  
 Remarks:

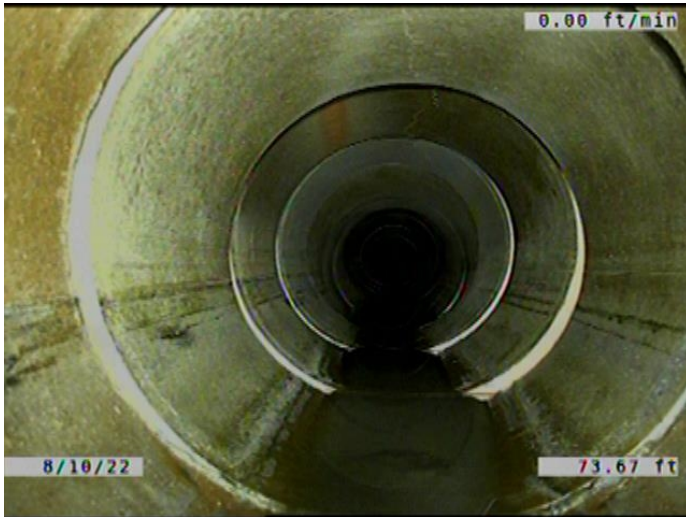
Code: **MWLS**  
Description: **Miscellaneous Water Level Sag**

Distance (ft): **73.7**  
Structural Grade: **2**  
O&M Grade: **0**  
Clock Start/From:  
Clock To:  
1st Value:  
2nd Value:  
Value Percent: **10.000**  
Continuous Index: **F05**  
Within 8" of Joint: **NO**  
Remarks:

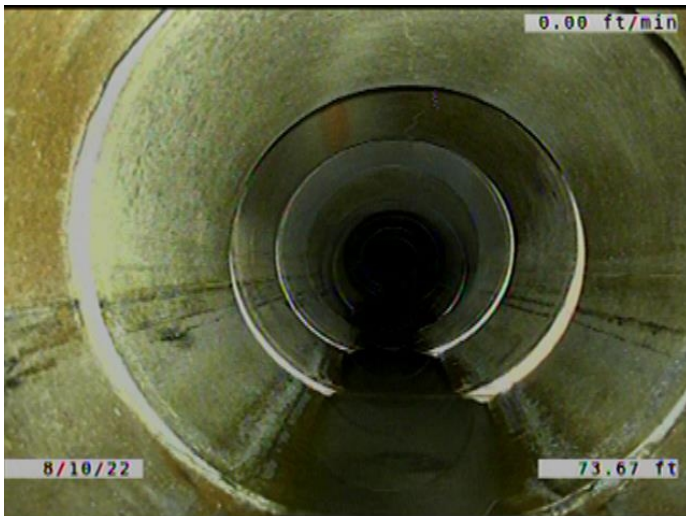
Code: **DAE**  
Description: **Deposits Attached Encrustation**

Distance (ft): **73.7**  
Structural Grade: **0**  
O&M Grade: **2**  
Clock Start/From: **2**  
Clock To: **10**  
1st Value:  
2nd Value:  
Value Percent: **5.000**  
Continuous Index: **F03**  
Within 8" of Joint: **YES**  
Remarks:

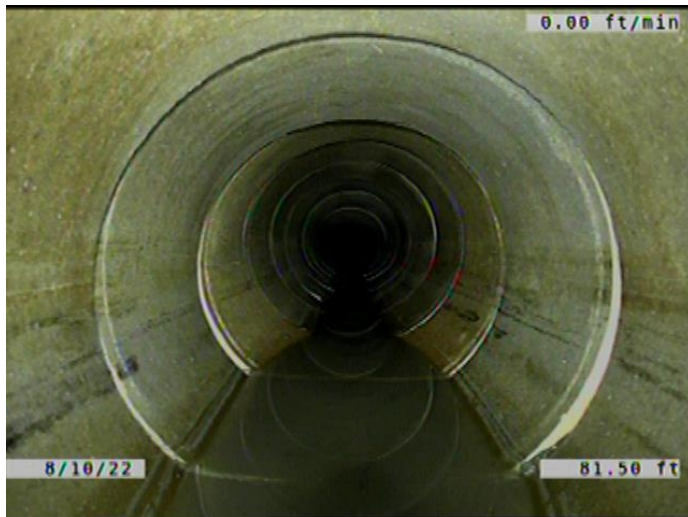
Code: **MWLS**  
Description: **Miscellaneous Water Level Sag**

Distance (ft): **81.5**  
Structural Grade: **2**  
O&M Grade: **0**  
Clock Start/From:  
Clock To:  
1st Value:  
2nd Value:  
Value Percent: **10.000**  
Continuous Index: **S06**  
Within 8" of Joint: **NO**  
Remarks:

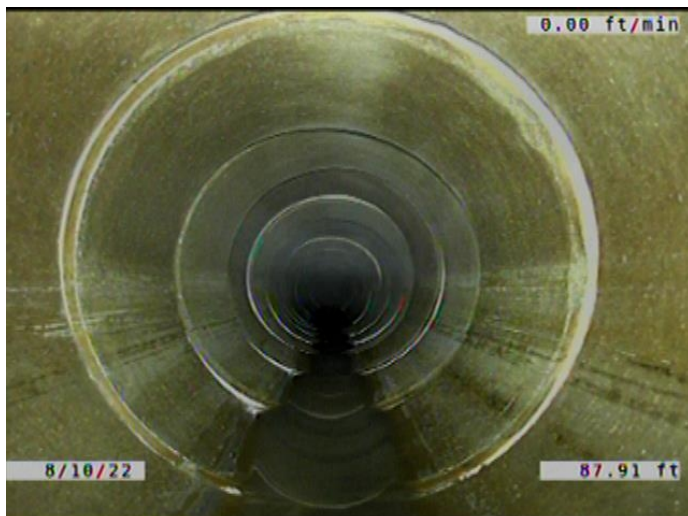
Code: **MWLS**  
Description: **Miscellaneous Water Level Sag**

Distance (ft): **87.9**  
Structural Grade: **2**  
O&M Grade: **0**  
Clock Start/From:  
Clock To:  
1st Value:  
2nd Value:  
Value Percent: **10.000**  
Continuous Index: **F06**  
Within 8" of Joint: **NO**  
Remarks:

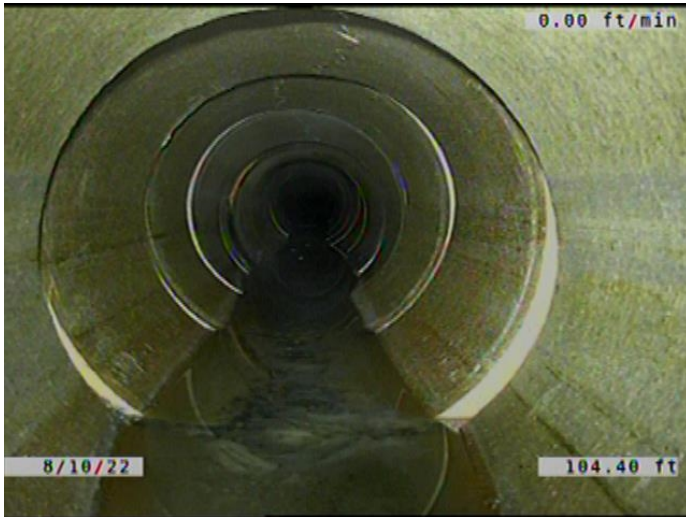
Code: **MWLS**  
Description: **Miscellaneous Water Level Sag**

Distance (ft): **104.4**  
Structural Grade: **2**  
O&M Grade: **0**  
Clock Start/From:  
Clock To:  
1st Value:  
2nd Value:  
Value Percent: **5.000**  
Continuous Index: **S07**  
Within 8" of Joint: **NO**  
Remarks:

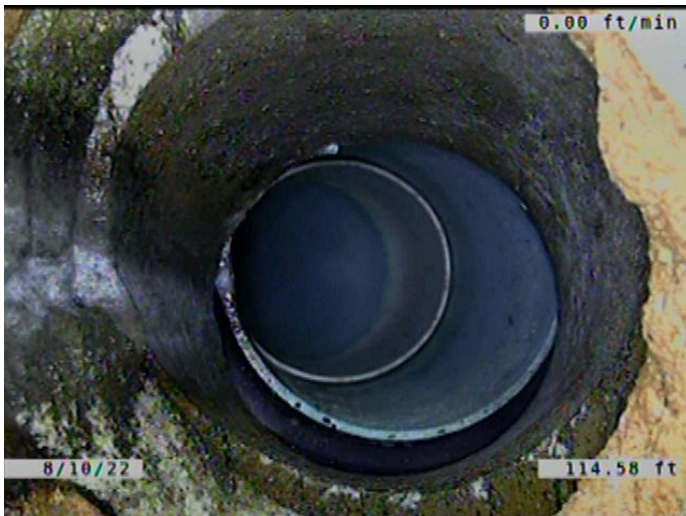
Code: **TB**  
Description: **Tap Break-in/Hammer**

Distance (ft): **114.6**  
Structural Grade: **0**  
O&M Grade: **0**  
Clock Start/From: **10**  
Clock To:  
1st Value: **6.000**  
2nd Value:  
Value Percent:  
Continuous Index:  
Within 8" of Joint: **YES**  
Remarks: **CONSTANTLY RUNNING WATER.**

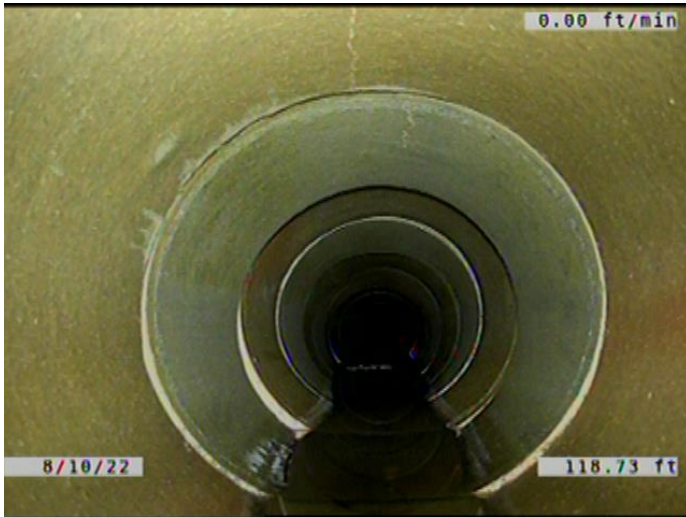
Code: **MWLS**  
 Description: **Miscellaneous Water Level Sag**

Distance (ft): **118.7**  
 Structural Grade: **2**  
 O&M Grade: **0**  
 Clock Start/From:  
 Clock To:  
 1st Value:  
 2nd Value:  
 Value Percent: **5.000**  
 Continuous Index: **F07**  
 Within 8" of Joint: **NO**  
 Remarks:

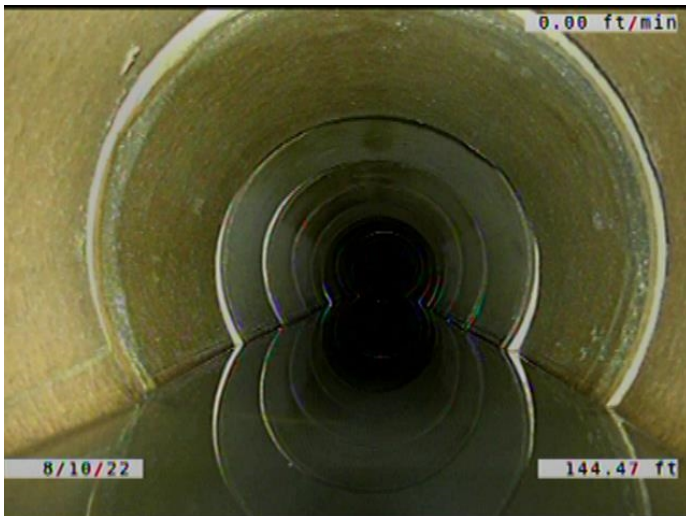
Code: **MWLS**  
 Description: **Miscellaneous Water Level Sag**

Distance (ft): **144.5**  
 Structural Grade: **2**  
 O&M Grade: **0**  
 Clock Start/From:  
 Clock To:  
 1st Value:  
 2nd Value:  
 Value Percent: **15.000**  
 Continuous Index: **S08**  
 Within 8" of Joint: **NO**  
 Remarks:

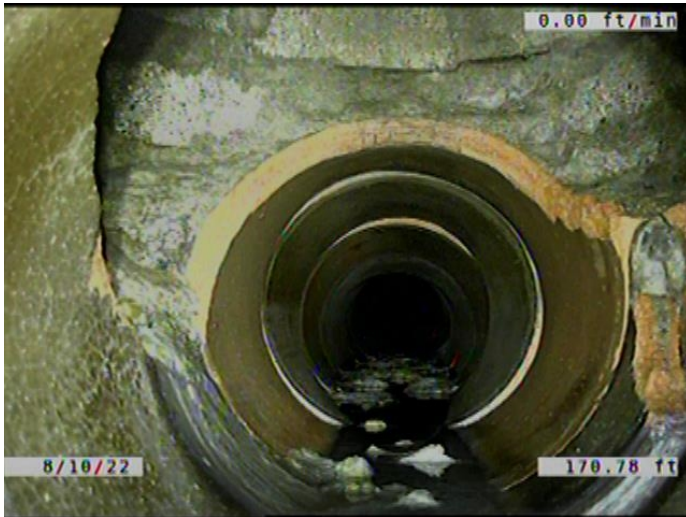
Code: **FM**  
 Description: **Fracture Multiple**

Distance (ft): **170.8**  
 Structural Grade: **4**  
 O&M Grade: **0**  
 Clock Start/From: **12**  
 Clock To: **12**  
 1st Value:  
 2nd Value:  
 Value Percent:  
 Continuous Index: **F02**  
 Within 8" of Joint: **YES**  
 Remarks:

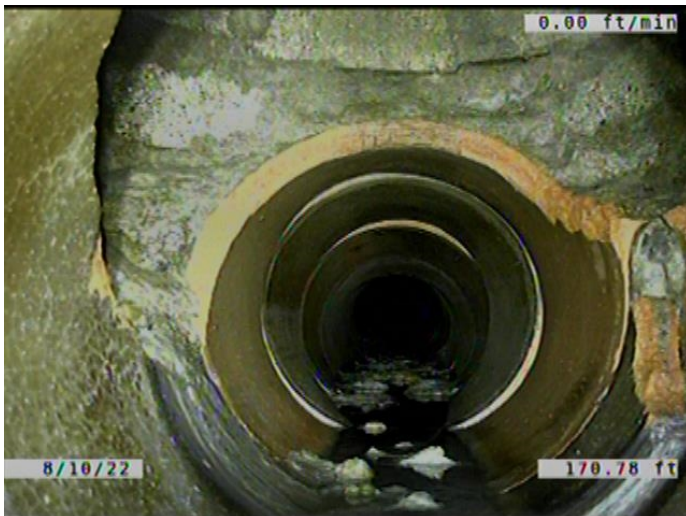
Code: **MWLS**  
 Description: **Miscellaneous Water Level Sag**

Distance (ft): **170.8**  
 Structural Grade: **2**  
 O&M Grade: **0**  
 Clock Start/From:  
 Clock To:  
 1st Value:  
 2nd Value:  
 Value Percent: **15.000**  
 Continuous Index: **F08**  
 Within 8" of Joint: **NO**  
 Remarks:
