# Profile/Photo Observation Report

Date:	<b>11/10/2021</b>	Weather:		Coding:	<b>PACP 7.0</b>
Pipe Length (ft):	<b>163.5</b>	Owner:	<b>City of Hobart</b>	Pre Clean:	<b>Heavy Cleaning</b>
P.O.#:	<b>YES502259</b>	Surveyor:	<b>Steven Bucklin</b>	PSR:	
Customer:	<b>City of Hobart, IN (Red</b>	Clean Date:	<b>11/10/2021</b>	Shape:	<b>C</b>

Street:	<b>West Home Avenue</b>	Flow Control:	<b>Not Controlled</b>
City:	<b>City of Hobart</b>	Year Renewed:	
Location:	<b>Local rural streets with light traffic, t</b>	Tape/Media #:	
Purpose:	<b>Routine Assessment</b>	Dia/Height:	<b>10"</b>
Use:	<b>Sanitary Sewage Pipe</b>	Material:	<b>VCP</b>
Drain Area:		Lining:	<b>None</b>
Category:	<b>NA</b>		
Comment:			
Location Details:		Direction of Survey:	<b>Downstream</b>
US MH:	<b>UNK W HOME AVE</b>	DS MH:	<b>M-604-058</b>
		Total Length Surveyed (ft):	<b>163.5</b>

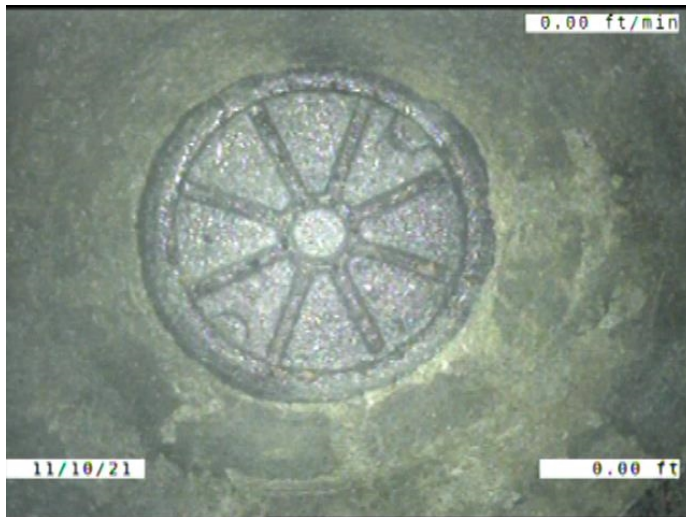
Code: **AMH**  
Description: **Manhole**

Distance (ft): **.0**  
Structural Grade: **0**  
O&M Grade: **0**  
Clock Start/From:  
Clock To:  
1st Value:  
2nd Value:  
Value Percent:  
Continuous Index:  
Within 8" of Joint: **NO**  
Remarks: **UNK W HOME AVE**

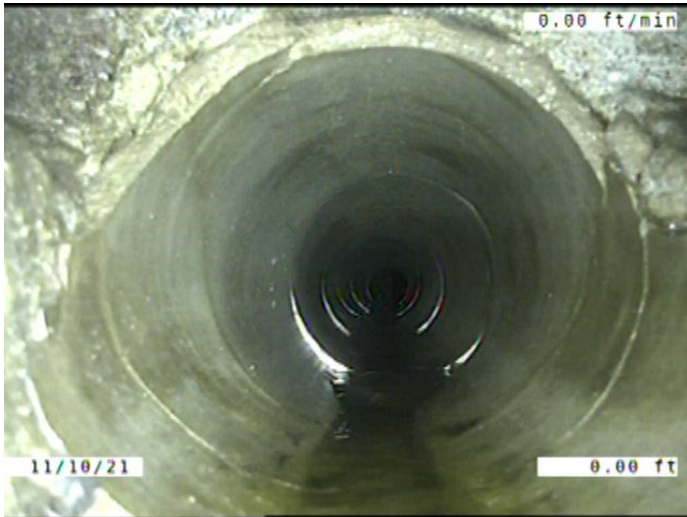
Code: **MWL**  
 Description: **Miscellaneous Water Level**

Distance (ft): **.0**  
 Structural Grade: **0**  
 O&M Grade: **0**  
 Clock Start/From:  
 Clock To:  
 1st Value:  
 2nd Value:  
 Value Percent: **5.000**  
 Continuous Index:  
 Within 8" of Joint: **NO**  
 Remarks:

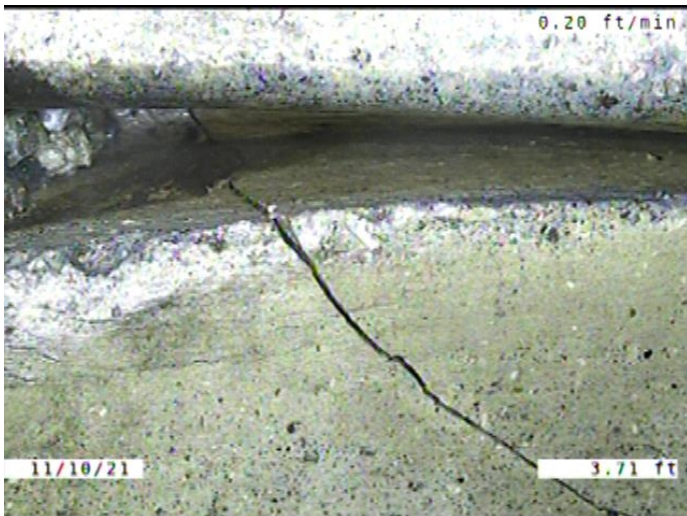
Code: **FS**  
 Description: **Fracture Spiral**

Distance (ft): **3.7**  
 Structural Grade: **3**  
 O&M Grade: **0**  
 Clock Start/From: **8**  
 Clock To: **1**  
 1st Value:  
 2nd Value:  
 Value Percent:  
 Continuous Index:  
 Within 8" of Joint: **YES**  
 Remarks:

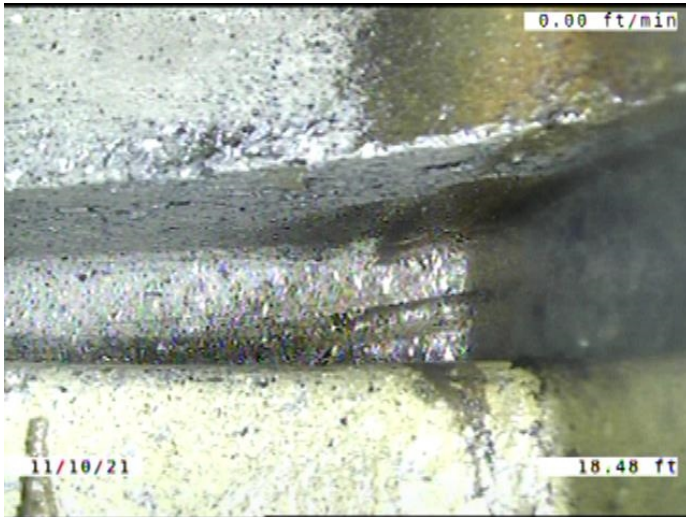
Code: **JAM**  
 Description: **Joint Angular Medium**

Distance (ft): **18.5**  
 Structural Grade: **3**  
 O&M Grade: **0**  
 Clock Start/From:  
 Clock To:  
 1st Value:  
 2nd Value:  
 Value Percent:  
 Continuous Index:  
 Within 8" of Joint: **NO**  
 Remarks:

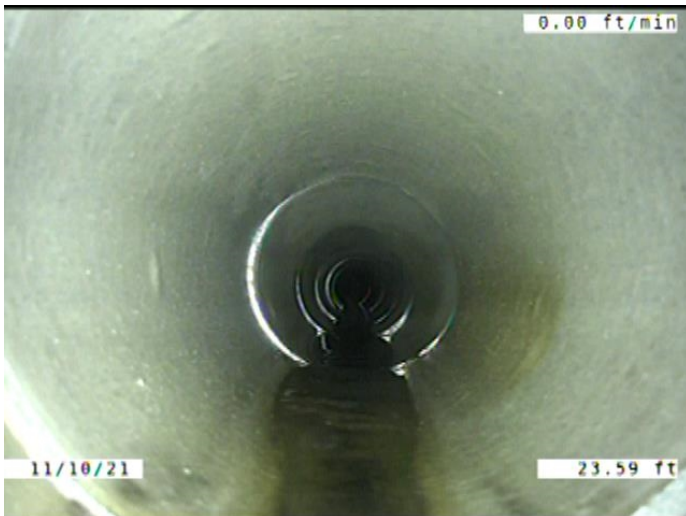
Code: **MWLS**  
 Description: **Miscellaneous Water Level Sag**

Distance (ft): **23.6**  
 Structural Grade: **2**  
 O&M Grade: **0**  
 Clock Start/From:  
 Clock To:  
 1st Value:  
 2nd Value:  
 Value Percent: **5.000**  
 Continuous Index: **F02**  
 Within 8" of Joint: **NO**  
 Remarks:

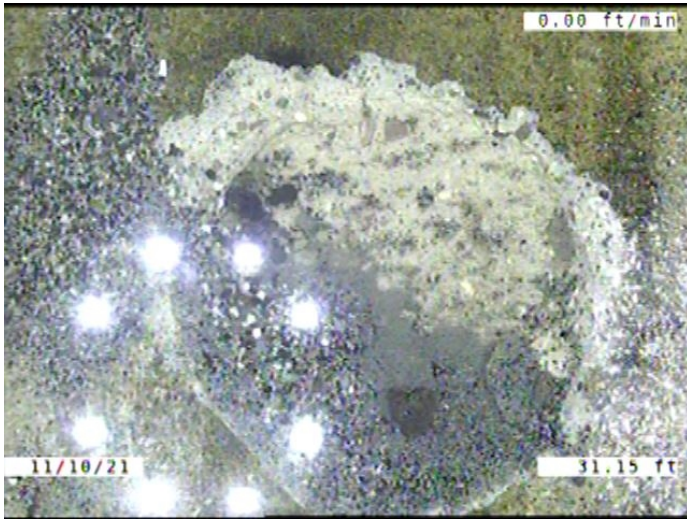
Code: **SSS**  
Description: **Surface Damage Surface Spalling**

Distance (ft): **31.1**  
Structural Grade: **2**  
O&M Grade: **0**  
Clock Start/From: **5**  
Clock To: **6**  
1st Value:  
2nd Value:  
Value Percent:  
Continuous Index:  
Within 8" of Joint: **YES**  
Remarks:

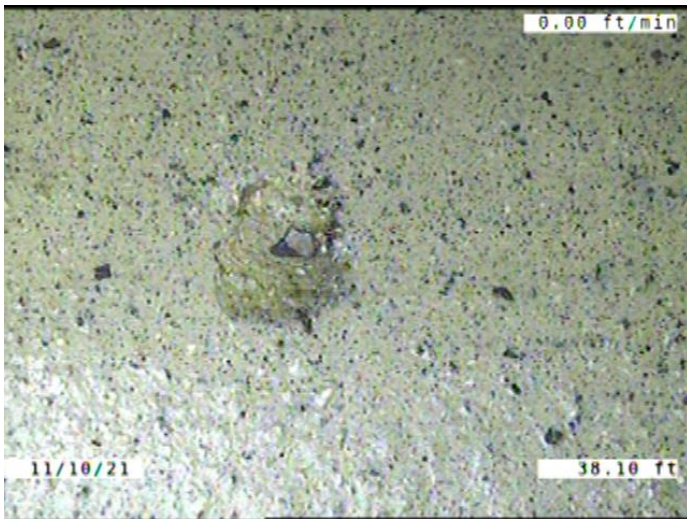
Code: **SSS**  
Description: **Surface Damage Surface Spalling**

Distance (ft): **38.1**  
Structural Grade: **2**  
O&M Grade: **0**  
Clock Start/From: **3**  
Clock To:  
1st Value:  
2nd Value:  
Value Percent:  
Continuous Index:  
Within 8" of Joint: **NO**  
Remarks:

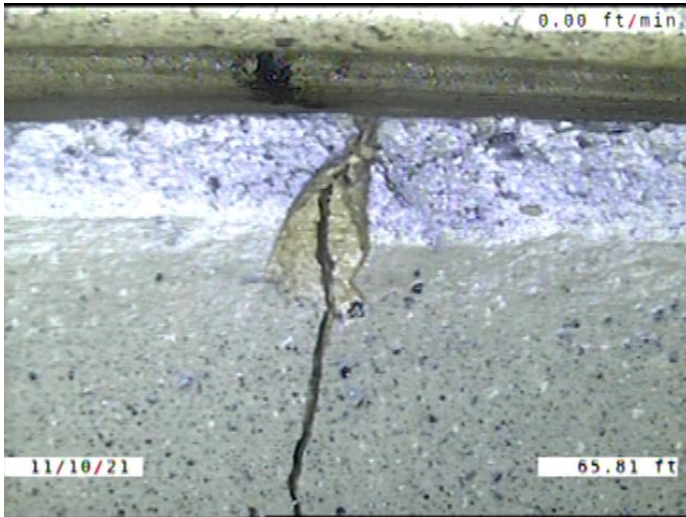
Code: **FM**  
 Description: **Fracture Multiple**

Distance (ft): **65.8**  
 Structural Grade: **4**  
 O&M Grade: **0**  
 Clock Start/From: **9**  
 Clock To: **10**  
 1st Value:  
 2nd Value:  
 Value Percent:  
 Continuous Index:  
 Within 8" of Joint: **YES**  
 Remarks:

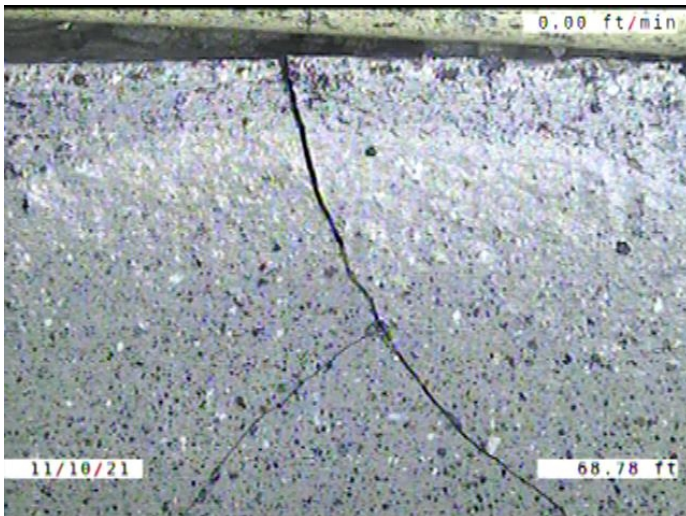
Code: **FM**  
 Description: **Fracture Multiple**

Distance (ft): **68.8**  
 Structural Grade: **4**  
 O&M Grade: **0**  
 Clock Start/From: **12**  
 Clock To: **2**  
 1st Value:  
 2nd Value:  
 Value Percent:  
 Continuous Index:  
 Within 8" of Joint: **YES**  
 Remarks:

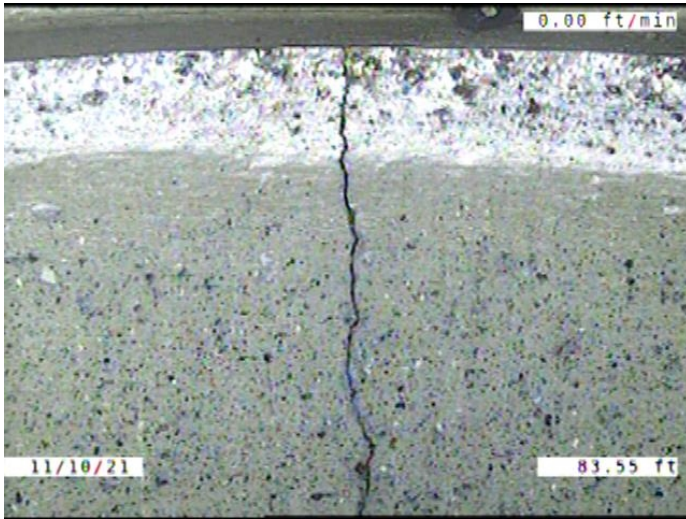
Code: **CL**  
 Description: **Crack Longitudinal**

Distance (ft): **83.5**  
 Structural Grade: **2**  
 O&M Grade: **0**  
 Clock Start/From: **12**  
 Clock To:  
 1st Value:  
 2nd Value:  
 Value Percent:  
 Continuous Index:  
 Within 8" of Joint: **YES**  
 Remarks:

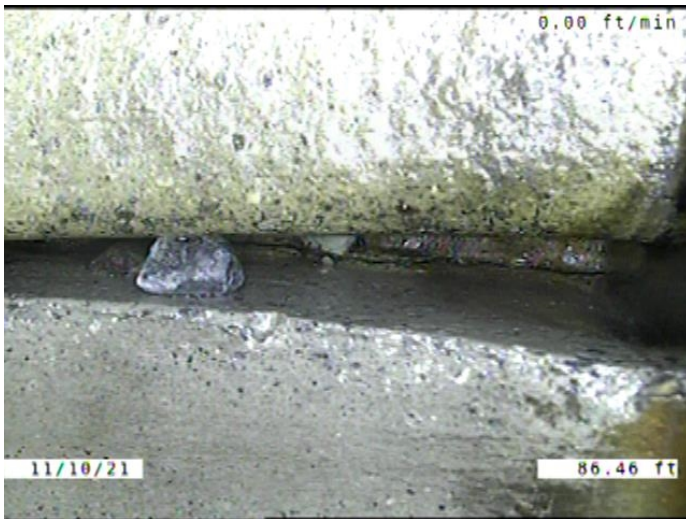
Code: **FS**  
 Description: **Fracture Spiral**

Distance (ft): **86.5**  
 Structural Grade: **3**  
 O&M Grade: **0**  
 Clock Start/From: **2**  
 Clock To: **3**  
 1st Value:  
 2nd Value:  
 Value Percent:  
 Continuous Index:  
 Within 8" of Joint: **YES**  
 Remarks:

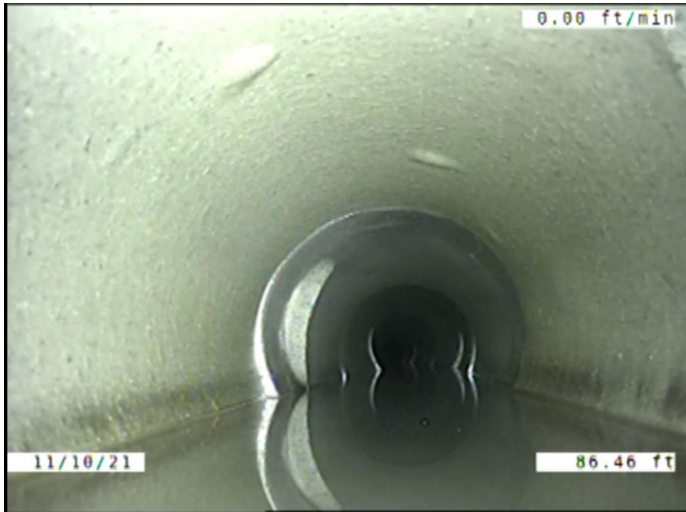
Code: **SZ**  
Description: **Surface Damage Other**

Distance (ft): **86.5**  
Structural Grade: **0**  
O&M Grade: **0**  
Clock Start/From: **10**  
Clock To: **2**  
1st Value:  
2nd Value:  
Value Percent:  
Continuous Index:  
Within 8" of Joint: **NO**  
Remarks: **Indentations, Factory Defect**

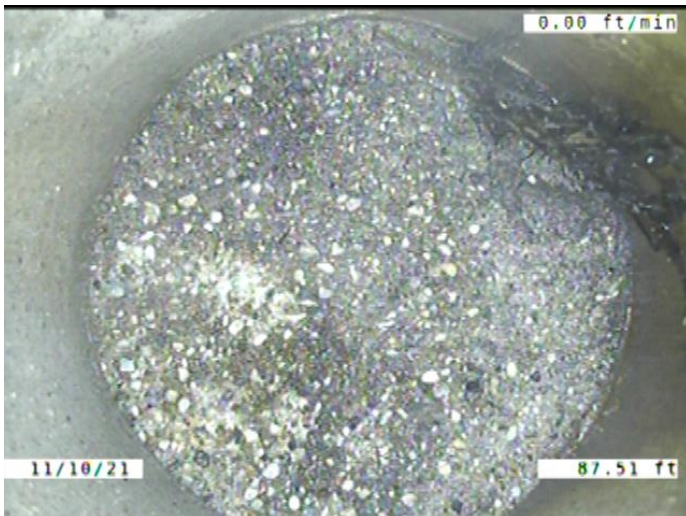
Code: **TFC**  
Description: **Tap Factory Capped**

Distance (ft): **87.5**  
Structural Grade: **0**  
O&M Grade: **0**  
Clock Start/From: **2**  
Clock To:  
1st Value: **4.000**  
2nd Value:  
Value Percent:  
Continuous Index:  
Within 8" of Joint: **YES**  
Remarks: **ROOTS GROWING AROUND THE  
CAP. CAP LOOKS TO BE LEAKING**

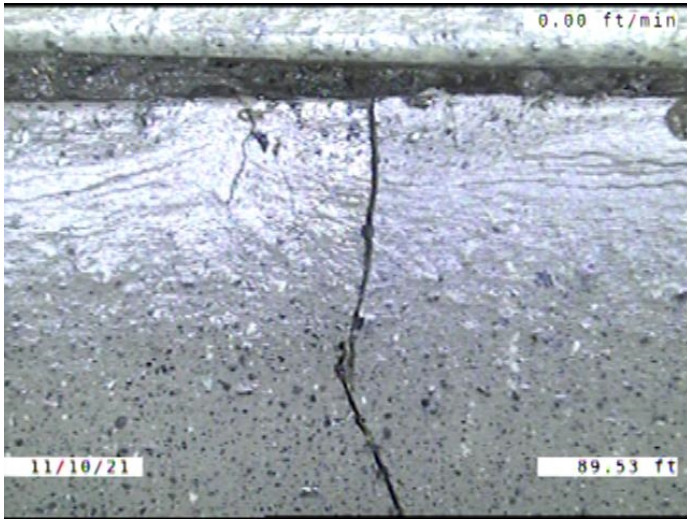
Code: **FM**  
 Description: **Fracture Multiple**

Distance (ft): **89.5**  
 Structural Grade: **4**  
 O&M Grade: **0**  
 Clock Start/From: **1**  
 Clock To: **2**  
 1st Value:  
 2nd Value:  
 Value Percent:  
 Continuous Index:  
 Within 8" of Joint: **YES**  
 Remarks:

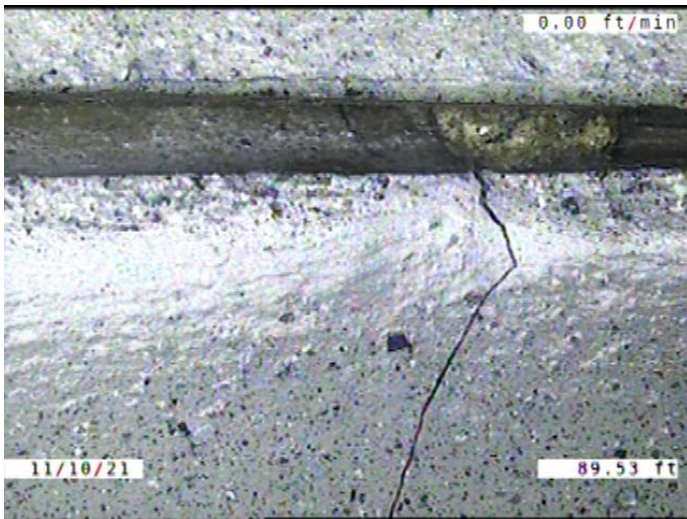
Code: **FS**  
 Description: **Fracture Spiral**

Distance (ft): **89.5**  
 Structural Grade: **3**  
 O&M Grade: **0**  
 Clock Start/From: **11**  
 Clock To: **12**  
 1st Value:  
 2nd Value:  
 Value Percent:  
 Continuous Index:  
 Within 8" of Joint: **YES**  
 Remarks:

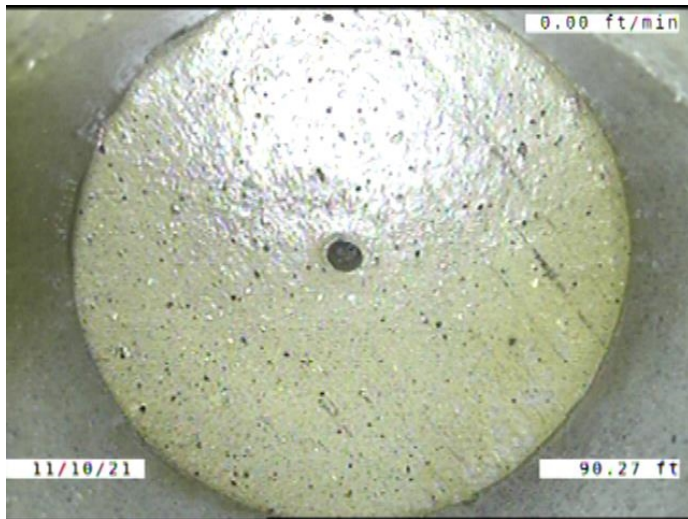
Code: **TFC**  
 Description: **Tap Factory Capped**

Distance (ft): **90.3**  
 Structural Grade: **0**  
 O&M Grade: **0**  
 Clock Start/From: **10**  
 Clock To:  
 1st Value: **4.000**  
 2nd Value:  
 Value Percent:  
 Continuous Index:  
 Within 8" of Joint: **YES**  
 Remarks:

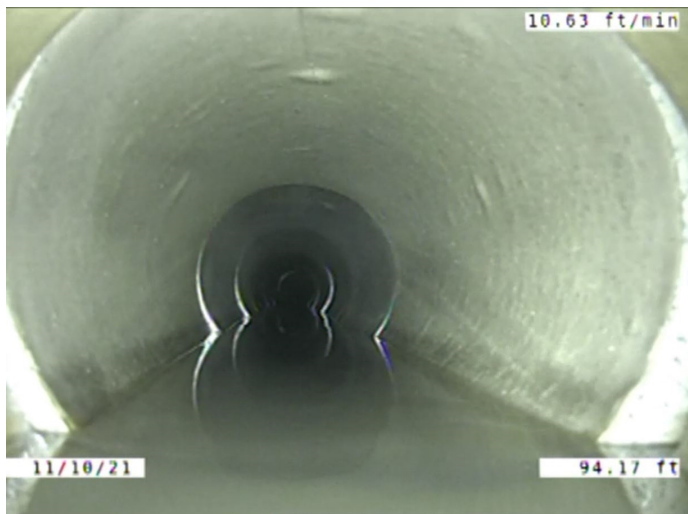
Code: **SZ**  
 Description: **Surface Damage Other**

Distance (ft): **94.2**  
 Structural Grade: **0**  
 O&M Grade: **0**  
 Clock Start/From: **10**  
 Clock To: **2**  
 1st Value:  
 2nd Value:  
 Value Percent:  
 Continuous Index: **S10**  
 Within 8" of Joint: **NO**  
 Remarks: **Indentations, Factory Defect**

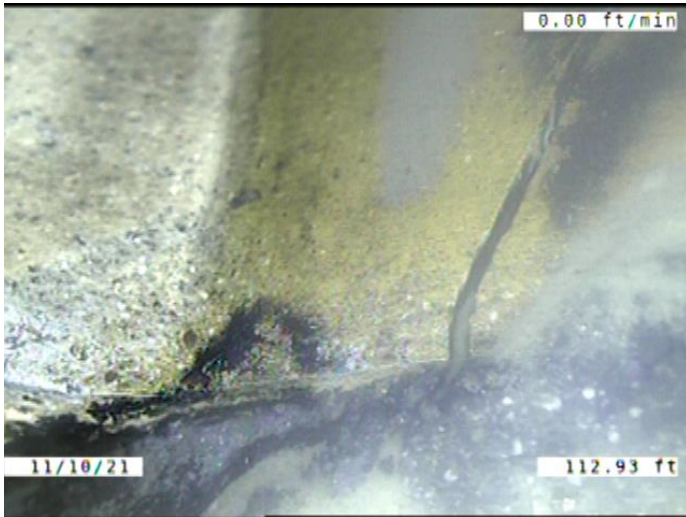
Code: **B**  
Description: **Broken**

Distance (ft): **112.9**  
Structural Grade: **4**  
O&M Grade: **0**  
Clock Start/From: **12**  
Clock To: **12**  
1st Value:  
2nd Value:  
Value Percent:  
Continuous Index:  
Within 8" of Joint: **YES**  
Remarks:

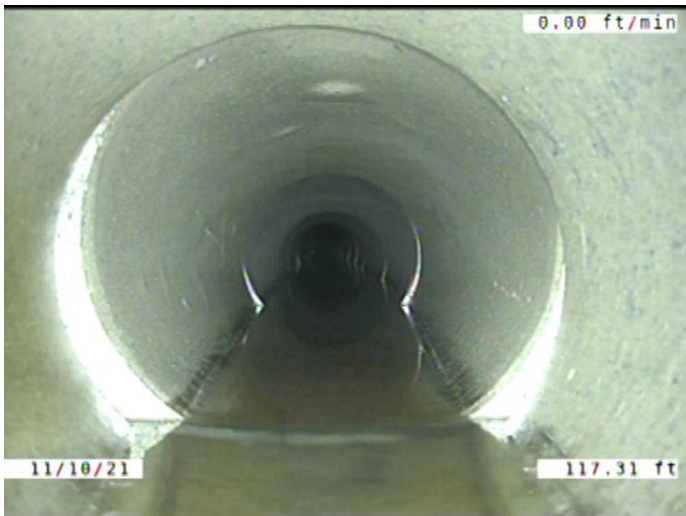
Code: **MWLS**  
Description: **Miscellaneous Water Level Sag**

Distance (ft): **117.3**  
Structural Grade: **2**  
O&M Grade: **0**  
Clock Start/From:  
Clock To:  
1st Value:  
2nd Value:  
Value Percent: **10.000**  
Continuous Index: **S05**  
Within 8" of Joint: **NO**  
Remarks:

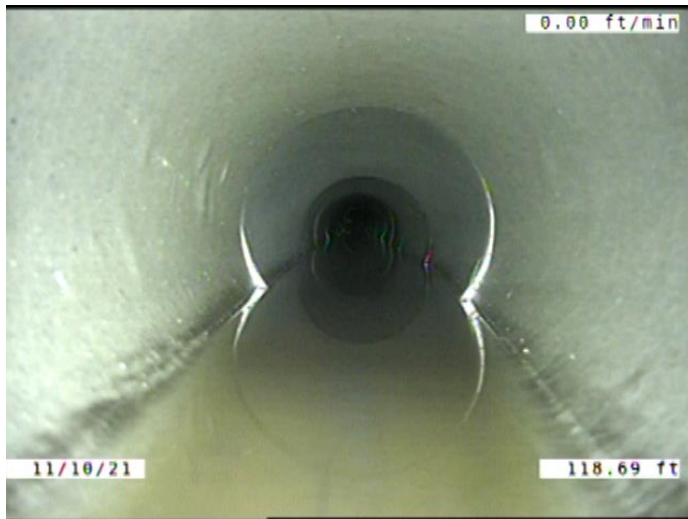
Code: **FM**  
 Description: **Fracture Multiple**

Distance (ft): **118.7**  
 Structural Grade: **4**  
 O&M Grade: **0**  
 Clock Start/From: **9**  
 Clock To: **3**  
 1st Value:  
 2nd Value:  
 Value Percent:  
 Continuous Index: **F04**  
 Within 8" of Joint: **YES**  
 Remarks:

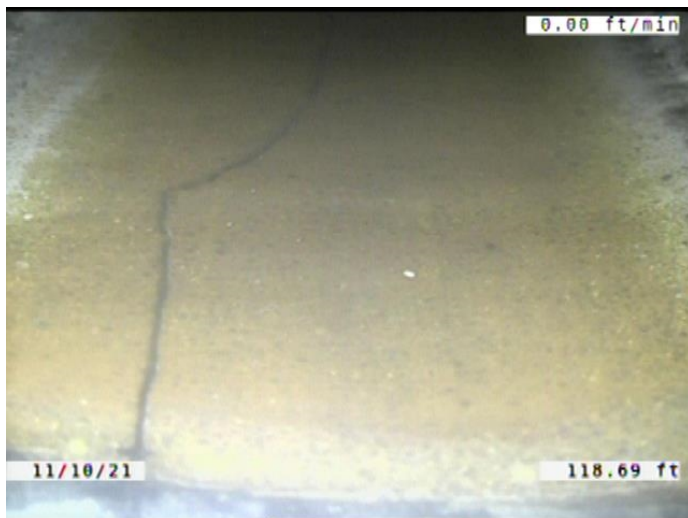
Code: **FM**  
 Description: **Fracture Multiple**

Distance (ft): **118.7**  
 Structural Grade: **4**  
 O&M Grade: **0**  
 Clock Start/From: **12**  
 Clock To: **12**  
 1st Value:  
 2nd Value:  
 Value Percent:  
 Continuous Index:  
 Within 8" of Joint: **YES**  
 Remarks:

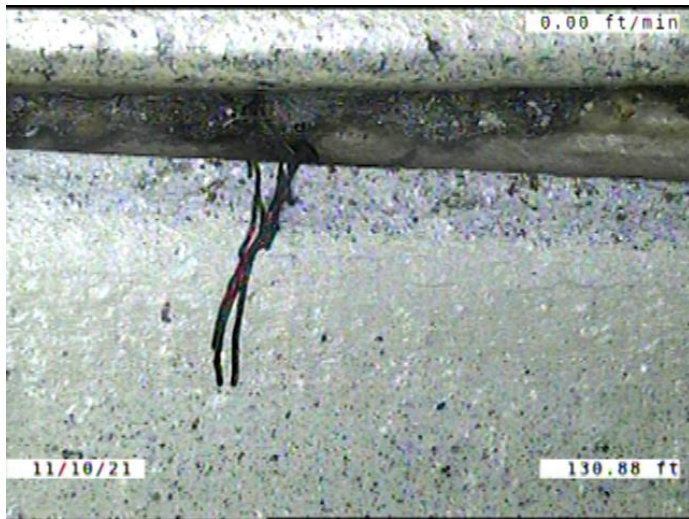
Code: **RFJ**  
 Description: **Roots Fine Joint**

Distance (ft): **130.9**  
 Structural Grade: **0**  
 O&M Grade: **1**  
 Clock Start/From: **10**  
 Clock To:  
 1st Value:  
 2nd Value:  
 Value Percent:  
 Continuous Index:  
 Within 8" of Joint: **YES**  
 Remarks:

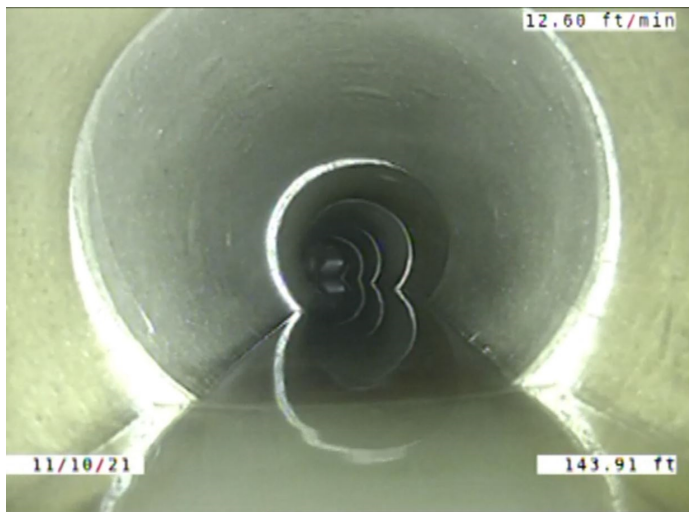
Code: **CM**  
 Description: **Crack Multiple**

Distance (ft): **143.9**  
 Structural Grade: **3**  
 O&M Grade: **0**  
 Clock Start/From: **8**  
 Clock To: **4**  
 1st Value:  
 2nd Value:  
 Value Percent:  
 Continuous Index:  
 Within 8" of Joint: **YES**  
 Remarks:

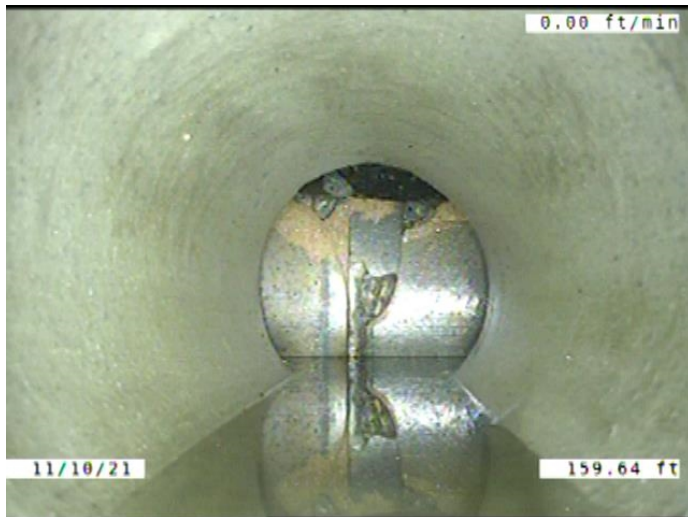
Code: **MWLS**  
 Description: **Miscellaneous Water Level Sag**

Distance (ft): **159.6**  
 Structural Grade: **2**  
 O&M Grade: **0**  
 Clock Start/From:  
 Clock To:  
 1st Value:  
 2nd Value:  
 Value Percent: **10.000**  
 Continuous Index: **F03**  
 Within 8" of Joint: **NO**  
 Remarks:

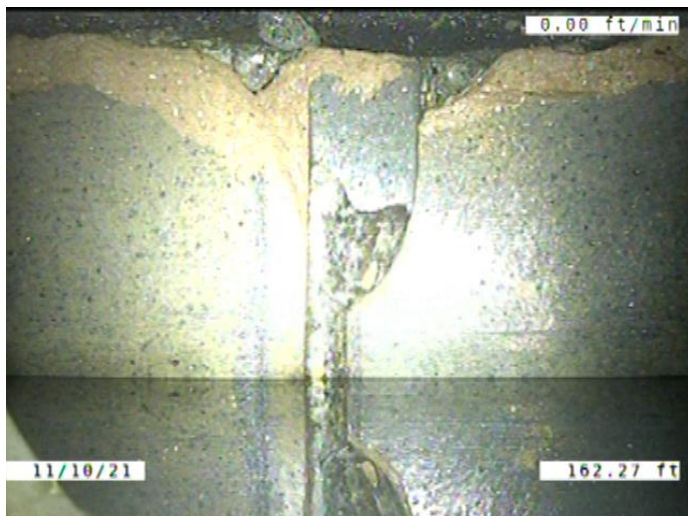
Code: **DSF**  
 Description: **Deposits Settled Fine**

Distance (ft): **162.3**  
 Structural Grade: **0**  
 O&M Grade: **2**  
 Clock Start/From: **5**  
 Clock To: **7**  
 1st Value:  
 2nd Value:  
 Value Percent: **5.000**  
 Continuous Index: **F01**  
 Within 8" of Joint: **YES**  
 Remarks:

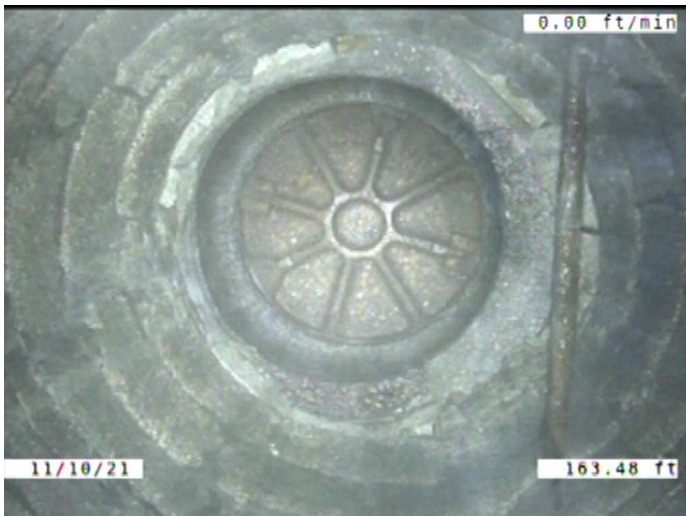
Code: **AMH**  
 Description: **Manhole**

Distance (ft): **163.5**  
 Structural Grade: **0**  
 O&M Grade: **0**  
 Clock Start/From:  
 Clock To:  
 1st Value:  
 2nd Value:  
 Value Percent:  
 Continuous Index:  
 Within 8" of Joint: **NO**  
 Remarks: **M-604-058**
