Profile/Photo Observation Report

| Street: | N CONNECTICUT ST | Flow Control: | Not Controlled |
| City: | Hobart, IN | Year Renewed: | |

| US MH: | M-604-057 | DS MH: | M-604-109 |

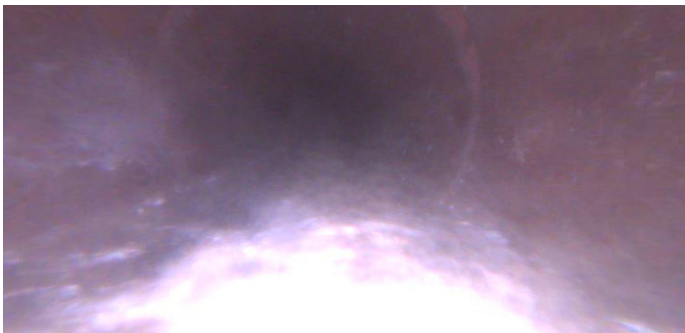
| Code: | DSZ |
| Description: | Deposits Settled Other |

| O&M Grade: | 2 |
| Clock Start/From: | 6 |
| Value Percent: | 5.000 |
| Remarks: | tissue?/debris |

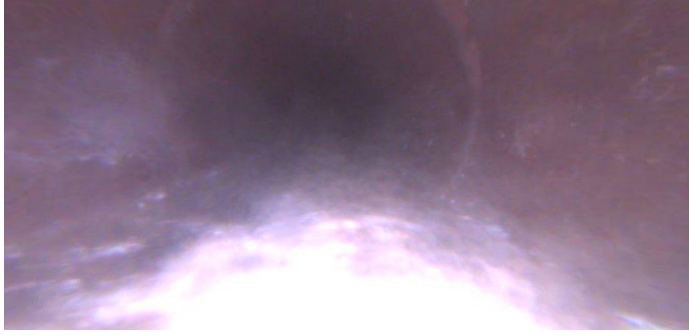
| Code: | MGO |
| Description: | General Observation |
| Remarks: | steam |

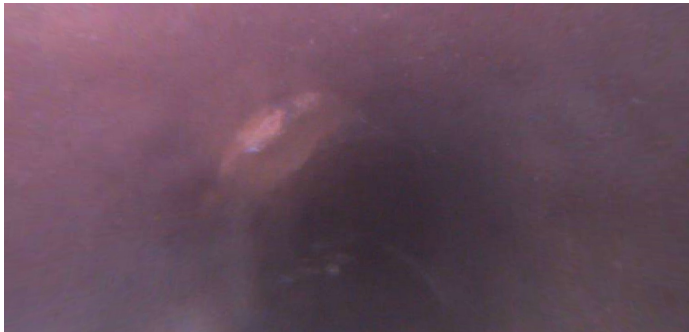
| Code: | TB |
| Description: | Tap Break-in |
| Distance (ft): | 4.4 |

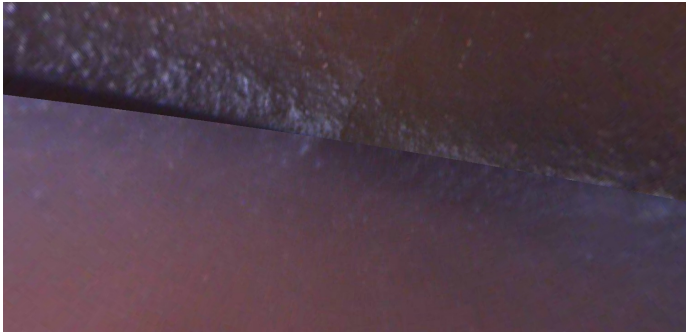
Code: **CL**
Description: **Crack Longitudinal**

Distance (ft): **78.1**
Structural Grade: **2**
O&M Grade: **0**
Clock Start/From: **12**
Clock To:
1st Value:
2nd Value:
Value Percent:
Continuous Index: **S02**
Within 8" of Joint: **YES**
Remarks:

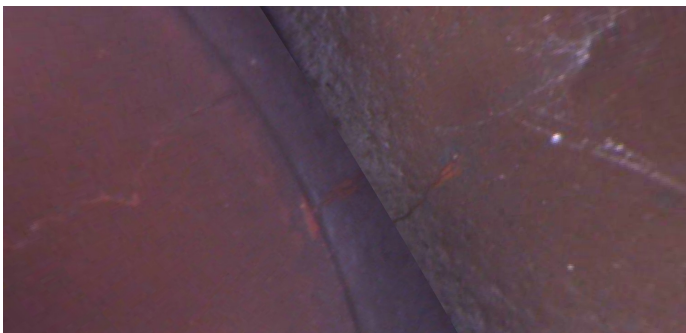
Code: **CM**
Description: **Crack Multiple**

Distance (ft): **82.8**
Structural Grade: **3**
O&M Grade: **0**
Clock Start/From: **12**
Clock To: **1**
1st Value:
2nd Value:
Value Percent:
Continuous Index: **S03**
Within 8" of Joint: **YES**
Remarks: **wandering**

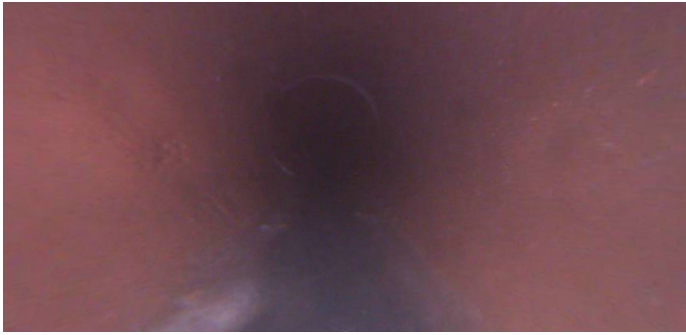
Code: **CL**
Description: **Crack Longitudinal**

Distance (ft): **82.8**
Structural Grade: **2**
O&M Grade: **0**
Clock Start/From: **12**
Clock To:
1st Value:
2nd Value:
Value Percent:
Continuous Index: **F02**
Within 8" of Joint: **YES**
Remarks:

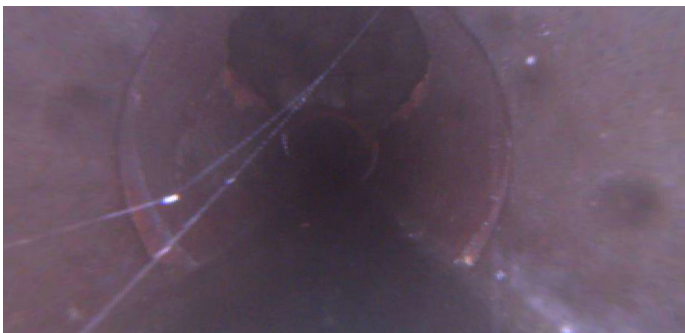
Code: **DSZ**
Description: **Deposits Settled Other**

Distance (ft): **134.8**
Structural Grade: **0**
O&M Grade: **2**
Clock Start/From: **6**
Clock To:
1st Value:
2nd Value:
Value Percent: **5.000**
Continuous Index: **F01**
Within 8" of Joint: **NO**
Remarks: **tissue?/debris**

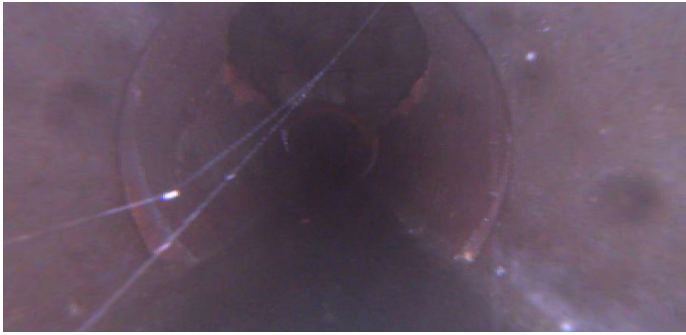
Code: **CM**
Description: **Crack Multiple**

Distance (ft): **134.8**
Structural Grade: **3**
O&M Grade: **0**
Clock Start/From: **12**
Clock To: **1**
1st Value:
2nd Value:
Value Percent:
Continuous Index: **F03**
Within 8" of Joint: **YES**
Remarks: **wandering**
