Profile/Photo Observation Report

Date:	04/20/2018	Weather:		Coding:	PACP 6.0
Pipe Length (ft):	282.1	Owner:	NA	Pre Clean:	Not Known
P.O.#:		Surveyor:	Byrd Fitzgerald	PSR:	P-604-109-057
Customer:		Clean Date:	01/01/1900	Shape:	C

Street:	Summerlin	Flow Control:	Not Controlled
City:	Hobart, IN	Year Renewed:	
Location:	Light Highway	Tape/Media #:	
Purpose:	Not Known	Dia/Height:	10"
Use:	Sanitary	Material:	VCP
Drain Area:	NA	Lining:	
Category:	NA		
Comment:

Location Details:		Direction of Survey:	Downstream
US MH:	M-604-057	DS MH:	M-604-109
		Total Length Surveyed (ft):	137.4

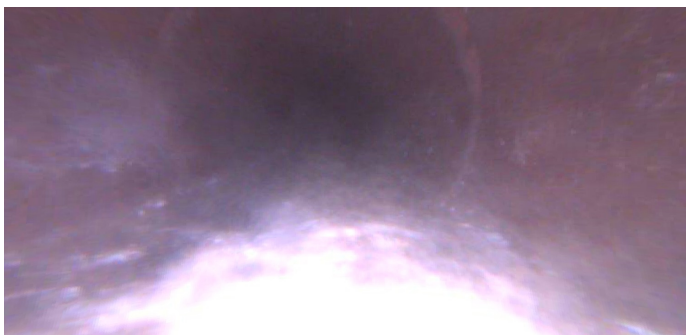
Code: **AMH**
Description: **Manhole**

Distance (ft): **.0**
Structural Grade: **0**
O&M Grade: **0**
Clock Start/From:
Clock To:
1st Value:
2nd Value:
Value Percent:
Continuous Index:
Within 8" of Joint: **NO**
Remarks: **M-604-057**

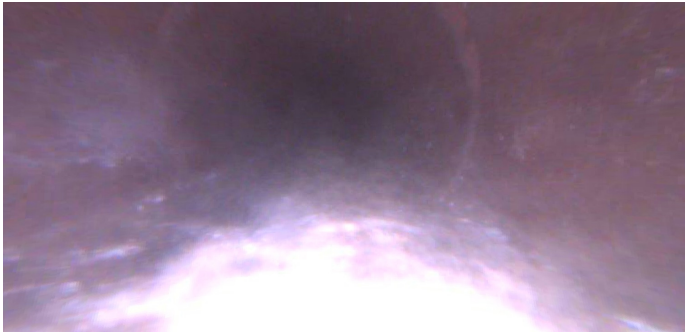
Code:	MWL
Description:	Water Level

Distance (ft):	.0
Structural Grade:	0
O&M Grade:	0
Clock Start/From:	
Clock To:	
1st Value:	
2nd Value:	
Value Percent:	5.000
Continuous Index:	
Within 8" of Joint:	NO
Remarks:

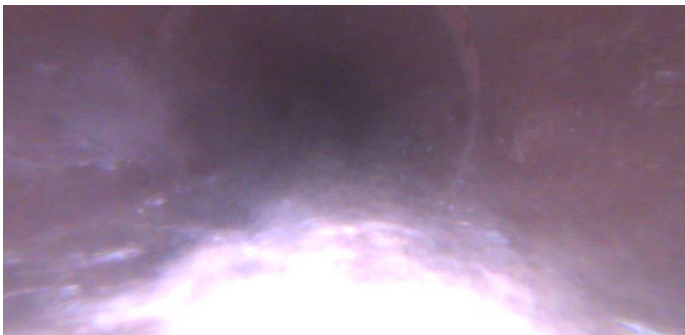
Code:	DSZ
Description:	Deposits Settled Other

Distance (ft):	.0
Structural Grade:	0
O&M Grade:	2
Clock Start/From:	6
Clock To:	
1st Value:	
2nd Value:	
Value Percent:	5.000
Continuous Index:	S01
Within 8" of Joint:	NO
Remarks:	tissue?/debris

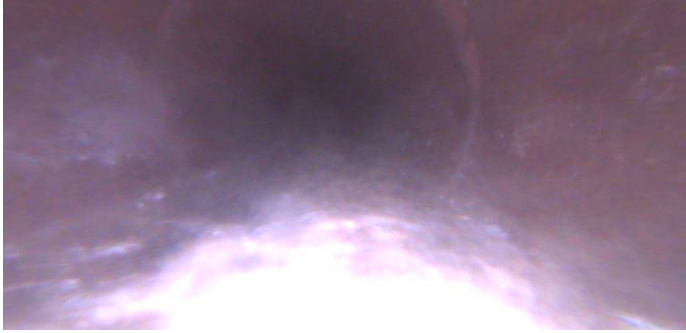
Code: **MGO**
Description: **General Observation**

Distance (ft): **.0**
Structural Grade: **0**
O&M Grade: **0**
Clock Start/From:
Clock To:
1st Value:
2nd Value:
Value Percent:
Continuous Index:
Within 8" of Joint: **NO**
Remarks: **steam**

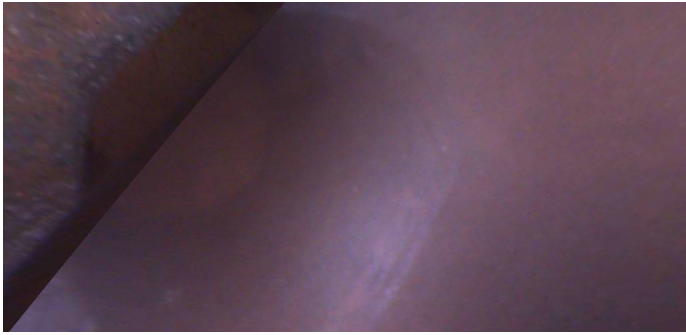
Code: **TFC**
Description: **Tap Factory Capped**

Distance (ft): **29.7**
Structural Grade: **0**
O&M Grade: **0**
Clock Start/From: **10**
Clock To:
1st Value: **4.000**
2nd Value:
Value Percent:
Continuous Index:
Within 8" of Joint: **YES**
Remarks:

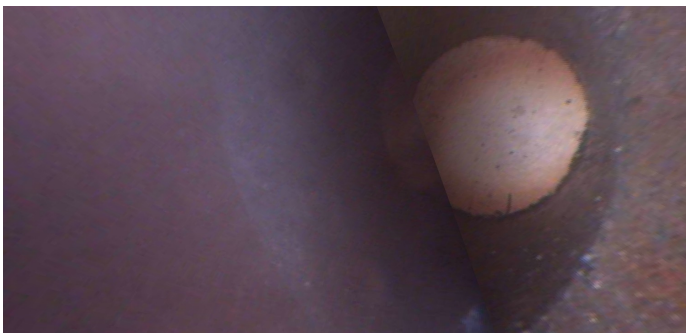
Code: **TFC**
Description: **Tap Factory Capped**

Distance (ft): **39.7**
Structural Grade: **0**
O&M Grade: **0**
Clock Start/From: **2**
Clock To:
1st Value: **4.000**
2nd Value:
Value Percent:
Continuous Index:
Within 8" of Joint: **YES**
Remarks:

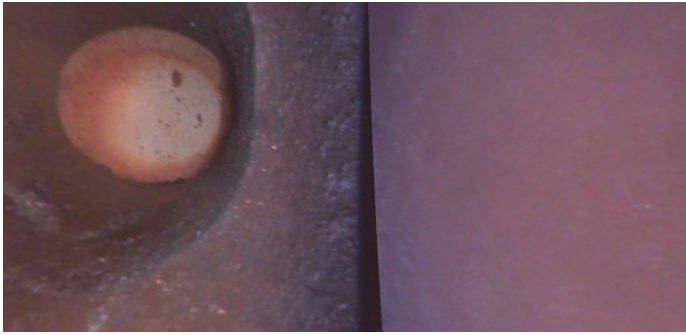
Code: **TFC**
Description: **Tap Factory Capped**

Distance (ft): **52.3**
Structural Grade: **0**
O&M Grade: **0**
Clock Start/From: **10**
Clock To:
1st Value: **4.000**
2nd Value:
Value Percent:
Continuous Index:
Within 8" of Joint: **YES**
Remarks:

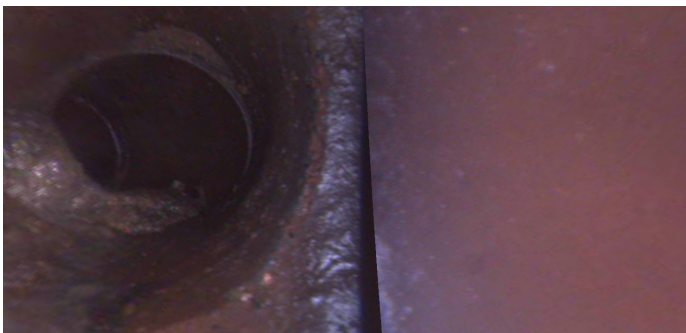
Code: **TF**
Description: **Tap Factory**

Distance (ft): **77.9**
Structural Grade: **0**
O&M Grade: **0**
Clock Start/From: **10**
Clock To:
1st Value: **4.000**
2nd Value:
Value Percent:
Continuous Index:
Within 8" of Joint: **YES**
Remarks:

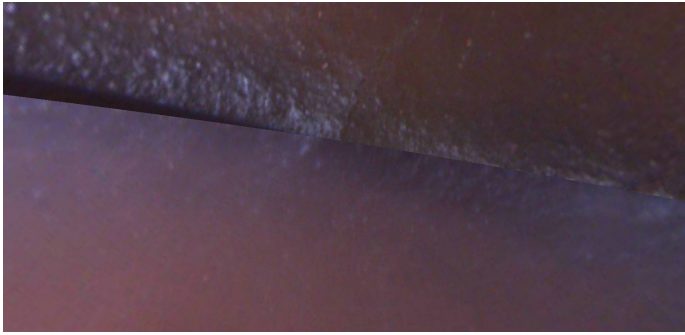
Code: **CL**
Description: **Crack Longitudinal**

Distance (ft): **78.1**
Structural Grade: **2**
O&M Grade: **0**
Clock Start/From: **12**
Clock To:
1st Value:
2nd Value:
Value Percent:
Continuous Index: **S02**
Within 8" of Joint: **YES**
Remarks:

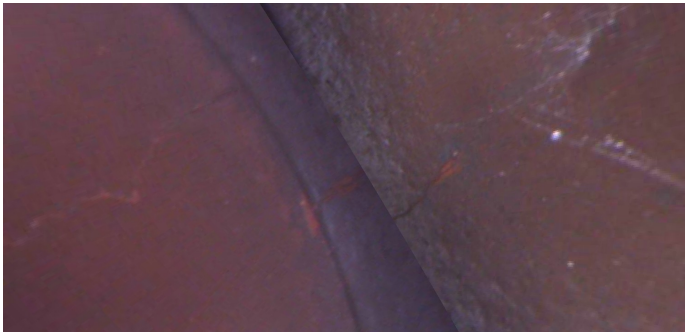
Code: **CM**
Description: **Crack Multiple**

Distance (ft): **82.8**
Structural Grade: **3**
O&M Grade: **0**
Clock Start/From: **12**
Clock To: **1**
1st Value:
2nd Value:
Value Percent:
Continuous Index: **S03**
Within 8" of Joint: **YES**
Remarks: **wandering**

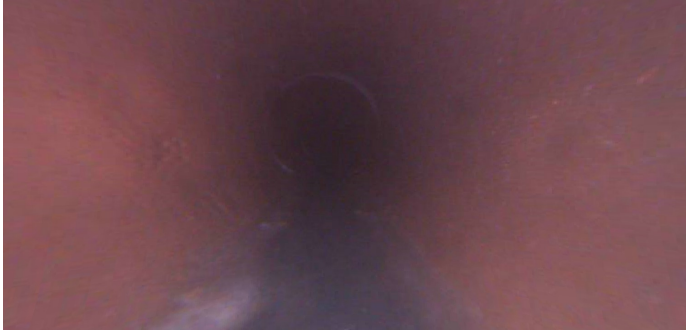
Code: **CL**
Description: **Crack Longitudinal**

Distance (ft): **82.8**
Structural Grade: **2**
O&M Grade: **0**
Clock Start/From: **12**
Clock To:
1st Value:
2nd Value:
Value Percent:
Continuous Index: **F02**
Within 8" of Joint: **YES**
Remarks:

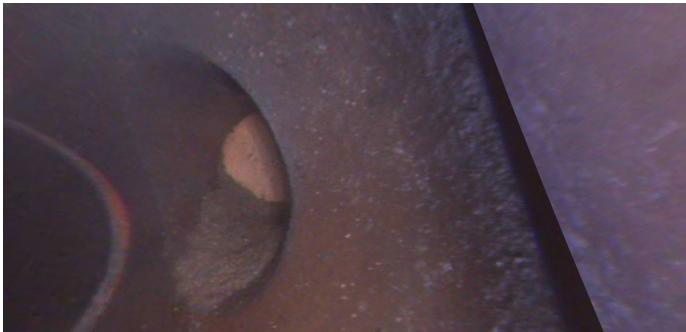
Code: **TFC**
Description: **Tap Factory Capped**

Distance (ft): **102.4**
Structural Grade: **0**
O&M Grade: **0**
Clock Start/From: **10**
Clock To:
1st Value: **4.000**
2nd Value:
Value Percent:
Continuous Index:
Within 8" of Joint: **YES**
Remarks:

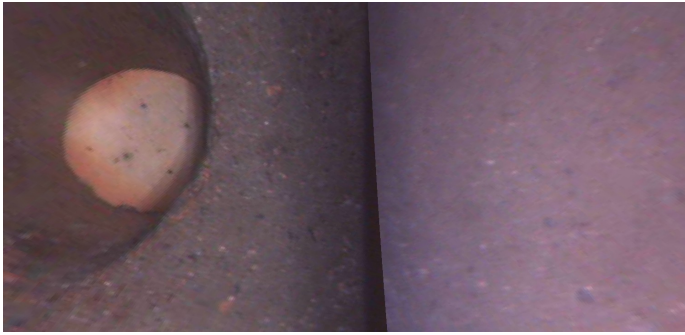
Code: **TFC**
Description: **Tap Factory Capped**

Distance (ft): **128.6**
Structural Grade: **0**
O&M Grade: **0**
Clock Start/From: **10**
Clock To:
1st Value: **4.000**
2nd Value:
Value Percent:
Continuous Index:
Within 8" of Joint: **YES**
Remarks:

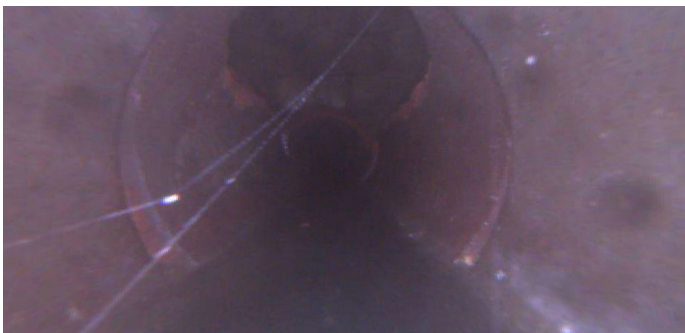
Code: **DSZ**
Description: **Deposits Settled Other**

Distance (ft): **134.8**
Structural Grade: **0**
O&M Grade: **2**
Clock Start/From: **6**
Clock To:
1st Value:
2nd Value:
Value Percent: **5.000**
Continuous Index: **F01**
Within 8" of Joint: **NO**
Remarks: **tissue?/debris**

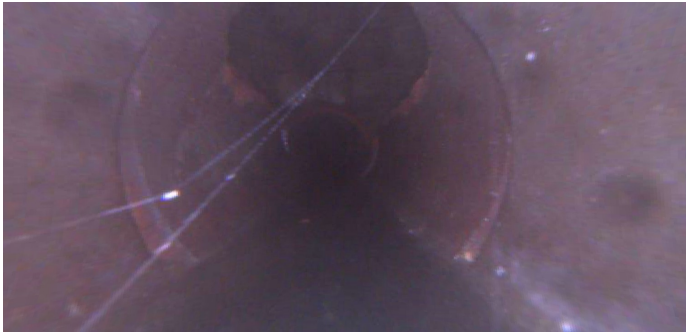
Code: **CM**
Description: **Crack Multiple**

Distance (ft): **134.8**
Structural Grade: **3**
O&M Grade: **0**
Clock Start/From: **12**
Clock To: **1**
1st Value:
2nd Value:
Value Percent:
Continuous Index: **F03**
Within 8" of Joint: **YES**
Remarks: **wandering**

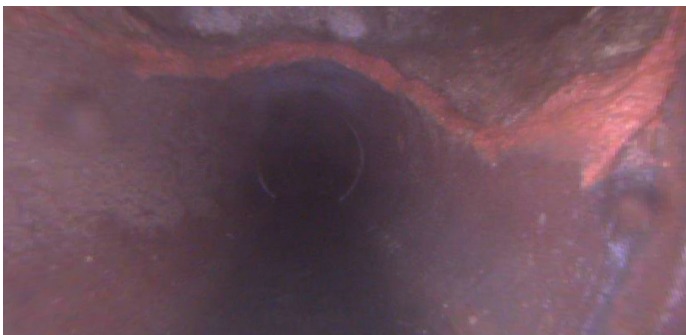
Code: **AMH**
Description: **Manhole**

Distance (ft): **137.4**
Structural Grade: **0**
O&M Grade: **0**
Clock Start/From:
Clock To:
1st Value:
2nd Value:
Value Percent:
Continuous Index:
Within 8" of Joint: **NO**
Remarks: **M-604-109**
