## Profile/Photo Observation Report

Date:	<b>04/16/2018</b>	Weather:		Coding:	<b>PACP 6.0</b>
Pipe Length (ft):		Owner:	<b>City of Hobart</b>	Pre Clean:	<b>No Pre-Cleaning</b>
P.O.#:	<b>62-1</b>	Surveyor:	<b>M. Pielacha</b>	PSR:	<b>M-604-058-M-604-059</b>
Customer:	<b>City of Hobart</b>	Clean Date:		Shape:	<b>C</b>

Street:	<b>1st Street</b>	Flow Control:	<b>Not Controlled</b>
City:	<b>Hobart, IN</b>	Year Renewed:	
Location:	<b>Light Highway</b>	Tape/Media #:	<b>DEP 62</b>
Purpose:	<b>Routine Assessment</b>	Dia/Height:	<b>18"</b>
Use:	<b>Sanitary</b>	Material:	<b>VCP</b>
Drain Area:		Lining:

US MH: **M-604-058** DS MH: **M-604-059** Total Length Surveyed (ft): **212.8**

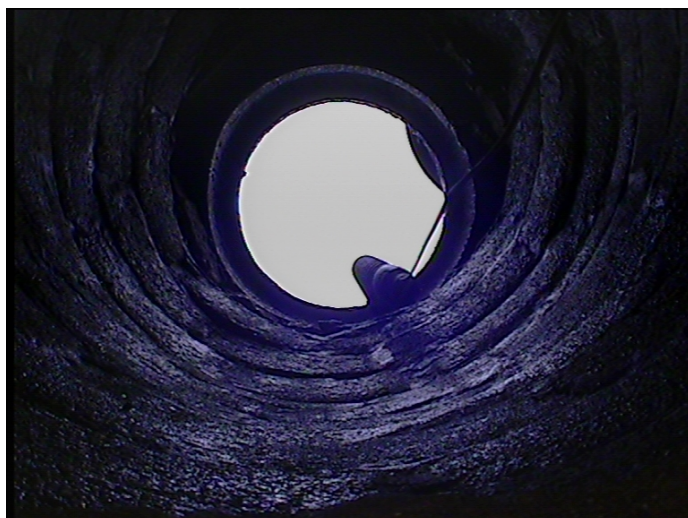
Code: **AMH**  
Description: **Manhole**

Distance (ft): **.0**  
Structural Grade: **0**  
O&M Grade: **0**  
Clock Start/From:  
Clock To:  
1st Value:  
2nd Value:  
Value Percent:  
Continuous Index:  
Within 8" of Joint: **NO**  
Remarks: **M-604-058**

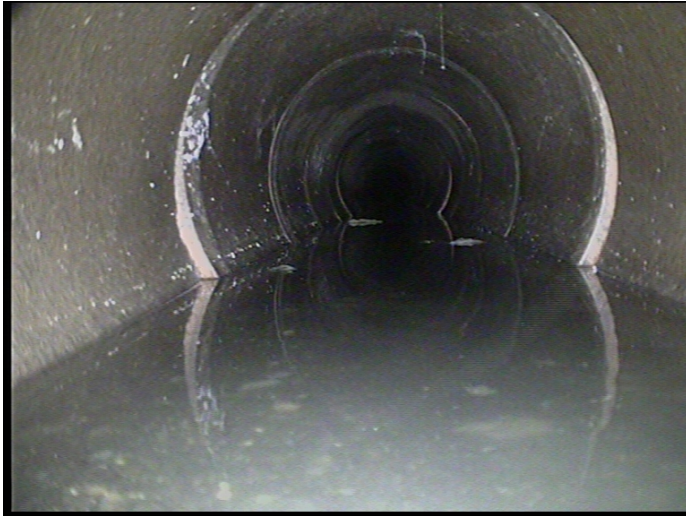
Code: **MWL**  
Description: **Water Level**

Distance (ft): **.0**  
Structural Grade: **0**  
O&M Grade: **0**  
Clock Start/From:  
Clock To:  
1st Value:  
2nd Value:  
Value Percent: **10.000**  
Continuous Index:  
Within 8" of Joint: **NO**  
Remarks:

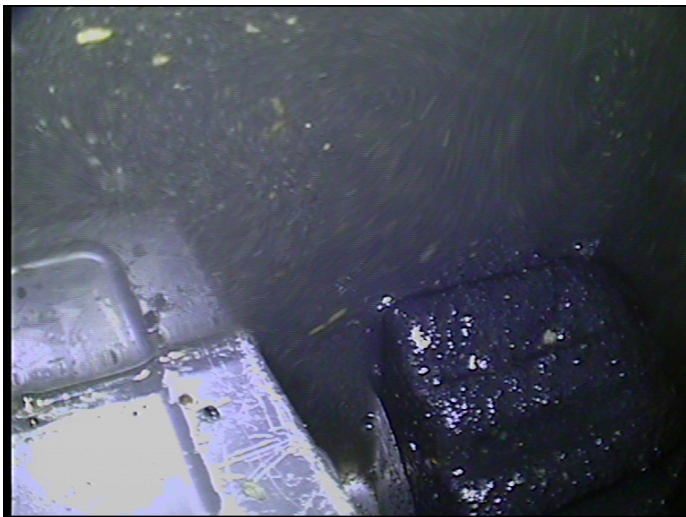
Code: **DSF**  
Description: **Deposits Settled Fine**

Distance (ft): **5.3**  
Structural Grade: **0**  
O&M Grade: **2**  
Clock Start/From: **5**  
Clock To: **7**  
1st Value:  
2nd Value:  
Value Percent: **10.000**  
Continuous Index: **S01**  
Within 8" of Joint: **YES**  
Remarks:

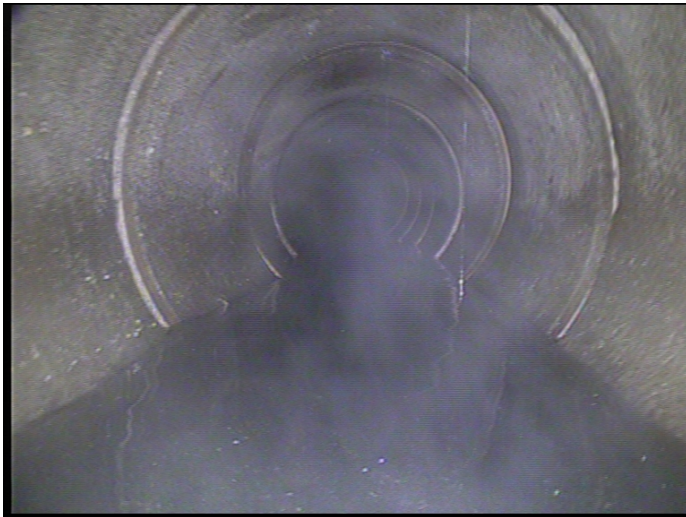
Code: **DSF**  
Description: **Deposits Settled Fine**

Distance (ft): **15.9**  
Structural Grade: **0**  
O&M Grade: **2**  
Clock Start/From: **5**  
Clock To: **7**  
1st Value:  
2nd Value:  
Value Percent: **10.000**  
Continuous Index: **F01**  
Within 8" of Joint: **NO**  
Remarks:

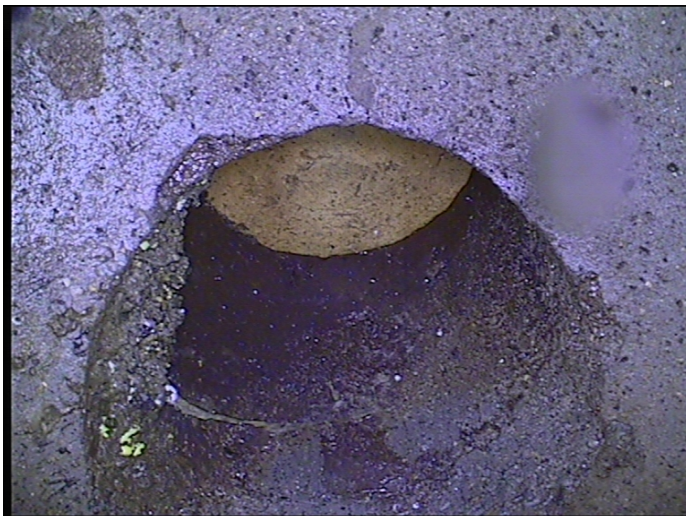
Code: **TFC**  
Description: **Tap Factory Capped**

Distance (ft): **55.7**  
Structural Grade: **0**  
O&M Grade: **0**  
Clock Start/From: **10**  
Clock To:  
1st Value: **4.000**  
2nd Value:  
Value Percent:  
Continuous Index:  
Within 8" of Joint: **NO**  
Remarks:

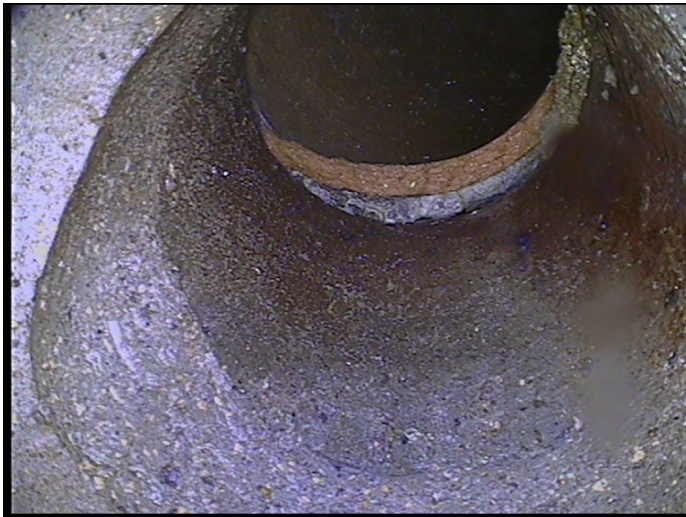
Code: **TF**  
Description: **Tap Factory**

Distance (ft): **58.2**  
Structural Grade: **0**  
O&M Grade: **0**  
Clock Start/From: **2**  
Clock To:  
1st Value: **4.000**  
2nd Value:  
Value Percent:  
Continuous Index:  
Within 8" of Joint: **NO**  
Remarks:

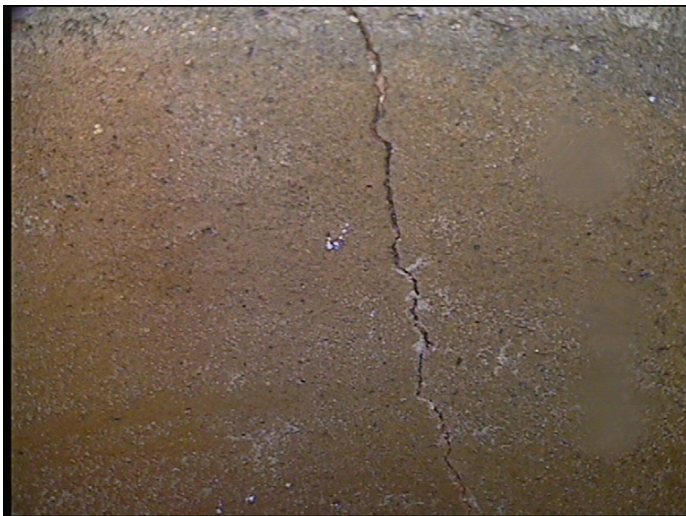
Code: **FL**  
Description: **Fracture Longitudinal**

Distance (ft): **65.4**  
Structural Grade: **3**  
O&M Grade: **0**  
Clock Start/From: **12**  
Clock To:  
1st Value:  
2nd Value:  
Value Percent:  
Continuous Index: **S02**  
Within 8" of Joint: **YES**  
Remarks:

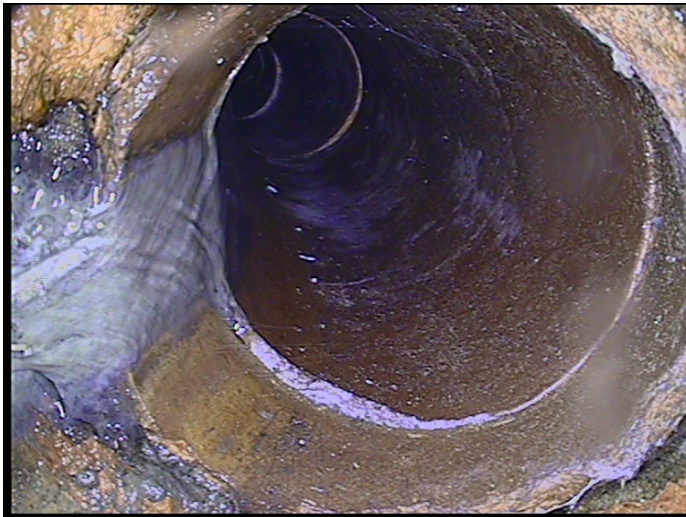
Code: **TBA**  
Description: **Tap Break-in Active**

Distance (ft): **80.6**  
Structural Grade: **0**  
O&M Grade: **0**  
Clock Start/From: **9**  
Clock To:  
1st Value: **4.000**  
2nd Value:  
Value Percent:  
Continuous Index:  
Within 8" of Joint: **NO**  
Remarks:

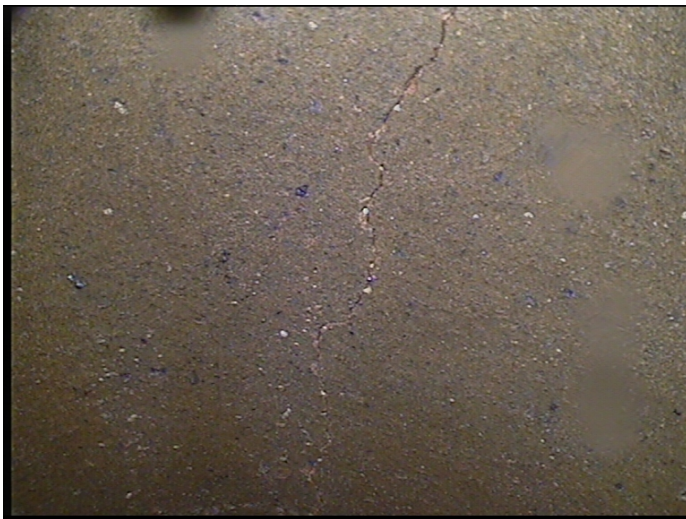
Code: **FL**  
Description: **Fracture Longitudinal**

Distance (ft): **86.8**  
Structural Grade: **3**  
O&M Grade: **0**  
Clock Start/From: **12**  
Clock To:  
1st Value:  
2nd Value:  
Value Percent:  
Continuous Index: **F02**  
Within 8" of Joint: **NO**  
Remarks:

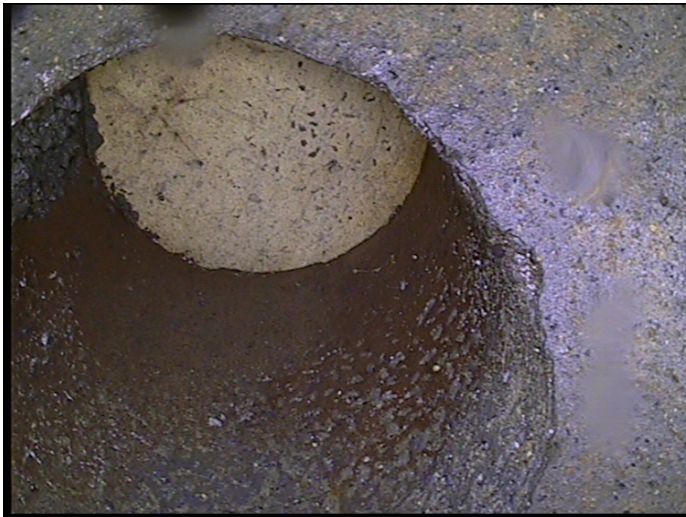
Code: **TFC**  
Description: **Tap Factory Capped**

Distance (ft): **95.6**  
Structural Grade: **0**  
O&M Grade: **0**  
Clock Start/From: **9**  
Clock To:  
1st Value: **4.000**  
2nd Value:  
Value Percent:  
Continuous Index:  
Within 8" of Joint: **NO**  
Remarks:

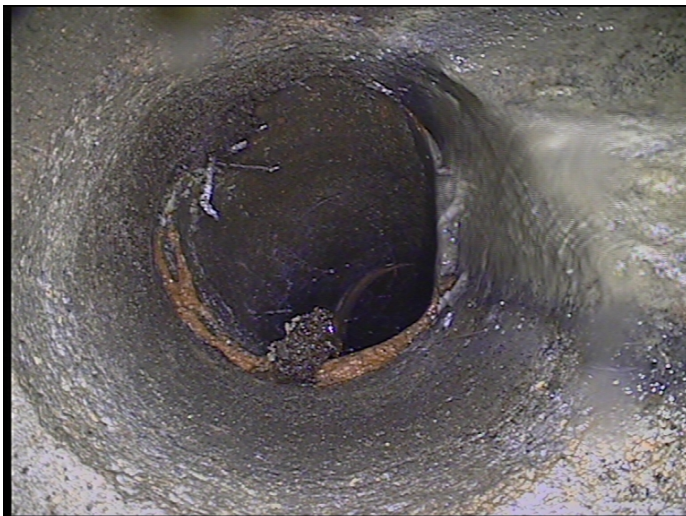
Code: **TFA**  
Description: **Tap Factory Active**

Distance (ft): **98.0**  
Structural Grade: **0**  
O&M Grade: **0**  
Clock Start/From: **2**  
Clock To:  
1st Value: **4.000**  
2nd Value:  
Value Percent:  
Continuous Index:  
Within 8" of Joint: **NO**  
Remarks:

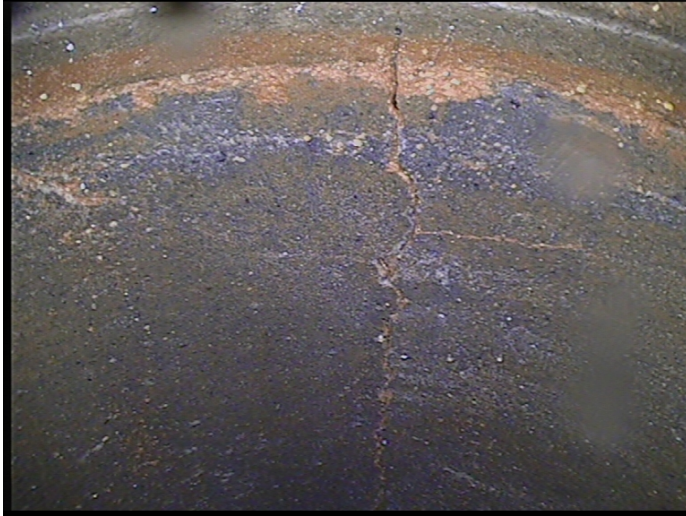
Code: **FL**  
Description: **Fracture Longitudinal**

Distance (ft): **110.9**  
Structural Grade: **3**  
O&M Grade: **0**  
Clock Start/From: **12**  
Clock To:  
1st Value:  
2nd Value:  
Value Percent:  
Continuous Index:  
Within 8" of Joint: **YES**  
Remarks:

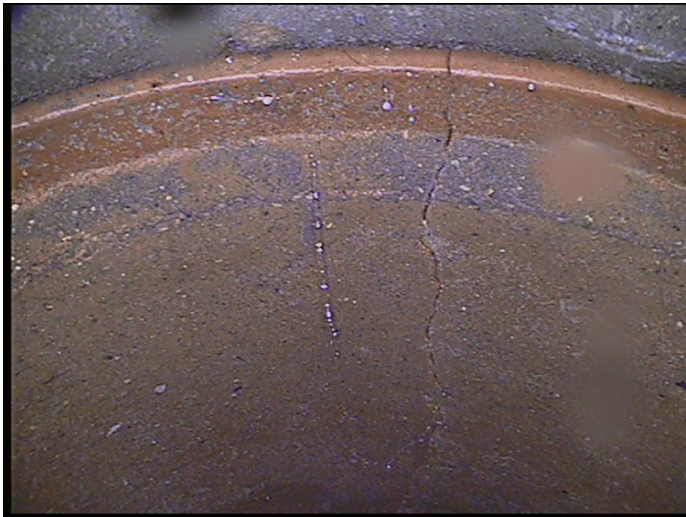
Code: **FL**  
Description: **Fracture Longitudinal**

Distance (ft): **129.3**  
Structural Grade: **3**  
O&M Grade: **0**  
Clock Start/From: **12**  
Clock To:  
1st Value:  
2nd Value:  
Value Percent:  
Continuous Index:  
Within 8" of Joint: **YES**  
Remarks:

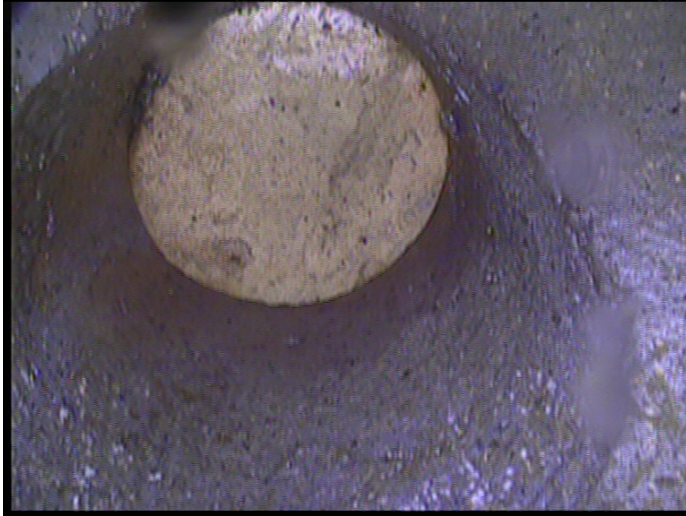
Code: **TFC**  
Description: **Tap Factory Capped**

Distance (ft): **134.8**  
Structural Grade: **0**  
O&M Grade: **0**  
Clock Start/From: **10**  
Clock To:  
1st Value: **4.000**  
2nd Value:  
Value Percent:  
Continuous Index:  
Within 8" of Joint: **NO**  
Remarks:

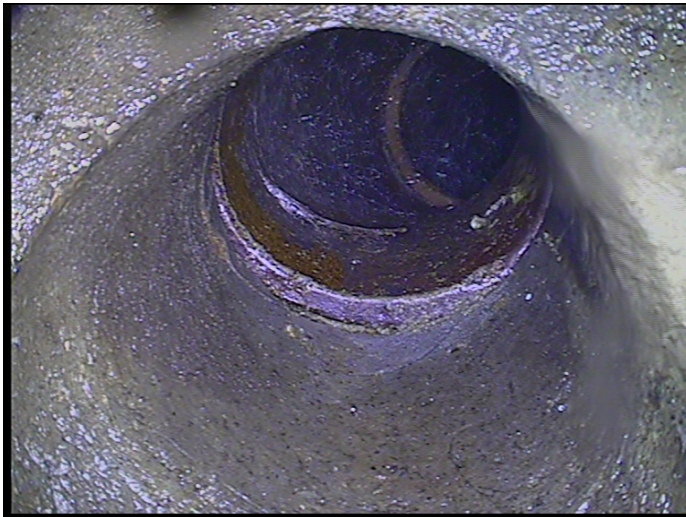
Code: **TFA**  
Description: **Tap Factory Active**

Distance (ft): **136.8**  
Structural Grade: **0**  
O&M Grade: **0**  
Clock Start/From: **2**  
Clock To:  
1st Value: **4.000**  
2nd Value:  
Value Percent:  
Continuous Index:  
Within 8" of Joint: **NO**  
Remarks:

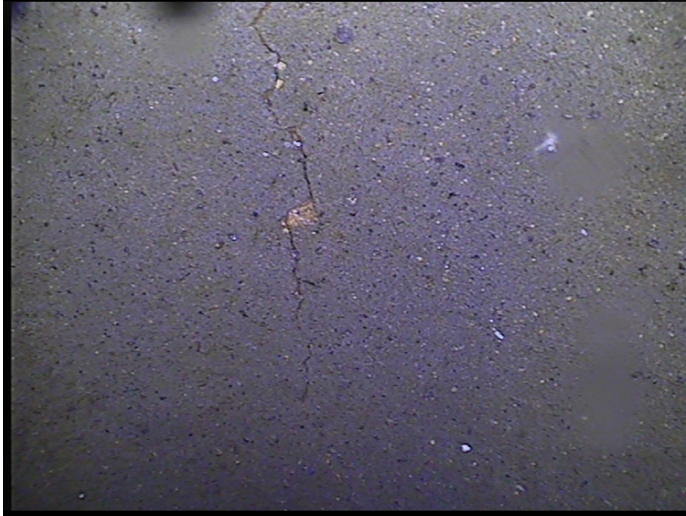
Code: **CL**  
Description: **Crack Longitudinal**

Distance (ft): **144.5**  
Structural Grade: **2**  
O&M Grade: **0**  
Clock Start/From: **12**  
Clock To:  
1st Value:  
2nd Value:  
Value Percent:  
Continuous Index: **S03**  
Within 8" of Joint: **YES**  
Remarks:

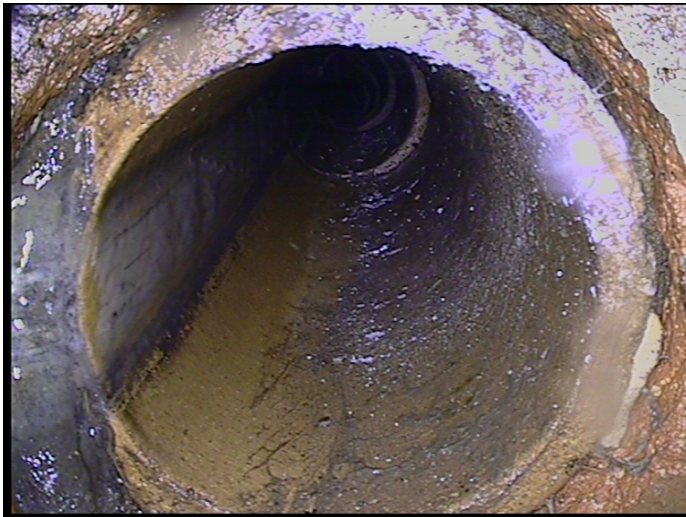
Code: **TB**  
Description: **Tap Break-in**

Distance (ft): **153.3**  
Structural Grade: **0**  
O&M Grade: **0**  
Clock Start/From: **9**  
Clock To:  
1st Value: **4.000**  
2nd Value:  
Value Percent:  
Continuous Index:  
Within 8" of Joint: **YES**  
Remarks:

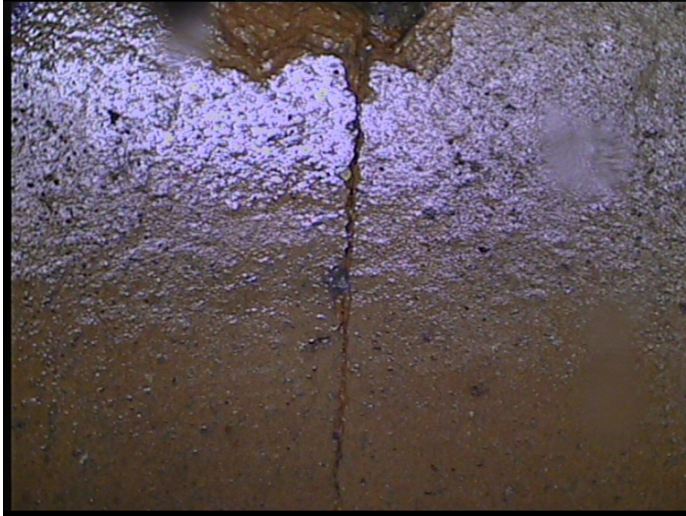
Code: **CL**  
Description: **Crack Longitudinal**

Distance (ft): **153.9**  
Structural Grade: **2**  
O&M Grade: **0**  
Clock Start/From: **9**  
Clock To:  
1st Value:  
2nd Value:  
Value Percent:  
Continuous Index:  
Within 8" of Joint: **YES**  
Remarks:

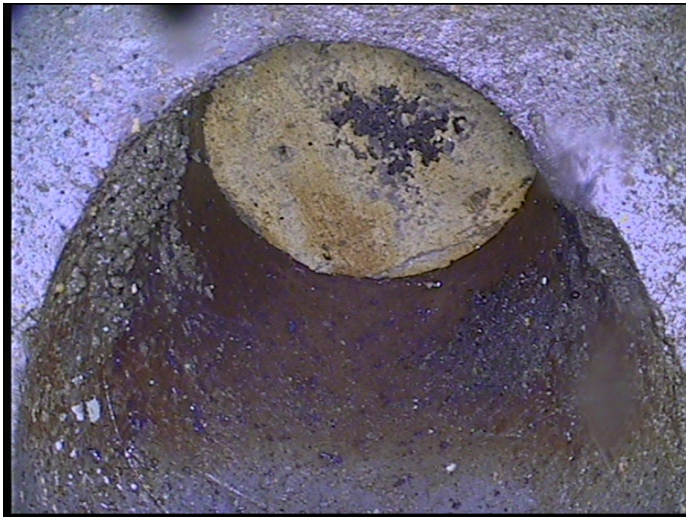
Code: **TFC**  
Description: **Tap Factory Capped**

Distance (ft): **176.2**  
Structural Grade: **0**  
O&M Grade: **0**  
Clock Start/From: **10**  
Clock To:  
1st Value: **4.000**  
2nd Value:  
Value Percent:  
Continuous Index:  
Within 8" of Joint: **NO**  
Remarks:

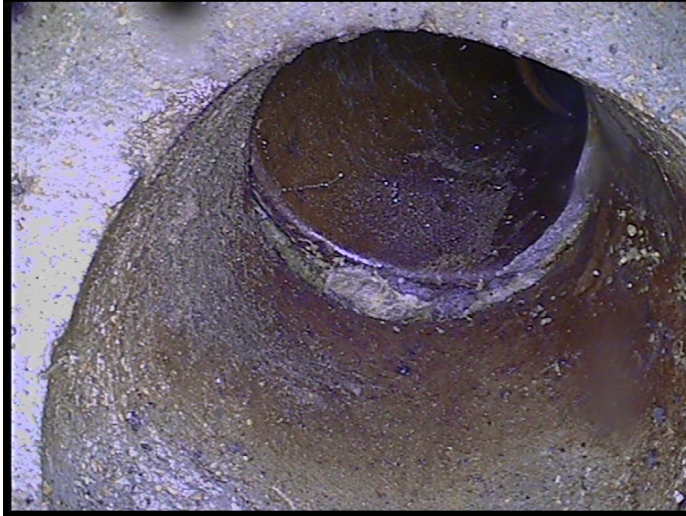
Code: **TF**  
Description: **Tap Factory**

Distance (ft): **178.5**  
Structural Grade: **0**  
O&M Grade: **0**  
Clock Start/From: **2**  
Clock To:  
1st Value: **4.000**  
2nd Value:  
Value Percent:  
Continuous Index:  
Within 8" of Joint: **NO**  
Remarks:

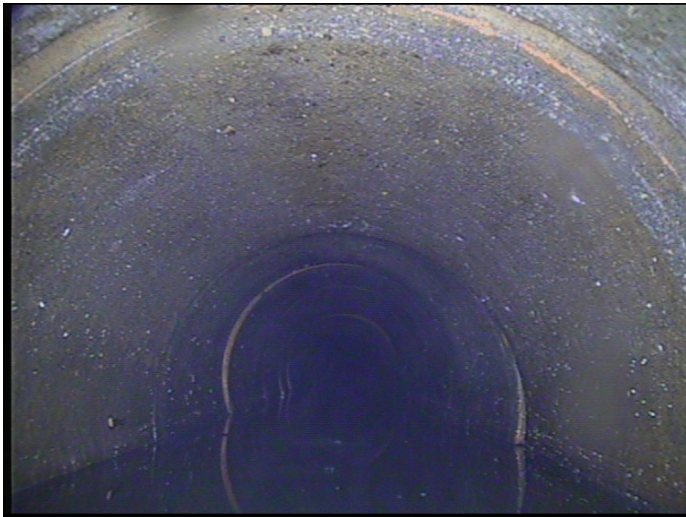
Code: **CL**  
Description: **Crack Longitudinal**

Distance (ft): **178.5**  
Structural Grade: **2**  
O&M Grade: **0**  
Clock Start/From: **12**  
Clock To:  
1st Value:  
2nd Value:  
Value Percent:  
Continuous Index: **F03**  
Within 8" of Joint: **NO**  
Remarks:

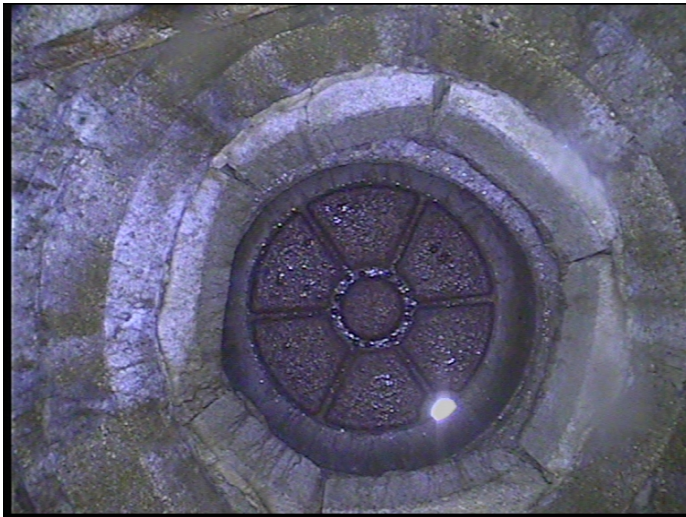
Code:	<b>AMH</b>
Description:	<b>Manhole</b>
Distance (ft):	<b>212.8</b>
Structural Grade:	<b>0</b>
O&M Grade:	<b>0</b>
Clock Start/From:	
Clock To:	
1st Value:	
2nd Value:	
Value Percent:	
Continuous Index:	
Within 8" of Joint:	<b>NO</b>
Remarks:	<b>M-604-059</b>
