## Profile/Photo Observation Report

Street:	<b>N CONNECTICUT ST &amp; W HOME AVE</b>	Flow Control:	<b>Not Controlled</b>
City:	<b>Hobart, IN</b>	Year Renewed:	
Location:	<b>Other</b>	Tape/Media #:	
Purpose:	<b>Not Known</b>	Dia/Height:	<b>12"</b>
Use:	<b>Sanitary</b>	Material:	<b>VCP</b>
Drain Area:	<b>NA</b>	Lining:	
Category:	<b>NA</b>		
Comment:

Location Details:		Direction of Survey:	<b>Upstream</b>
US MH:	<b>M-604-058</b>	DS MH:	<b>M-604-107</b>
		Total Length Surveyed (ft):	<b>11.8</b>

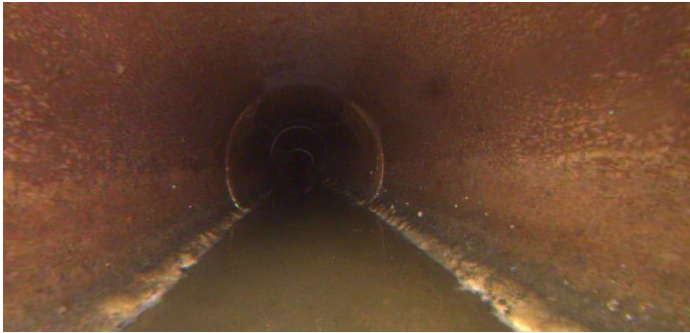
Code: AMH

Description: Manhole

Remarks: M-604-107

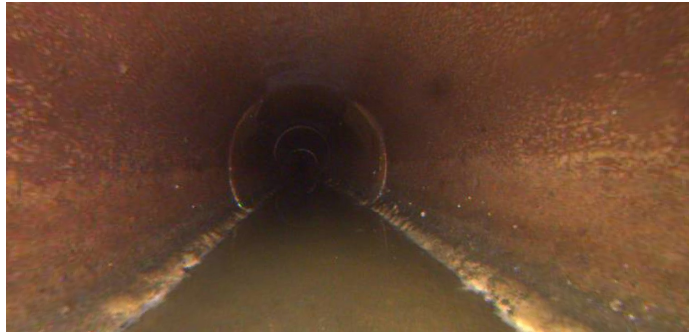
Code: **MWL**  
Description: **Water Level**

Distance (ft): **.0**  
Structural Grade: **0**  
O&M Grade: **0**  
Clock Start/From:  
Clock To:  
1st Value:  
2nd Value:  
Value Percent: **10.000**  
Continuous Index:  
Within 8" of Joint: **NO**  
Remarks:

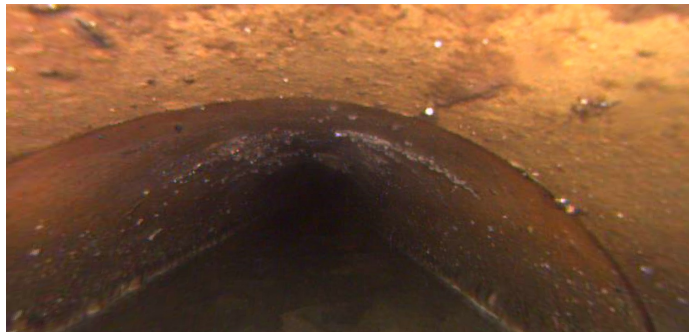
Code: **MSA**  
Description: **Abandoned Survey**

Distance (ft): **11.8**  
Structural Grade: **0**  
O&M Grade: **0**  
Clock Start/From:  
Clock To:  
1st Value:  
2nd Value:  
Value Percent:  
Continuous Index:  
Within 8" of Joint: **NO**  
Remarks: **debris under water**
