Profile/Photo Observation Report

Date:	11/10/2021	Weather:		Coding:	PACP 7.0
Pipe Length (ft):	164.5	Owner:	City of Hobart	Pre Clean:	Heavy Cleaning
P.O.#:	YES502259	Surveyor:	Steven Bucklin	PSR:	P-604-107-058
Customer:	City of Hobart, IN (Red	Clean Date:	11/10/2021	Shape:	C

Street:	West Home Avenue	Flow Control:	Not Controlled
City:	City of Hobart	Year Renewed:	
Location:	Local rural streets with light traffic, t	Tape/Media #:	
Purpose:	Routine Assessment	Dia/Height:	10"
Use:	Sanitary Sewage Pipe	Material:	VCP
Drain Area:		Lining:	None
Category:	NA		
Comment:			
Location Details:		Direction of Survey:	Downstream
US MH:	M-604-058	DS MH:	M-604-107
		Total Length Surveyed (ft):	164.5

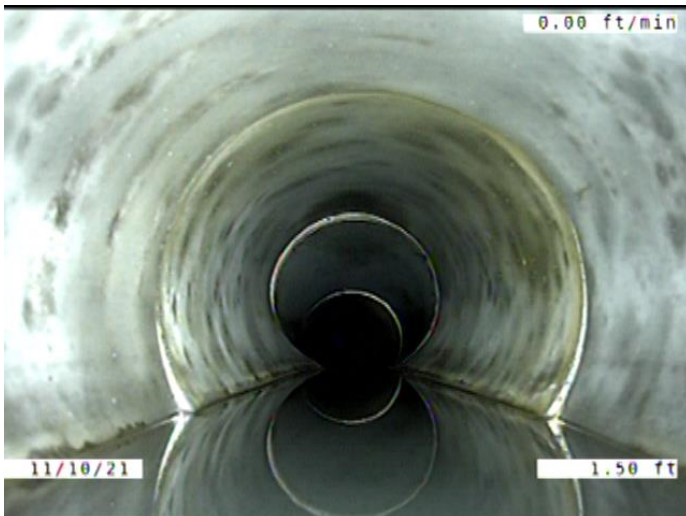
Code: **MGO**
 Description: **Miscellaneous General Observation**

Distance (ft): **1.5**
 Structural Grade: **0**
 O&M Grade: **0**
 Clock Start/From:
 Clock To:
 1st Value:
 2nd Value:
 Value Percent:
 Continuous Index:
 Within 8" of Joint: **NO**
 Remarks: **DROP INTO THE MANHOLE. HAD TO START IN THE PIPE.**

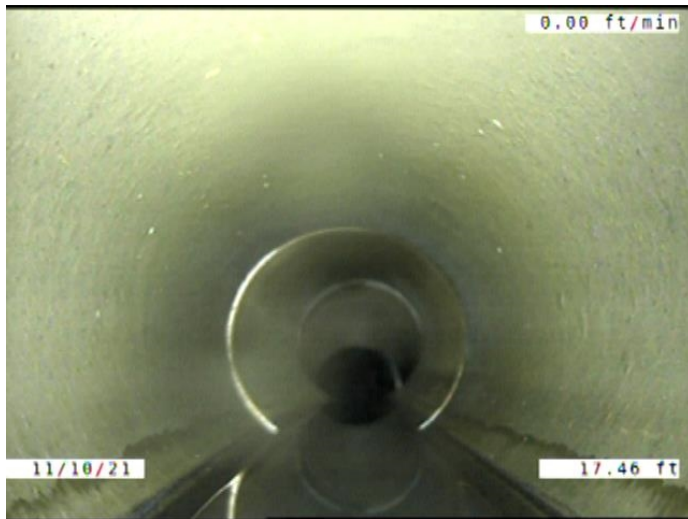
Code: **MWLS**
 Description: **Miscellaneous Water Level Sag**

Distance (ft): **17.5**
 Structural Grade: **2**
 O&M Grade: **0**
 Clock Start/From:
 Clock To:
 1st Value:
 2nd Value:
 Value Percent: **15.000**
 Continuous Index: **F01**
 Within 8" of Joint: **NO**
 Remarks:

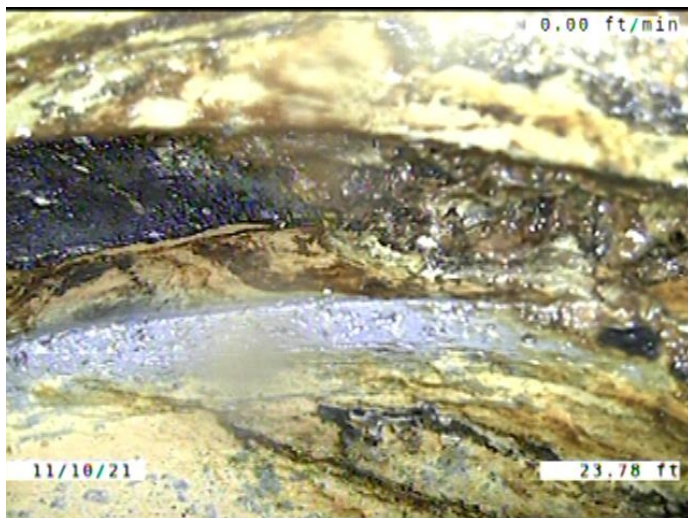
Code: **DAE**
 Description: **Deposits Attached Encrustation**

Distance (ft): **23.8**
 Structural Grade: **0**
 O&M Grade: **2**
 Clock Start/From: **8**
 Clock To: **4**
 1st Value:
 2nd Value:
 Value Percent: **5.000**
 Continuous Index:
 Within 8" of Joint: **YES**
 Remarks:

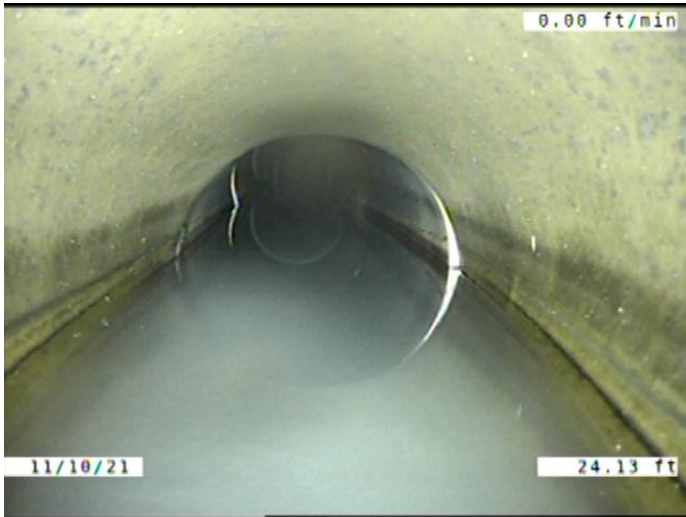
Code: **MWLS**
Description: **Miscellaneous Water Level Sag**

Distance (ft): **24.1**
Structural Grade: **2**
O&M Grade: **0**
Clock Start/From:
Clock To:
1st Value:
2nd Value:
Value Percent: **20.000**
Continuous Index: **S02**
Within 8" of Joint: **NO**
Remarks:

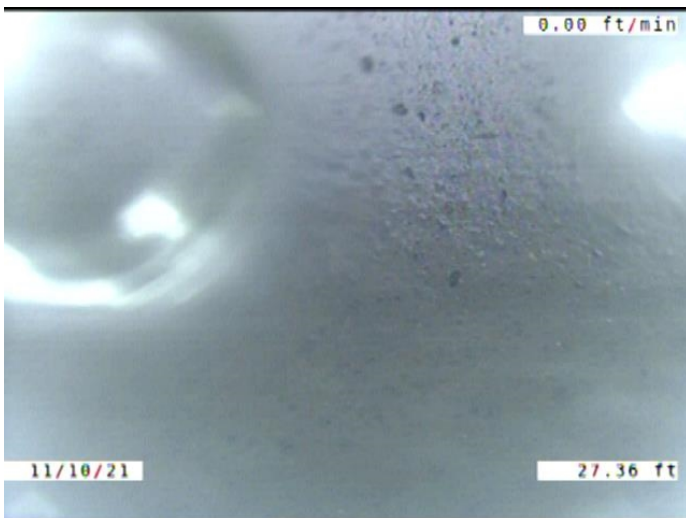
Code: **MCU**
Description: **Miscellaneous Camera Underwater**

Distance (ft): **27.4**
Structural Grade: **0**
O&M Grade: **4**
Clock Start/From:
Clock To:
1st Value:
2nd Value:
Value Percent:
Continuous Index:
Within 8" of Joint: **NO**
Remarks: **Out at 28.5**

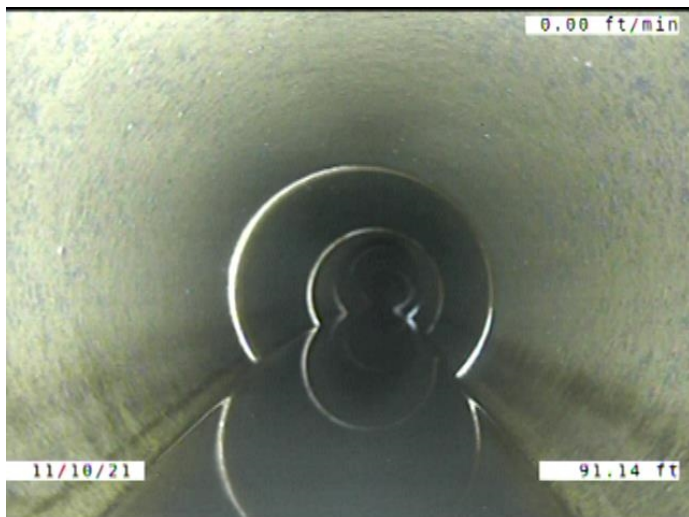
Code: **MWLS**
Description: **Miscellaneous Water Level Sag**

Distance (ft): **91.1**
Structural Grade: **2**
O&M Grade: **0**
Clock Start/From:
Clock To:
1st Value:
2nd Value:
Value Percent: **10.000**
Continuous Index: **S05**
Within 8" of Joint: **NO**
Remarks:

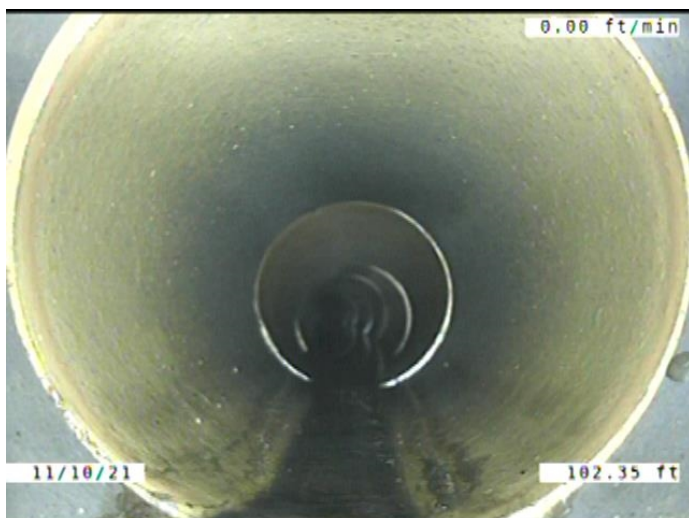
Code: **MWLS**
Description: **Miscellaneous Water Level Sag**

Distance (ft): **102.3**
Structural Grade: **2**
O&M Grade: **0**
Clock Start/From:
Clock To:
1st Value:
2nd Value:
Value Percent: **10.000**
Continuous Index: **F05**
Within 8" of Joint: **NO**
Remarks:

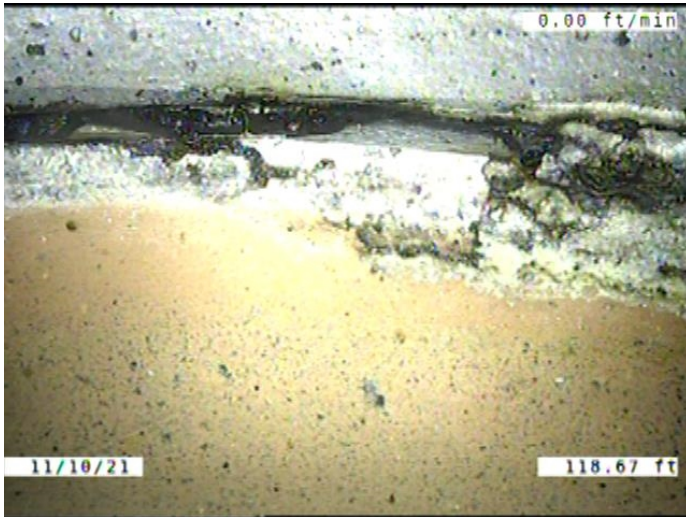
Code: **DAE**
 Description: **Deposits Attached Encrustation**

Distance (ft): **118.7**
 Structural Grade: **0**
 O&M Grade: **2**
 Clock Start/From: **9**
 Clock To: **3**
 1st Value:
 2nd Value:
 Value Percent: **5.000**
 Continuous Index:
 Within 8" of Joint: **YES**
 Remarks:

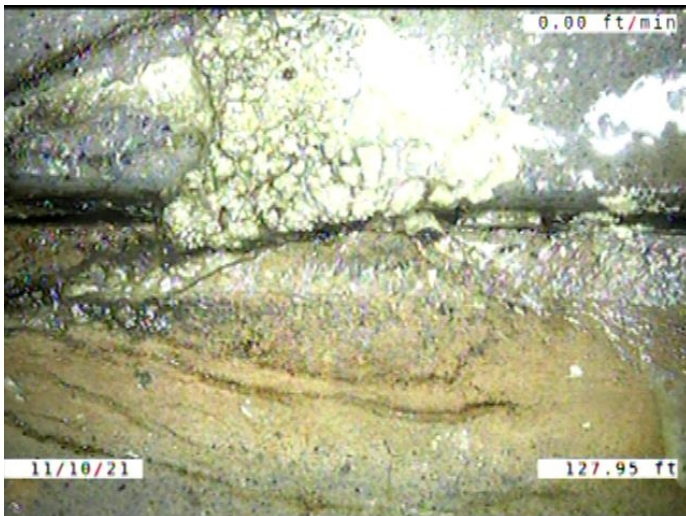
Code: **DAE**
 Description: **Deposits Attached Encrustation**

Distance (ft): **128.0**
 Structural Grade: **0**
 O&M Grade: **2**
 Clock Start/From: **2**
 Clock To: **4**
 1st Value:
 2nd Value:
 Value Percent: **5.000**
 Continuous Index:
 Within 8" of Joint: **YES**
 Remarks:

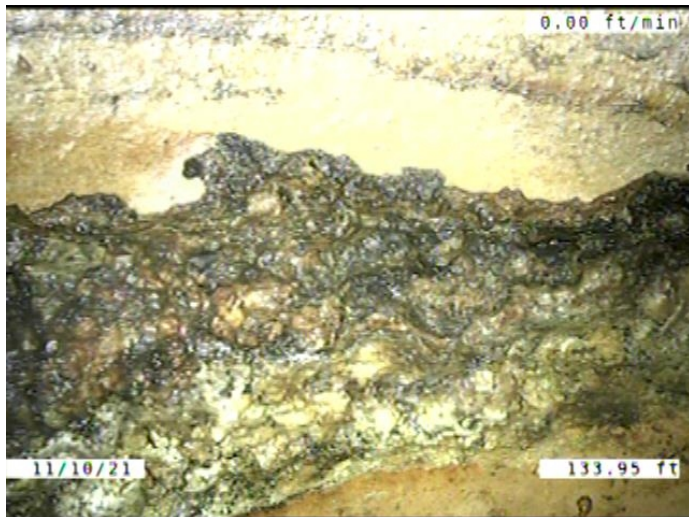
Code: **DAE**
 Description: **Deposits Attached Encrustation**

Distance (ft): **134.0**
 Structural Grade: **0**
 O&M Grade: **2**
 Clock Start/From: **9**
 Clock To: **11**
 1st Value:
 2nd Value:
 Value Percent: **5.000**
 Continuous Index:
 Within 8" of Joint: **YES**
 Remarks:

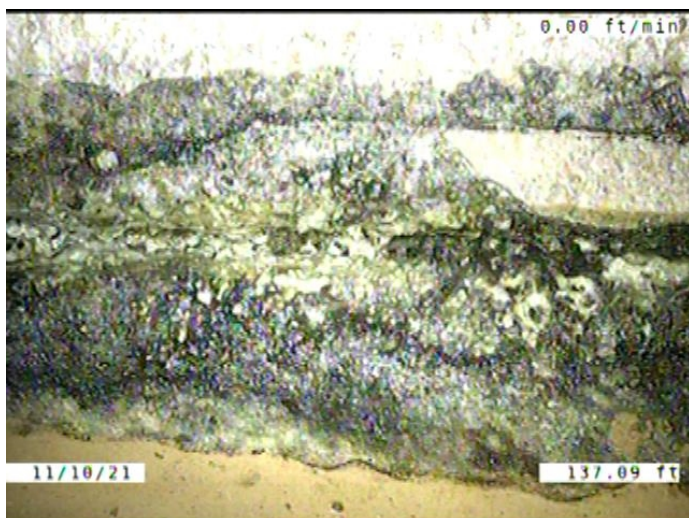
Code: **DAE**
 Description: **Deposits Attached Encrustation**

Distance (ft): **137.1**
 Structural Grade: **0**
 O&M Grade: **2**
 Clock Start/From: **8**
 Clock To: **4**
 1st Value:
 2nd Value:
 Value Percent: **5.000**
 Continuous Index:
 Within 8" of Joint: **YES**
 Remarks:

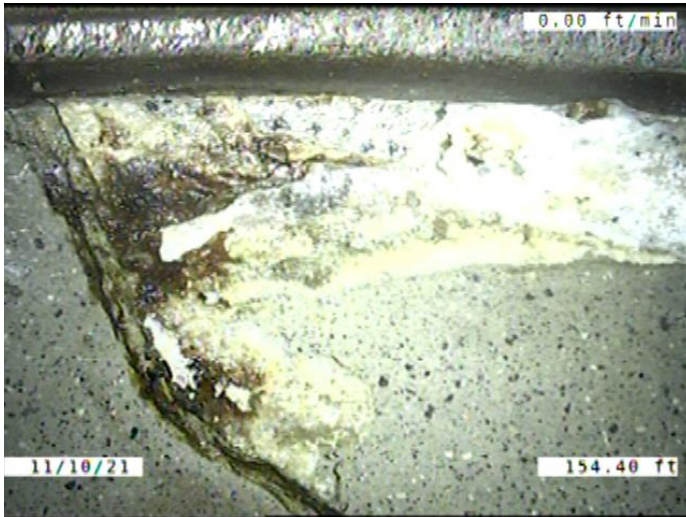
Code: **DAE**
 Description: **Deposits Attached Encrustation**

Distance (ft): **154.4**
 Structural Grade: **0**
 O&M Grade: **2**
 Clock Start/From: **1**
 Clock To: **2**
 1st Value:
 2nd Value:
 Value Percent: **5.000**
 Continuous Index:
 Within 8" of Joint: **YES**
 Remarks:

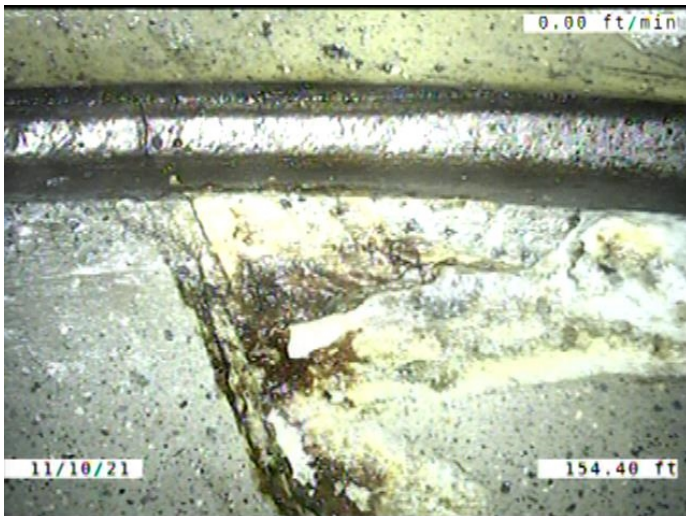
Code: **CL**
 Description: **Crack Longitudinal**

Distance (ft): **154.4**
 Structural Grade: **2**
 O&M Grade: **0**
 Clock Start/From: **1**
 Clock To:
 1st Value:
 2nd Value:
 Value Percent:
 Continuous Index:
 Within 8" of Joint: **YES**
 Remarks:
