Profile/Photo Observation Report

Date:	11/10/2021	Weather:		Coding:	PACP 7.0
Pipe Length (ft):	164.5	Owner:	City of Hobart	Pre Clean:	Heavy Cleaning
P.O.#:	YES502259	Surveyor:	Steven Bucklin	PSR:	P-604-107-058
Customer:	City of Hobart, IN (Red	Clean Date:	11/10/2021	Shape:	C

Street:	West Home Avenue	Flow Control:	Not Controlled
City:	City of Hobart	Year Renewed:	
Location:	Local rural streets with light traffic, t	Tape/Media #:	
Purpose:	Routine Assessment	Dia/Height:	10"
Use:	Sanitary Sewage Pipe	Material:	VCP
Drain Area:		Lining:	None
Category:	NA		
Comment:			
Location Details:		Direction of Survey:	Downstream
US MH:	M-604-058	DS MH:	M-604-107
		Total Length Surveyed (ft):	164.5

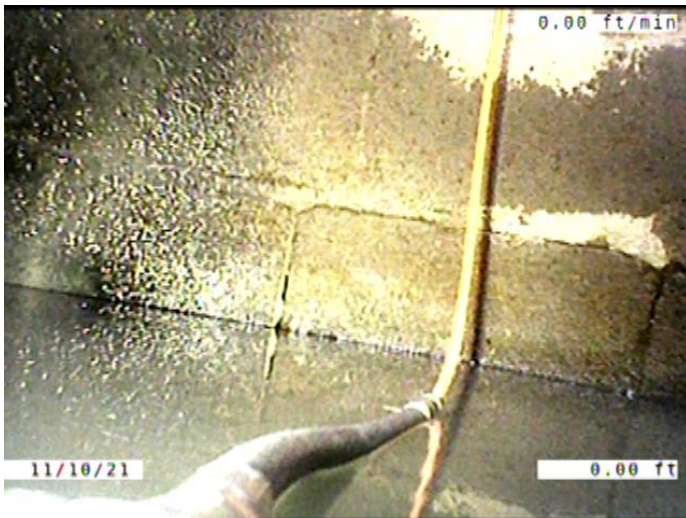
Code: **AMH**
Description: **Manhole**

Distance (ft): **.0**
Structural Grade: **0**
O&M Grade: **0**
Clock Start/From:
Clock To:
1st Value:
2nd Value:
Value Percent:
Continuous Index:
Within 8" of Joint: **NO**
Remarks: **M-604-058**

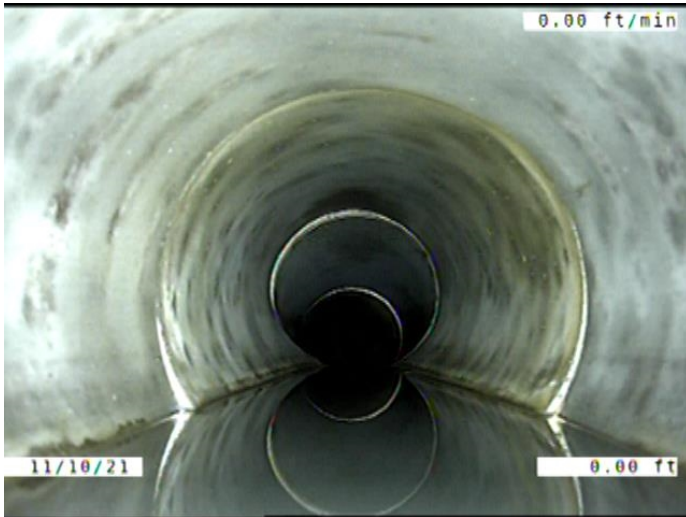
Code: **MWL**
Description: **Miscellaneous Water Level**

Distance (ft): **.0**
Structural Grade: **0**
O&M Grade: **0**
Clock Start/From:
Clock To:
1st Value:
2nd Value:
Value Percent: **10.000**
Continuous Index:
Within 8" of Joint: **NO**
Remarks:

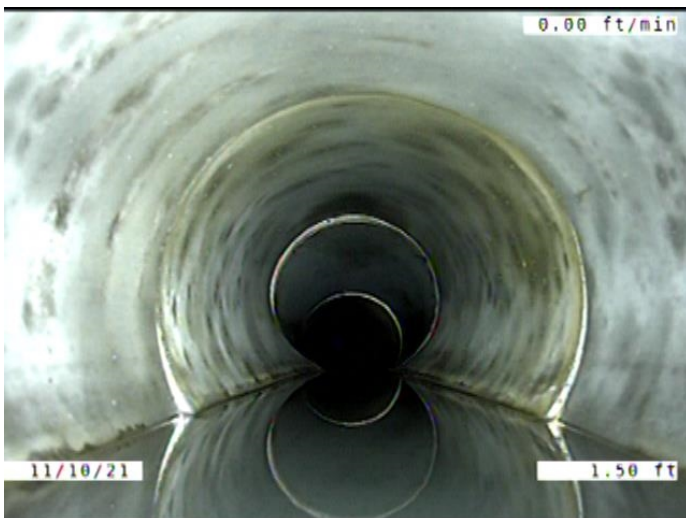
Code: **MGO**
Description: **Miscellaneous General Observation**

Distance (ft): **1.5**
Structural Grade: **0**
O&M Grade: **0**
Clock Start/From:
Clock To:
1st Value:
2nd Value:
Value Percent:
Continuous Index:
Within 8" of Joint: **NO**
Remarks: **DROP INTO THE MANHOLE. HAD TO START IN THE PIPE.**

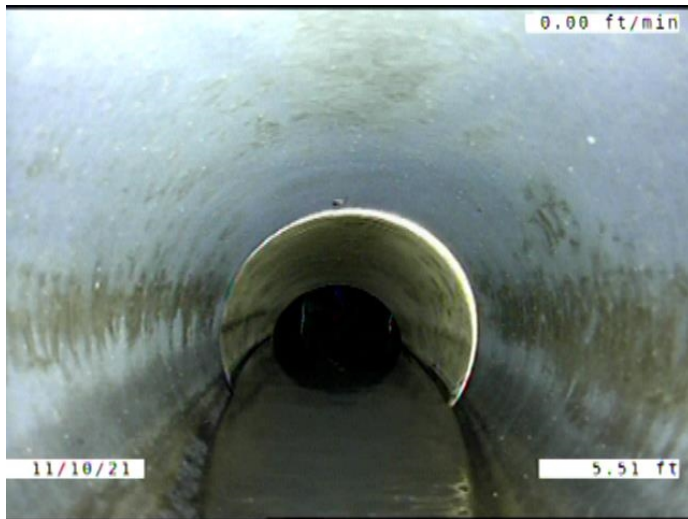
Code: **LD**
Description: **Line Down**

Distance (ft): **5.5**
Structural Grade: **0**
O&M Grade: **1**
Clock Start/From:
Clock To:
1st Value:
2nd Value:
Value Percent: **5.000**
Continuous Index:
Within 8" of Joint: **NO**
Remarks:

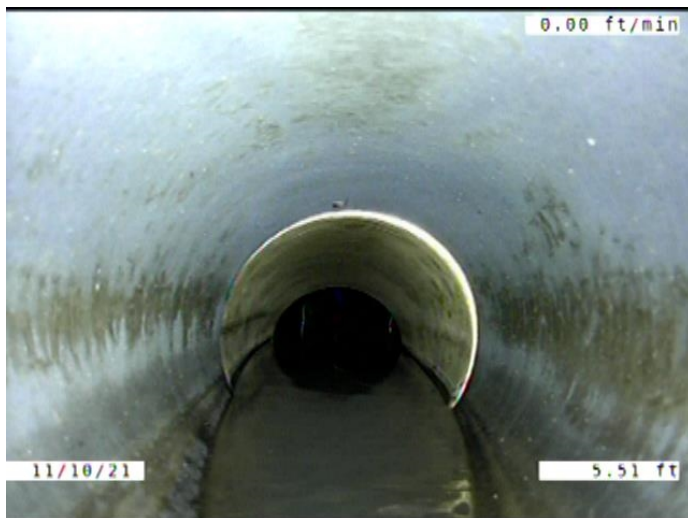
Code: **MWLS**
Description: **Miscellaneous Water Level Sag**

Distance (ft): **5.5**
Structural Grade: **2**
O&M Grade: **0**
Clock Start/From:
Clock To:
1st Value:
2nd Value:
Value Percent: **15.000**
Continuous Index: **S01**
Within 8" of Joint: **NO**
Remarks:

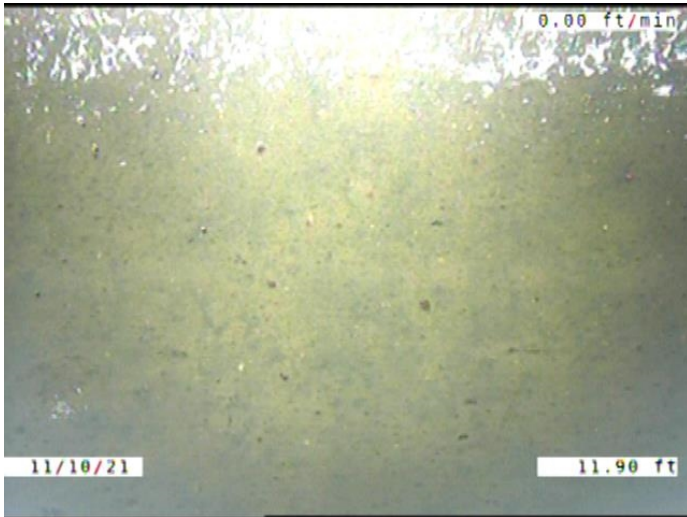
Code: **MCU**
 Description: **Miscellaneous Camera Underwater**

Distance (ft): **11.9**
 Structural Grade: **0**
 O&M Grade: **4**
 Clock Start/From:
 Clock To:
 1st Value:
 2nd Value:
 Value Percent:
 Continuous Index:
 Within 8" of Joint: **NO**
 Remarks: **Out at 13**

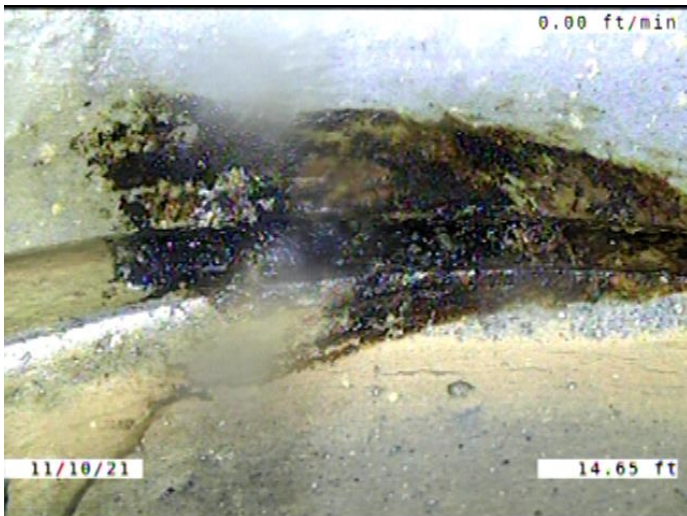
Code: **ISJ**
 Description: **Infiltration Stain Joint**

Distance (ft): **14.6**
 Structural Grade: **0**
 O&M Grade: **1**
 Clock Start/From: **10**
 Clock To: **1**
 1st Value:
 2nd Value:
 Value Percent:
 Continuous Index:
 Within 8" of Joint: **YES**
 Remarks:

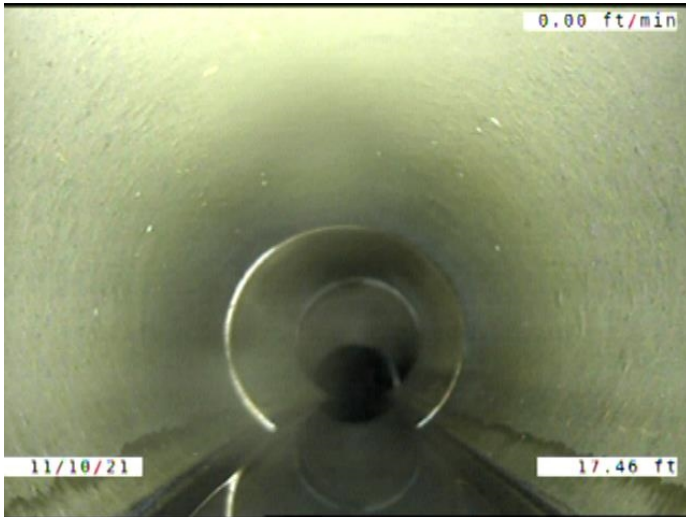
Code: **MWLS**
Description: **Miscellaneous Water Level Sag**

Distance (ft): **17.5**
Structural Grade: **2**
O&M Grade: **0**
Clock Start/From:
Clock To:
1st Value:
2nd Value:
Value Percent: **15.000**
Continuous Index: **F01**
Within 8" of Joint: **NO**
Remarks:

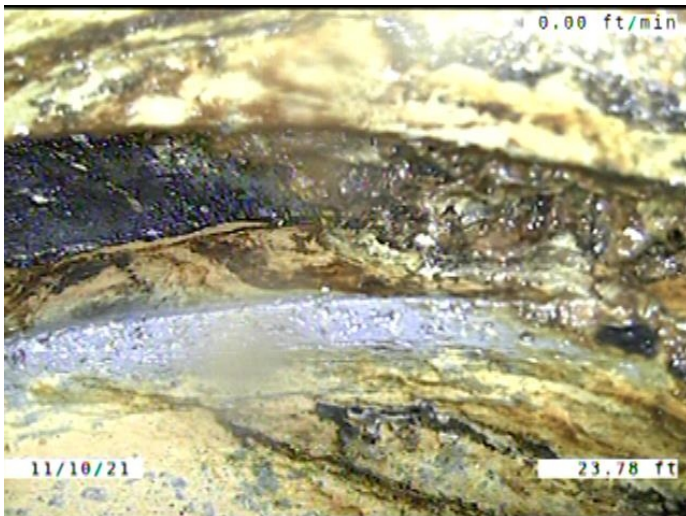
Code: **DAE**
Description: **Deposits Attached Encrustation**

Distance (ft): **23.8**
Structural Grade: **0**
O&M Grade: **2**
Clock Start/From: **8**
Clock To: **4**
1st Value:
2nd Value:
Value Percent: **5.000**
Continuous Index:
Within 8" of Joint: **YES**
Remarks:

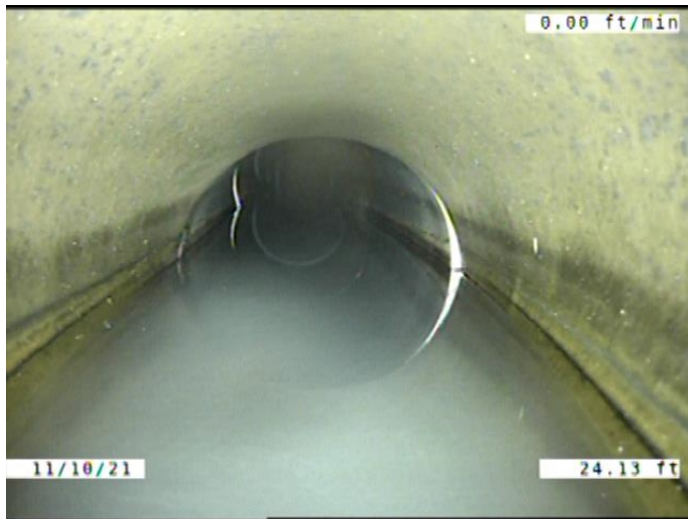
Code: **MWLS**
 Description: **Miscellaneous Water Level Sag**

Distance (ft): **24.1**
 Structural Grade: **2**
 O&M Grade: **0**
 Clock Start/From:
 Clock To:
 1st Value:
 2nd Value:
 Value Percent: **20.000**
 Continuous Index: **S02**
 Within 8" of Joint: **NO**
 Remarks:

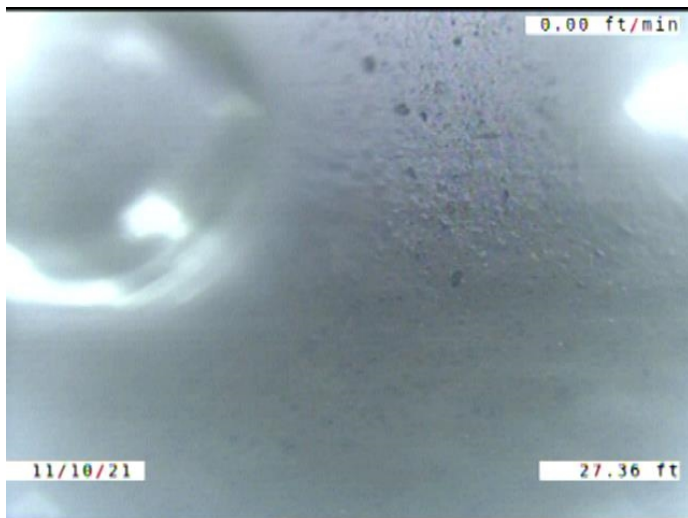
Code: **MCU**
 Description: **Miscellaneous Camera Underwater**

Distance (ft): **27.4**
 Structural Grade: **0**
 O&M Grade: **4**
 Clock Start/From:
 Clock To:
 1st Value:
 2nd Value:
 Value Percent:
 Continuous Index:
 Within 8" of Joint: **NO**
 Remarks: **Out at 28.5**

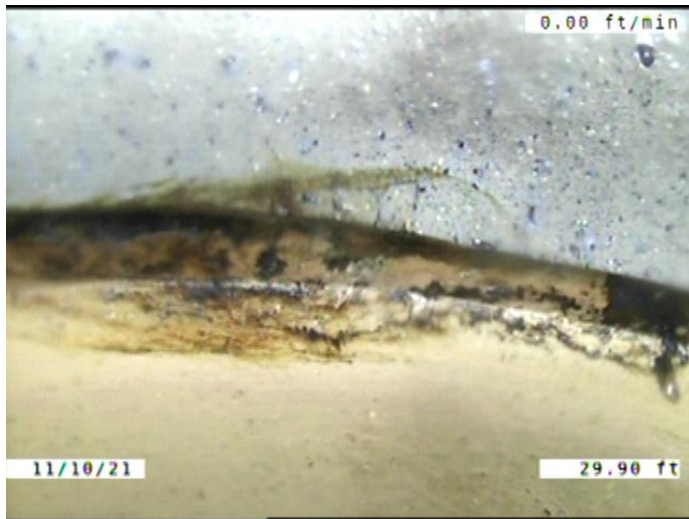
Code: **DAE**
 Description: **Deposits Attached Encrustation**

Distance (ft): **29.9**
 Structural Grade: **0**
 O&M Grade: **2**
 Clock Start/From: **9**
 Clock To: **3**
 1st Value:
 2nd Value:
 Value Percent: **5.000**
 Continuous Index:
 Within 8" of Joint: **YES**
 Remarks:

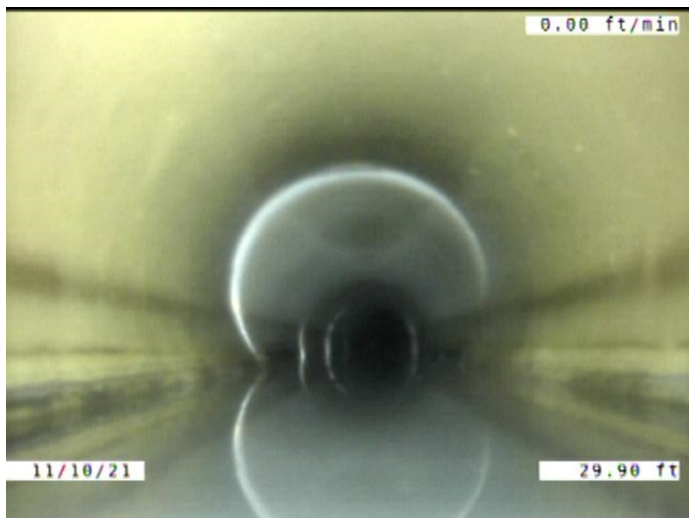
Code: **MWLS**
 Description: **Miscellaneous Water Level Sag**

Distance (ft): **29.9**
 Structural Grade: **2**
 O&M Grade: **0**
 Clock Start/From:
 Clock To:
 1st Value:
 2nd Value:
 Value Percent: **20.000**
 Continuous Index: **F02**
 Within 8" of Joint: **NO**
 Remarks:

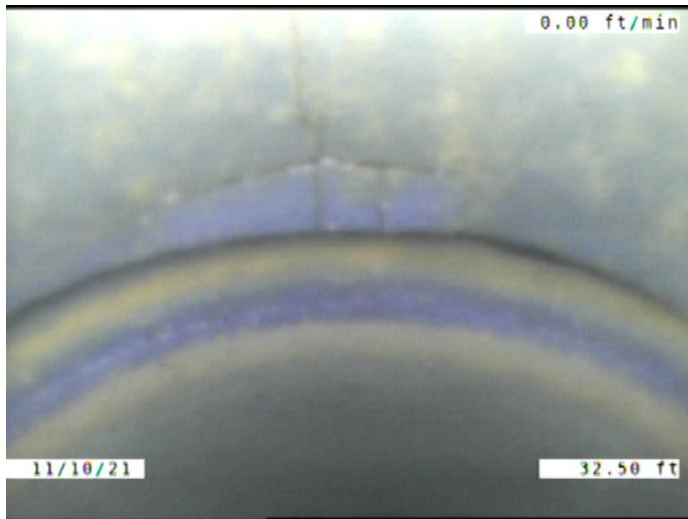
Code: **FM**
 Description: **Fracture Multiple**

Distance (ft): **32.5**
 Structural Grade: **4**
 O&M Grade: **0**
 Clock Start/From: **12**
 Clock To: **1**
 1st Value:
 2nd Value:
 Value Percent:
 Continuous Index:
 Within 8" of Joint: **YES**
 Remarks:

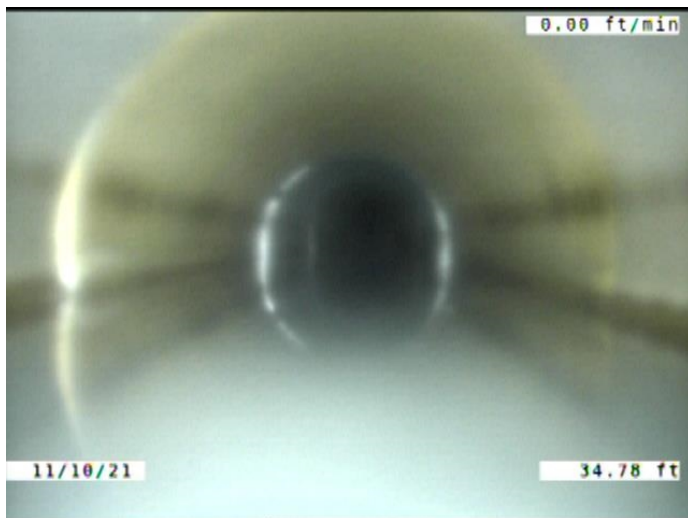
Code: **MWLS**
 Description: **Miscellaneous Water Level Sag**

Distance (ft): **34.8**
 Structural Grade: **2**
 O&M Grade: **0**
 Clock Start/From:
 Clock To:
 1st Value:
 2nd Value:
 Value Percent: **20.000**
 Continuous Index: **S03**
 Within 8" of Joint: **NO**
 Remarks:

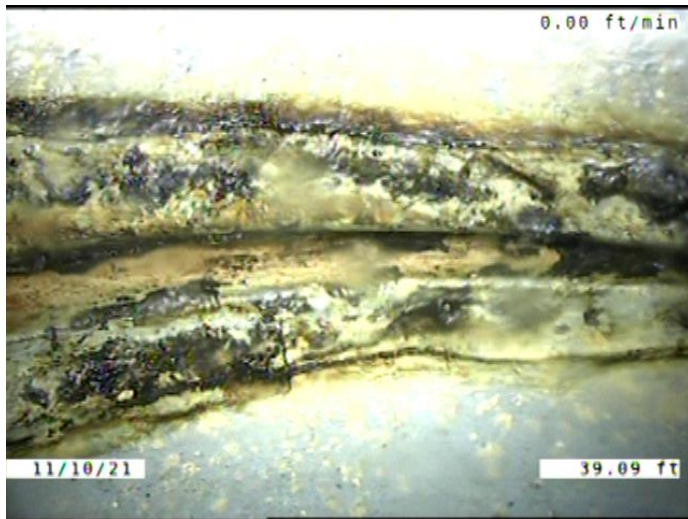
Code: **DAE**
 Description: **Deposits Attached Encrustation**

Distance (ft): **39.1**
 Structural Grade: **0**
 O&M Grade: **2**
 Clock Start/From: **9**
 Clock To: **1**
 1st Value:
 2nd Value:
 Value Percent: **5.000**
 Continuous Index:
 Within 8" of Joint: **YES**
 Remarks:

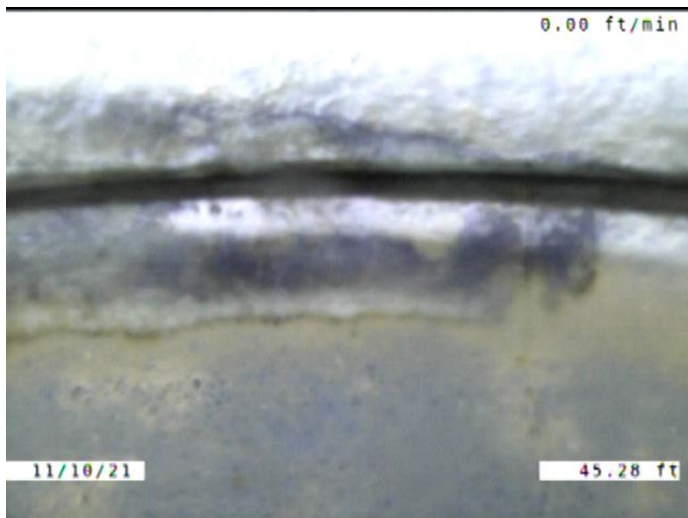
Code: **DAE**
 Description: **Deposits Attached Encrustation**

Distance (ft): **45.3**
 Structural Grade: **0**
 O&M Grade: **2**
 Clock Start/From: **10**
 Clock To: **12**
 1st Value:
 2nd Value:
 Value Percent: **5.000**
 Continuous Index:
 Within 8" of Joint: **YES**
 Remarks:

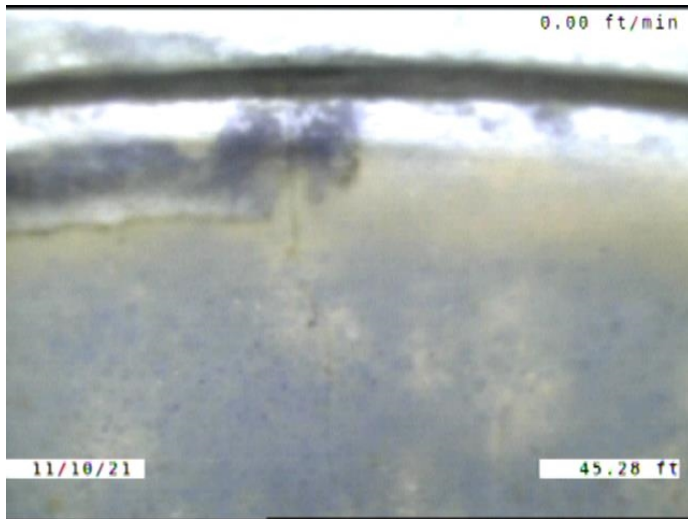
Code: **CL**
 Description: **Crack Longitudinal**

Distance (ft): **45.3**
 Structural Grade: **2**
 O&M Grade: **0**
 Clock Start/From: **12**
 Clock To:
 1st Value:
 2nd Value:
 Value Percent:
 Continuous Index:
 Within 8" of Joint: **YES**
 Remarks:

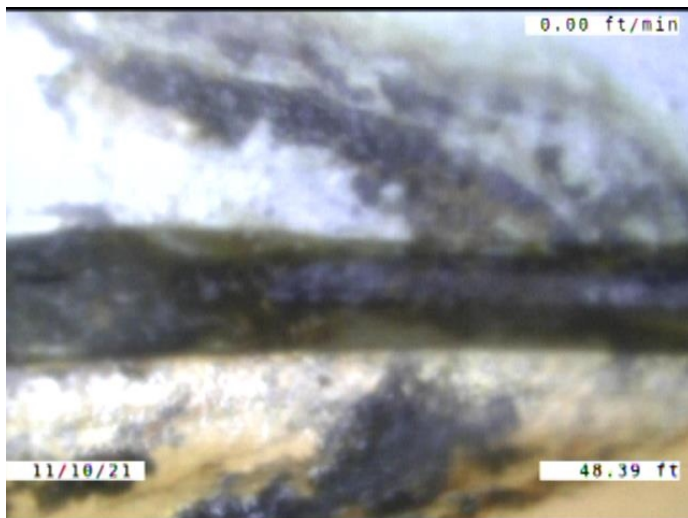
Code: **DAE**
 Description: **Deposits Attached Encrustation**

Distance (ft): **48.4**
 Structural Grade: **0**
 O&M Grade: **2**
 Clock Start/From: **9**
 Clock To: **11**
 1st Value:
 2nd Value:
 Value Percent: **5.000**
 Continuous Index:
 Within 8" of Joint: **YES**
 Remarks:

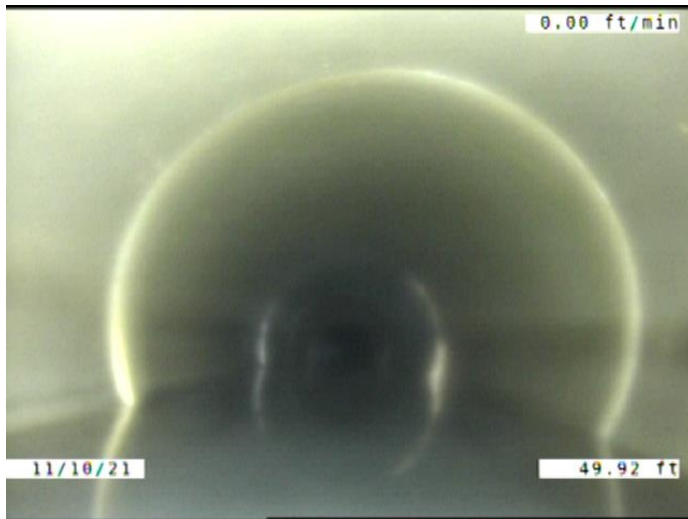
Code: **MWLS**
 Description: **Miscellaneous Water Level Sag**

Distance (ft): **49.9**
 Structural Grade: **2**
 O&M Grade: **0**
 Clock Start/From:
 Clock To:
 1st Value:
 2nd Value:
 Value Percent: **20.000**
 Continuous Index: **F03**
 Within 8" of Joint: **NO**
 Remarks:

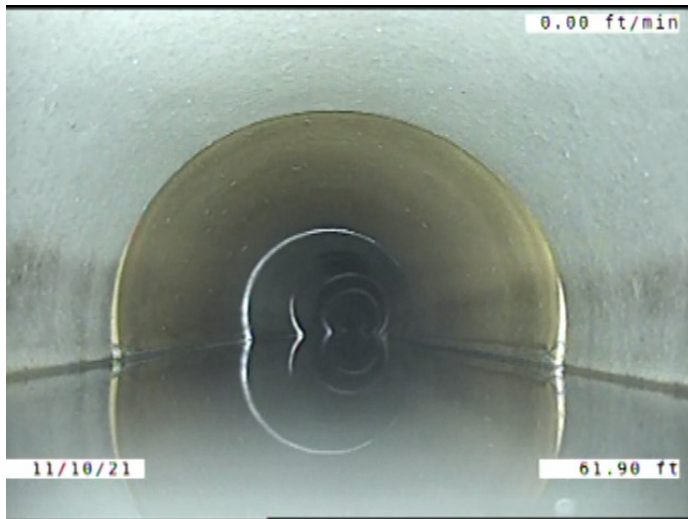
Code: **MWLS**
Description: **Miscellaneous Water Level Sag**

Distance (ft): **61.9**
Structural Grade: **2**
O&M Grade: **0**
Clock Start/From:
Clock To:
1st Value:
2nd Value:
Value Percent: **10.000**
Continuous Index: **S04**
Within 8" of Joint: **NO**
Remarks:

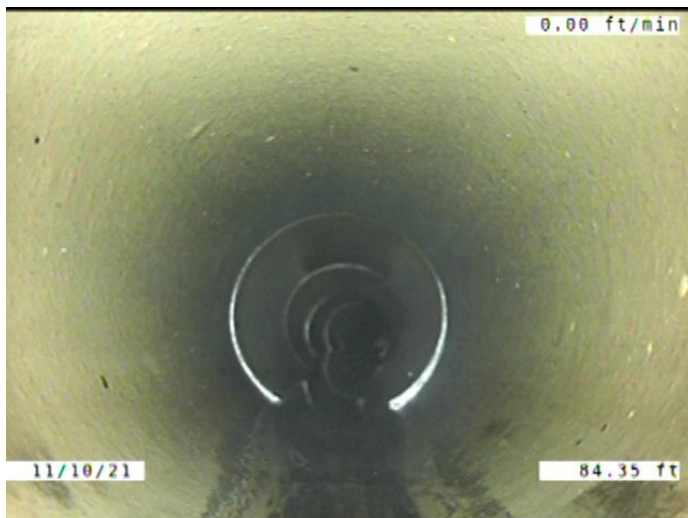
Code: **MWLS**
Description: **Miscellaneous Water Level Sag**

Distance (ft): **84.4**
Structural Grade: **2**
O&M Grade: **0**
Clock Start/From:
Clock To:
1st Value:
2nd Value:
Value Percent: **10.000**
Continuous Index: **F04**
Within 8" of Joint: **NO**
Remarks:

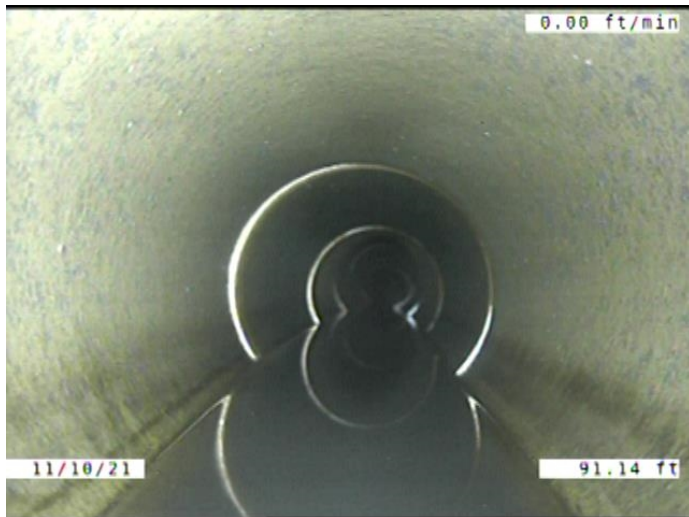
Code: **MWLS**
Description: **Miscellaneous Water Level Sag**

Distance (ft): **91.1**
Structural Grade: **2**
O&M Grade: **0**
Clock Start/From:
Clock To:
1st Value:
2nd Value:
Value Percent: **10.000**
Continuous Index: **S05**
Within 8" of Joint: **NO**
Remarks:

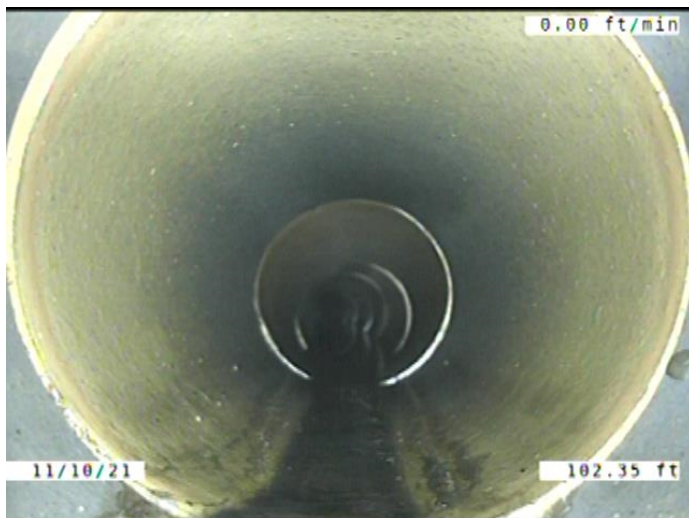
Code: **MWLS**
Description: **Miscellaneous Water Level Sag**

Distance (ft): **102.3**
Structural Grade: **2**
O&M Grade: **0**
Clock Start/From:
Clock To:
1st Value:
2nd Value:
Value Percent: **10.000**
Continuous Index: **F05**
Within 8" of Joint: **NO**
Remarks:

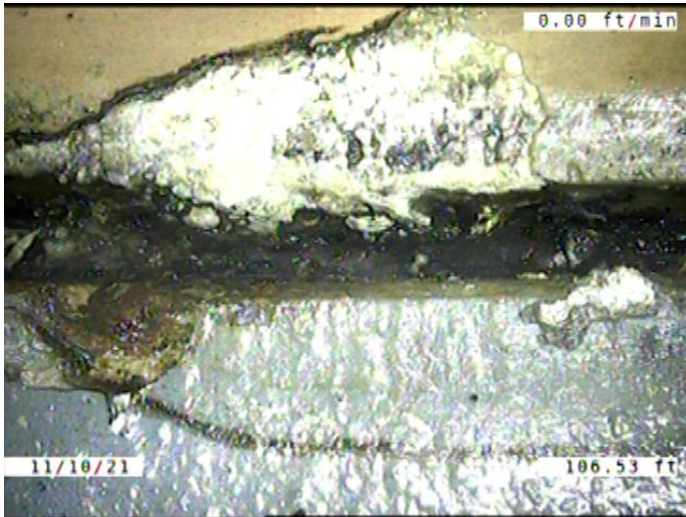
Code: **DAE**
Description: **Deposits Attached Encrustation**

Distance (ft): **106.5**
Structural Grade: **0**
O&M Grade: **2**
Clock Start/From: **8**
Clock To: **4**
1st Value:
2nd Value:
Value Percent: **5.000**
Continuous Index:
Within 8" of Joint: **YES**
Remarks:

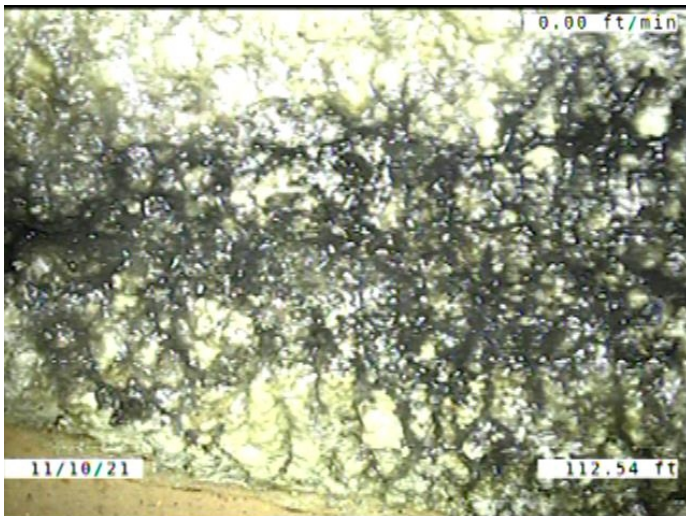
Code: **DAE**
Description: **Deposits Attached Encrustation**

Distance (ft): **112.5**
Structural Grade: **0**
O&M Grade: **2**
Clock Start/From: **12**
Clock To: **3**
1st Value:
2nd Value:
Value Percent: **5.000**
Continuous Index:
Within 8" of Joint: **YES**
Remarks:

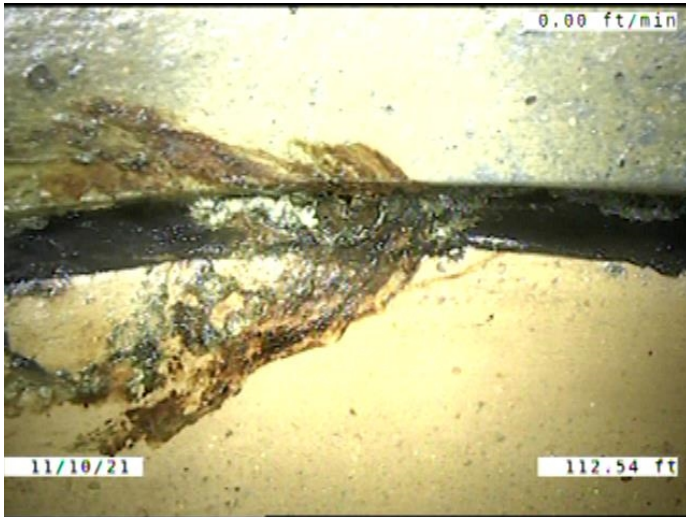
Code: **DAE**
 Description: **Deposits Attached Encrustation**

Distance (ft): **112.5**
 Structural Grade: **0**
 O&M Grade: **2**
 Clock Start/From: **9**
 Clock To: **10**
 1st Value:
 2nd Value:
 Value Percent: **5.000**
 Continuous Index:
 Within 8" of Joint: **YES**
 Remarks:

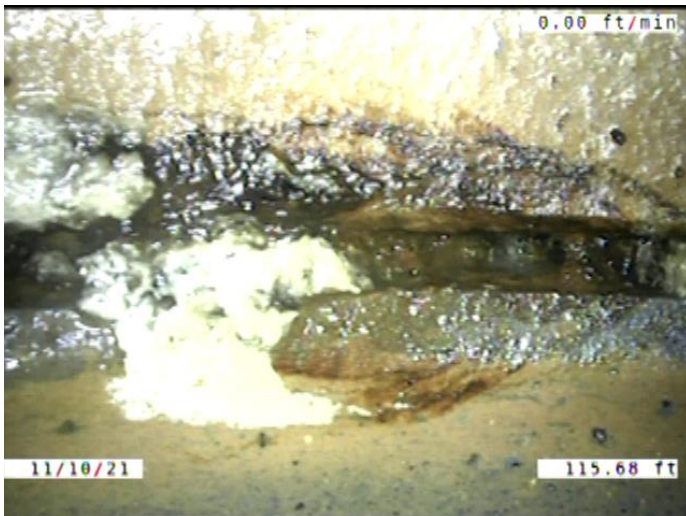
Code: **DAE**
 Description: **Deposits Attached Encrustation**

Distance (ft): **115.7**
 Structural Grade: **0**
 O&M Grade: **2**
 Clock Start/From: **8**
 Clock To: **10**
 1st Value:
 2nd Value:
 Value Percent: **5.000**
 Continuous Index:
 Within 8" of Joint: **YES**
 Remarks:

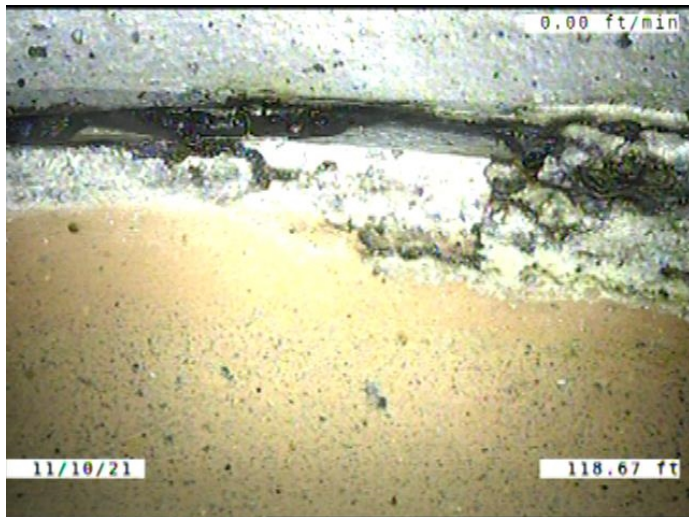
Code: **DAE**
 Description: **Deposits Attached Encrustation**

Distance (ft): **118.7**
 Structural Grade: **0**
 O&M Grade: **2**
 Clock Start/From: **9**
 Clock To: **3**
 1st Value:
 2nd Value:
 Value Percent: **5.000**
 Continuous Index:
 Within 8" of Joint: **YES**
 Remarks:

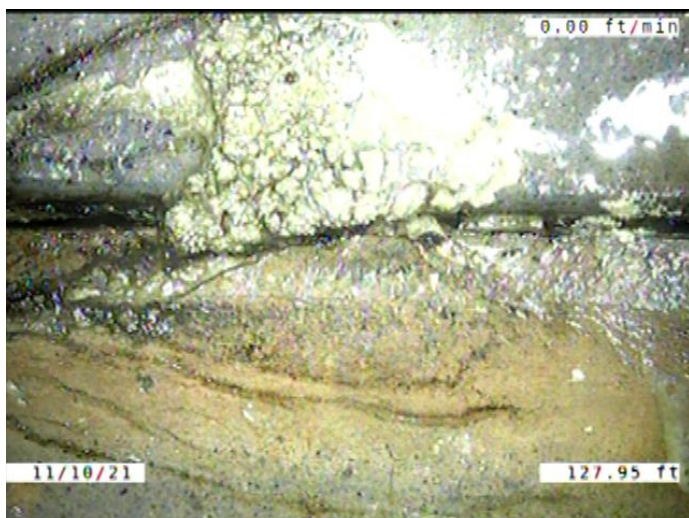
Code: **DAE**
 Description: **Deposits Attached Encrustation**

Distance (ft): **128.0**
 Structural Grade: **0**
 O&M Grade: **2**
 Clock Start/From: **2**
 Clock To: **4**
 1st Value:
 2nd Value:
 Value Percent: **5.000**
 Continuous Index:
 Within 8" of Joint: **YES**
 Remarks:

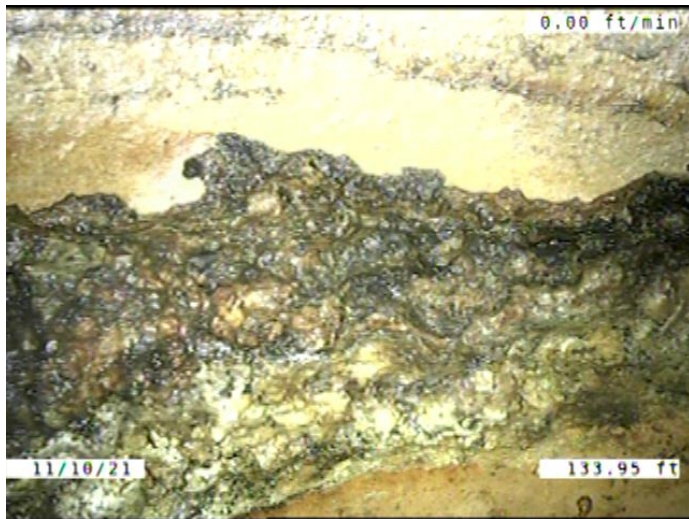
Code: **DAE**
 Description: **Deposits Attached Encrustation**

Distance (ft): **134.0**
 Structural Grade: **0**
 O&M Grade: **2**
 Clock Start/From: **9**
 Clock To: **11**
 1st Value:
 2nd Value:
 Value Percent: **5.000**
 Continuous Index:
 Within 8" of Joint: **YES**
 Remarks:

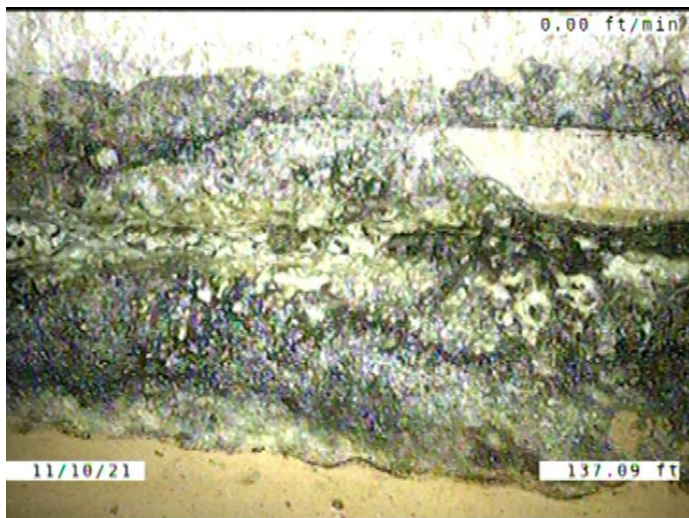
Code: **DAE**
 Description: **Deposits Attached Encrustation**

Distance (ft): **137.1**
 Structural Grade: **0**
 O&M Grade: **2**
 Clock Start/From: **8**
 Clock To: **4**
 1st Value:
 2nd Value:
 Value Percent: **5.000**
 Continuous Index:
 Within 8" of Joint: **YES**
 Remarks:

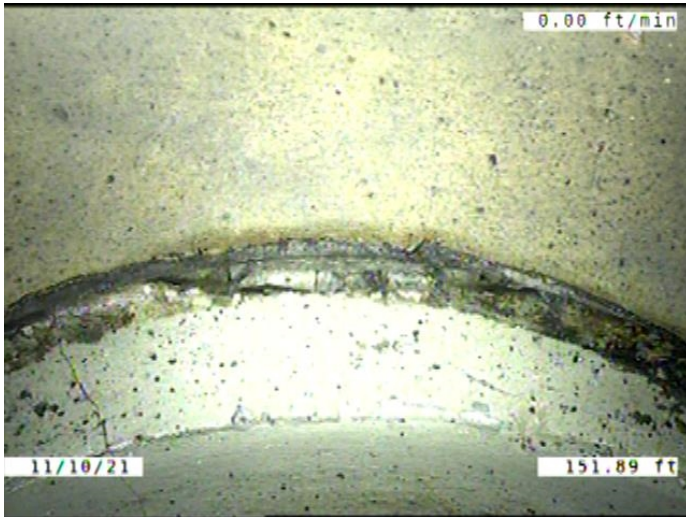
Code: **JOMD**
 Description: **Joint Offset Medium Defective**

Distance (ft): **151.9**
 Structural Grade: **3**
 O&M Grade: **0**
 Clock Start/From:
 Clock To:
 1st Value:
 2nd Value:
 Value Percent:
 Continuous Index:
 Within 8" of Joint: **NO**
 Remarks:

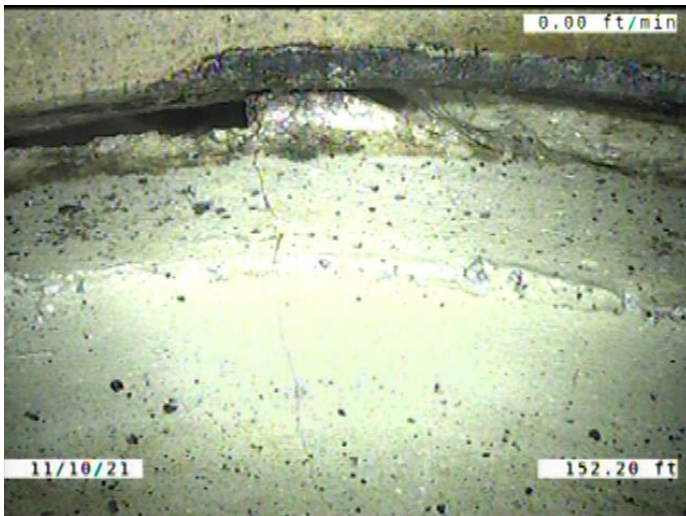
Code: **CL**
 Description: **Crack Longitudinal**

Distance (ft): **152.2**
 Structural Grade: **2**
 O&M Grade: **0**
 Clock Start/From: **12**
 Clock To:
 1st Value:
 2nd Value:
 Value Percent:
 Continuous Index:
 Within 8" of Joint: **YES**
 Remarks:

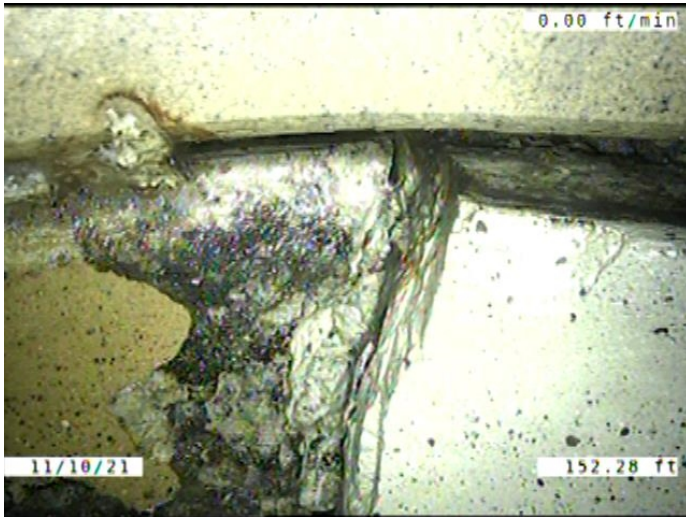
Code: **B**
Description: **Broken**

Distance (ft): **152.3**
Structural Grade: **4**
O&M Grade: **0**
Clock Start/From: **4**
Clock To: **9**
1st Value:
2nd Value:
Value Percent:
Continuous Index:
Within 8" of Joint: **YES**
Remarks:

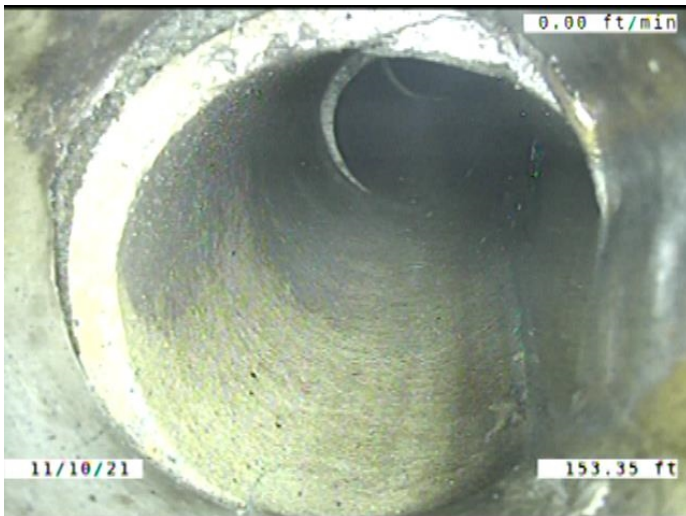
Code: **TFD**
Description: **Tap Factory Defective**

Distance (ft): **153.3**
Structural Grade: **0**
O&M Grade: **3**
Clock Start/From: **3**
Clock To:
1st Value: **4.000**
2nd Value:
Value Percent:
Continuous Index:
Within 8" of Joint: **YES**
Remarks: **OFFSET**

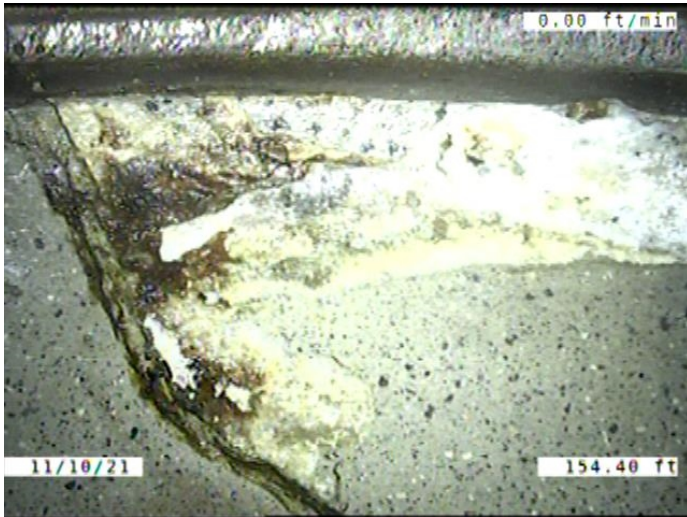
Code: **DAE**
 Description: **Deposits Attached Encrustation**

Distance (ft): **154.4**
 Structural Grade: **0**
 O&M Grade: **2**
 Clock Start/From: **1**
 Clock To: **2**
 1st Value:
 2nd Value:
 Value Percent: **5.000**
 Continuous Index:
 Within 8" of Joint: **YES**
 Remarks:

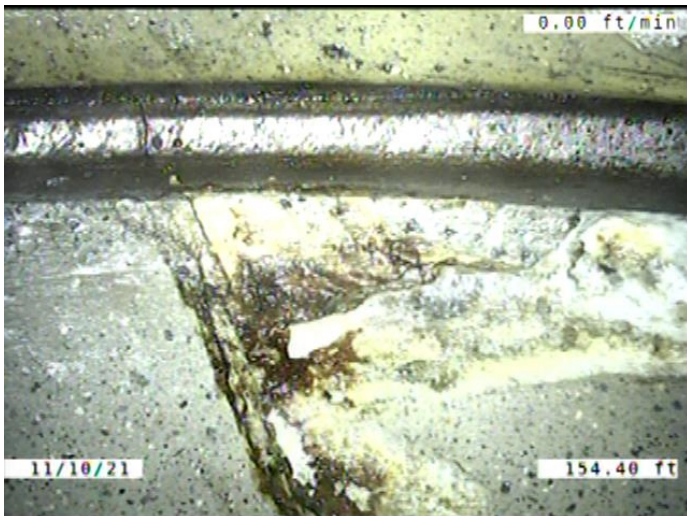
Code: **CL**
 Description: **Crack Longitudinal**

Distance (ft): **154.4**
 Structural Grade: **2**
 O&M Grade: **0**
 Clock Start/From: **1**
 Clock To:
 1st Value:
 2nd Value:
 Value Percent:
 Continuous Index:
 Within 8" of Joint: **YES**
 Remarks:

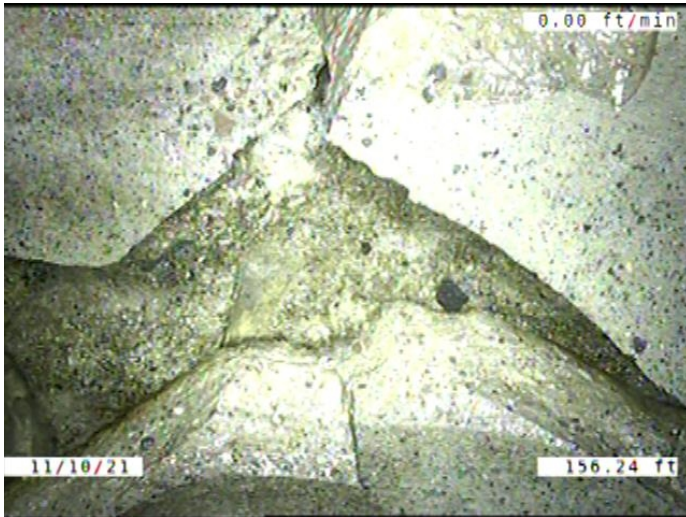
Code: **B**
Description: **Broken**

Distance (ft): **156.2**
Structural Grade: **4**
O&M Grade: **0**
Clock Start/From: **12**
Clock To: **12**
1st Value:
2nd Value:
Value Percent:
Continuous Index: **S06**
Within 8" of Joint: **YES**
Remarks:

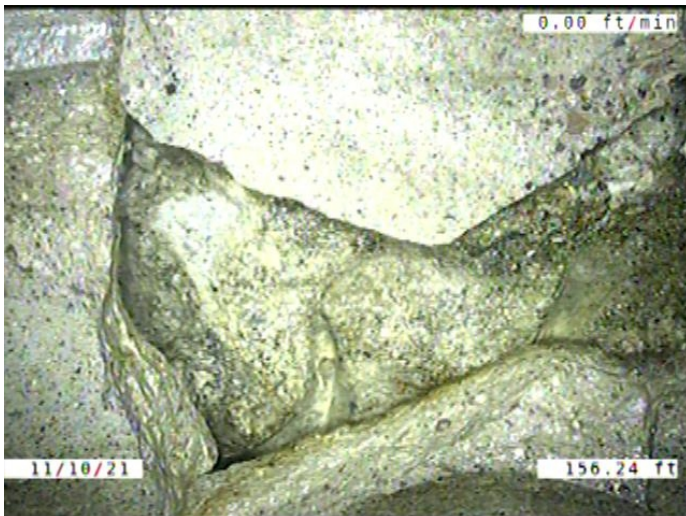
Code: **RPP**
Description: **Point Repair Patch**

Distance (ft): **156.2**
Structural Grade: **0**
O&M Grade: **0**
Clock Start/From: **11**
Clock To: **2**
1st Value:
2nd Value:
Value Percent:
Continuous Index:
Within 8" of Joint: **YES**
Remarks: **LOOKS TO BE REPAIRED**

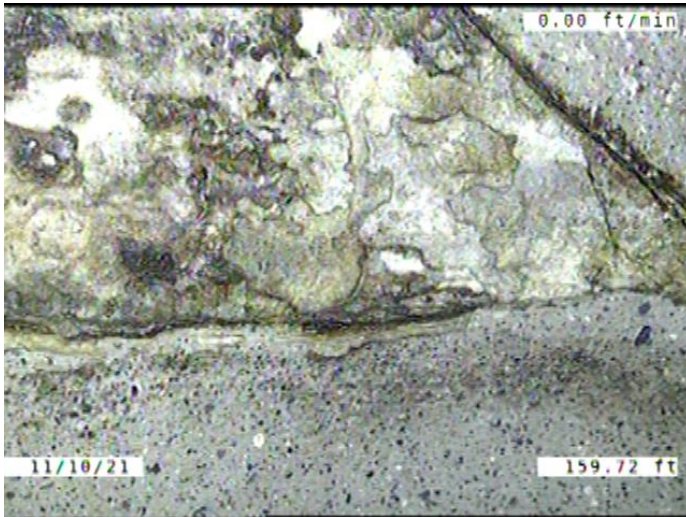
Code: **DAE**
 Description: **Deposits Attached Encrustation**

Distance (ft): **159.7**
 Structural Grade: **0**
 O&M Grade: **2**
 Clock Start/From: **9**
 Clock To: **12**
 1st Value:
 2nd Value:
 Value Percent: **5.000**
 Continuous Index:
 Within 8" of Joint: **YES**
 Remarks:

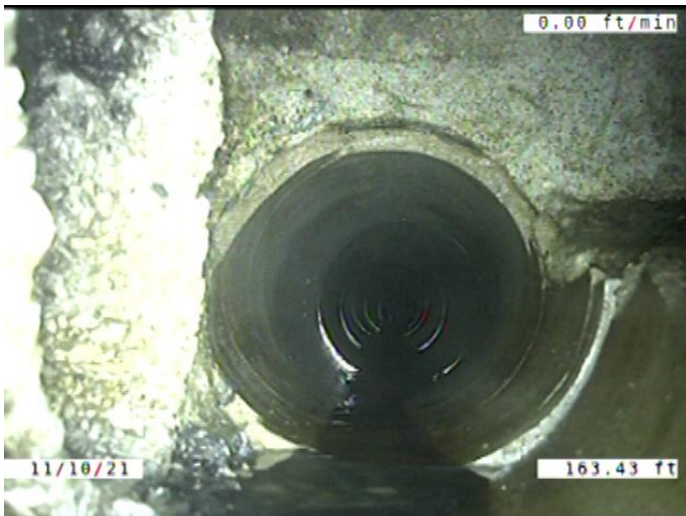
Code: **B**
 Description: **Broken**

Distance (ft): **163.4**
 Structural Grade: **4**
 O&M Grade: **0**
 Clock Start/From: **12**
 Clock To: **12**
 1st Value:
 2nd Value:
 Value Percent:
 Continuous Index: **F06**
 Within 8" of Joint: **YES**
 Remarks:

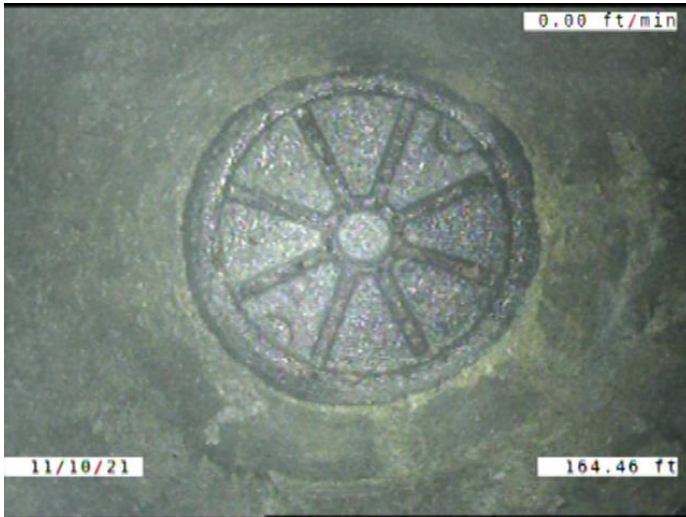
Code:	AMH
Description:	Manhole
Distance (ft):	164.5
Structural Grade:	0
O&M Grade:	0
Clock Start/From:	
Clock To:	
1st Value:	
2nd Value:	
Value Percent:	
Continuous Index:	
Within 8" of Joint:	NO
Remarks:	UNK W HOME AVE
