Profile/Photo Observation Report

Street:	S Pennsylvania St.	Flow Control:	Not Controlled
City:	Hobart, IN	Year Renewed:	
Location:	Other	Tape/Media #:	
Purpose:	Not Known	Dia/Height:	12"
Use:	Sanitary	Material:	PVC
Drain Area:	NA	Lining:	
Category:	NA		
Comment:

Location Details:		Direction of Survey:	Upstream
US MH:	M-604-065	DS MH:	M-604-064
		Total Length Surveyed (ft):	30.0

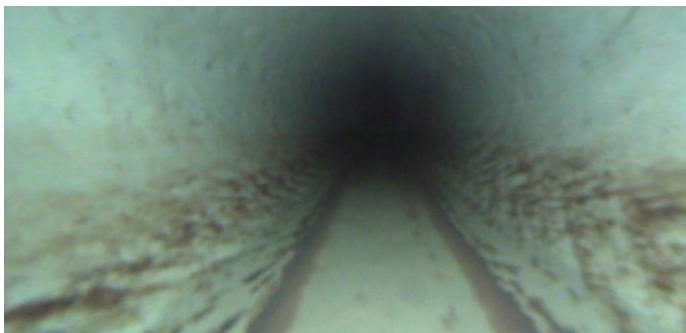
Code: **AMH**
Description: **Manhole**

Distance (ft): **.0**
Structural Grade: **0**
O&M Grade: **0**
Clock Start/From:
Clock To:
1st Value:
2nd Value:
Value Percent:
Continuous Index:
Within 8" of Joint: **NO**
Remarks: **M-604-064**

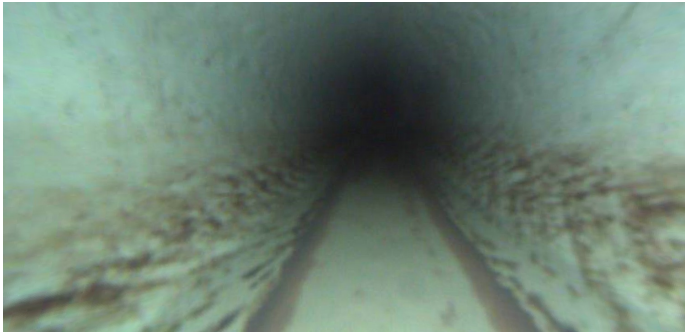
Code:	MWL
Description:	Water Level

Distance (ft):	.0
Structural Grade:	0
O&M Grade:	0
Clock Start/From:	
Clock To:	
1st Value:	
2nd Value:	
Value Percent:	5.000
Continuous Index:	
Within 8" of Joint:	NO
Remarks:

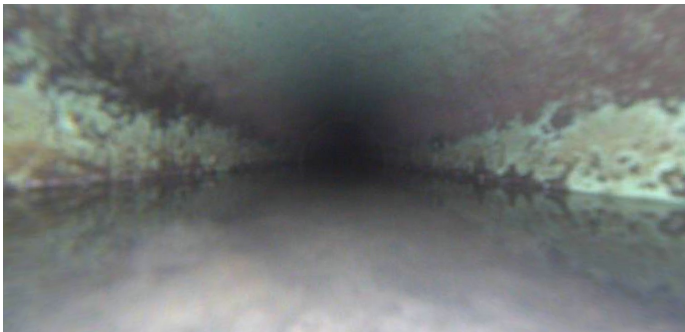
Code:	MWL
Description:	Water Level

Distance (ft):	24.4
Structural Grade:	0
O&M Grade:	0
Clock Start/From:	
Clock To:	
1st Value:	
2nd Value:	
Value Percent:	40.000
Continuous Index:	
Within 8" of Joint:	NO
Remarks:

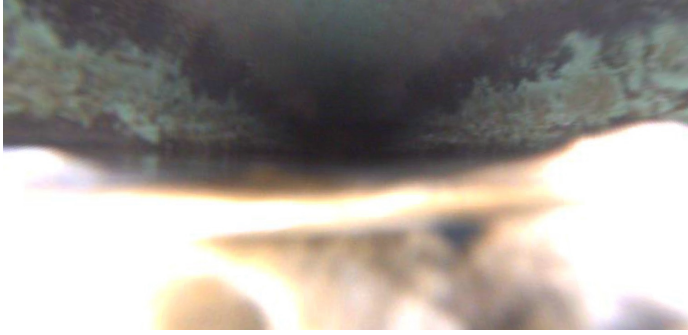
Code:	MSA
Description:	Abandoned Survey
Distance (ft):	30.0
Structural Grade:	0
O&M Grade:	0
Clock Start/From:	
Clock To:	
1st Value:	
2nd Value:	
Value Percent:	
Continuous Index:	
Within 8" of Joint:	NO
Remarks:	high water
