Profile/Photo Observation Report

Date:	11/08/2021	Weather:		Coding:	PACP 7.0
Pipe Length (ft):	218.0	Owner:	City of Hobart	Pre Clean:	Heavy Cleaning
P.O.#:	YES502259	Surveyor:	Steven Bucklin	PSR:	P-604-065-064
Customer:	City of Hobart, IN (Red	Clean Date:	11/08/2021	Shape:	C

Street:	North Pennsylvania Street	Flow Control:	Not Controlled
City:	City of Hobart	Year Renewed:	
Location:	Local rural streets with light traffic, t	Tape/Media #:	
Purpose:	Routine Assessment	Dia/Height:	12"
Use:	Sanitary Sewage Pipe	Material:	VCP
Drain Area:		Lining:	None
Category:	NA		
Comment:			
Location Details:		Direction of Survey:	Upstream
US MH:	M-604-065	DS MH:	M-604-064
		Total Length Surveyed (ft):	218.0

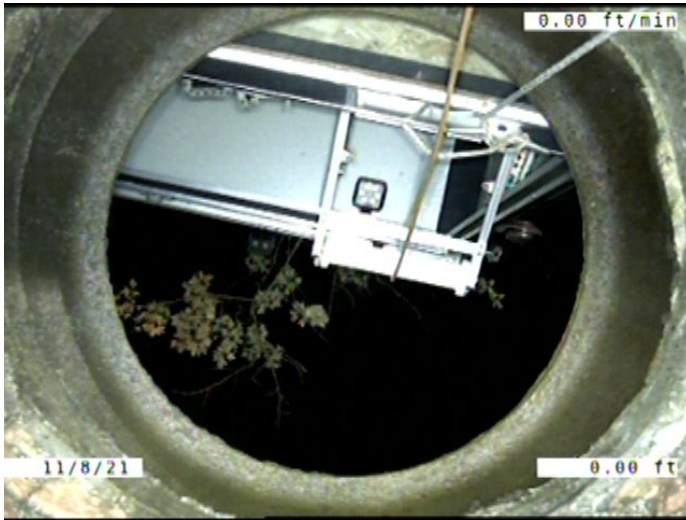
Code: **AMH**
Description: **Manhole**

Distance (ft): **.0**
Structural Grade: **0**
O&M Grade: **0**
Clock Start/From:
Clock To:
1st Value:
2nd Value:
Value Percent:
Continuous Index:
Within 8" of Joint: **NO**
Remarks: **M-604-064**

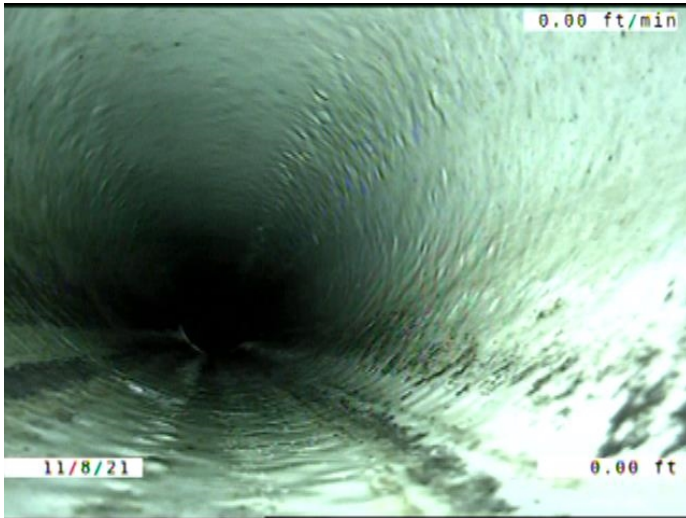
Code: **MWL**
Description: **Miscellaneous Water Level**

Distance (ft): **.0**
Structural Grade: **0**
O&M Grade: **0**
Clock Start/From:
Clock To:
1st Value:
2nd Value:
Value Percent: **5.000**
Continuous Index:
Within 8" of Joint: **NO**
Remarks:

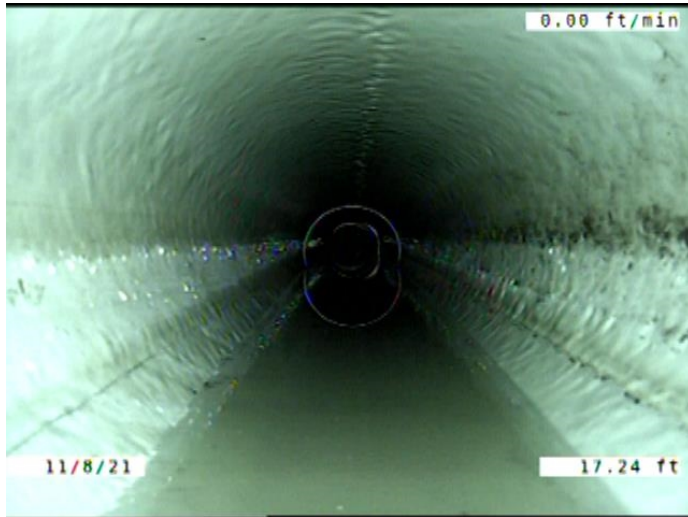
Code: **MWLS**
 Description: **Miscellaneous Water Level Sag**

Distance (ft): **17.2**
 Structural Grade: **2**
 O&M Grade: **0**
 Clock Start/From:
 Clock To:
 1st Value:
 2nd Value:
 Value Percent: **15.000**
 Continuous Index: **S01**
 Within 8" of Joint: **NO**
 Remarks:

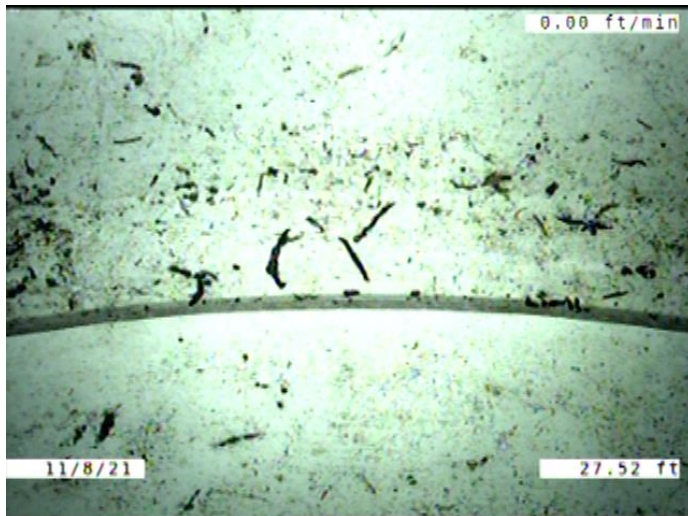
Code: **MGO**
 Description: **Miscellaneous General Observation**

Distance (ft): **27.5**
 Structural Grade: **0**
 O&M Grade: **0**
 Clock Start/From:
 Clock To:
 1st Value:
 2nd Value:
 Value Percent:
 Continuous Index:
 Within 8" of Joint: **NO**
 Remarks: **JOINT/ PIPES NOT PUSHED ALL THE WAY TOGETHER WHEN INSTALLED**

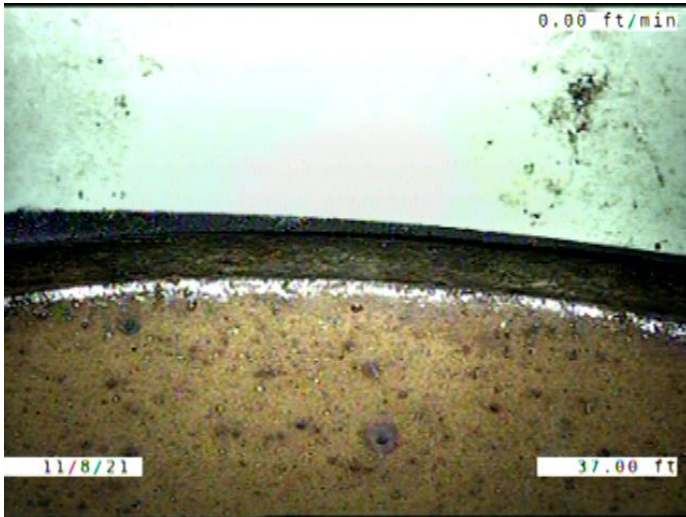
Code: **MMC**
Description: **Miscellaneous Material Change**

Distance (ft): **37.0**
Structural Grade: **0**
O&M Grade: **0**
Clock Start/From:
Clock To:
1st Value:
2nd Value:
Value Percent:
Continuous Index:
Within 8" of Joint: **NO**
Remarks: **PVC TO VCP**

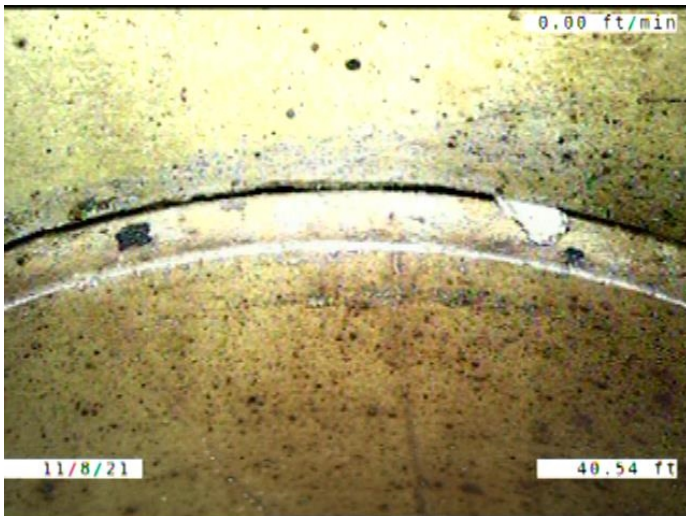
Code: **MWL**
Description: **Miscellaneous Water Level**

Distance (ft): **40.5**
Structural Grade: **0**
O&M Grade: **0**
Clock Start/From:
Clock To:
1st Value:
2nd Value:
Value Percent: **30.000**
Continuous Index:
Within 8" of Joint: **NO**
Remarks:

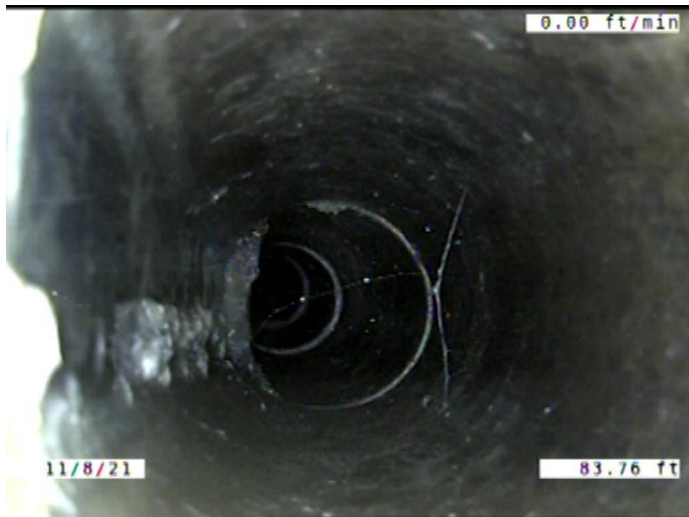
Code: **TBI**
 Description: **Tap Break-in Intruding**

Distance (ft): **83.8**
 Structural Grade: **0**
 O&M Grade: **2**
 Clock Start/From: **9**
 Clock To:
 1st Value: **6.000**
 2nd Value: **2.000**
 Value Percent:
 Continuous Index:
 Within 8" of Joint: **YES**
 Remarks:

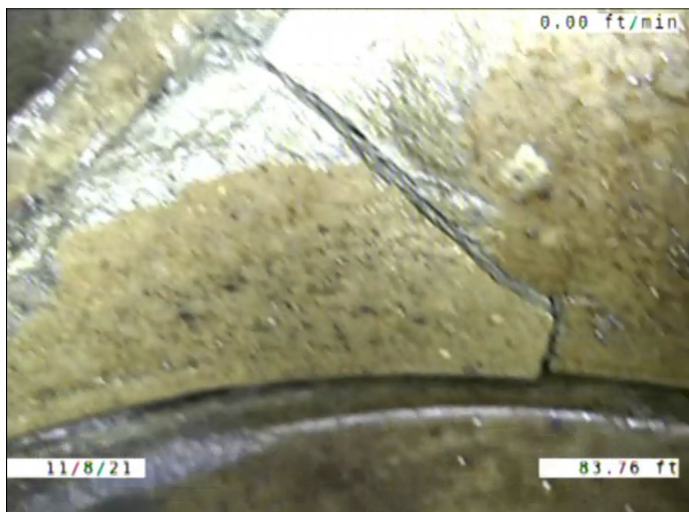
Code: **B**
 Description: **Broken**

Distance (ft): **83.8**
 Structural Grade: **4**
 O&M Grade: **0**
 Clock Start/From: **9**
 Clock To: **10**
 1st Value:
 2nd Value:
 Value Percent:
 Continuous Index:
 Within 8" of Joint: **NO**
 Remarks:

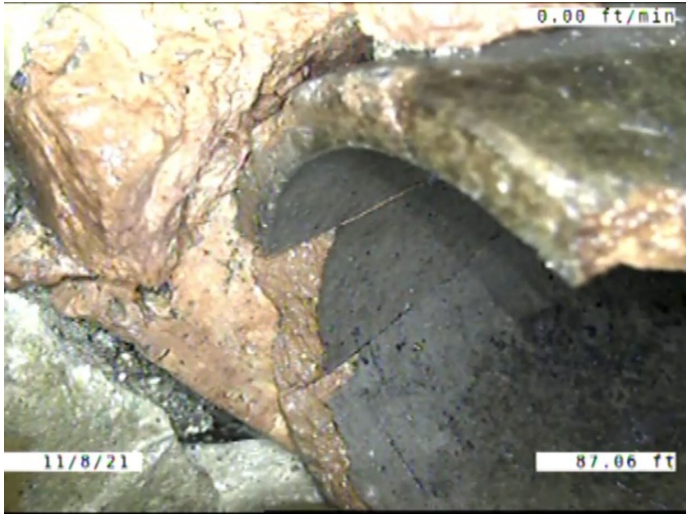
Code: **RPP**
 Description: **Point Repair Patch**

Distance (ft): **87.1**
 Structural Grade: **0**
 O&M Grade: **0**
 Clock Start/From: **1**
 Clock To:
 1st Value:
 2nd Value:
 Value Percent:
 Continuous Index:
 Within 8" of Joint: **NO**
 Remarks: **Brick**

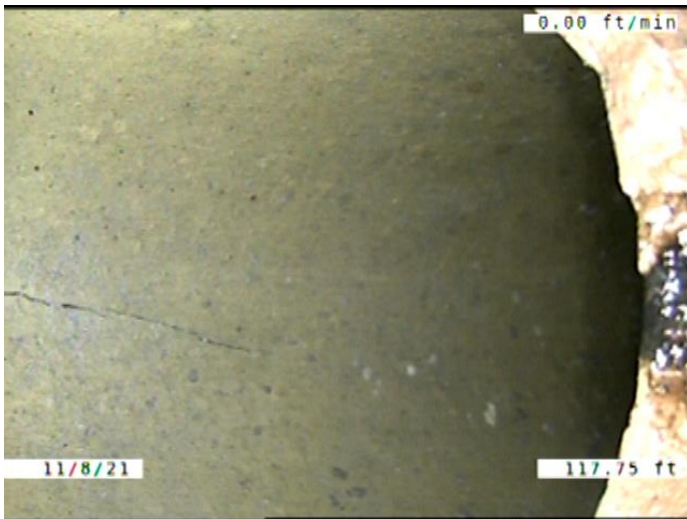
Code:	TB
Description:	Tap Break-in/Hammer
Distance (ft):	117.7
Structural Grade:	0
O&M Grade:	0
Clock Start/From:	1
Clock To:	
1st Value:	4.000
2nd Value:	
Value Percent:	
Continuous Index:	
Within 8" of Joint:	YES
Remarks:

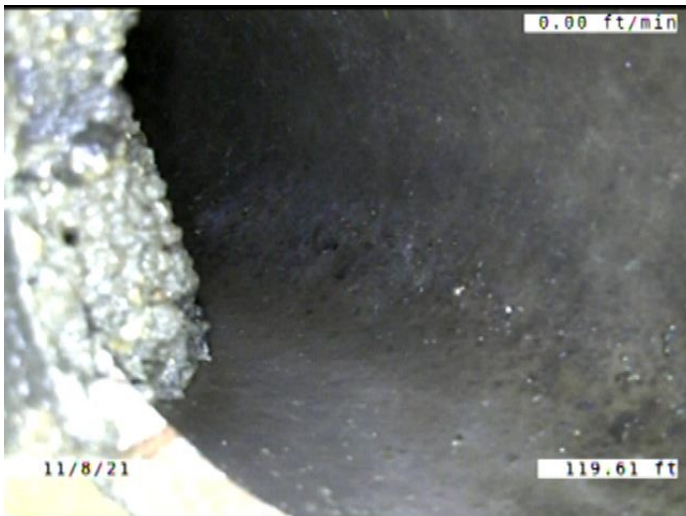
Code: **TBI**
 Description: **Tap Break-in Intruding**

Distance (ft): **119.6**
 Structural Grade: **0**
 O&M Grade: **2**
 Clock Start/From: **10**
 Clock To:
 1st Value: **4.000**
 2nd Value: **2.000**
 Value Percent:
 Continuous Index:
 Within 8" of Joint: **YES**
 Remarks:

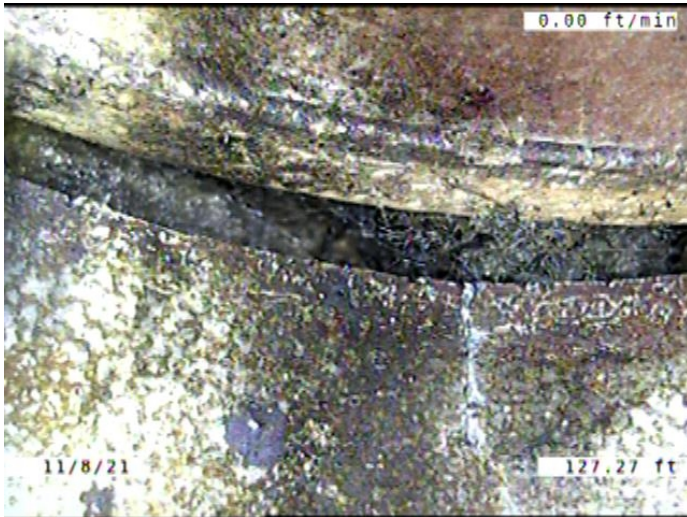
Code: **RFJ**
 Description: **Roots Fine Joint**

Distance (ft): **127.3**
 Structural Grade: **0**
 O&M Grade: **1**
 Clock Start/From: **3**
 Clock To:
 1st Value:
 2nd Value:
 Value Percent:
 Continuous Index:
 Within 8" of Joint: **YES**
 Remarks:

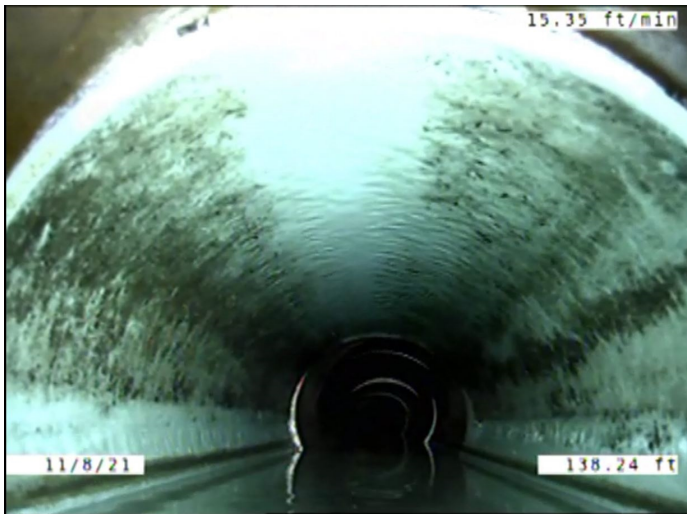
Code: **FM**
 Description: **Fracture Multiple**

Distance (ft): **138.2**
 Structural Grade: **4**
 O&M Grade: **0**
 Clock Start/From: **8**
 Clock To: **4**
 1st Value:
 2nd Value:
 Value Percent:
 Continuous Index: **F02**
 Within 8" of Joint: **YES**
 Remarks: **Wandering**

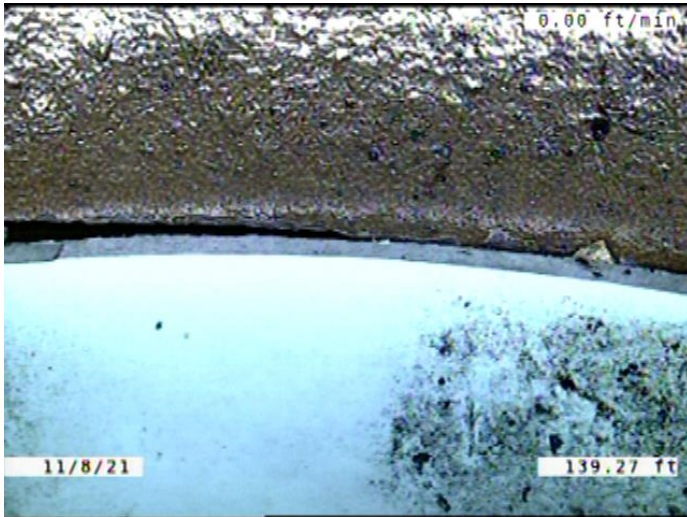
Code: **MMC**
 Description: **Miscellaneous Material Change**

Distance (ft): **139.3**
 Structural Grade: **0**
 O&M Grade: **0**
 Clock Start/From:
 Clock To:
 1st Value:
 2nd Value:
 Value Percent:
 Continuous Index:
 Within 8" of Joint: **NO**
 Remarks: **VCP TO PVC**

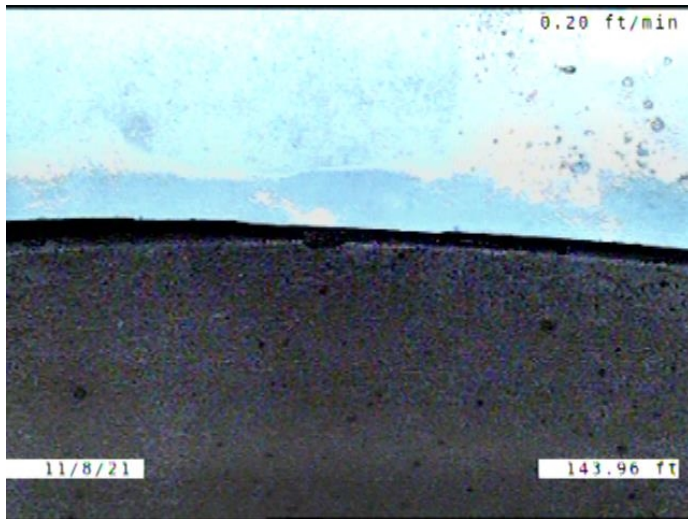
Code: **MMC**
 Description: **Miscellaneous Material Change**

Distance (ft): **144.0**
 Structural Grade: **0**
 O&M Grade: **0**
 Clock Start/From:
 Clock To:
 1st Value:
 2nd Value:
 Value Percent:
 Continuous Index:
 Within 8" of Joint: **NO**
 Remarks: **PVC TO VCP**

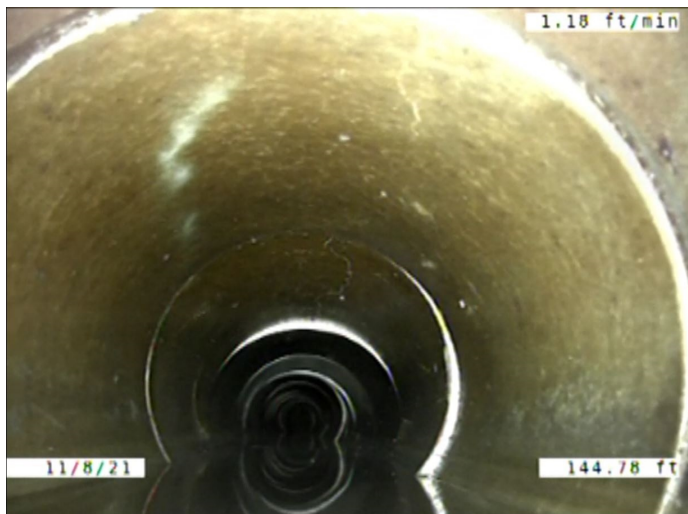
Code: **CM**
 Description: **Crack Multiple**

Distance (ft): **144.8**
 Structural Grade: **3**
 O&M Grade: **0**
 Clock Start/From: **8**
 Clock To: **4**
 1st Value:
 2nd Value:
 Value Percent:
 Continuous Index: **S05**
 Within 8" of Joint: **YES**
 Remarks:

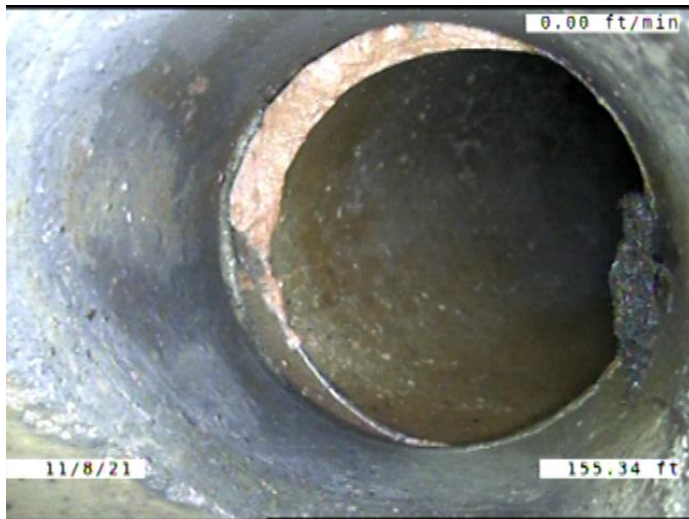
Code: **TBD**
 Description: **Tap Break-in/Hammer Defective**

Distance (ft): **155.3**
 Structural Grade: **0**
 O&M Grade: **3**
 Clock Start/From: **2**
 Clock To:
 1st Value: **4.000**
 2nd Value:
 Value Percent:
 Continuous Index:
 Within 8" of Joint: **YES**
 Remarks: **OFFSET. SOIL VISIBLE.**

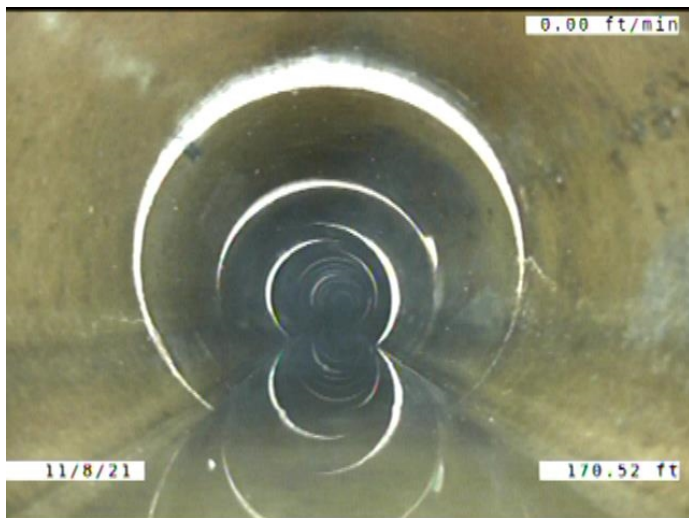
Code: **MWLS**
 Description: **Miscellaneous Water Level Sag**

Distance (ft): **170.5**
 Structural Grade: **2**
 O&M Grade: **0**
 Clock Start/From:
 Clock To:
 1st Value:
 2nd Value:
 Value Percent: **15.000**
 Continuous Index: **F04**
 Within 8" of Joint: **NO**
 Remarks:

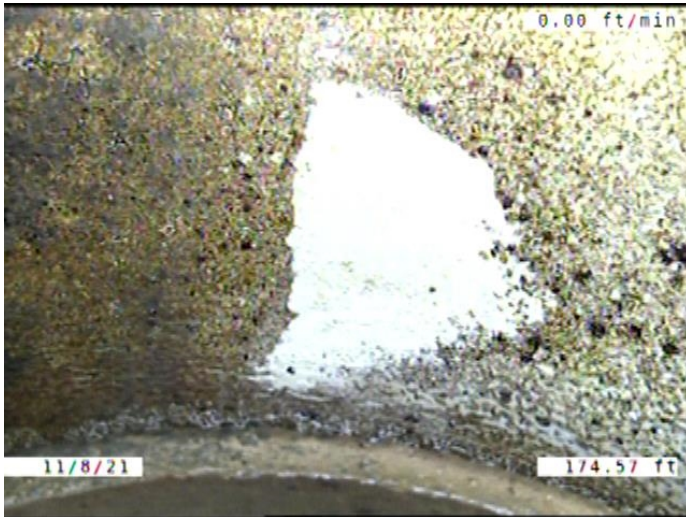
Code: **DAE**
Description: **Deposits Attached Encrustation**

Distance (ft): **174.6**
Structural Grade: **0**
O&M Grade: **2**
Clock Start/From: **2**
Clock To:
1st Value:
2nd Value:
Value Percent: **5.000**
Continuous Index:
Within 8" of Joint: **YES**
Remarks:

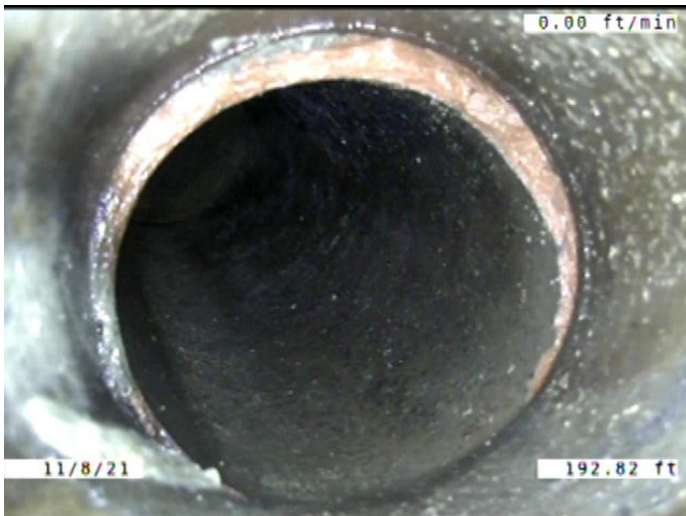
Code: **TF**
Description: **Tap Factory**

Distance (ft): **192.8**
Structural Grade: **0**
O&M Grade: **0**
Clock Start/From: **10**
Clock To:
1st Value: **4.000**
2nd Value:
Value Percent:
Continuous Index:
Within 8" of Joint: **YES**
Remarks:

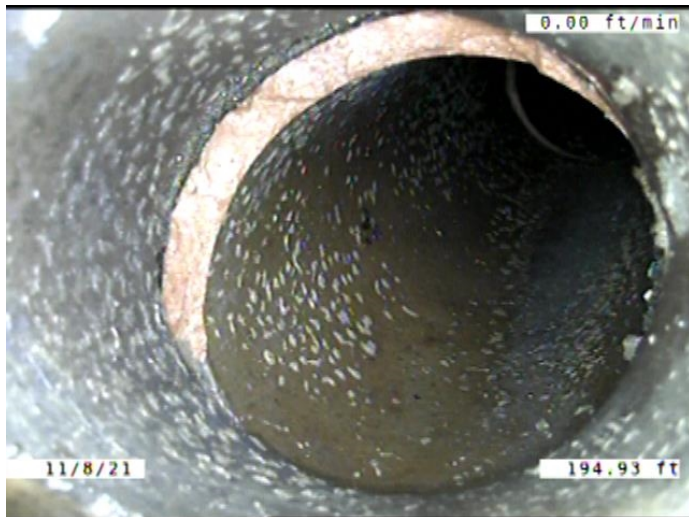
Code: **TFD**
 Description: **Tap Factory Defective**

Distance (ft): **194.9**
 Structural Grade: **0**
 O&M Grade: **3**
 Clock Start/From: **2**
 Clock To:
 1st Value: **4.000**
 2nd Value:
 Value Percent:
 Continuous Index:
 Within 8" of Joint: **YES**
 Remarks: **OFFSET. SOIL VISIBLE**

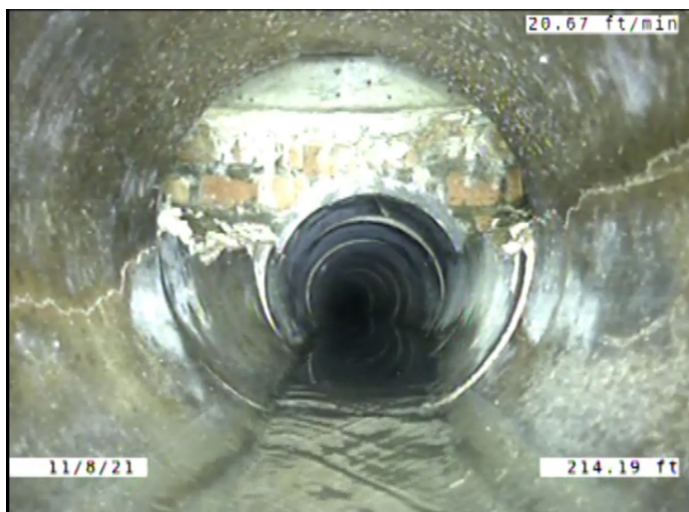
Code: **CM**
 Description: **Crack Multiple**

Distance (ft): **214.2**
 Structural Grade: **3**
 O&M Grade: **0**
 Clock Start/From: **8**
 Clock To: **4**
 1st Value:
 2nd Value:
 Value Percent:
 Continuous Index: **F05**
 Within 8" of Joint: **YES**
 Remarks:

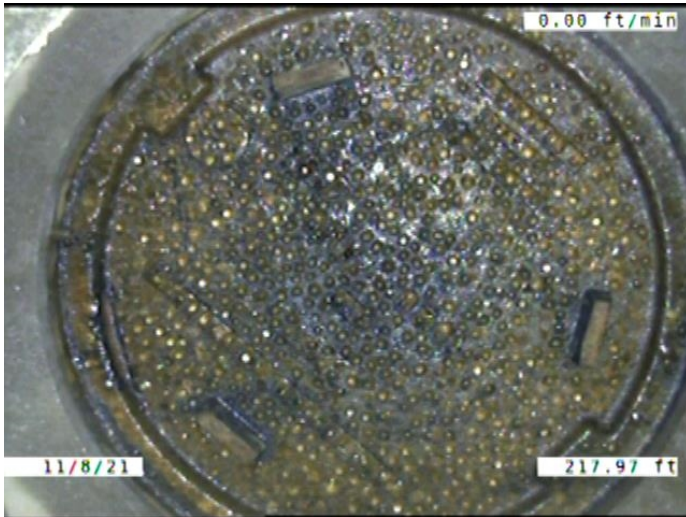
Code:	AMH
Description:	Manhole
Distance (ft):	218.0
Structural Grade:	0
O&M Grade:	0
Clock Start/From:	
Clock To:	
1st Value:	
2nd Value:	
Value Percent:	
Continuous Index:	
Within 8" of Joint:	NO
Remarks:	M-604-065
