## Profile/Photo Observation Report

Date:	<b>11/08/2021</b>	Weather:		Coding:	<b>PACP 7.0</b>
Pipe Length (ft):	<b>218.0</b>	Owner:	<b>City of Hobart</b>	Pre Clean:	<b>Heavy Cleaning</b>
P.O.#:	<b>YES502259</b>	Surveyor:	<b>Steven Bucklin</b>	PSR:	<b>P-604-065-064</b>
Customer:	<b>City of Hobart, IN (Red</b>	Clean Date:	<b>11/08/2021</b>	Shape:	<b>C</b>

Street:	<b>North Pennsylvania Street</b>	Flow Control:	<b>Not Controlled</b>
City:	<b>City of Hobart</b>	Year Renewed:	
Location:	<b>Local rural streets with light traffic, t</b>	Tape/Media #:	
Purpose:	<b>Routine Assessment</b>	Dia/Height:	<b>12"</b>
Use:	<b>Sanitary Sewage Pipe</b>	Material:	<b>VCP</b>
Drain Area:		Lining:	<b>None</b>
Category:	<b>NA</b>		
Comment:			
Location Details:		Direction of Survey:	<b>Upstream</b>
US MH:	<b>M-604-065</b>	DS MH:	<b>M-604-064</b>
		Total Length Surveyed (ft):	<b>218.0</b>

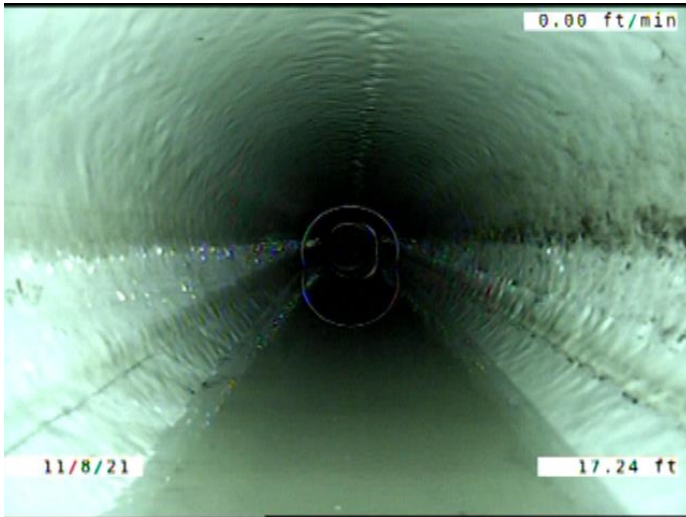
Code: **MWLS**  
Description: **Miscellaneous Water Level Sag**

Distance (ft): **17.2**  
Structural Grade: **2**  
O&M Grade: **0**  
Clock Start/From:  
Clock To:  
1st Value:  
2nd Value:  
Value Percent: **15.000**  
Continuous Index: **S01**  
Within 8" of Joint: **NO**  
Remarks:

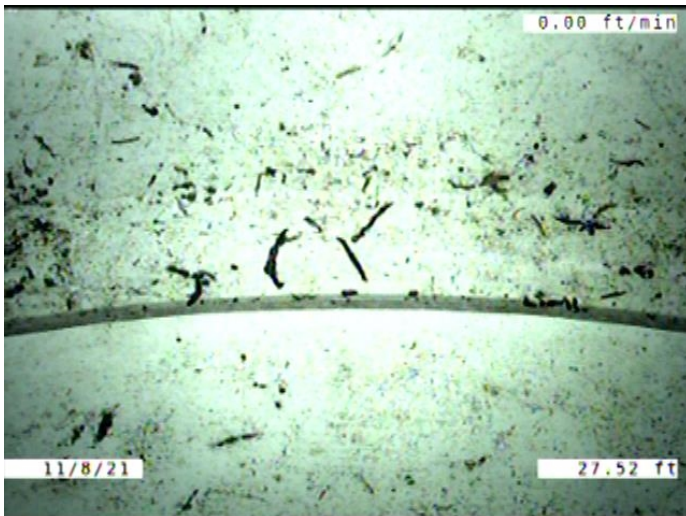
Code: **MGO**  
Description: **Miscellaneous General Observation**

Distance (ft): **27.5**  
Structural Grade: **0**  
O&M Grade: **0**  
Clock Start/From:  
Clock To:  
1st Value:  
2nd Value:  
Value Percent:  
Continuous Index:  
Within 8" of Joint: **NO**  
Remarks: **JOINT/ PIPES NOT PUSHED ALL THE WAY TOGETHER WHEN INSTALLED**

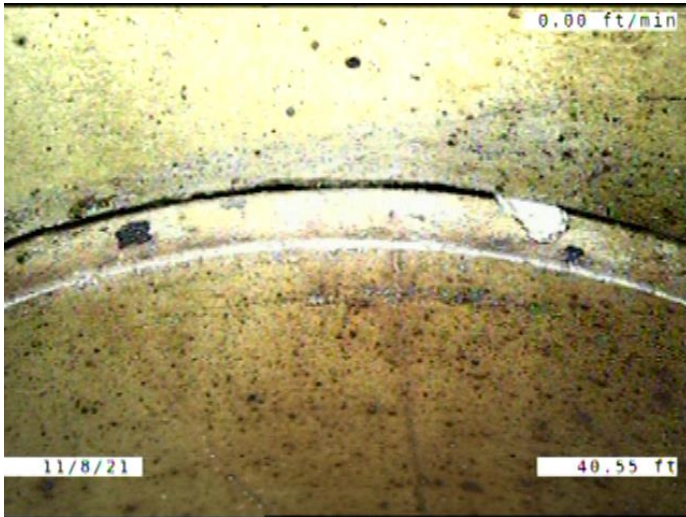
Code: **JOM**  
 Description: **Joint Offset Medium**

Distance (ft): **40.5**  
 Structural Grade: **3**  
 O&M Grade: **0**  
 Clock Start/From:  
 Clock To:  
 1st Value:  
 2nd Value:  
 Value Percent:  
 Continuous Index:  
 Within 8" of Joint: **NO**  
 Remarks:

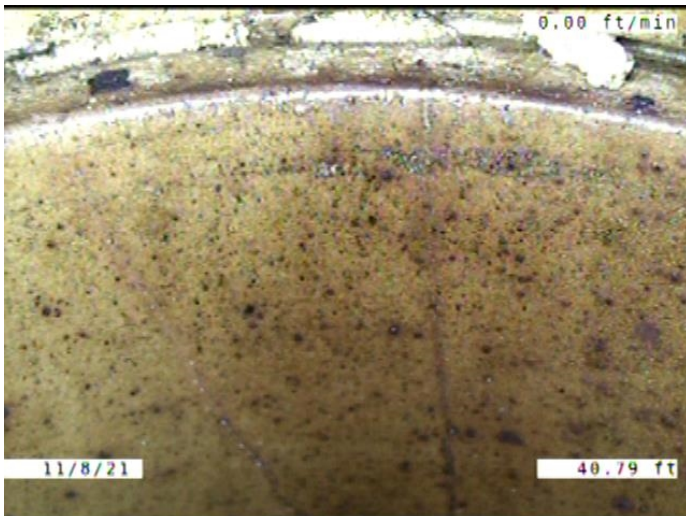
Code: **CM**  
 Description: **Crack Multiple**

Distance (ft): **40.8**  
 Structural Grade: **3**  
 O&M Grade: **0**  
 Clock Start/From: **11**  
 Clock To: **12**  
 1st Value:  
 2nd Value:  
 Value Percent:  
 Continuous Index:  
 Within 8" of Joint: **YES**  
 Remarks:

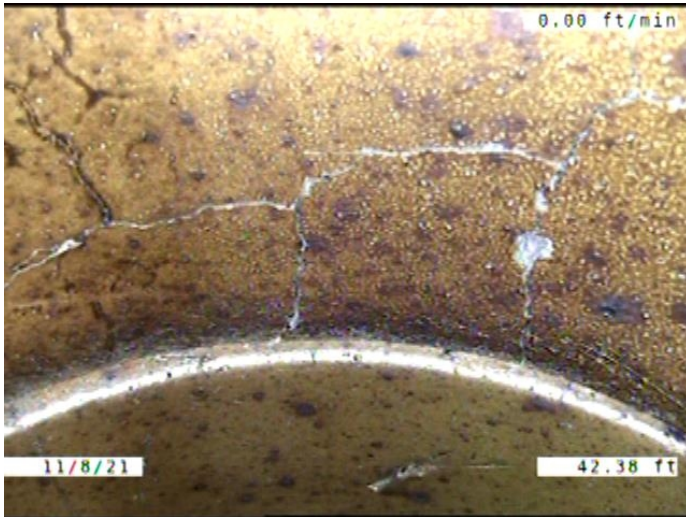
Code: **FM**  
Description: **Fracture Multiple**

Distance (ft): **42.4**  
Structural Grade: **4**  
O&M Grade: **0**  
Clock Start/From: **8**  
Clock To: **4**  
1st Value:  
2nd Value:  
Value Percent:  
Continuous Index: **S02**  
Within 8" of Joint: **YES**  
Remarks: **Wandering**

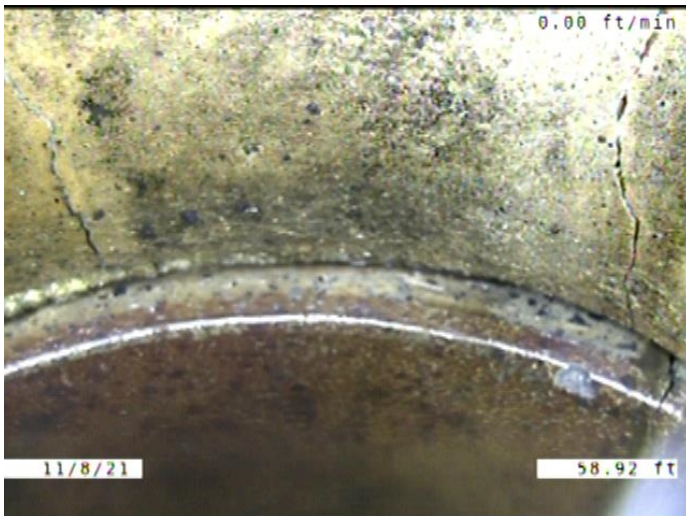
Code: **B**  
Description: **Broken**

Distance (ft): **58.9**  
Structural Grade: **4**  
O&M Grade: **0**  
Clock Start/From: **10**  
Clock To: **2**  
1st Value:  
2nd Value:  
Value Percent:  
Continuous Index:  
Within 8" of Joint: **YES**  
Remarks:

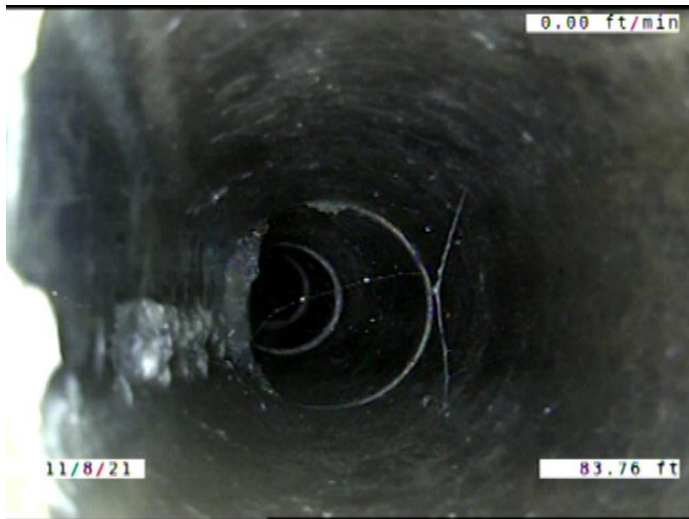
Code: **TBI**  
Description: **Tap Break-in Intruding**

Distance (ft): **83.8**  
Structural Grade: **0**  
O&M Grade: **2**  
Clock Start/From: **9**  
Clock To:  
1st Value: **6.000**  
2nd Value: **2.000**  
Value Percent:  
Continuous Index:  
Within 8" of Joint: **YES**  
Remarks:

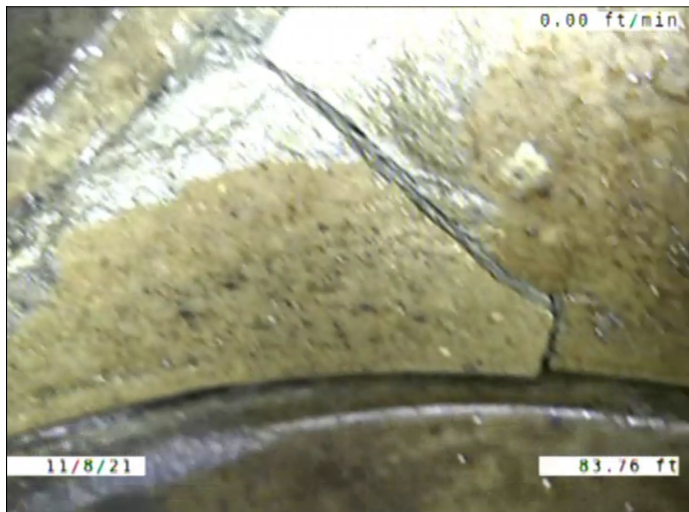
Code: **B**  
Description: **Broken**

Distance (ft): **83.8**  
Structural Grade: **4**  
O&M Grade: **0**  
Clock Start/From: **9**  
Clock To: **10**  
1st Value:  
2nd Value:  
Value Percent:  
Continuous Index:  
Within 8" of Joint: **NO**  
Remarks:

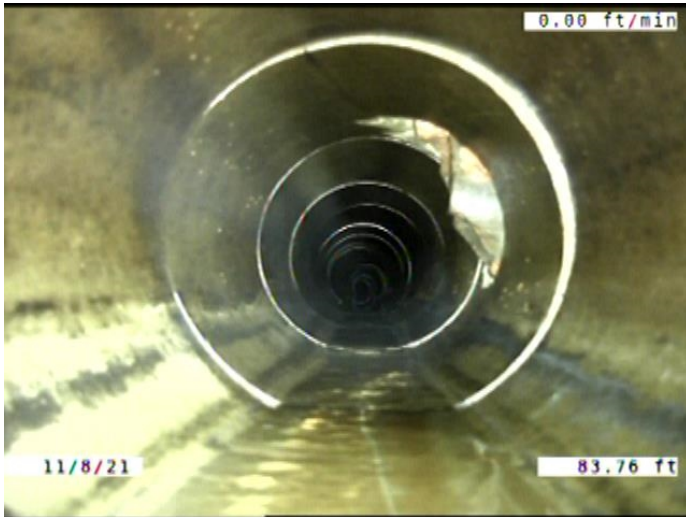
Code: **MWLS**  
 Description: **Miscellaneous Water Level Sag**

Distance (ft): **83.8**  
 Structural Grade: **2**  
 O&M Grade: **0**  
 Clock Start/From:  
 Clock To:  
 1st Value:  
 2nd Value:  
 Value Percent: **15.000**  
 Continuous Index: **F01**  
 Within 8" of Joint: **NO**  
 Remarks:

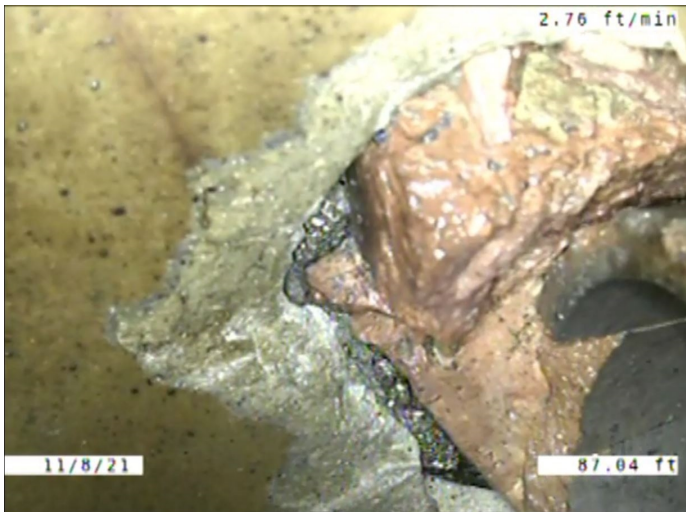
Code: **SSS**  
 Description: **Surface Damage Surface Spalling**

Distance (ft): **87.0**  
 Structural Grade: **2**  
 O&M Grade: **0**  
 Clock Start/From: **1**  
 Clock To: **3**  
 1st Value:  
 2nd Value:  
 Value Percent:  
 Continuous Index:  
 Within 8" of Joint: **NO**  
 Remarks:

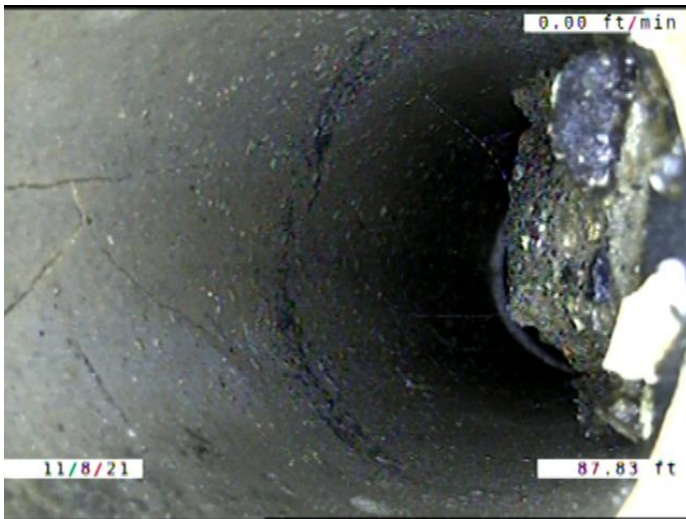
Code: **TBI**  
 Description: **Tap Break-in Intruding**

Distance (ft): **87.8**  
 Structural Grade: **0**  
 O&M Grade: **2**  
 Clock Start/From: **2**  
 Clock To:  
 1st Value: **4.000**  
 2nd Value: **3.000**  
 Value Percent:  
 Continuous Index:  
 Within 8" of Joint: **YES**  
 Remarks:

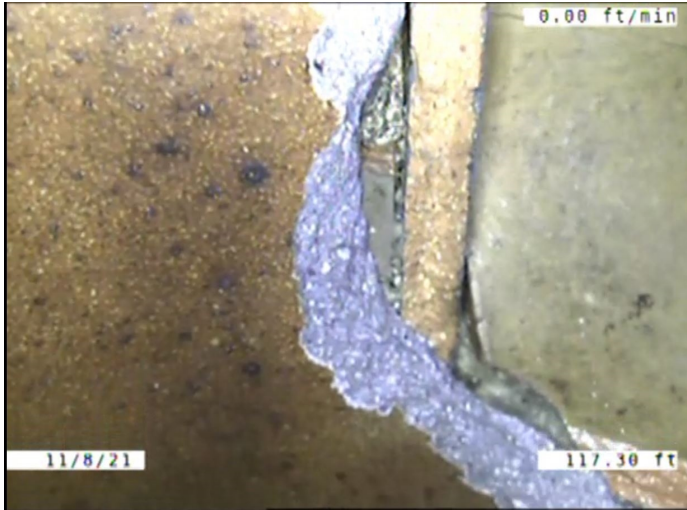
Code: **SSS**  
Description: **Surface Damage Surface Spalling**

Distance (ft): **117.3**  
Structural Grade: **2**  
O&M Grade: **0**  
Clock Start/From: **1**  
Clock To: **3**  
1st Value:  
2nd Value:  
Value Percent:  
Continuous Index:  
Within 8" of Joint: **NO**  
Remarks:

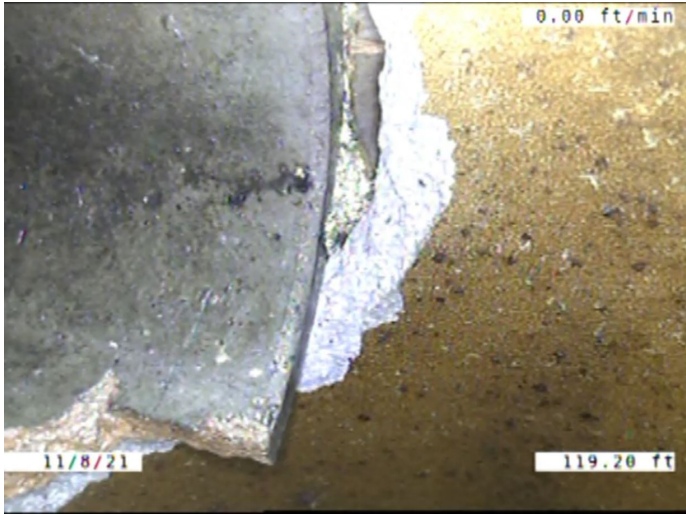
Code: **SSS**  
 Description: **Surface Damage Surface Spalling**

Distance (ft): **119.2**  
 Structural Grade: **2**  
 O&M Grade: **0**  
 Clock Start/From: **9**  
 Clock To: **11**  
 1st Value:  
 2nd Value:  
 Value Percent:  
 Continuous Index:  
 Within 8" of Joint: **NO**  
 Remarks:

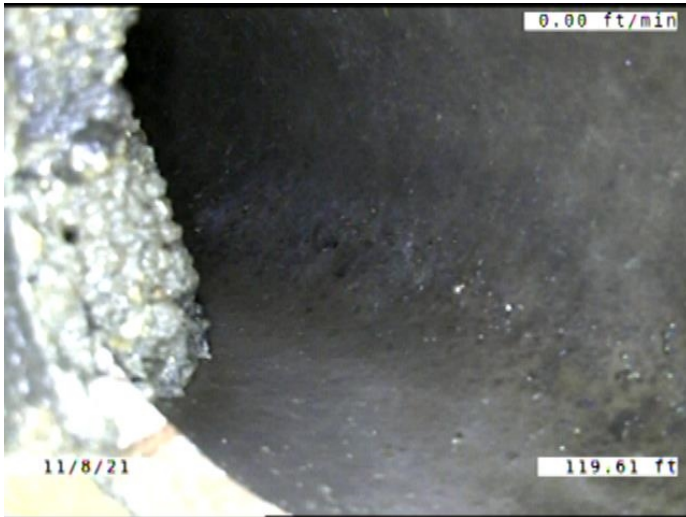
Code: **TBI**  
 Description: **Tap Break-in Intruding**

Distance (ft): **119.6**  
 Structural Grade: **0**  
 O&M Grade: **2**  
 Clock Start/From: **10**  
 Clock To:  
 1st Value: **4.000**  
 2nd Value: **2.000**  
 Value Percent:  
 Continuous Index:  
 Within 8" of Joint: **YES**  
 Remarks:

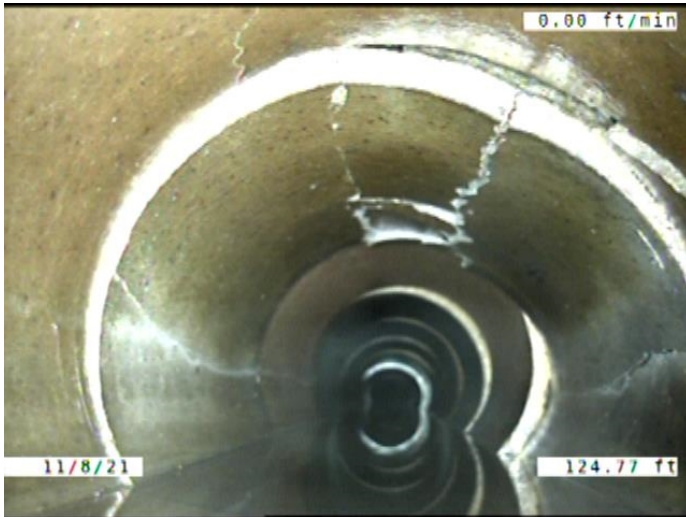
Code: **DR**  
 Description: **Deformed Rigid**

Distance (ft): **124.8**  
 Structural Grade: **4**  
 O&M Grade: **0**  
 Clock Start/From:  
 Clock To:  
 1st Value:  
 2nd Value:  
 Value Percent: **5.000**  
 Continuous Index:  
 Within 8" of Joint: **NO**  
 Remarks:

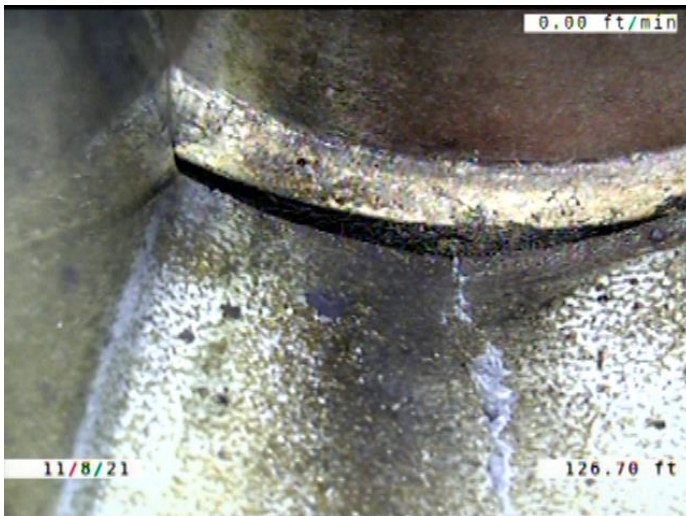
Code: **JOMD**  
 Description: **Joint Offset Medium Defective**

Distance (ft): **126.7**  
 Structural Grade: **3**  
 O&M Grade: **0**  
 Clock Start/From:  
 Clock To:  
 1st Value:  
 2nd Value:  
 Value Percent:  
 Continuous Index:  
 Within 8" of Joint: **NO**  
 Remarks:

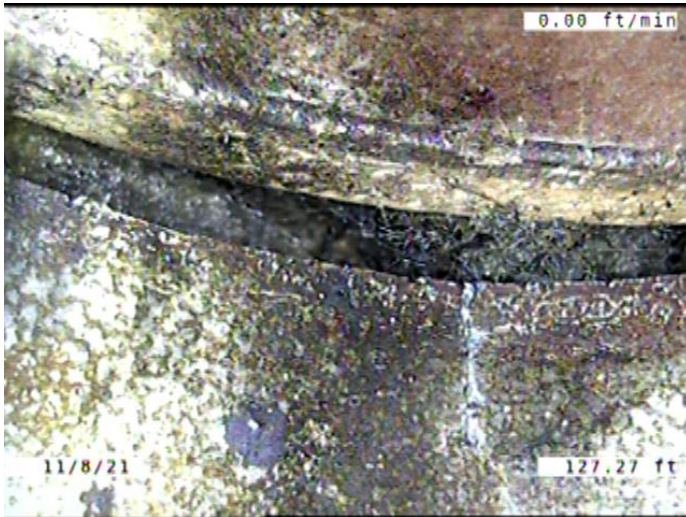
Code: **RFJ**  
Description: **Roots Fine Joint**

Distance (ft): **127.3**  
Structural Grade: **0**  
O&M Grade: **1**  
Clock Start/From: **3**  
Clock To:  
1st Value:  
2nd Value:  
Value Percent:  
Continuous Index:  
Within 8" of Joint: **YES**  
Remarks:

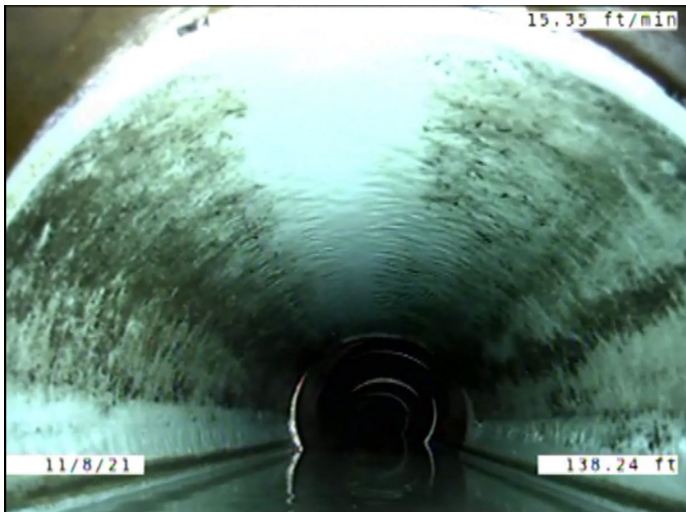
Code: **FM**  
Description: **Fracture Multiple**

Distance (ft): **138.2**  
Structural Grade: **4**  
O&M Grade: **0**  
Clock Start/From: **8**  
Clock To: **4**  
1st Value:  
2nd Value:  
Value Percent:  
Continuous Index: **F02**  
Within 8" of Joint: **YES**  
Remarks: **Wandering**

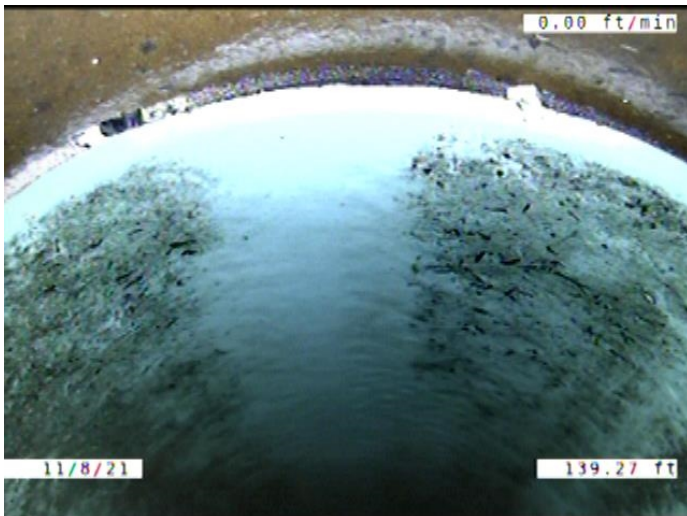
Code: **JOM**  
 Description: **Joint Offset Medium**

Distance (ft): **139.3**  
 Structural Grade: **3**  
 O&M Grade: **0**  
 Clock Start/From:  
 Clock To:  
 1st Value:  
 2nd Value:  
 Value Percent:  
 Continuous Index:  
 Within 8" of Joint: **NO**  
 Remarks:

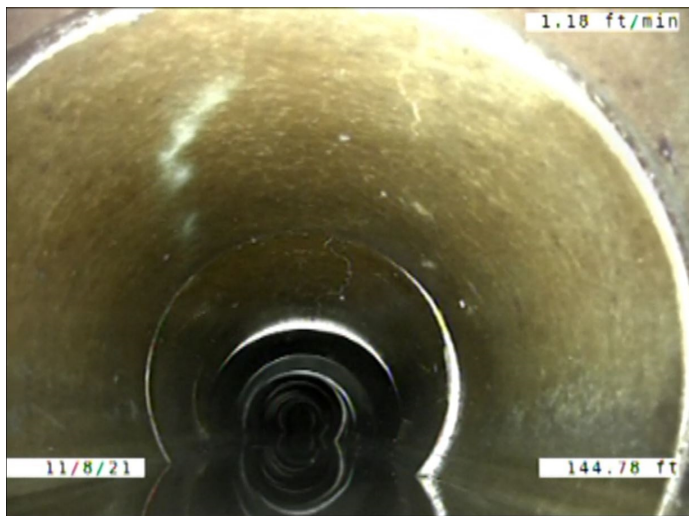
Code:	<b>CM</b>
Description:	<b>Crack Multiple</b>
Distance (ft):	<b>144.8</b>
Structural Grade:	<b>3</b>
O&M Grade:	<b>0</b>
Clock Start/From:	<b>8</b>
Clock To:	<b>4</b>
1st Value:	
2nd Value:	
Value Percent:	
Continuous Index:	<b>S05</b>
Within 8" of Joint:	<b>YES</b>
Remarks:

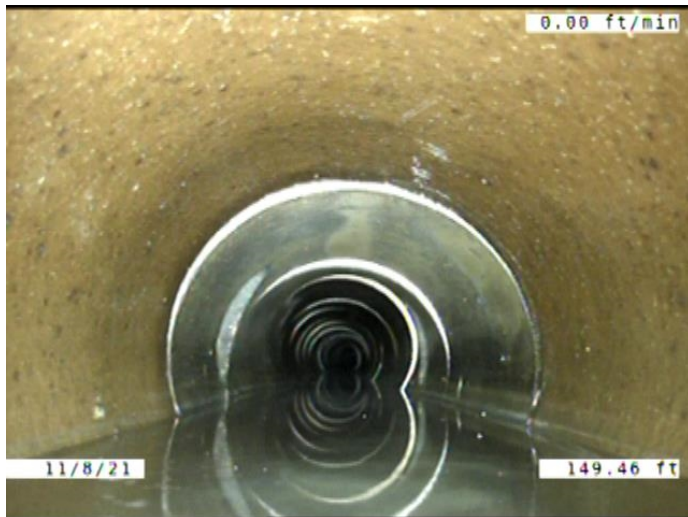
Code: **MWLS**  
 Description: **Miscellaneous Water Level Sag**

Distance (ft): **149.5**  
 Structural Grade: **2**  
 O&M Grade: **0**  
 Clock Start/From:  
 Clock To:  
 1st Value:  
 2nd Value:  
 Value Percent: **15.000**  
 Continuous Index: **S04**  
 Within 8" of Joint: **NO**  
 Remarks:

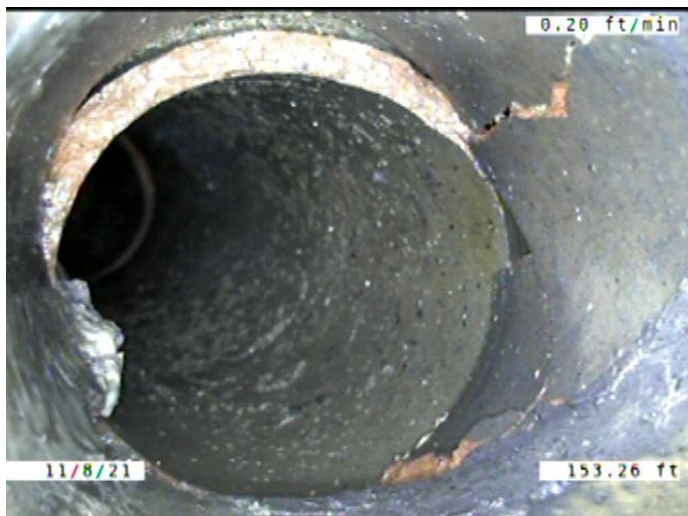
Code: **TFD**  
 Description: **Tap Factory Defective**

Distance (ft): **153.3**  
 Structural Grade: **0**  
 O&M Grade: **3**  
 Clock Start/From: **10**  
 Clock To:  
 1st Value: **4.000**  
 2nd Value:  
 Value Percent:  
 Continuous Index:  
 Within 8" of Joint: **YES**  
 Remarks: **BROKEN. OFFSET. SOIL VISIBLE.**

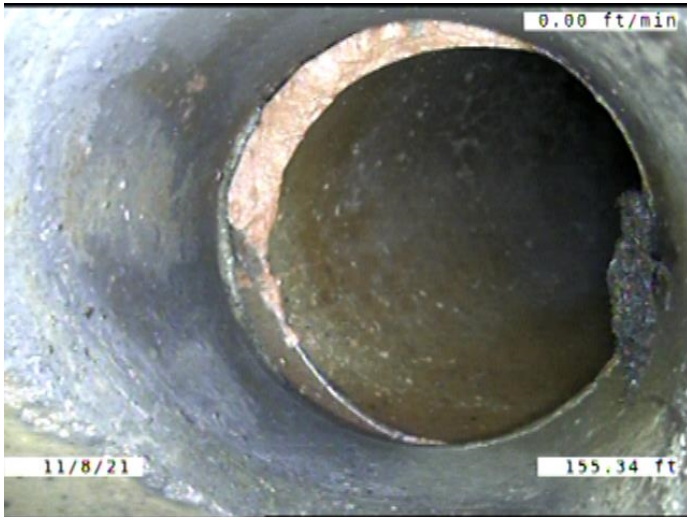
Code: **TBD**  
Description: **Tap Break-in/Hammer Defective**

Distance (ft): **155.3**  
Structural Grade: **0**  
O&M Grade: **3**  
Clock Start/From: **2**  
Clock To:  
1st Value: **4.000**  
2nd Value:  
Value Percent:  
Continuous Index:  
Within 8" of Joint: **YES**  
Remarks: **OFFSET. SOIL VISIBLE.**

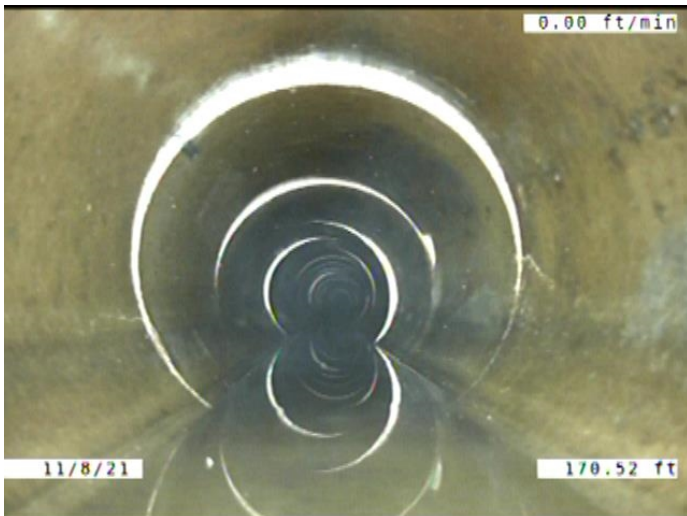
Code: **MWLS**  
Description: **Miscellaneous Water Level Sag**

Distance (ft): **170.5**  
Structural Grade: **2**  
O&M Grade: **0**  
Clock Start/From:  
Clock To:  
1st Value:  
2nd Value:  
Value Percent: **15.000**  
Continuous Index: **F04**  
Within 8" of Joint: **NO**  
Remarks:

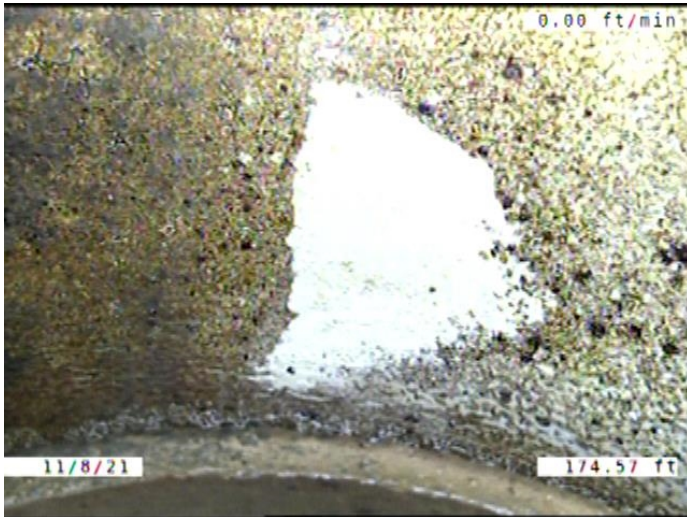
Code: **DAE**  
Description: **Deposits Attached Encrustation**

Distance (ft): **174.6**  
Structural Grade: **0**  
O&M Grade: **2**  
Clock Start/From: **2**  
Clock To:  
1st Value:  
2nd Value:  
Value Percent: **5.000**  
Continuous Index:  
Within 8" of Joint: **YES**  
Remarks:

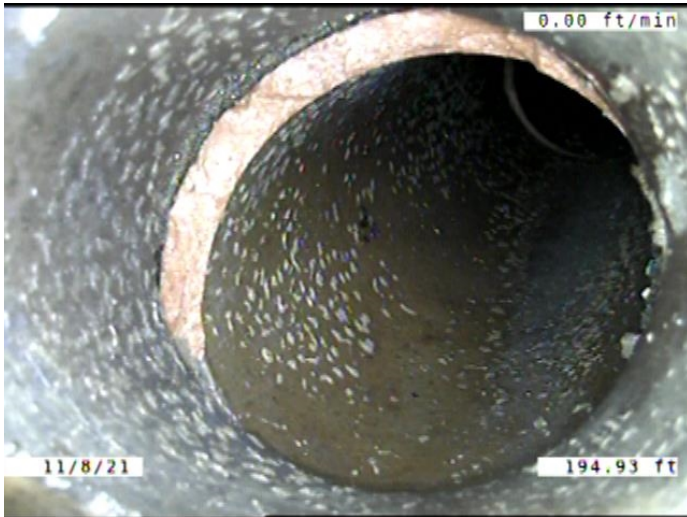
Code: **TFD**  
 Description: **Tap Factory Defective**

Distance (ft): **194.9**  
 Structural Grade: **0**  
 O&M Grade: **3**  
 Clock Start/From: **2**  
 Clock To:  
 1st Value: **4.000**  
 2nd Value:  
 Value Percent:  
 Continuous Index:  
 Within 8" of Joint: **YES**  
 Remarks: **OFFSET. SOIL VISIBLE**

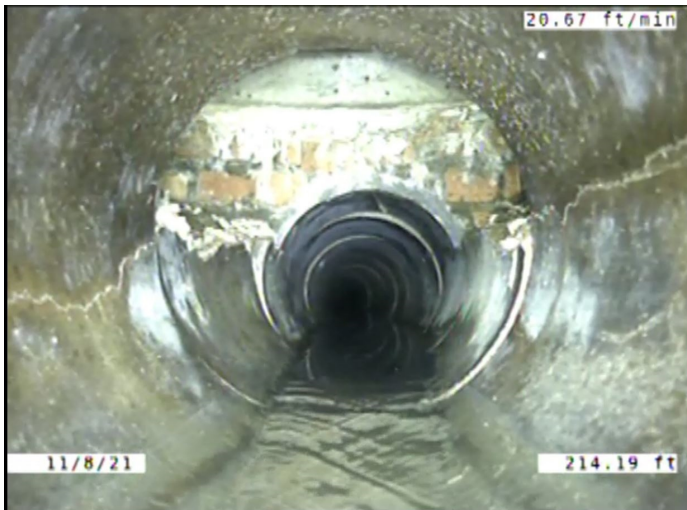
Code: **CM**  
 Description: **Crack Multiple**

Distance (ft): **214.2**  
 Structural Grade: **3**  
 O&M Grade: **0**  
 Clock Start/From: **8**  
 Clock To: **4**  
 1st Value:  
 2nd Value:  
 Value Percent:  
 Continuous Index: **F05**  
 Within 8" of Joint: **YES**  
 Remarks:
