Profile/Photo Observation Report

Date:	04/24/2018	Weather:		Coding:	PACP 6.0
Pipe Length (ft):	222.5	Owner:	NA	Pre Clean:	Not Known
P.O.#:		Surveyor:	Jen Costello	PSR:	P-604-066-065
Customer:		Clean Date:	01/01/1900	Shape:	C

Street:	N PENNSYLVANIA ST	Flow Control:	Not Controlled
City:	Hobart, IN	Year Renewed:	
Location:	Other	Tape/Media #:	
Purpose:	Not Known	Dia/Height:	12"
Use:	Sanitary	Material:	VCP
Drain Area:	NA	Lining:	
Category:	NA		
Comment:

Location Details:		Direction of Survey:	Downstream
US MH:	M-604-066	DS MH:	M-604-065
		Total Length Surveyed (ft):	216.4

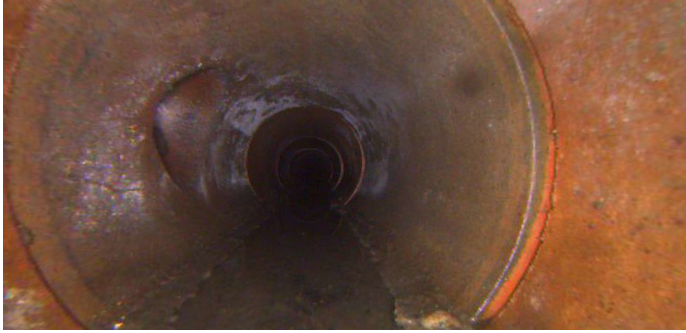
Code: **AMH**
Description: **Manhole**

Distance (ft): **.0**
Structural Grade: **0**
O&M Grade: **0**
Clock Start/From:
Clock To:
1st Value:
2nd Value:
Value Percent:
Continuous Index:
Within 8" of Joint: **NO**
Remarks: **M-604-066**

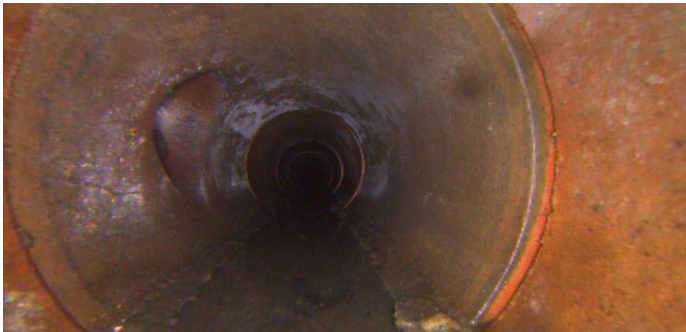
Code: **MWL**
Description: **Water Level**

Distance (ft): **.0**
Structural Grade: **0**
O&M Grade: **0**
Clock Start/From:
Clock To:
1st Value:
2nd Value:
Value Percent: **5.000**
Continuous Index:
Within 8" of Joint: **NO**
Remarks:

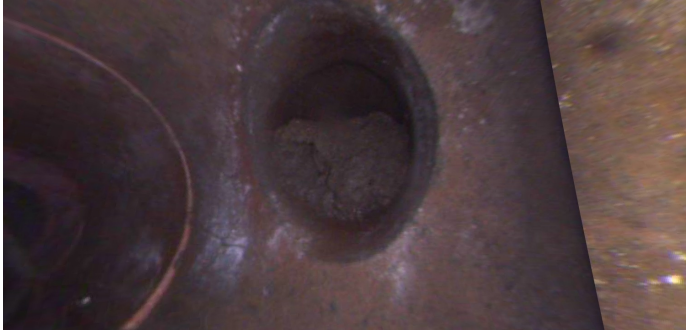
Code: **TF**
Description: **Tap Factory**

Distance (ft): **2.6**
Structural Grade: **0**
O&M Grade: **0**
Clock Start/From: **9**
Clock To:
1st Value: **4.000**
2nd Value:
Value Percent:
Continuous Index:
Within 8" of Joint:
Remarks:

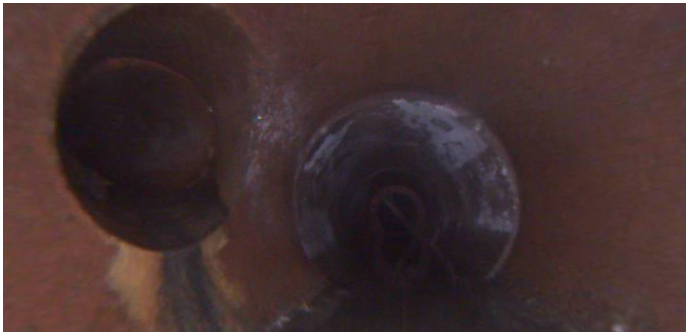
Code: **TFA**
Description: **Tap Factory Active**

Distance (ft): **4.8**
Structural Grade: **0**
O&M Grade: **0**
Clock Start/From: **3**
Clock To:
1st Value: **4.000**
2nd Value:
Value Percent:
Continuous Index:
Within 8" of Joint:
Remarks:

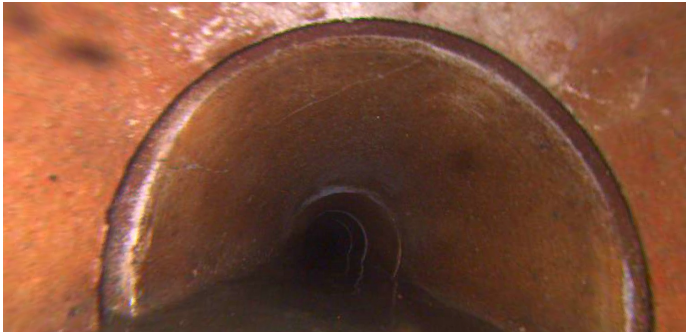
Code: **FC**
Description: **Fracture Circumferential**

Distance (ft): **21.4**
Structural Grade: **2**
O&M Grade: **0**
Clock Start/From: **9**
Clock To: **12**
1st Value:
2nd Value:
Value Percent:
Continuous Index:
Within 8" of Joint: **YES**
Remarks:

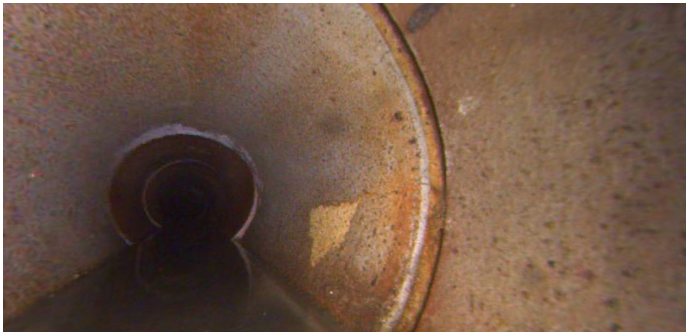
Code: **FL**
Description: **Fracture Longitudinal**

Distance (ft): **36.0**
Structural Grade: **3**
O&M Grade: **0**
Clock Start/From: **3**
Clock To:
1st Value:
2nd Value:
Value Percent:
Continuous Index:
Within 8" of Joint: **YES**
Remarks:

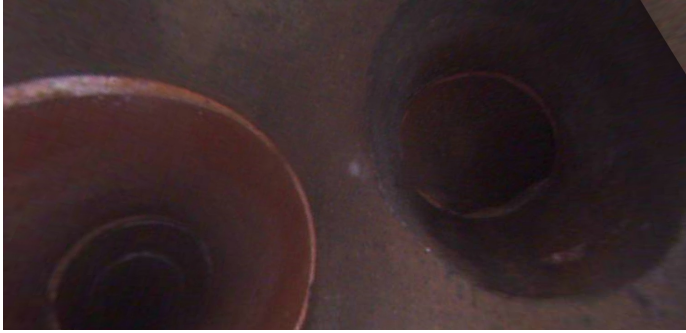
Code: **TF**
Description: **Tap Factory**

Distance (ft): **43.7**
Structural Grade: **0**
O&M Grade: **0**
Clock Start/From: **10**
Clock To:
1st Value: **4.000**
2nd Value:
Value Percent:
Continuous Index:
Within 8" of Joint:
Remarks:

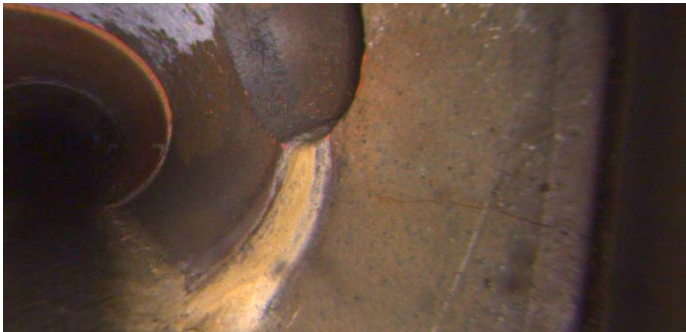
Code: **FL**
Description: **Fracture Longitudinal**

Distance (ft): **44.8**
Structural Grade: **3**
O&M Grade: **0**
Clock Start/From: **3**
Clock To:
1st Value:
2nd Value:
Value Percent:
Continuous Index:
Within 8" of Joint: **YES**
Remarks:

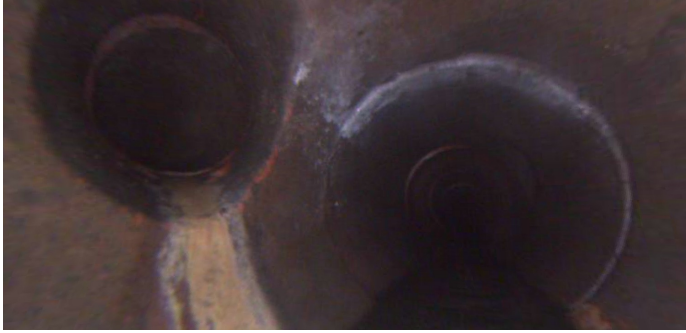
Code: **TF**
Description: **Tap Factory**

Distance (ft): **45.9**
Structural Grade: **0**
O&M Grade: **0**
Clock Start/From: **2**
Clock To:
1st Value: **4.000**
2nd Value:
Value Percent:
Continuous Index:
Within 8" of Joint:
Remarks:

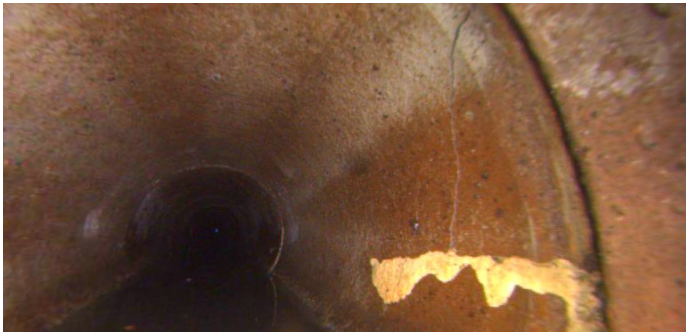
Code: **FM**
Description: **Fracture Multiple**

Distance (ft): **48.6**
Structural Grade: **4**
O&M Grade: **0**
Clock Start/From: **8**
Clock To: **4**
1st Value:
2nd Value:
Value Percent:
Continuous Index: **S01**
Within 8" of Joint: **YES**
Remarks:

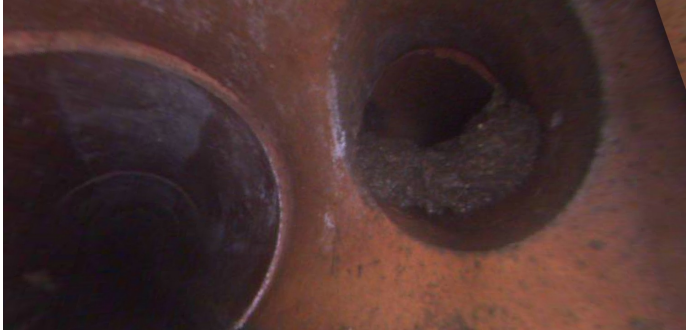
Code: **TF**
Description: **Tap Factory**

Distance (ft): **83.1**
Structural Grade: **0**
O&M Grade: **0**
Clock Start/From: **10**
Clock To:
1st Value: **4.000**
2nd Value:
Value Percent:
Continuous Index:
Within 8" of Joint:
Remarks:

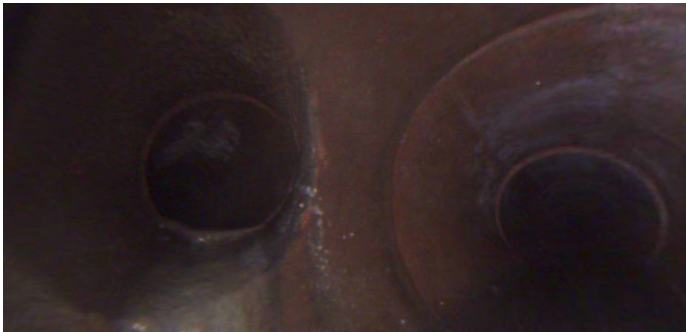
Code: **TFA**
Description: **Tap Factory Active**

Distance (ft): **85.0**
Structural Grade: **0**
O&M Grade: **0**
Clock Start/From: **3**
Clock To:
1st Value: **4.000**
2nd Value:
Value Percent:
Continuous Index:
Within 8" of Joint:
Remarks:

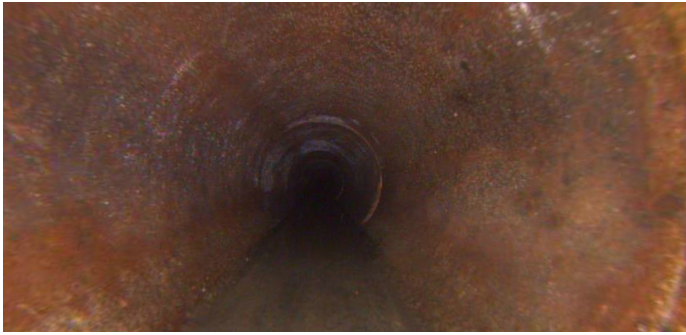
Code: **FM**
Description: **Fracture Multiple**

Distance (ft): **100.3**
Structural Grade: **4**
O&M Grade: **0**
Clock Start/From: **8**
Clock To: **4**
1st Value:
2nd Value:
Value Percent:
Continuous Index: **F01**
Within 8" of Joint: **YES**
Remarks:

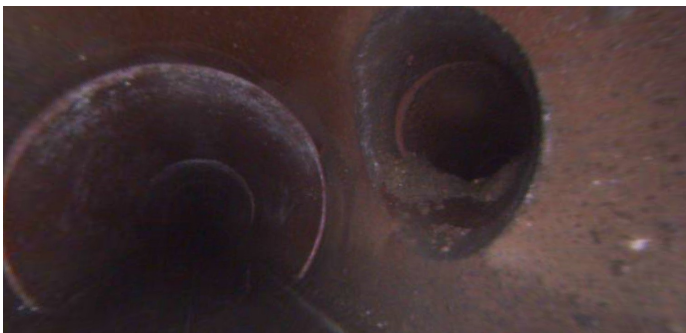
Code: **TF**
Description: **Tap Factory**

Distance (ft): **122.5**
Structural Grade: **0**
O&M Grade: **0**
Clock Start/From: **9**
Clock To:
1st Value: **4.000**
2nd Value:
Value Percent:
Continuous Index:
Within 8" of Joint:
Remarks:

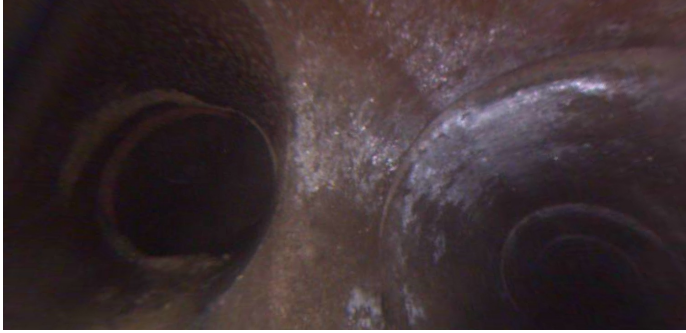
Code: **TF**
Description: **Tap Factory**

Distance (ft): **124.2**
Structural Grade: **0**
O&M Grade: **0**
Clock Start/From: **3**
Clock To:
1st Value: **4.000**
2nd Value:
Value Percent:
Continuous Index:
Within 8" of Joint:
Remarks:

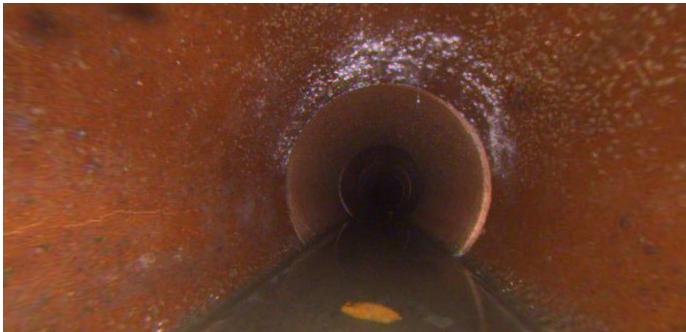
Code: **CL**
Description: **Crack Longitudinal**

Distance (ft): **132.2**
Structural Grade: **2**
O&M Grade: **0**
Clock Start/From: **9**
Clock To:
1st Value:
2nd Value:
Value Percent:
Continuous Index:
Within 8" of Joint:
Remarks:

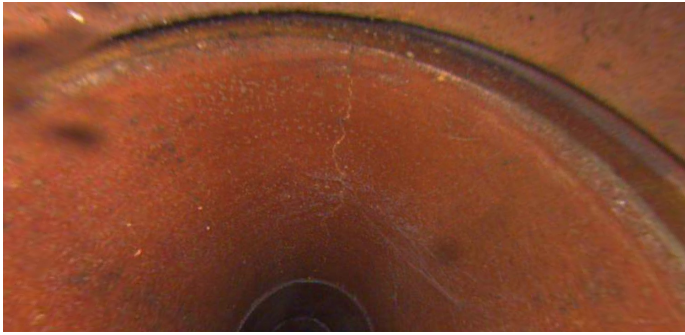
Code: **FL**
Description: **Fracture Longitudinal**

Distance (ft): **139.6**
Structural Grade: **3**
O&M Grade: **0**
Clock Start/From: **12**
Clock To:
1st Value:
2nd Value:
Value Percent:
Continuous Index: **S02**
Within 8" of Joint: **YES**
Remarks:

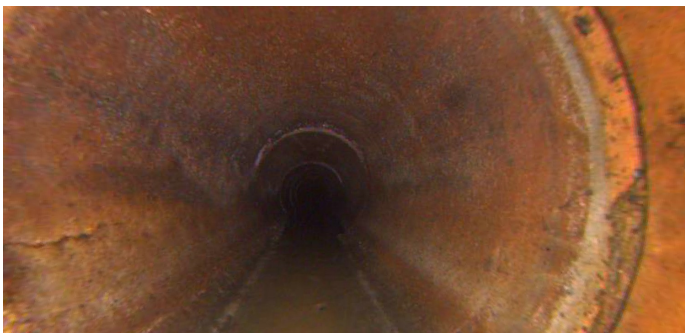
Code: **FL**
Description: **Fracture Longitudinal**

Distance (ft): **156.0**
Structural Grade: **3**
O&M Grade: **0**
Clock Start/From: **12**
Clock To:
1st Value:
2nd Value:
Value Percent:
Continuous Index: **F02**
Within 8" of Joint: **YES**
Remarks:

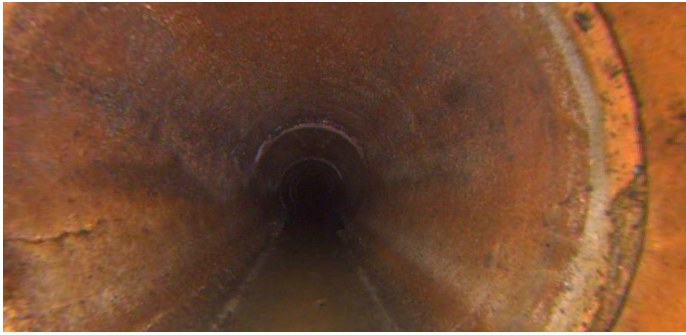
Code: **FL**
Description: **Fracture Longitudinal**

Distance (ft): **156.0**
Structural Grade: **3**
O&M Grade: **0**
Clock Start/From: **9**
Clock To:
1st Value:
2nd Value:
Value Percent:
Continuous Index:
Within 8" of Joint: **YES**
Remarks:

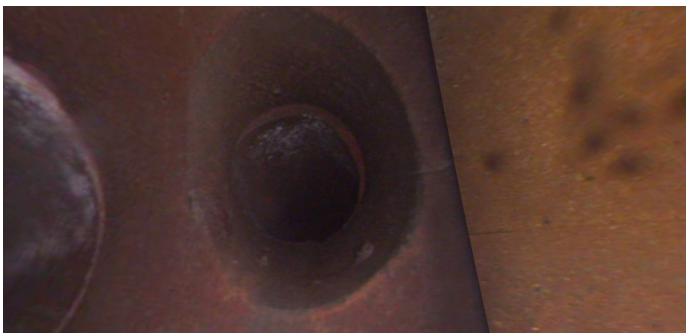
Code: **TF**
Description: **Tap Factory**

Distance (ft): **161.8**
Structural Grade: **0**
O&M Grade: **0**
Clock Start/From: **9**
Clock To:
1st Value: **4.000**
2nd Value:
Value Percent:
Continuous Index:
Within 8" of Joint:
Remarks:

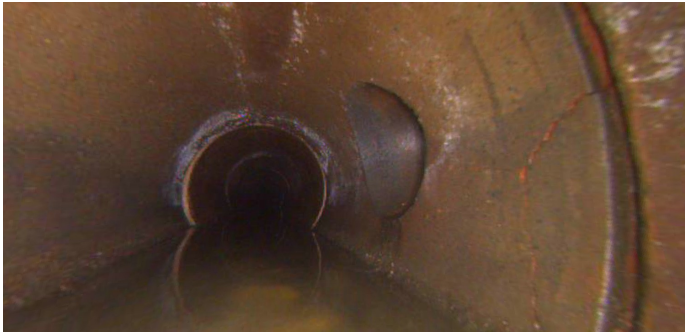
Code: **FS**
Description: **Fracture Spiral**

Distance (ft): **162.4**
Structural Grade: **3**
O&M Grade: **0**
Clock Start/From: **3**
Clock To: **5**
1st Value:
2nd Value:
Value Percent:
Continuous Index:
Within 8" of Joint: **YES**
Remarks:

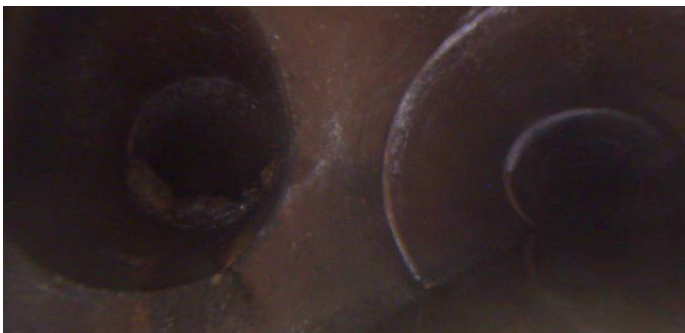
Code: **TF**
Description: **Tap Factory**

Distance (ft): **163.7**
Structural Grade: **0**
O&M Grade: **0**
Clock Start/From: **3**
Clock To:
1st Value: **4.000**
2nd Value:
Value Percent:
Continuous Index:
Within 8" of Joint:
Remarks:

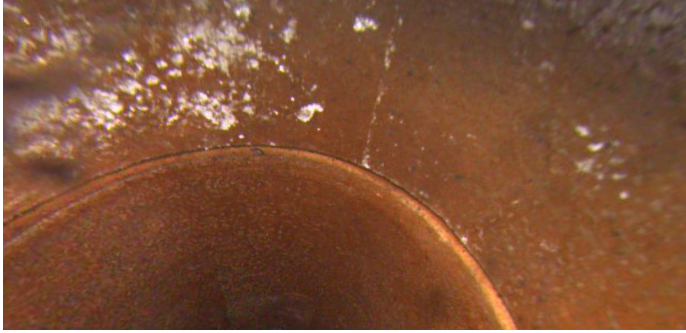
Code: **CL**
Description: **Crack Longitudinal**

Distance (ft): **166.2**
Structural Grade: **2**
O&M Grade: **0**
Clock Start/From: **1**
Clock To:
1st Value:
2nd Value:
Value Percent:
Continuous Index:
Within 8" of Joint: **YES**
Remarks:

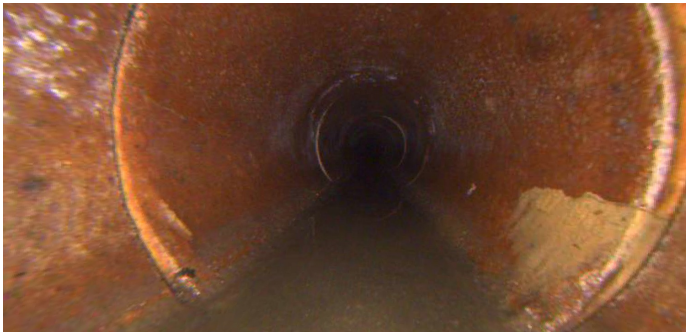
Code: **FM**
Description: **Fracture Multiple**

Distance (ft): **190.0**
Structural Grade: **4**
O&M Grade: **0**
Clock Start/From: **8**
Clock To: **4**
1st Value:
2nd Value:
Value Percent:
Continuous Index:
Within 8" of Joint: **YES**
Remarks:

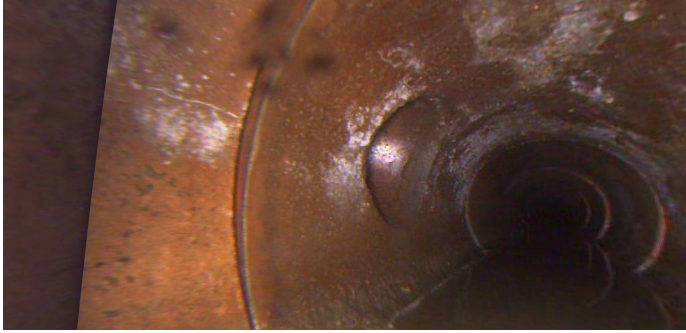
Code: **CL**
Description: **Crack Longitudinal**

Distance (ft): **196.4**
Structural Grade: **2**
O&M Grade: **0**
Clock Start/From: **9**
Clock To:
1st Value:
2nd Value:
Value Percent:
Continuous Index:
Within 8" of Joint: **YES**
Remarks:

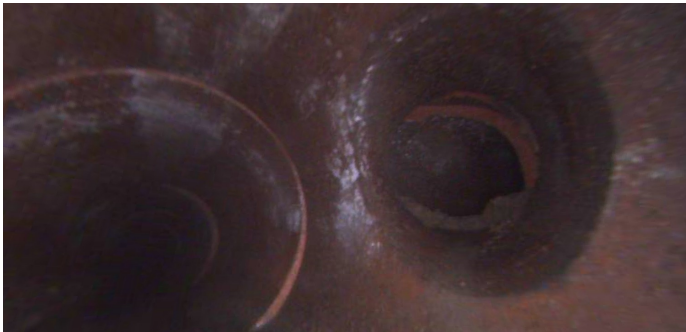
Code: **TF**
Description: **Tap Factory**

Distance (ft): **197.9**
Structural Grade: **0**
O&M Grade: **0**
Clock Start/From: **9**
Clock To:
1st Value: **4.000**
2nd Value:
Value Percent:
Continuous Index:
Within 8" of Joint:
Remarks:

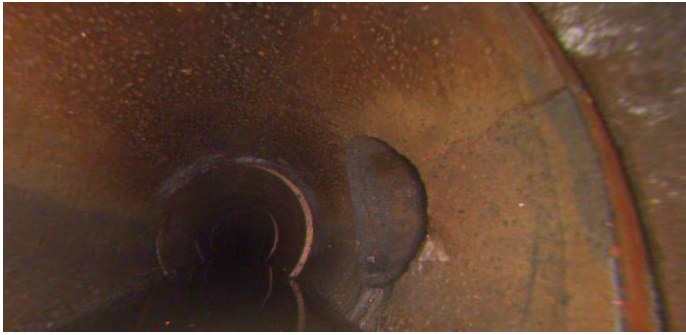
Code: **FL**
Description: **Fracture Longitudinal**

Distance (ft): **198.5**
Structural Grade: **3**
O&M Grade: **0**
Clock Start/From: **2**
Clock To:
1st Value:
2nd Value:
Value Percent:
Continuous Index:
Within 8" of Joint: **YES**
Remarks:

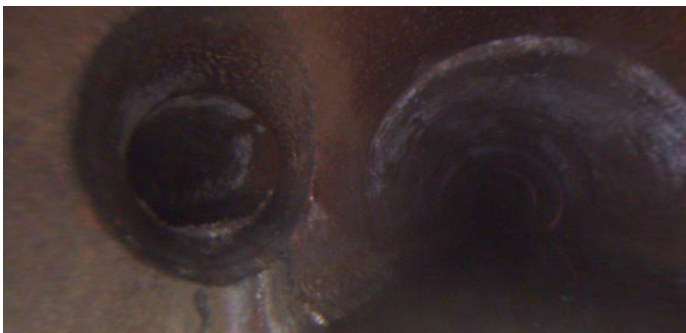
Code: **TFA**
Description: **Tap Factory Active**

Distance (ft): **199.9**
Structural Grade: **0**
O&M Grade: **0**
Clock Start/From: **3**
Clock To:
1st Value: **4.000**
2nd Value:
Value Percent:
Continuous Index:
Within 8" of Joint:
Remarks:

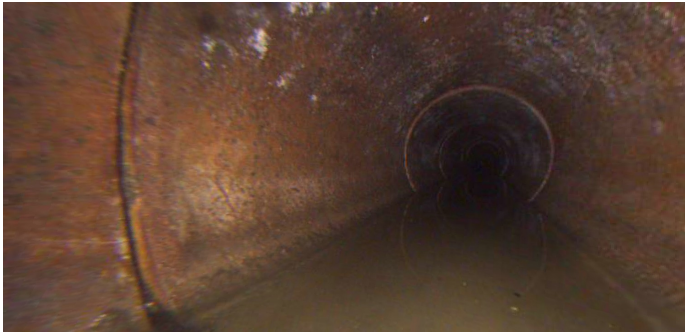
Code: **CL**
Description: **Crack Longitudinal**

Distance (ft): **206.7**
Structural Grade: **2**
O&M Grade: **0**
Clock Start/From: **8**
Clock To:
1st Value:
2nd Value:
Value Percent:
Continuous Index:
Within 8" of Joint: **YES**
Remarks:

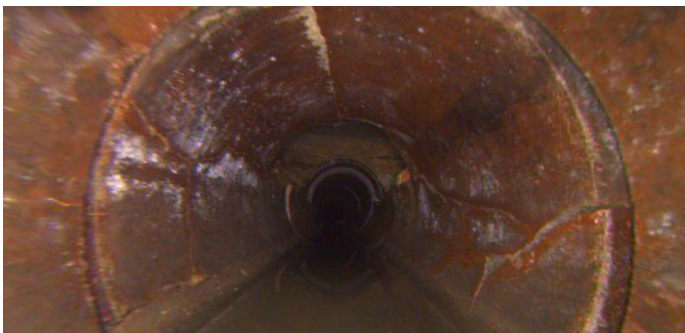
Code: **FM**
Description: **Fracture Multiple**

Distance (ft): **212.7**
Structural Grade: **4**
O&M Grade: **0**
Clock Start/From: **8**
Clock To: **4**
1st Value:
2nd Value:
Value Percent:
Continuous Index:
Within 8" of Joint: **YES**
Remarks:

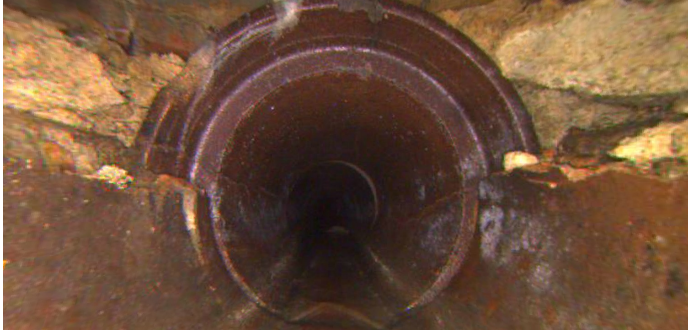
Code:	AMH
Description:	Manhole
Distance (ft):	216.4
Structural Grade:	0
O&M Grade:	0
Clock Start/From:	
Clock To:	
1st Value:	
2nd Value:	
Value Percent:	
Continuous Index:	
Within 8" of Joint:	NO
Remarks:	M-604-065
