## Profile/Photo Observation Report

Street:	<b>N PENNSYLVANIA ST &amp; W HOME AV</b>	Flow Control:	<b>Not Controlled</b>
City:	<b>Hobart, IN</b>	Year Renewed:	
Location:	<b>Other</b>	Tape/Media #:	
Purpose:	<b>Not Known</b>	Dia/Height:	<b>12"</b>
Use:	<b>Sanitary</b>	Material:	<b>VCP</b>
Drain Area:	<b>NA</b>	Lining:	
Category:	<b>NA</b>		
Comment:

Location Details:		Direction of Survey:	<b>Upstream</b>
US MH:	<b>M-604-067</b>	DS MH:	<b>M-604-066</b>
		Total Length Surveyed (ft):	<b>3.7</b>

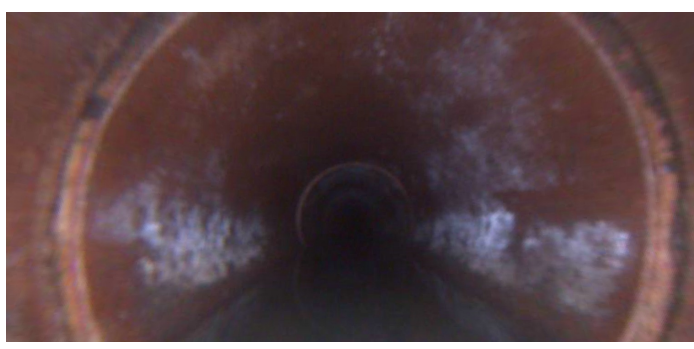
Code: **AMH**  
Description: **Manhole**

Distance (ft): **.0**  
Structural Grade: **0**  
O&M Grade: **0**  
Clock Start/From:  
Clock To:  
1st Value:  
2nd Value:  
Value Percent:  
Continuous Index:  
Within 8" of Joint: **NO**  
Remarks: **M-604-066**

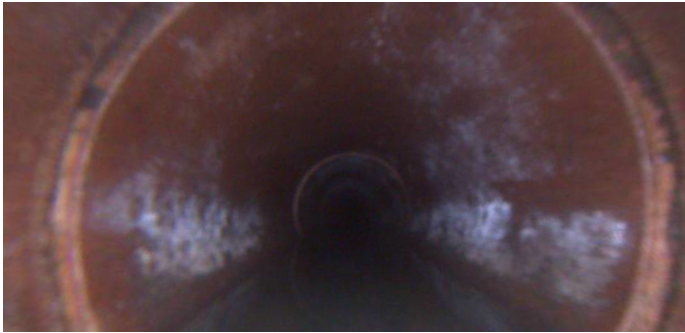
Code:	<b>MWL</b>
Description:	<b>Water Level</b>

Distance (ft):	<b>.0</b>
Structural Grade:	<b>0</b>
O&M Grade:	<b>0</b>
Clock Start/From:	
Clock To:	
1st Value:	
2nd Value:	
Value Percent:	<b>10.000</b>
Continuous Index:	
Within 8" of Joint:	<b>NO</b>
Remarks:

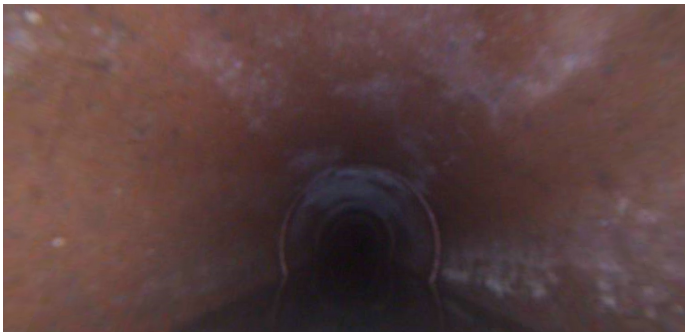
Code:	<b>MSA</b>
Description:	<b>Abandoned Survey</b>

Distance (ft):	<b>3.7</b>
Structural Grade:	<b>0</b>
O&M Grade:	<b>0</b>
Clock Start/From:	
Clock To:	
1st Value:	
2nd Value:	
Value Percent:	
Continuous Index:	
Within 8" of Joint:	<b>NO</b>
Remarks:	<b>DEBRIS UNDER WATER</b>
