Profile/Photo Observation Report

| Street: | S Pennsylvania St. | Flow Control: | Not Controlled |
| City: | Hobart, IN | Year Renewed: | |

| US MH: | M-604-067 | DS MH: | M-604-066 |

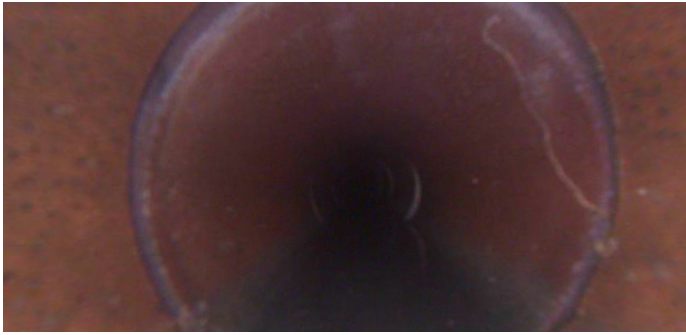
| | Position | Code | Observation | Video (sec) | Grade |
|--|---|---|---|---|---|
| | .0 | FC | Fracture Circumferential | 33 | S 2 |

Code: **FC**
Description: **Fracture Circumferential**

Distance (ft): **.0**
Structural Grade: **2**
O&M Grade: **0**
Clock Start/From: **1**
Clock To: **3**
1st Value:
2nd Value:
Value Percent:
Continuous Index:
Within 8" of Joint: **YES**
Remarks:

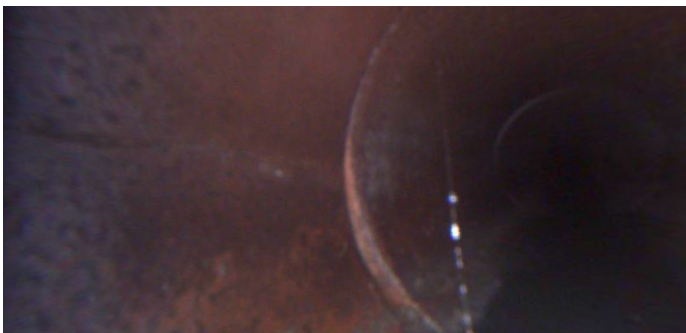
| | Position | Code | Observation | Video (sec) | Grade |
|--|---|---|---|---|---|
| | 13.9 | CL | Crack Longitudinal | 72 | S 2 |

Code: **CL**
Description: **Crack Longitudinal**

Distance (ft): **13.9**
Structural Grade: **2**
O&M Grade: **0**
Clock Start/From: **9**
Clock To:
1st Value:
2nd Value:
Value Percent:
Continuous Index:
Within 8" of Joint: **YES**
Remarks:

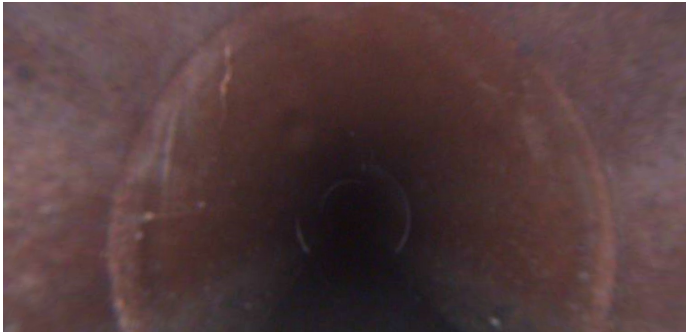
| | Position | Code | Observation | Video (sec) | Grade |
|--|---|---|---|---|---|
| | 18.1 | FM | Fracture Multiple | 92 | S 4 |

Code: **FM**
Description: **Fracture Multiple**

Distance (ft): **18.1**
Structural Grade: **4**
O&M Grade: **0**
Clock Start/From: **8**
Clock To: **4**
1st Value:
2nd Value:
Value Percent:
Continuous Index:
Within 8" of Joint: **YES**
Remarks:

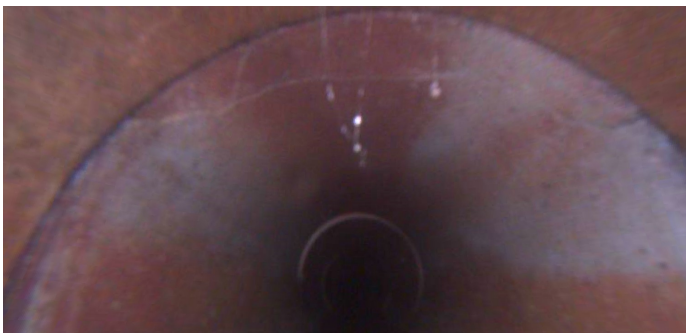
| | Position | Code | Observation | Video (sec) | Grade |
|--|---|---|---|---|---|
| | 20.3 | FM | Fracture Multiple | 109 | S 4 |

Code: **FM**
Description: **Fracture Multiple**

Distance (ft): **20.3**
Structural Grade: **4**
O&M Grade: **0**
Clock Start/From: **10**
Clock To: **2**
1st Value:
2nd Value:
Value Percent:
Continuous Index:
Within 8" of Joint: **YES**
Remarks:

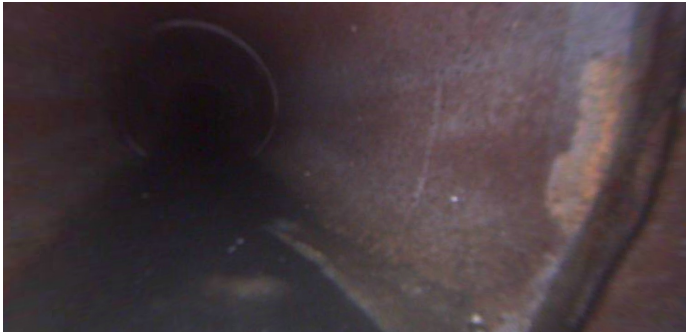
| | Position | Code | Observation | Video (sec) | Grade |
|--|---|---|---|---|---|
| | 29.0 | SSS | Surface Spalling | 138 | S 2 |

Code: **SSS**
Description: **Surface Spalling**

Distance (ft): **29.0**
Structural Grade: **2**
O&M Grade: **0**
Clock Start/From: **3**
Clock To: **4**
1st Value:
2nd Value:
Value Percent:
Continuous Index:
Within 8" of Joint: **YES**
Remarks:

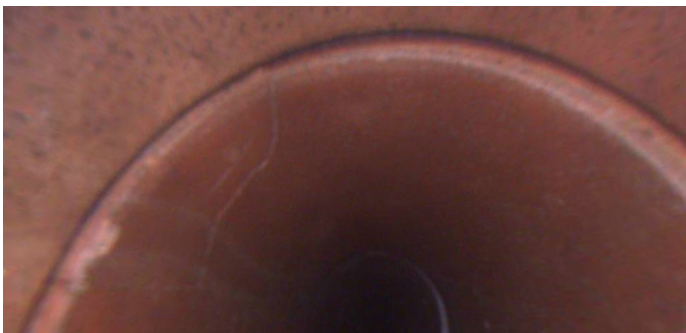
| | Position | Code | Observation | Video (sec) | Grade |
|--|---|---|---|---|---|
| | 35.0 | FM | Fracture Multiple | 162 | S 4 |

Code: **FM**
Description: **Fracture Multiple**

Distance (ft): **35.0**
Structural Grade: **4**
O&M Grade: **0**
Clock Start/From: **9**
Clock To: **11**
1st Value:
2nd Value:
Value Percent:
Continuous Index:
Within 8" of Joint: **YES**
Remarks:

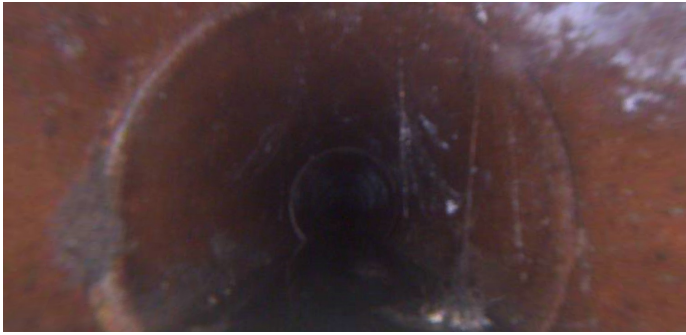
| | Position | Code | Observation | Video (sec) | Grade |
|--|---|---|---|---|---|
| | 49.5 | RFJ(S01) | Roots Fine Joint | 203 | M 1 |

Code: **RFJ**
Description: **Roots Fine Joint**

Distance (ft): **49.5**
Structural Grade: **0**
O&M Grade: **1**
Clock Start/From: **8**
Clock To: **4**
1st Value:
2nd Value:
Value Percent:
Continuous Index: **S01**
Within 8" of Joint: **YES**
Remarks:

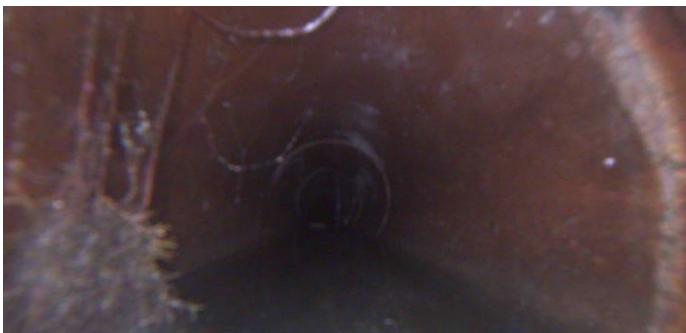
| | Position | Code | Observation | Video (sec) | Grade |
|--|---|---|---|---|---|
| | 60.2 | RMJ | Roots Medium Joint | 236 | M 3 |

Code: **RMJ**
Description: **Roots Medium Joint**

Distance (ft): **60.2**
Structural Grade: **0**
O&M Grade: **3**
Clock Start/From: **10**
Clock To:
1st Value:
2nd Value:
Value Percent: **10.000**
Continuous Index:
Within 8" of Joint: **YES**
Remarks:

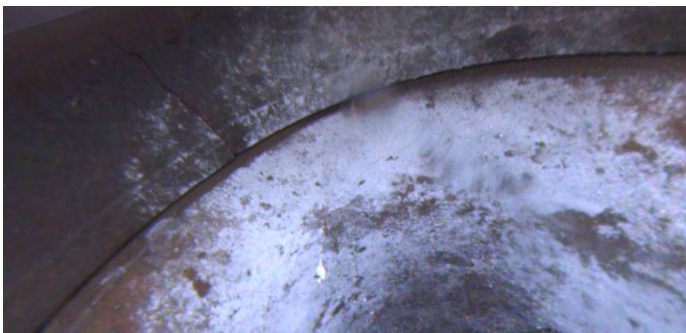
| | Position | Code | Observation | Video (sec) | Grade |
|--|---|---|---|---|---|
| | 71.3 | FL | Fracture Longitudinal | 287 | S 3 |

Code: **FL**
Description: **Fracture Longitudinal**

Distance (ft): **71.3**
Structural Grade: **3**
O&M Grade: **0**
Clock Start/From: **1**
Clock To:
1st Value:
2nd Value:
Value Percent:
Continuous Index:
Within 8" of Joint: **YES**
Remarks:

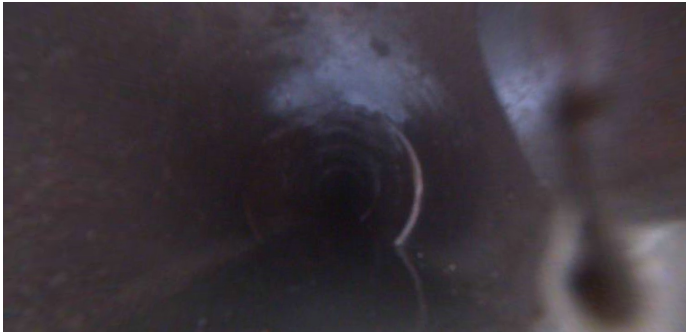
| | Position | Code | Observation | Video (sec) | Grade |
|--|---|---|---|---|---|
| | 71.3 | RFJ(F01) | Roots Fine Joint | 300 | M 1 |

Code: **RFJ**
Description: **Roots Fine Joint**

Distance (ft): **71.3**
Structural Grade: **0**
O&M Grade: **1**
Clock Start/From: **8**
Clock To: **4**
1st Value:
2nd Value:
Value Percent:
Continuous Index: **F01**
Within 8" of Joint: **YES**
Remarks:

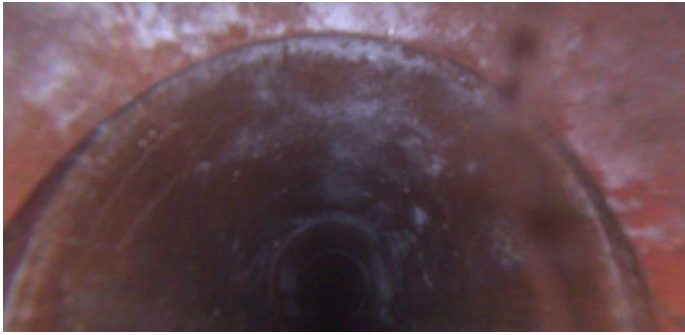
| | Position | Code | Observation | Video (sec) | Grade |
|--|---|---|---|---|---|
| | 83.1 | FM | Fracture Multiple | 351 | S 4 |

Code: **FM**
Description: **Fracture Multiple**

Distance (ft): **83.1**
Structural Grade: **4**
O&M Grade: **0**
Clock Start/From: **9**
Clock To: **11**
1st Value:
2nd Value:
Value Percent:
Continuous Index:
Within 8" of Joint: **YES**
Remarks:

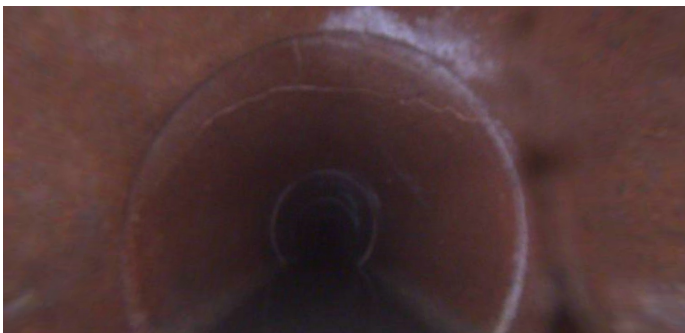
| | Position | Code | Observation | Video (sec) | Grade |
|--|---|---|---|---|---|
| | 95.5 | FM | Fracture Multiple | 388 | S 4 |

Code: **FM**
Description: **Fracture Multiple**

Distance (ft): **95.5**
Structural Grade: **4**
O&M Grade: **0**
Clock Start/From: **10**
Clock To: **2**
1st Value:
2nd Value:
Value Percent:
Continuous Index:
Within 8" of Joint: **YES**
Remarks:

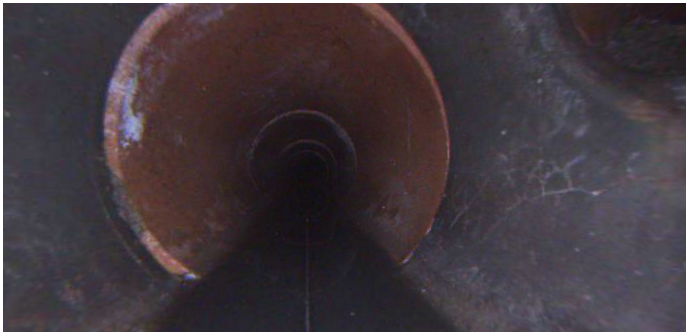
| | Position | Code | Observation | Video (sec) | Grade |
|--|---|---|---|---|---|
| | 111.9 | CM | Crack Multiple | 445 | S 3 |

Code: **CM**
Description: **Crack Multiple**

Distance (ft): **111.9**
Structural Grade: **3**
O&M Grade: **0**
Clock Start/From: **3**
Clock To: **4**
1st Value:
2nd Value:
Value Percent:
Continuous Index:
Within 8" of Joint: **YES**
Remarks:

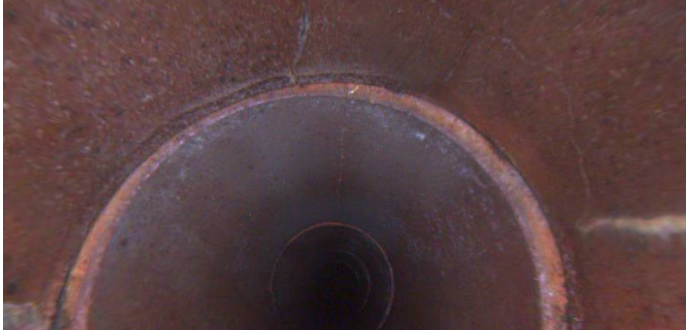
| | Position | Code | Observation | Video (sec) | Grade |
|--|---|---|---|---|---|
| | 124.3 | FM(S02) | Fracture Multiple | 509 | S 4 |

Code: **FM**
Description: **Fracture Multiple**

Distance (ft): **124.3**
Structural Grade: **4**
O&M Grade: **0**
Clock Start/From: **8**
Clock To: **4**
1st Value:
2nd Value:
Value Percent:
Continuous Index: **S02**
Within 8" of Joint: **YES**
Remarks:

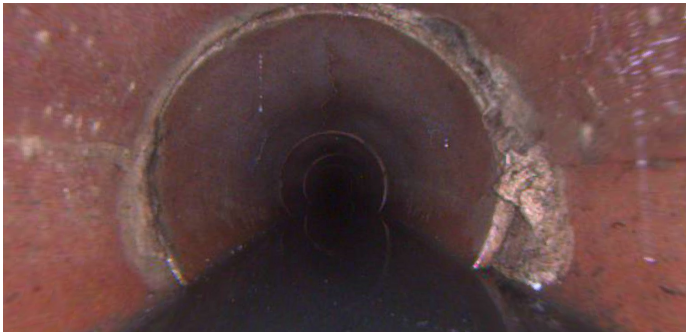
| | Position | Code | Observation | Video (sec) | Grade |
|--|---|---|---|---|---|
| | 137.1 | DAE(S03) | Deposits Attached Encrustation | 546 | M 2 |

Code: **DAE**
Description: **Deposits Attached Encrustation**

Distance (ft): **137.1**
Structural Grade: **0**
O&M Grade: **2**
Clock Start/From: **8**
Clock To: **4**
1st Value:
2nd Value:
Value Percent: **5.000**
Continuous Index: **S03**
Within 8" of Joint: **YES**
Remarks:

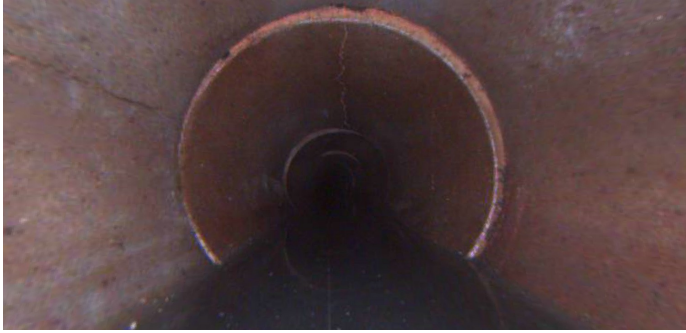
| | Position | Code | Observation | Video (sec) | Grade |
|--|---|---|---|---|---|
| | 145.5 | DAE(F03) | Deposits Attached Encrustation | 574 | M 2 |

Code: **DAE**
Description: **Deposits Attached Encrustation**

Distance (ft): **145.5**
Structural Grade: **0**
O&M Grade: **2**
Clock Start/From: **8**
Clock To: **4**
1st Value:
2nd Value:
Value Percent: **5.000**
Continuous Index: **F03**
Within 8" of Joint: **YES**
Remarks:

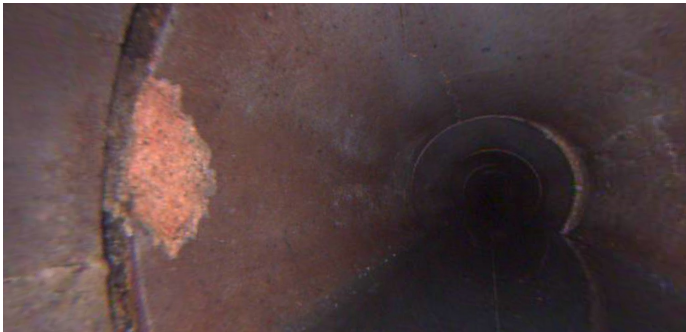
| | Position | Code | Observation | Video (sec) | Grade |
|--|---|---|---|---|---|
| | 149.1 | SSS | Surface Spalling | 593 | S 2 |

Code: **SSS**
Description: **Surface Spalling**

Distance (ft): **149.1**
Structural Grade: **2**
O&M Grade: **0**
Clock Start/From: **3**
Clock To:
1st Value:
2nd Value:
Value Percent:
Continuous Index:
Within 8" of Joint: **YES**
Remarks:

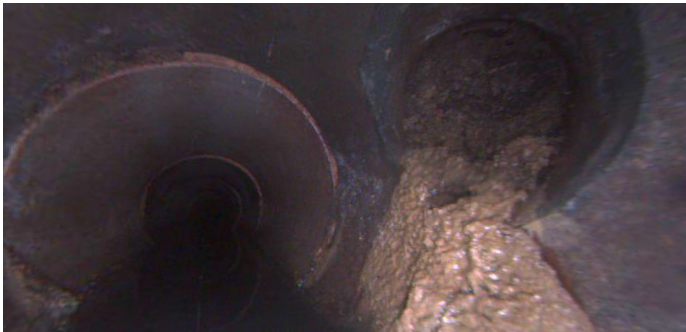
| | Position | Code | Observation | Video (sec) | Grade |
|--|---|---|---|---|---|
| | 152.1 | DAE | Deposits Attached Encrustation | 622 | M 2 |

Code: **DAE**
Description: **Deposits Attached Encrustation**

Distance (ft): **152.1**
Structural Grade: **0**
O&M Grade: **2**
Clock Start/From: **7**
Clock To: **9**
1st Value:
2nd Value:
Value Percent: **5.000**
Continuous Index:
Within 8" of Joint: **NO**
Remarks:

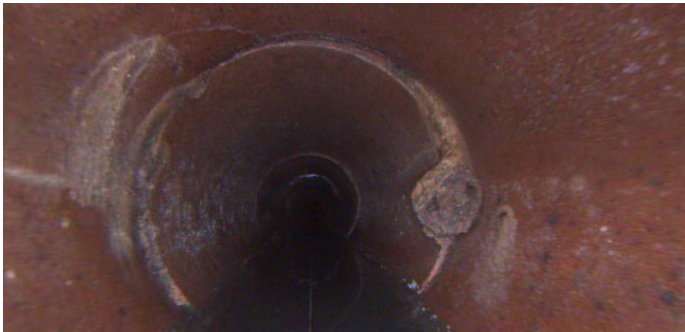
| | Position | Code | Observation | Video (sec) | Grade |
|--|---|---|---|---|---|
| | 160.2 | DAE | Deposits Attached Encrustation | 662 | M 2 |

Code: **DAE**
Description: **Deposits Attached Encrustation**

Distance (ft): **160.2**
Structural Grade: **0**
O&M Grade: **2**
Clock Start/From: **9**
Clock To:
1st Value:
2nd Value:
Value Percent: **5.000**
Continuous Index:
Within 8" of Joint: **YES**
Remarks:

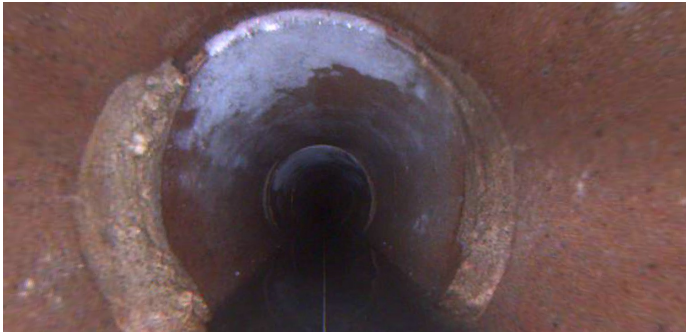
| | Position | Code | Observation | Video (sec) | Grade |
|--|---|---|---|---|---|
| | 189.3 | DAE | Deposits Attached Encrustation | 731 | M 2 |

Code: **DAE**
Description: **Deposits Attached Encrustation**

Distance (ft): **189.3**
Structural Grade: **0**
O&M Grade: **2**
Clock Start/From: **8**
Clock To: **4**
1st Value:
2nd Value:
Value Percent: **5.000**
Continuous Index:
Within 8" of Joint: **YES**
Remarks:

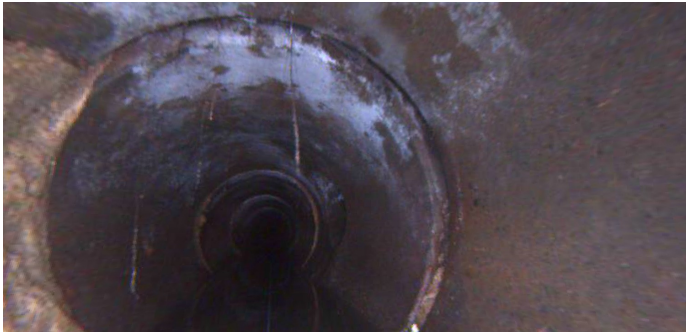
| | Position | Code | Observation | Video (sec) | Grade |
|--|---|---|---|---|---|
| | 193.4 | RFJ | Roots Fine Joint | 763 | M 1 |

Code: **RFJ**
Description: **Roots Fine Joint**

Distance (ft): **193.4**
Structural Grade: **0**
O&M Grade: **1**
Clock Start/From: **11**
Clock To: **1**
1st Value:
2nd Value:
Value Percent:
Continuous Index:
Within 8" of Joint: **YES**
Remarks:

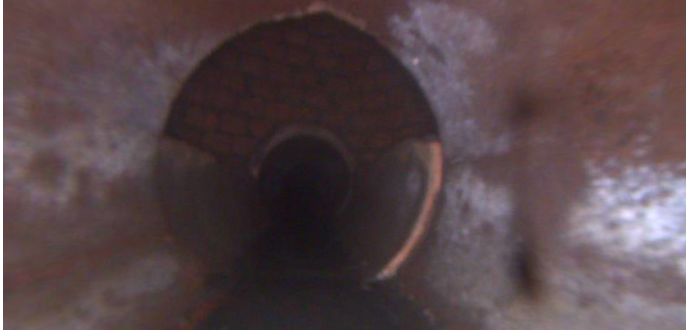
| | Position | Code | Observation | Video (sec) | Grade |
|--|---|---|---|---|---|
| | 225.1 | FM(F02) | Fracture Multiple | 852 | S 4 |

Code: **FM**
Description: **Fracture Multiple**

Distance (ft): **225.1**
Structural Grade: **4**
O&M Grade: **0**
Clock Start/From: **8**
Clock To: **4**
1st Value:
2nd Value:
Value Percent:
Continuous Index: **F02**
Within 8" of Joint: **YES**
Remarks:
