Profile/Photo Observation Report

Street:	N PENNSYLVANIA ST	Flow Control:	Not Controlled
City:	Hobart, IN	Year Renewed:	
Location:	Light Highway	Tape/Media #:	
Purpose:	Not Known	Dia/Height:	10"
Use:	Sanitary	Material:	VCP
Drain Area:	NA	Lining:	
Category:	NA		
Comment:

Location Details:		Direction of Survey:	Downstream
US MH:	M-604-068	DS MH:	M-604-069
		Total Length Surveyed (ft):	58.1

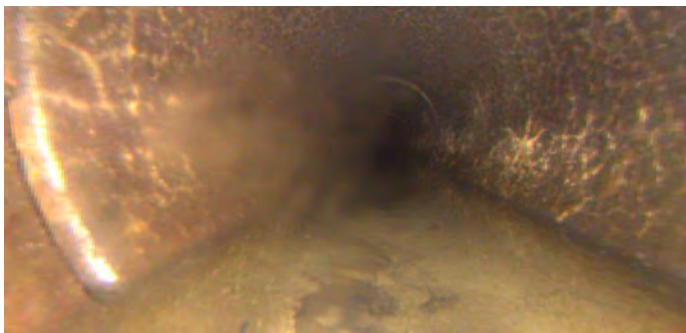
Code: **AMH**
Description: **Manhole**

Distance (ft): **.0**
Structural Grade: **0**
O&M Grade: **0**
Clock Start/From:
Clock To:
1st Value:
2nd Value:
Value Percent:
Continuous Index:
Within 8" of Joint: **NO**
Remarks: **M-604-068**

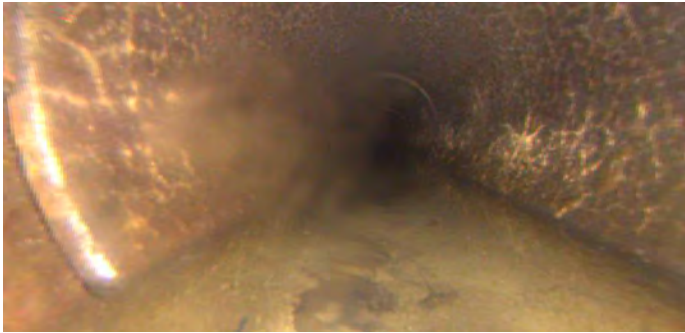
Code:	MWL
Description:	Water Level

Distance (ft):	.0
Structural Grade:	0
O&M Grade:	0
Clock Start/From:	
Clock To:	
1st Value:	
2nd Value:	
Value Percent:	5.000
Continuous Index:	
Within 8" of Joint:	NO
Remarks:

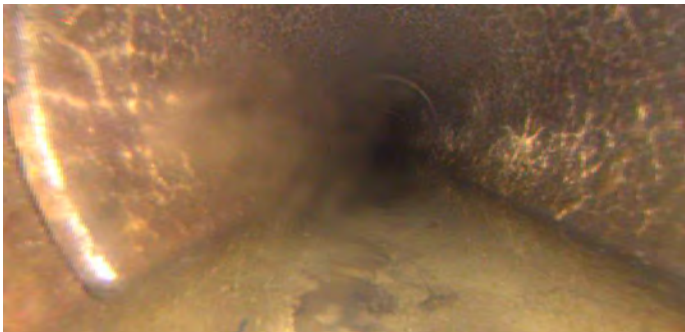
Code:	CM
Description:	Crack Multiple

Distance (ft):	.0
Structural Grade:	3
O&M Grade:	0
Clock Start/From:	7
Clock To:	5
1st Value:	
2nd Value:	
Value Percent:	
Continuous Index:	S01
Within 8" of Joint:	YES
Remarks:

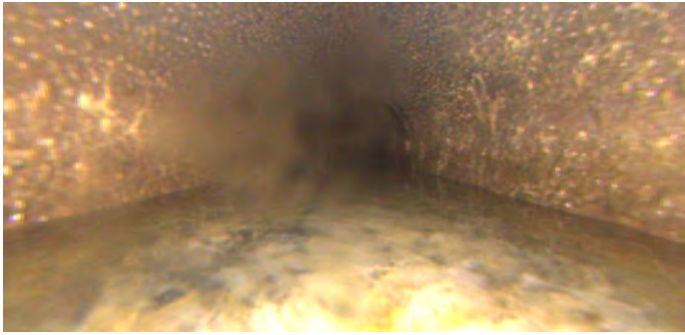
Code: **DSZ**
Description: **Deposits Settled Other**

Distance (ft): **5.6**
Structural Grade: **0**
O&M Grade: **2**
Clock Start/From: **6**
Clock To:
1st Value:
2nd Value:
Value Percent: **5.000**
Continuous Index: **S02**
Within 8" of Joint: **NO**
Remarks: **tissue/debris**

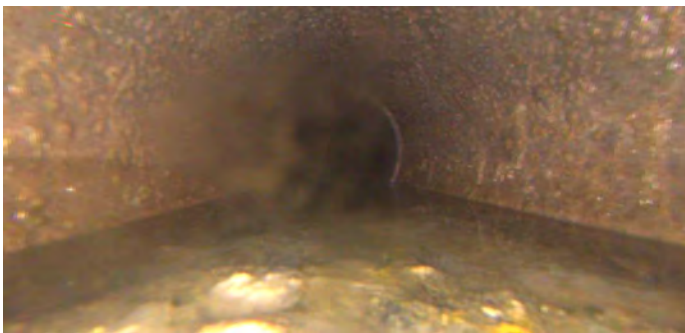
Code: **MWL**
Description: **Water Level**

Distance (ft): **17.9**
Structural Grade: **0**
O&M Grade: **0**
Clock Start/From:
Clock To:
1st Value:
2nd Value:
Value Percent: **25.000**
Continuous Index:
Within 8" of Joint: **NO**
Remarks:

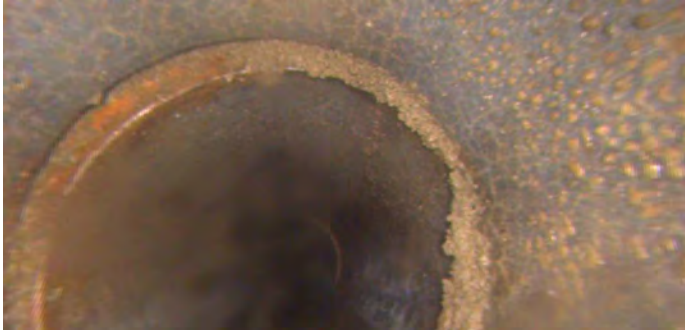
Code: **DAZ**
Description: **Deposits Attached Other**

Distance (ft): **22.9**
Structural Grade: **0**
O&M Grade: **2**
Clock Start/From: **12**
Clock To: **5**
1st Value:
2nd Value:
Value Percent: **5.000**
Continuous Index: **S03**
Within 8" of Joint: **YES**
Remarks: **wandering**

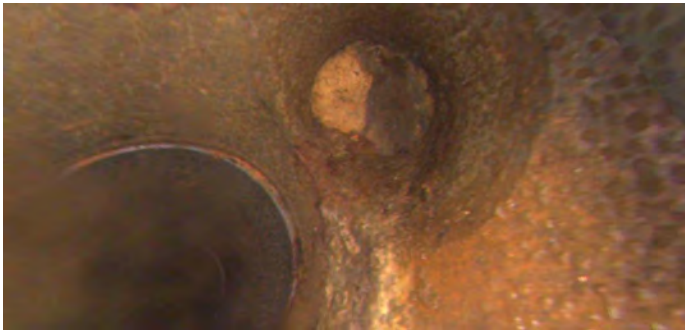
Code: **TFC**
Description: **Tap Factory Capped**

Distance (ft): **42.3**
Structural Grade: **0**
O&M Grade: **0**
Clock Start/From: **1**
Clock To:
1st Value: **4.000**
2nd Value:
Value Percent:
Continuous Index:
Within 8" of Joint: **YES**
Remarks:

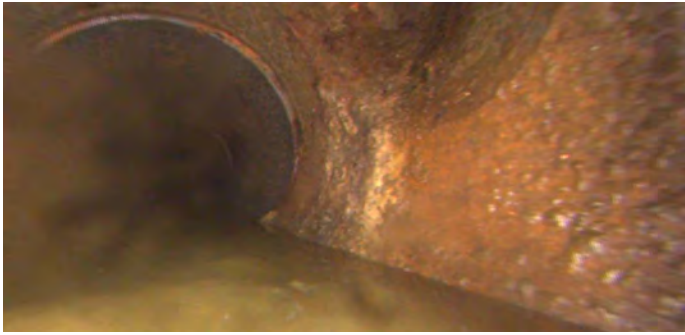
Code: **DAZ**
Description: **Deposits Attached Other**

Distance (ft): **42.3**
Structural Grade: **0**
O&M Grade: **2**
Clock Start/From: **3**
Clock To: **5**
1st Value:
2nd Value:
Value Percent: **5.000**
Continuous Index:
Within 8" of Joint: **NO**
Remarks:

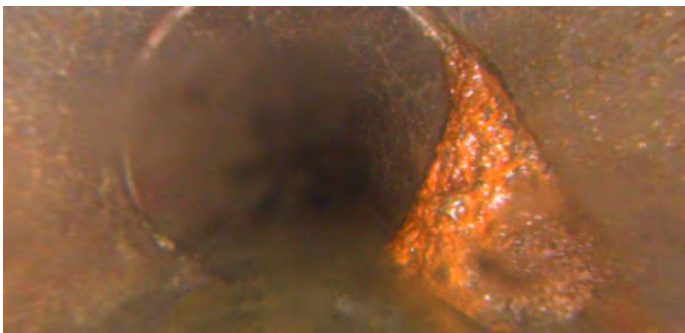
Code: **DAE**
Description: **Deposits Attached Encrustation**

Distance (ft): **50.6**
Structural Grade: **0**
O&M Grade: **2**
Clock Start/From: **2**
Clock To: **5**
1st Value:
2nd Value:
Value Percent: **5.000**
Continuous Index:
Within 8" of Joint: **YES**
Remarks:

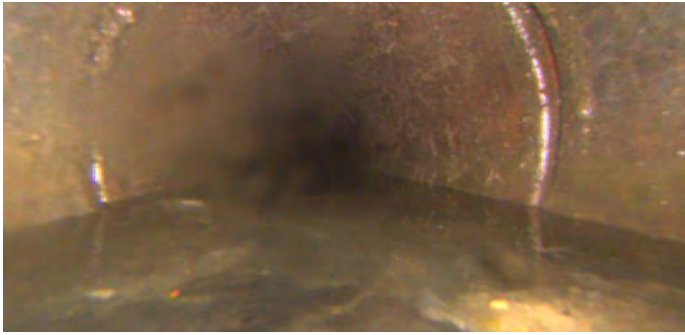
Code: **MSA**
Description: **Abandoned Survey**

Distance (ft): **58.1**
Structural Grade: **0**
O&M Grade: **0**
Clock Start/From:
Clock To:
1st Value:
2nd Value:
Value Percent:
Continuous Index:
Within 8" of Joint: **NO**
Remarks: **no blockage**

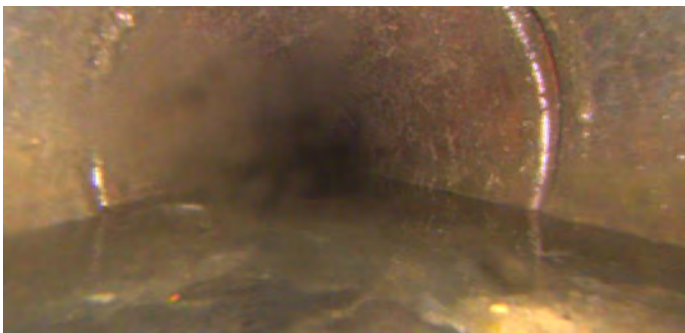
Code: **DAZ**
Description: **Deposits Attached Other**

Distance (ft): **58.1**
Structural Grade: **0**
O&M Grade: **2**
Clock Start/From: **12**
Clock To: **5**
1st Value:
2nd Value:
Value Percent: **5.000**
Continuous Index: **F03**
Within 8" of Joint: **YES**
Remarks: **wandering**

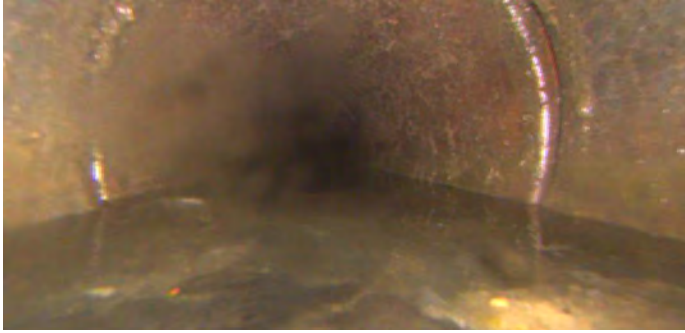
Code: **DSZ**
Description: **Deposits Settled Other**

Distance (ft): **58.1**
Structural Grade: **0**
O&M Grade: **2**
Clock Start/From: **6**
Clock To:
1st Value:
2nd Value:
Value Percent: **5.000**
Continuous Index: **F02**
Within 8" of Joint: **NO**
Remarks: **tissue/debris**

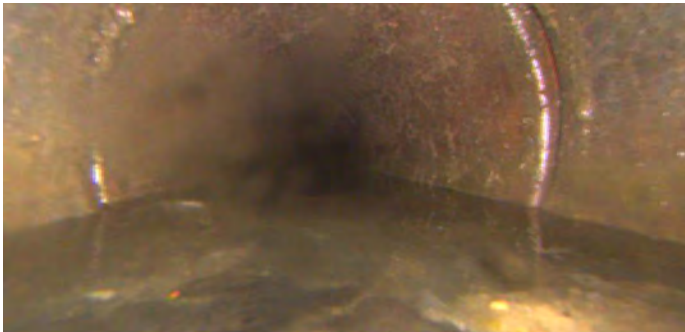
Code: **CM**
Description: **Crack Multiple**

Distance (ft): **58.1**
Structural Grade: **3**
O&M Grade: **0**
Clock Start/From: **7**
Clock To: **5**
1st Value:
2nd Value:
Value Percent:
Continuous Index: **F01**
Within 8" of Joint: **YES**
Remarks:
