Profile/Photo Observation Report

Date:	04/20/2018	Weather:		Coding:	PACP 6.0
Pipe Length (ft):	270.1	Owner:	NA	Pre Clean:	Not Known
P.O.#:		Surveyor:	Byrd Fitzgerald	PSR:	P-604-069-068
Customer:		Clean Date:	01/01/1900	Shape:	C

Street:	Summerlin	Flow Control:	Not Controlled
City:	Hobart, IN	Year Renewed:	
Location:	Light Highway	Tape/Media #:	
Purpose:	Not Known	Dia/Height:	10"
Use:	Sanitary	Material:	VCP
Drain Area:	NA	Lining:	
Category:	NA		
Comment:

Location Details:		Direction of Survey:	Downstream
US MH:	M-604-068	DS MH:	M-604-069
		Total Length Surveyed (ft):	58.1

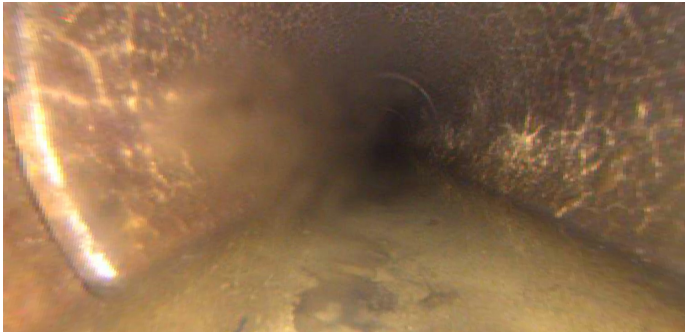
Code:	MWL
Description:	Water Level

Distance (ft):	.0
Structural Grade:	0
O&M Grade:	0
Clock Start/From:	
Clock To:	
1st Value:	
2nd Value:	
Value Percent:	5.000
Continuous Index:	
Within 8" of Joint:	NO
Remarks:

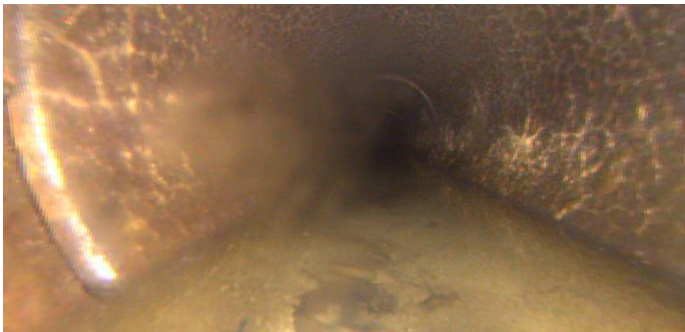
Code:	CM
Description:	Crack Multiple

Distance (ft):	.0
Structural Grade:	3
O&M Grade:	0
Clock Start/From:	7
Clock To:	5
1st Value:	
2nd Value:	
Value Percent:	
Continuous Index:	S01
Within 8" of Joint:	YES
Remarks:

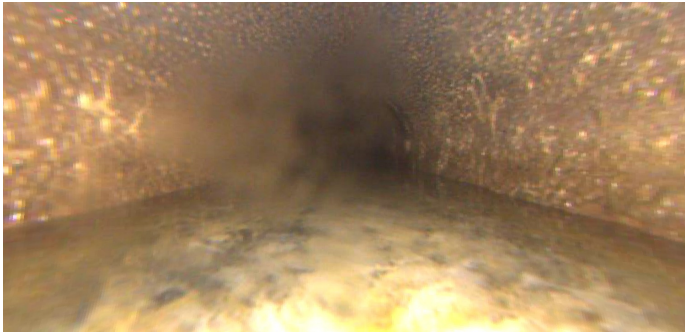
Code: **DSZ**
Description: **Deposits Settled Other**

Distance (ft): **5.6**
Structural Grade: **0**
O&M Grade: **2**
Clock Start/From: **6**
Clock To:
1st Value:
2nd Value:
Value Percent: **5.000**
Continuous Index: **S02**
Within 8" of Joint: **NO**
Remarks: **tissue/debris**

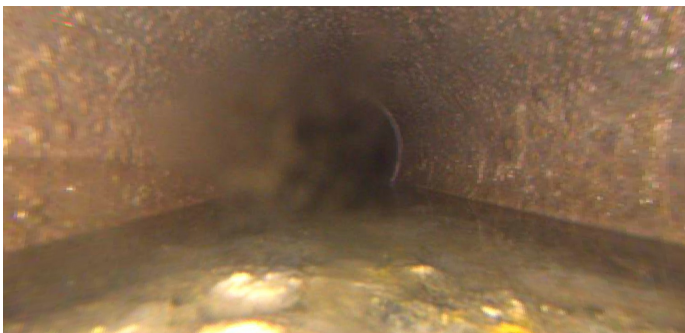
Code: **MWL**
Description: **Water Level**

Distance (ft): **17.9**
Structural Grade: **0**
O&M Grade: **0**
Clock Start/From:
Clock To:
1st Value:
2nd Value:
Value Percent: **25.000**
Continuous Index:
Within 8" of Joint: **NO**
Remarks:

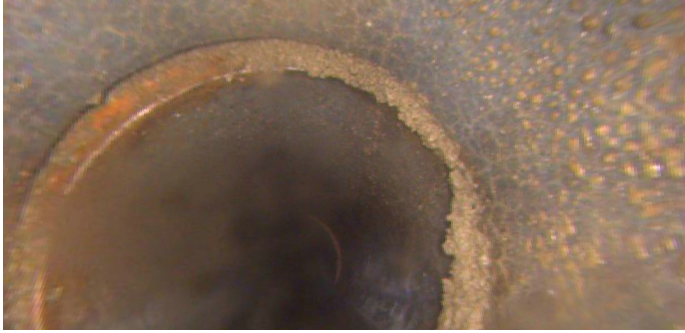
Code: **DAZ**
Description: **Deposits Attached Other**

Distance (ft): **22.9**
Structural Grade: **0**
O&M Grade: **2**
Clock Start/From: **12**
Clock To: **5**
1st Value:
2nd Value:
Value Percent: **5.000**
Continuous Index: **S03**
Within 8" of Joint: **YES**
Remarks: **wandering**

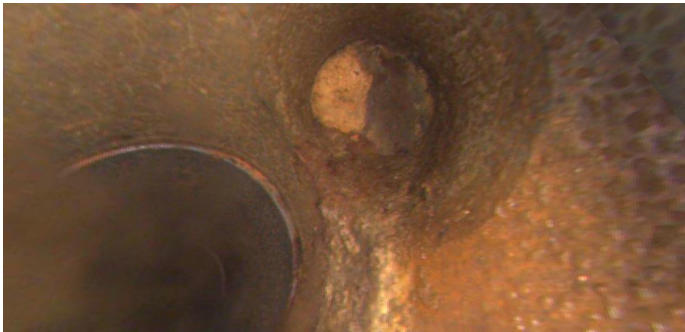
Code: **TFC**
Description: **Tap Factory Capped**

Distance (ft): **42.3**
Structural Grade: **0**
O&M Grade: **0**
Clock Start/From: **1**
Clock To:
1st Value: **4.000**
2nd Value:
Value Percent:
Continuous Index:
Within 8" of Joint: **YES**
Remarks:

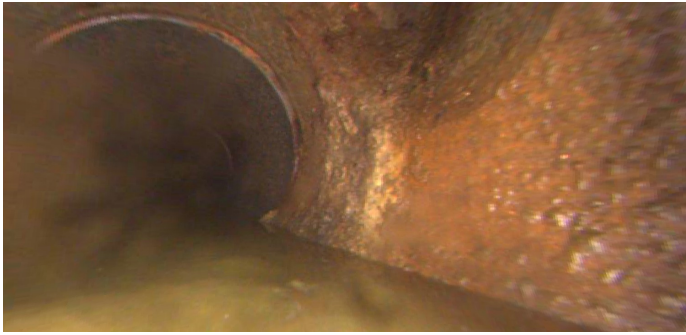
Code: **DAZ**
Description: **Deposits Attached Other**

Distance (ft): **42.3**
Structural Grade: **0**
O&M Grade: **2**
Clock Start/From: **3**
Clock To: **5**
1st Value:
2nd Value:
Value Percent: **5.000**
Continuous Index:
Within 8" of Joint: **NO**
Remarks:

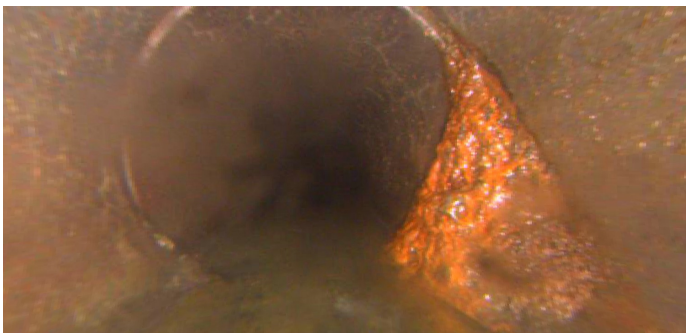
Code: **DAE**
Description: **Deposits Attached Encrustation**

Distance (ft): **50.6**
Structural Grade: **0**
O&M Grade: **2**
Clock Start/From: **2**
Clock To: **5**
1st Value:
2nd Value:
Value Percent: **5.000**
Continuous Index:
Within 8" of Joint: **YES**
Remarks:

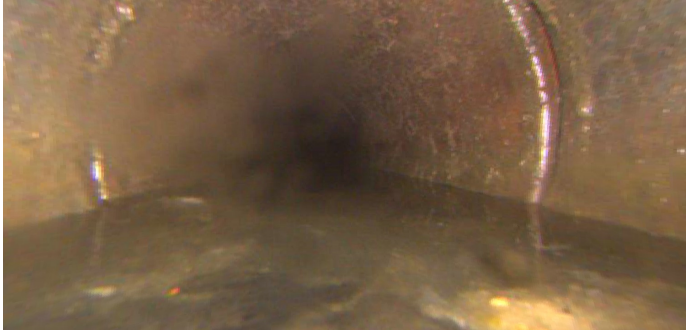
Code: **MSA**
Description: **Abandoned Survey**

Distance (ft): **58.1**
Structural Grade: **0**
O&M Grade: **0**
Clock Start/From:
Clock To:
1st Value:
2nd Value:
Value Percent:
Continuous Index:
Within 8" of Joint: **NO**
Remarks: **no blockage**

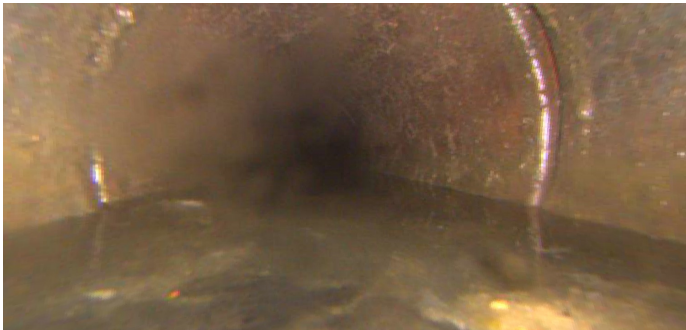
Code: **DAZ**
Description: **Deposits Attached Other**

Distance (ft): **58.1**
Structural Grade: **0**
O&M Grade: **2**
Clock Start/From: **12**
Clock To: **5**
1st Value:
2nd Value:
Value Percent: **5.000**
Continuous Index: **F03**
Within 8" of Joint: **YES**
Remarks: **wandering**

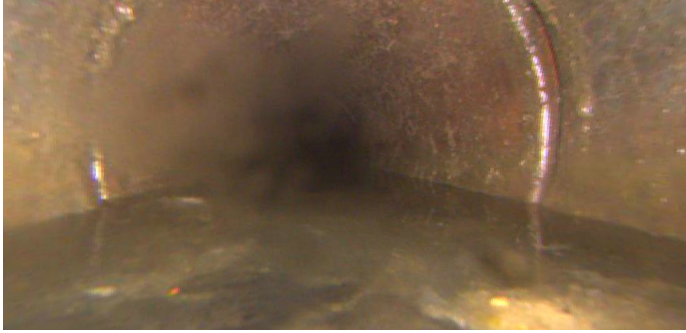
Code: **DSZ**
Description: **Deposits Settled Other**

Distance (ft): **58.1**
Structural Grade: **0**
O&M Grade: **2**
Clock Start/From: **6**
Clock To:
1st Value:
2nd Value:
Value Percent: **5.000**
Continuous Index: **F02**
Within 8" of Joint: **NO**
Remarks: **tissue/debris**

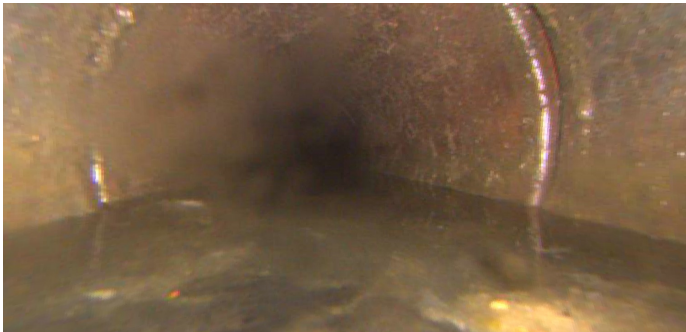
Code: **CM**
Description: **Crack Multiple**

Distance (ft): **58.1**
Structural Grade: **3**
O&M Grade: **0**
Clock Start/From: **7**
Clock To: **5**
1st Value:
2nd Value:
Value Percent:
Continuous Index: **F01**
Within 8" of Joint: **YES**
Remarks:
