Profile/Photo Observation Report

Date:	04/25/2018	Weather:		Coding:	PACP 6.0
Pipe Length (ft):	216.5	Owner:	NA	Pre Clean:	Not Known
P.O.#:		Surveyor:	Jen Costello	PSR:	P-604-070-046
Customer:		Clean Date:	01/01/1900	Shape:	C

Street:	Summerlin	Flow Control:	Not Controlled
City:	Hobart, IN	Year Renewed:	
Location:	Light Highway	Tape/Media #:	
Purpose:	Not Known	Dia/Height:	12"
Use:	Sanitary	Material:	VCP
Drain Area:	NA	Lining:	
Category:	NA		
Comment:

Location Details:		Direction of Survey:	Downstream
US MH:	M-604-070	DS MH:	M-605-046
		Total Length Surveyed (ft):	23.7

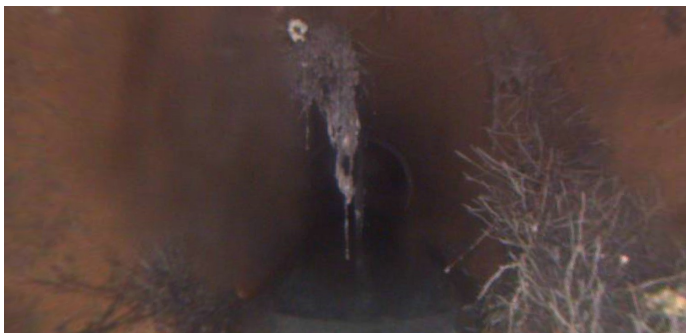
Code: **AMH**
Description: **Manhole**

Distance (ft): **.0**
Structural Grade: **0**
O&M Grade: **0**
Clock Start/From:
Clock To:
1st Value:
2nd Value:
Value Percent:
Continuous Index:
Within 8" of Joint: **NO**
Remarks: **M-604-070**

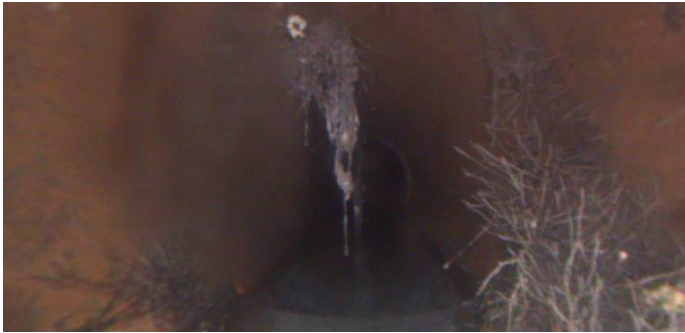
Code:	MWL
Description:	Water Level

Distance (ft):	.0
Structural Grade:	0
O&M Grade:	0
Clock Start/From:	
Clock To:	
1st Value:	
2nd Value:	
Value Percent:	5.000
Continuous Index:	
Within 8" of Joint:	NO
Remarks:

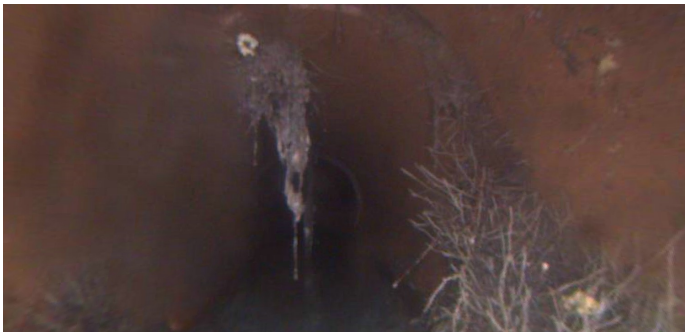
Code:	RMJ
Description:	Roots Medium Joint

Distance (ft):	.0
Structural Grade:	0
O&M Grade:	3
Clock Start/From:	8
Clock To:	4
1st Value:	
2nd Value:	
Value Percent:	10.000
Continuous Index:	
Within 8" of Joint:	YES
Remarks:

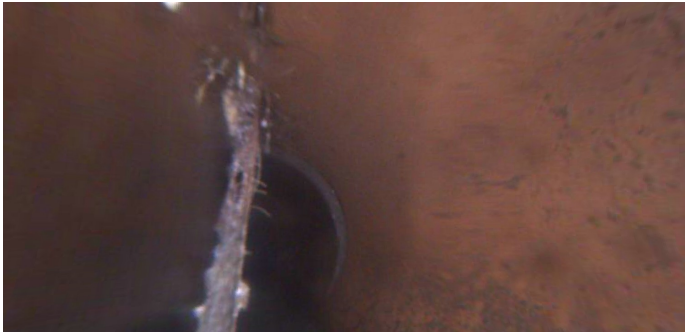
Code: **FL**
Description: **Fracture Longitudinal**

Distance (ft): **2.6**
Structural Grade: **3**
O&M Grade: **0**
Clock Start/From: **12**
Clock To:
1st Value:
2nd Value:
Value Percent:
Continuous Index: **S01**
Within 8" of Joint: **YES**
Remarks:

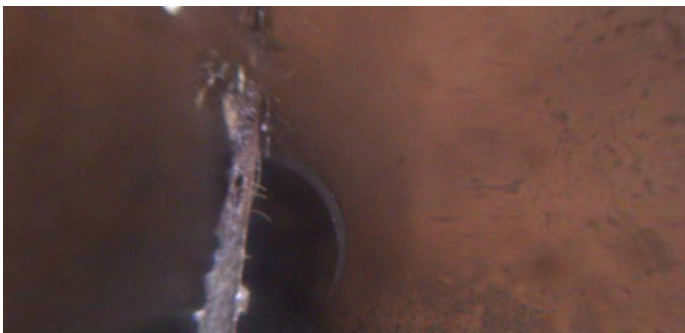
Code: **RMB**
Description: **Roots Medium Barrel**

Distance (ft): **2.6**
Structural Grade: **0**
O&M Grade: **4**
Clock Start/From: **12**
Clock To:
1st Value:
2nd Value:
Value Percent: **5.000**
Continuous Index:
Within 8" of Joint: **NO**
Remarks:

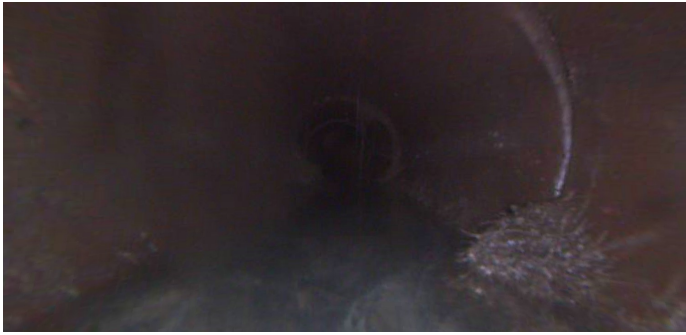
Code: **RMJ**
Description: **Roots Medium Joint**

Distance (ft): **5.3**
Structural Grade: **0**
O&M Grade: **3**
Clock Start/From: **8**
Clock To: **4**
1st Value:
2nd Value:
Value Percent: **5.000**
Continuous Index: **S02**
Within 8" of Joint: **YES**
Remarks:

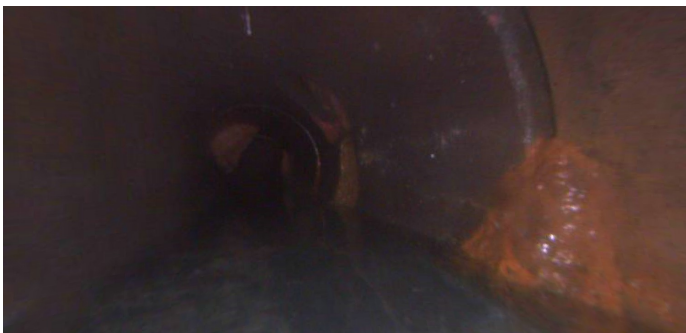
Code: **DAE**
Description: **Deposits Attached Encrustation**

Distance (ft): **9.7**
Structural Grade: **0**
O&M Grade: **2**
Clock Start/From: **3**
Clock To: **4**
1st Value:
2nd Value:
Value Percent: **5.000**
Continuous Index:
Within 8" of Joint: **YES**
Remarks:

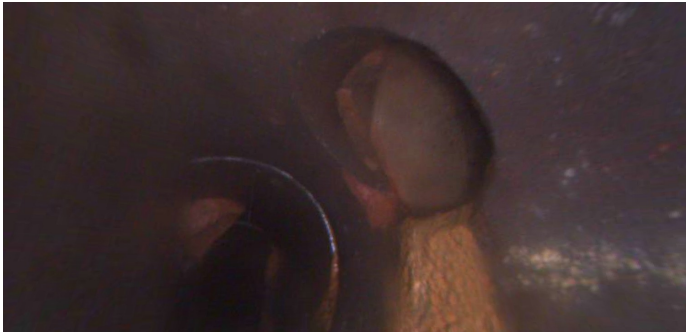
Code: **TFD**
Description: **Tap Factory Defective**

Distance (ft): **10.6**
Structural Grade: **0**
O&M Grade: **2**
Clock Start/From: **2**
Clock To:
1st Value: **4.000**
2nd Value:
Value Percent:
Continuous Index:
Within 8" of Joint:
Remarks: **dae**

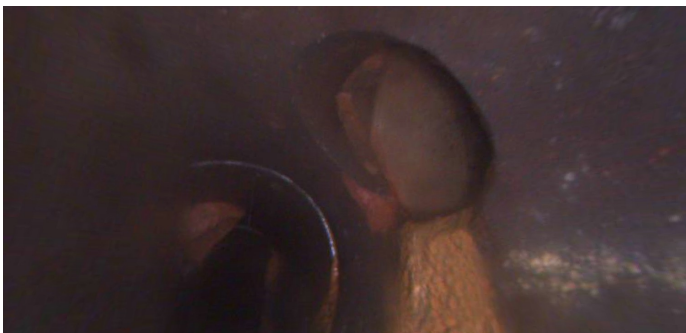
Code: **DAE**
Description: **Deposits Attached Encrustation**

Distance (ft): **10.6**
Structural Grade: **0**
O&M Grade: **2**
Clock Start/From: **3**
Clock To: **4**
1st Value:
2nd Value:
Value Percent: **5.000**
Continuous Index:
Within 8" of Joint: **NO**
Remarks:

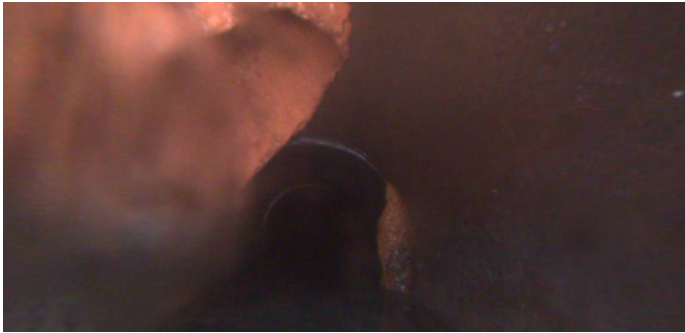
Code: **TBI**
Description: **Tap Break-in Intruding**

Distance (ft): **12.6**
Structural Grade: **0**
O&M Grade: **2**
Clock Start/From: **10**
Clock To:
1st Value: **4.000**
2nd Value: **2.000**
Value Percent:
Continuous Index:
Within 8" of Joint:
Remarks:

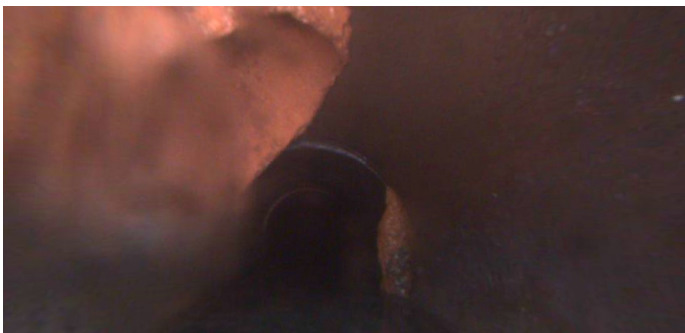
Code: **FL**
Description: **Fracture Longitudinal**

Distance (ft): **12.6**
Structural Grade: **3**
O&M Grade: **0**
Clock Start/From: **12**
Clock To:
1st Value:
2nd Value:
Value Percent:
Continuous Index: **F01**
Within 8" of Joint: **YES**
Remarks:

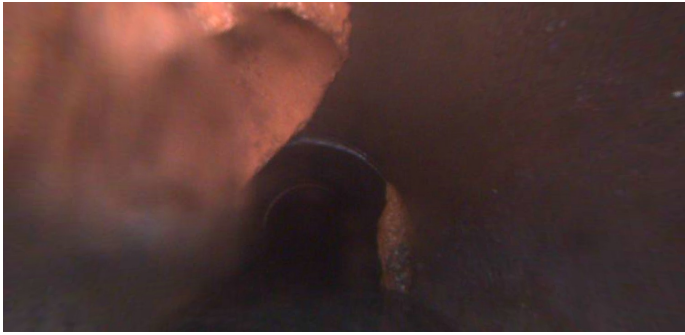
Code: **RMJ**
Description: **Roots Medium Joint**

Distance (ft): **12.6**
Structural Grade: **0**
O&M Grade: **3**
Clock Start/From: **8**
Clock To: **4**
1st Value:
2nd Value:
Value Percent: **5.000**
Continuous Index: **F02**
Within 8" of Joint: **YES**
Remarks:

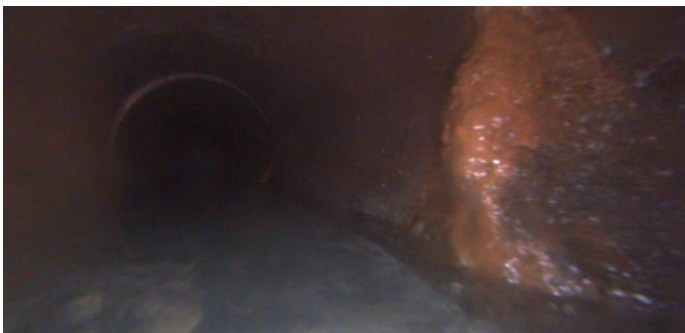
Code: **DAE**
Description: **Deposits Attached Encrustation**

Distance (ft): **13.7**
Structural Grade: **0**
O&M Grade: **2**
Clock Start/From: **3**
Clock To: **4**
1st Value:
2nd Value:
Value Percent: **10.000**
Continuous Index:
Within 8" of Joint: **YES**
Remarks:

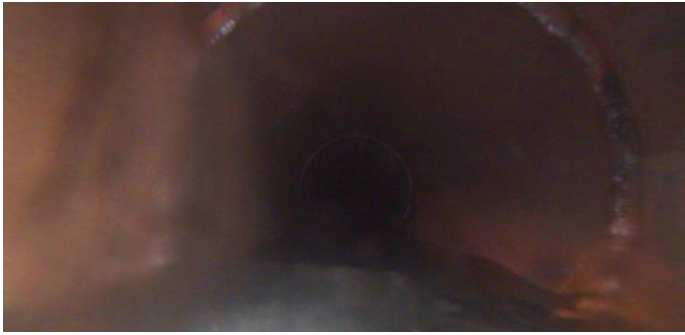
Code: **IW**
Description: **Infil Weeper**

Distance (ft): **15.5**
Structural Grade: **0**
O&M Grade: **2**
Clock Start/From: **8**
Clock To: **4**
1st Value:
2nd Value:
Value Percent:
Continuous Index: **S03**
Within 8" of Joint: **YES**
Remarks:

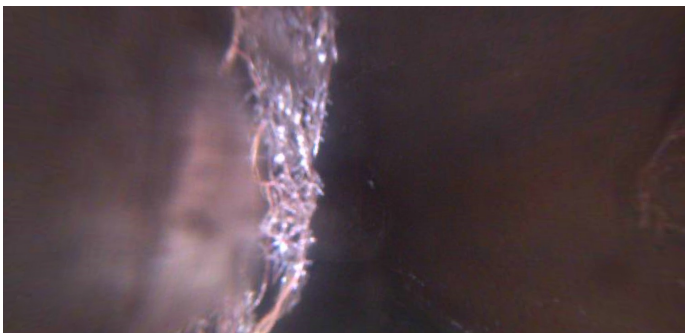
Code: **RMJ**
Description: **Roots Medium Joint**

Distance (ft): **22.0**
Structural Grade: **0**
O&M Grade: **3**
Clock Start/From: **8**
Clock To: **4**
1st Value:
2nd Value:
Value Percent: **10.000**
Continuous Index:
Within 8" of Joint: **YES**
Remarks:

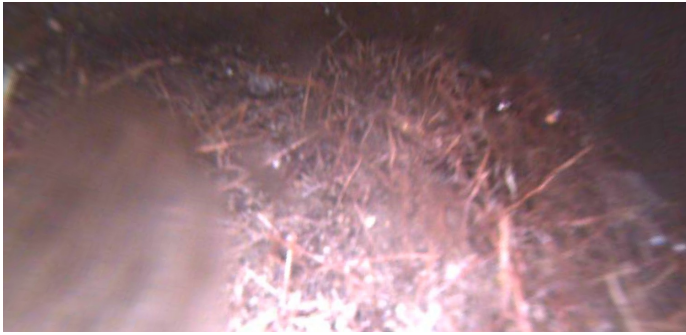
Code: **RBJ**
Description: **Roots Ball Joint**

Distance (ft): **23.7**
Structural Grade: **0**
O&M Grade: **4**
Clock Start/From: **12**
Clock To: **12**
1st Value:
2nd Value:
Value Percent: **90.000**
Continuous Index:
Within 8" of Joint: **YES**
Remarks:

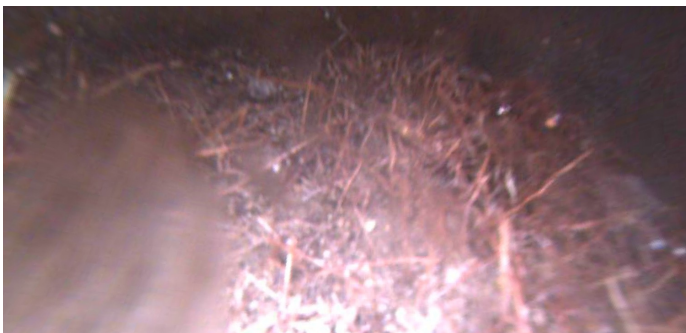
Code: **MSA**
Description: **Abandoned Survey**

Distance (ft): **23.7**
Structural Grade: **0**
O&M Grade: **0**
Clock Start/From:
Clock To:
1st Value:
2nd Value:
Value Percent:
Continuous Index:
Within 8" of Joint: **NO**
Remarks: **roots**

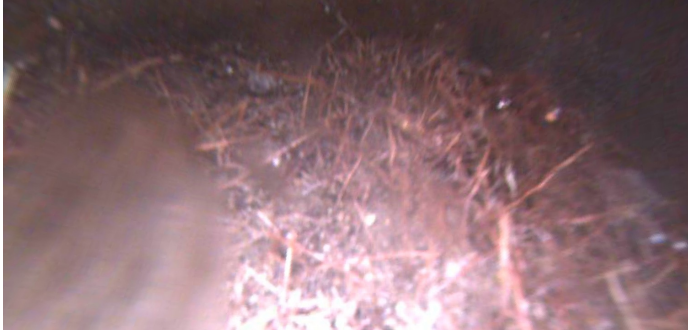
Code:	IW
Description:	Infil Weeper
Distance (ft):	23.7
Structural Grade:	0
O&M Grade:	2
Clock Start/From:	8
Clock To:	4
1st Value:	
2nd Value:	
Value Percent:	
Continuous Index:	F03
Within 8" of Joint:	YES
Remarks:
